**MINERALS PROGRAM INSPECTION REPORT**  
**PHONE: (303) 866-3567**

<b>MINE NAME:</b> Burnham Property Borrow	<b>MINE/PROSPECTING ID#:</b> M-2021-031	<b>MINERAL:</b> Borrow material for	<b>COUNTY:</b> Weld
<b>INSPECTION TYPE:</b> Monitoring	<b>WEATHER:</b> Clear	<b>INSP. DATE:</b> October 5, 2022	<b>INSP. TIME:</b> 12:00
<b>OPERATOR:</b> Ames Construction, Inc.	<b>OPERATOR REPRESENTATIVE:</b> Kirk Bergstrom	<b>TYPE OF OPERATION:</b> 111 - Construction by Government Agency

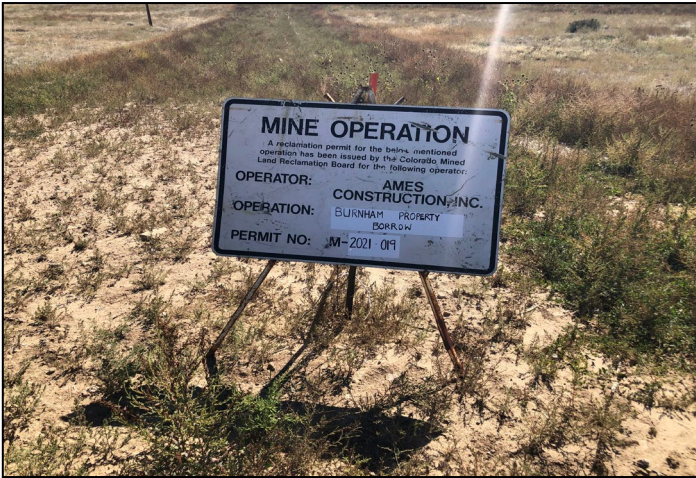
**PROBLEM/POSSIBLE VIOLATION:** Problem: The mine identification sign and affected area boundary markers were incorrect or not observed per the requirements of Rule 3.1.12. The Operator shall, at the entrance of the mine site post a sign, which shall be clearly visible from the access road, with a minimum size equaling one hundred and eighty-seven (187) square inches, such as eleven (11) inches in height and seventeen (17) inches in width, with appropriate font size, with the following: the name of the Operator, a statement that a reclamation permit for the operation has been issued by the Colorado Mined Land Reclamation Board; and the permit number. **The existing mine identification sign has the wrong permit number on it. (M2021-019, when it**

**should read M2021-031)**

**Photo 1 - Incorrect Permit # on Site identification sign will need to be corrected.**

**CORRECTIVE ACTIONS:** The operator must post a sign at the entrance to the mine site which shall be clearly visible from the access road and specify the following; the name of the operator, indicate that a reclamation permit for the operation has been issued by the Colorado Mined Land Reclamation Board, and the (corrected) permit number. The boundaries of the affected area must be marked by monuments or other markers that are clearly visible and adequate to delineate such boundaries. Photos of the corrected sign and boundary markers should be submitted to the Division by the corrective action date listed.

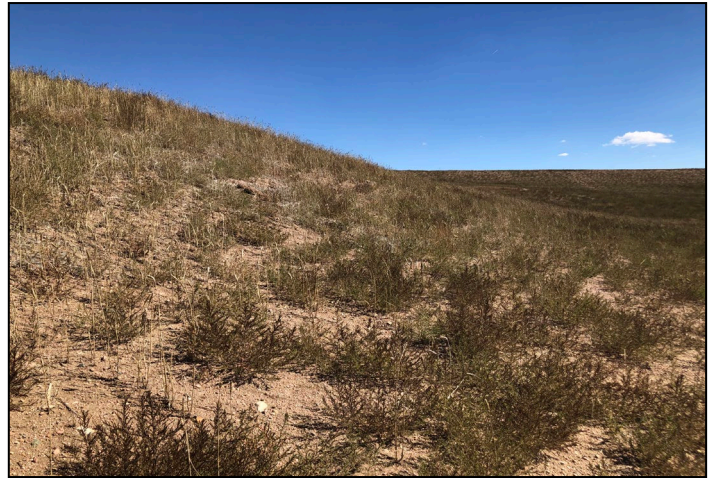
**PROBLEM/POSSIBLE VIOLATION:** Problem: The reclamation vegetation has not established on-site and the site is currently covered by nuisance species - primarily Russian Thistle. Only one species of reclamation grass was observed (a wheatgrass species) and it was thin and spotty in coverage.

**Photo 2 – Earthwork and re-sloping are stable, but site is covered in Russian thistle and only one species of reclamation vegetation was present in small areas.**

**CORRECTIVE ACTIONS:** The site will need to be reseeded in order to establish the desired approved reclamation species, either prior to major snowfall this season or late next spring. The site will need to be monitored to make sure reclamation vegetation becomes established.

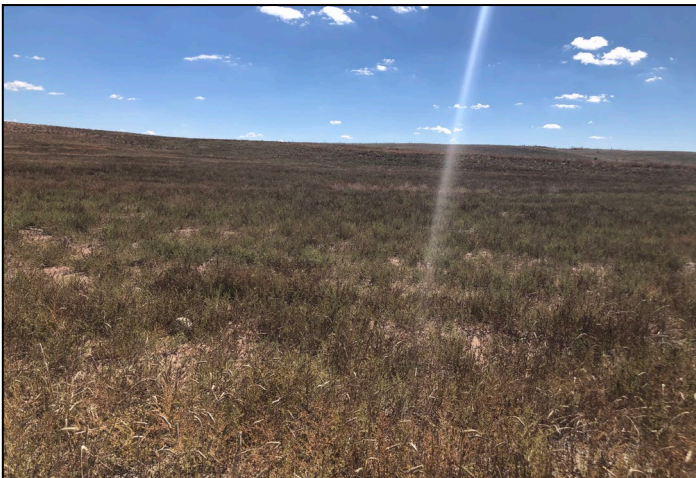
**Photo 3 – Earthwork and re-sloping are stable, but site is covered in Russian thistle and only one species of reclamation vegetation was present in small areas.**
