**MINERALS PROGRAM INSPECTION REPORT**  
**PHONE: (303) 866-3567**

<b>MINE NAME:</b> Cross Gold Mine	<b>MINE/PROSPECTING ID#:</b> M-1977-410	<b>MINERAL:</b> Gold, and silver	<b>COUNTY:</b> Boulder
<b>INSPECTION TYPE:</b> Monitoring	<b>WEATHER:</b> Clear	<b>INSP. DATE:</b> September 26, 2022	<b>INSP. TIME:</b> 09:00
<b>OPERATOR:</b> Grand Island Resources LLC	<b>OPERATOR REPRESENTATIVE:</b> Richard Mittasch	<b>TYPE OF OPERATION:</b> 110(2) - Hard Rock Limited Impact	
<b>REASON FOR INSPECTION:</b> Normal I&E Program	<b>BOND CALCULATION TYPE:</b> None	<b>BOND AMOUNT:</b> \$546,751.00	
<b>DATE OF COMPLAINT:</b> NA	<b>POST INSP. CONTACTS:</b> None	<b>JOINT INSP. AGENCY:</b> None	
<b>INSPECTOR(S):</b> Patrick Lennberg	<b>INSPECTOR'S SIGNATURE:</b>

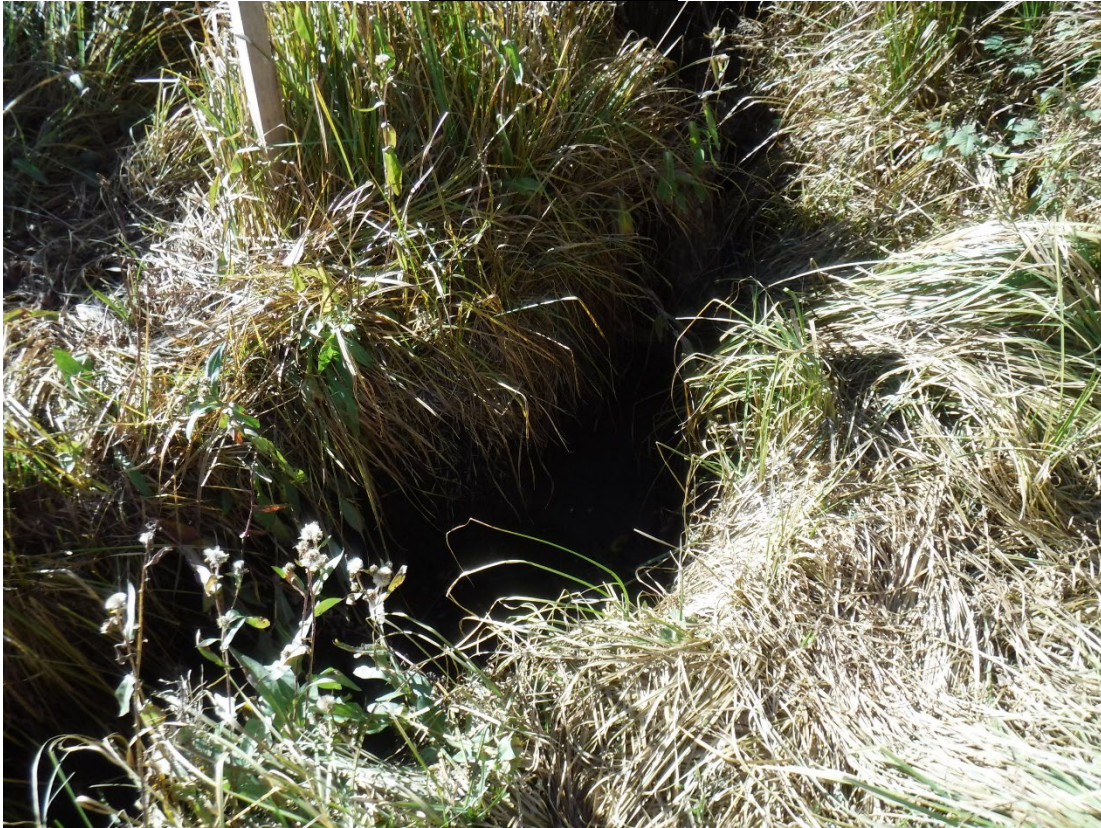
The Operator informed the Division during the inspection that a crew was in the process of collecting surface water samples. The Division was unable to observe sample collection. The Division did observe the upstream surface water location was dry. The downstream location did have water available to sample.

**Photo 1:** Upgradient surface water sampling location, adjacent to Caribou Road, dry

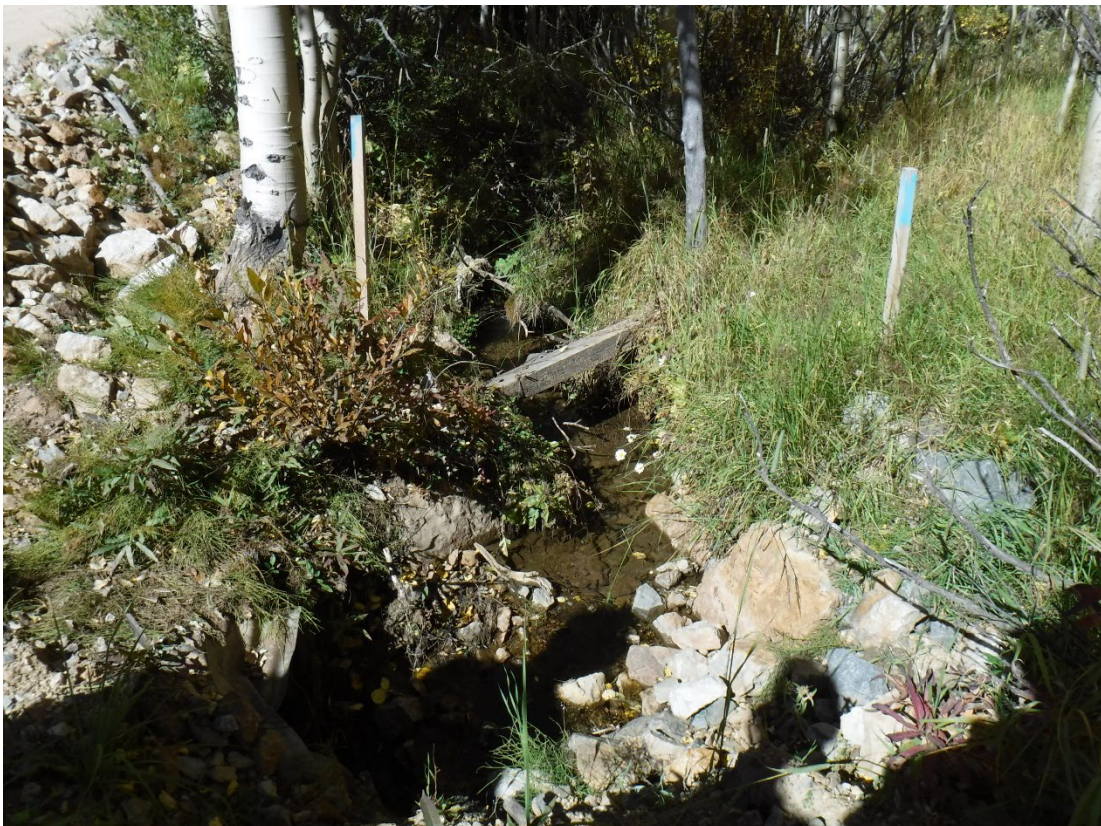
**Photo 2:** Downgradient surface water sampling location

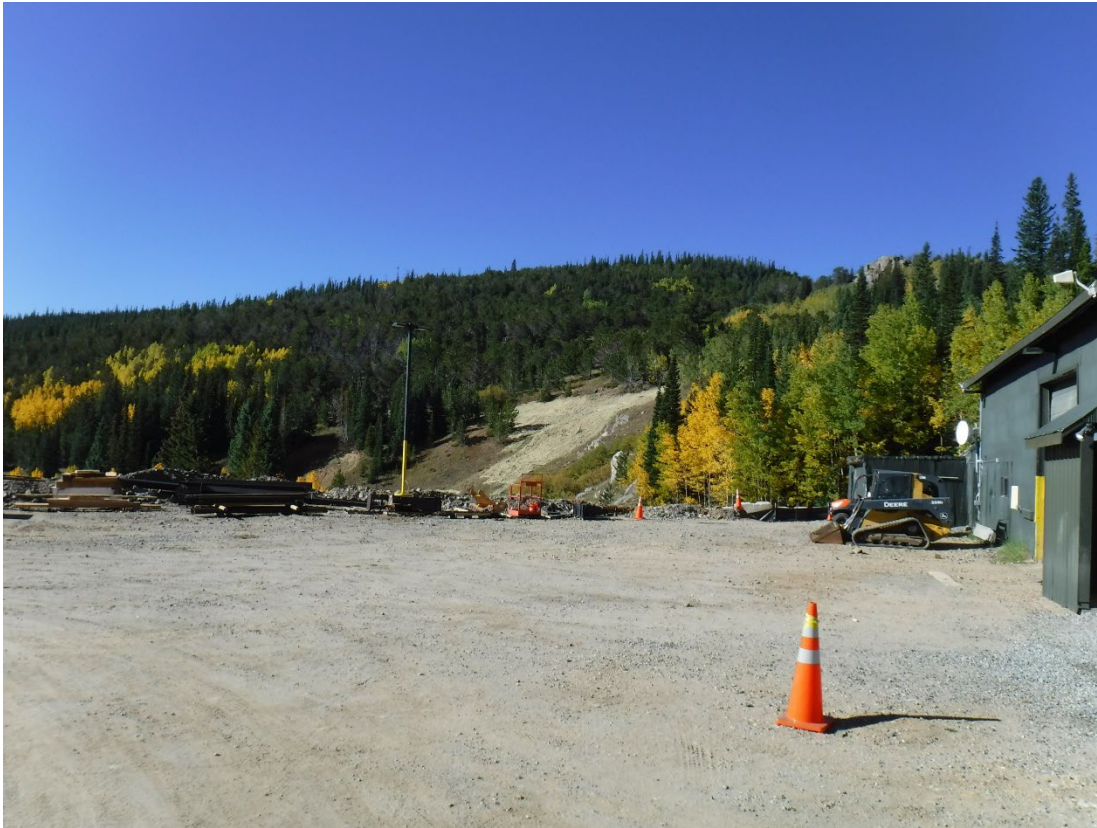
The Operator has recently completed Cross Shaft surface depression remediation and the activity was approved by the Division on June 23, 2022. The activities included filling in of a surface depression using locally sourced material, grading to match the surrounding topography, installation of erosion control mats, and revegetation. As part of the approval the Operator committed to submitting a brief summary report of activities including photographic documentation and approximate quantities of material used.

**Photo 3:** Looking west towards the Cross shaft remediation area from the main parking lot

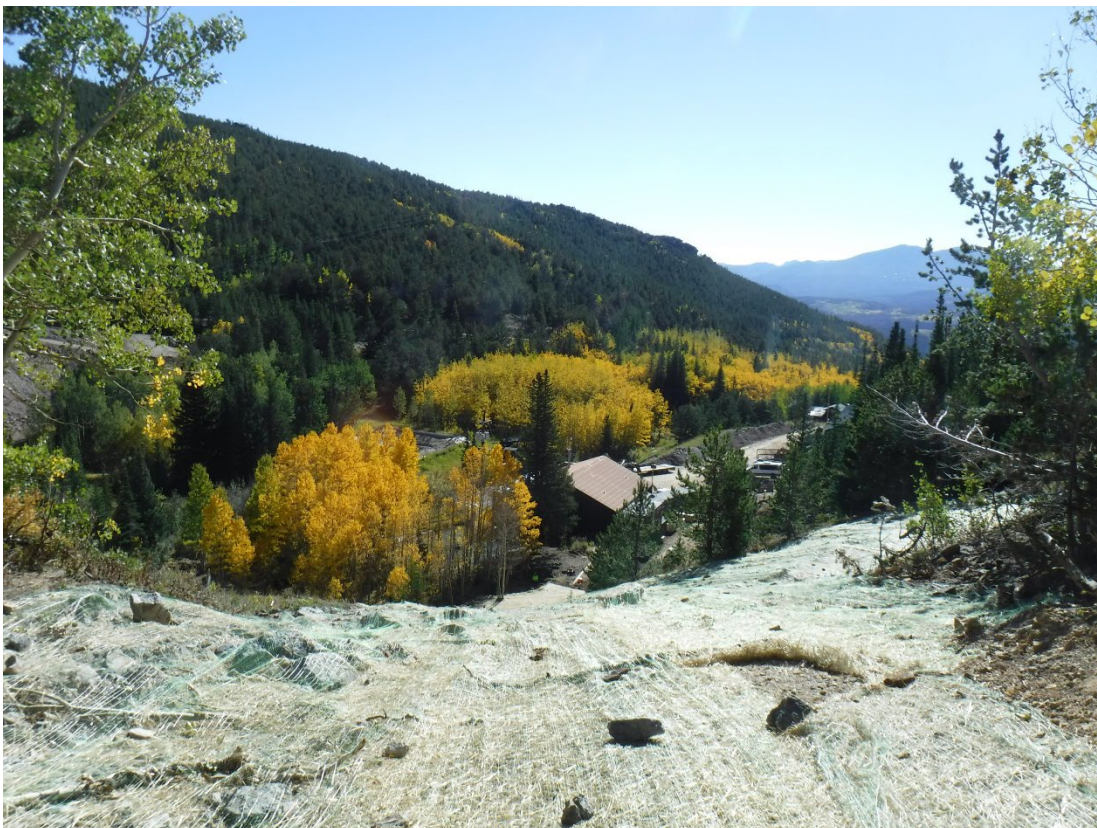
**Photo 4:** Looking down along the Cross shaft remediation area

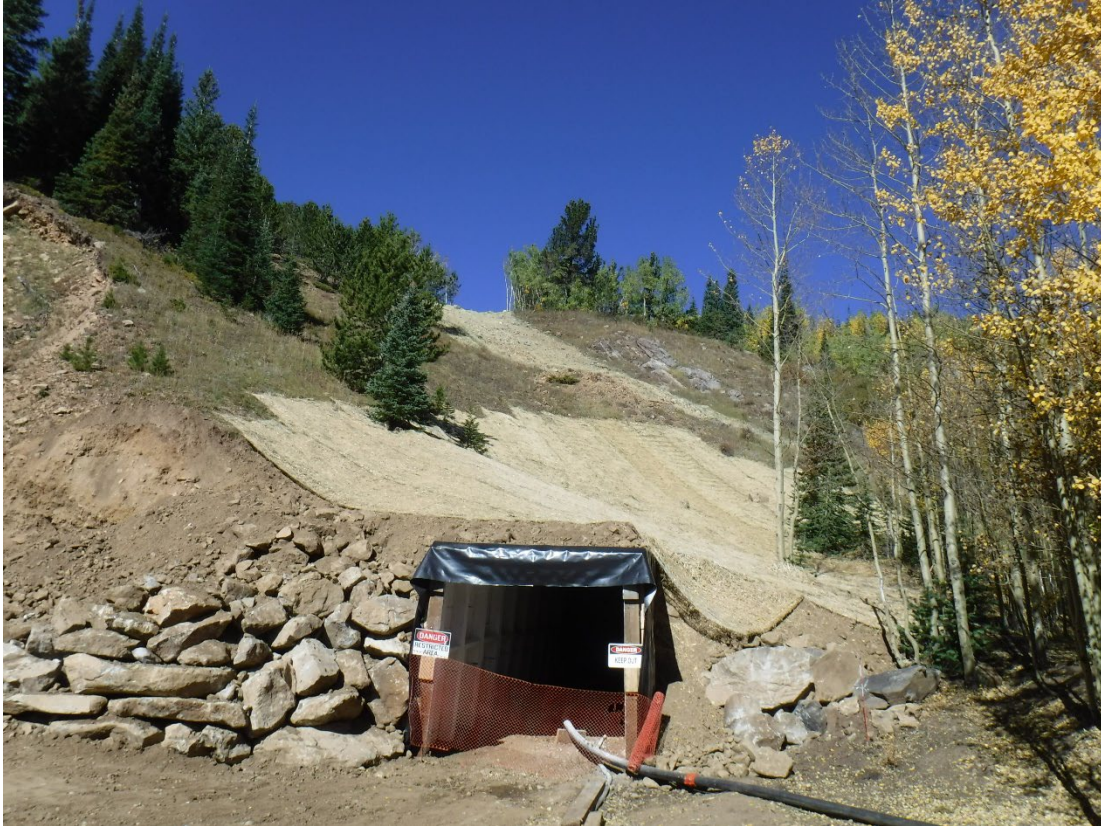
**Photo 5:** Looking up at Cross shaft remediation area from the Cross Mine portal

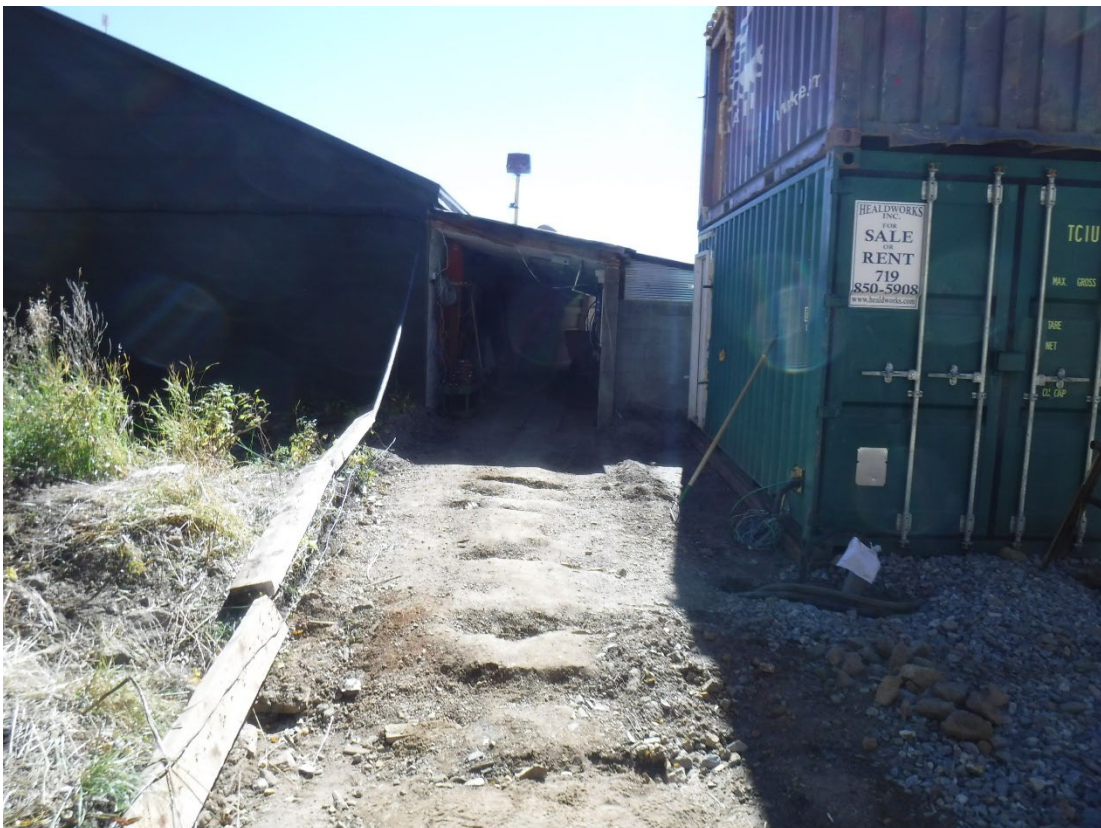
At the Cross Mine entrance the snow shed has been removed along with the associated narrow gauge railroad tracks and timbers. The Operator found the snow shed timbers were rotten and needed to be replaced for safety considerations. During the shed removal it was determined the timbers under the rails were also in very poor condition and need to be replaced. The shed and rails had been removed at the time of inspection and the Operator was waiting for delivery of timbers to begin reconstruction.

**Photo 6:** Snow shed and rail removal from the Cross Mine portal

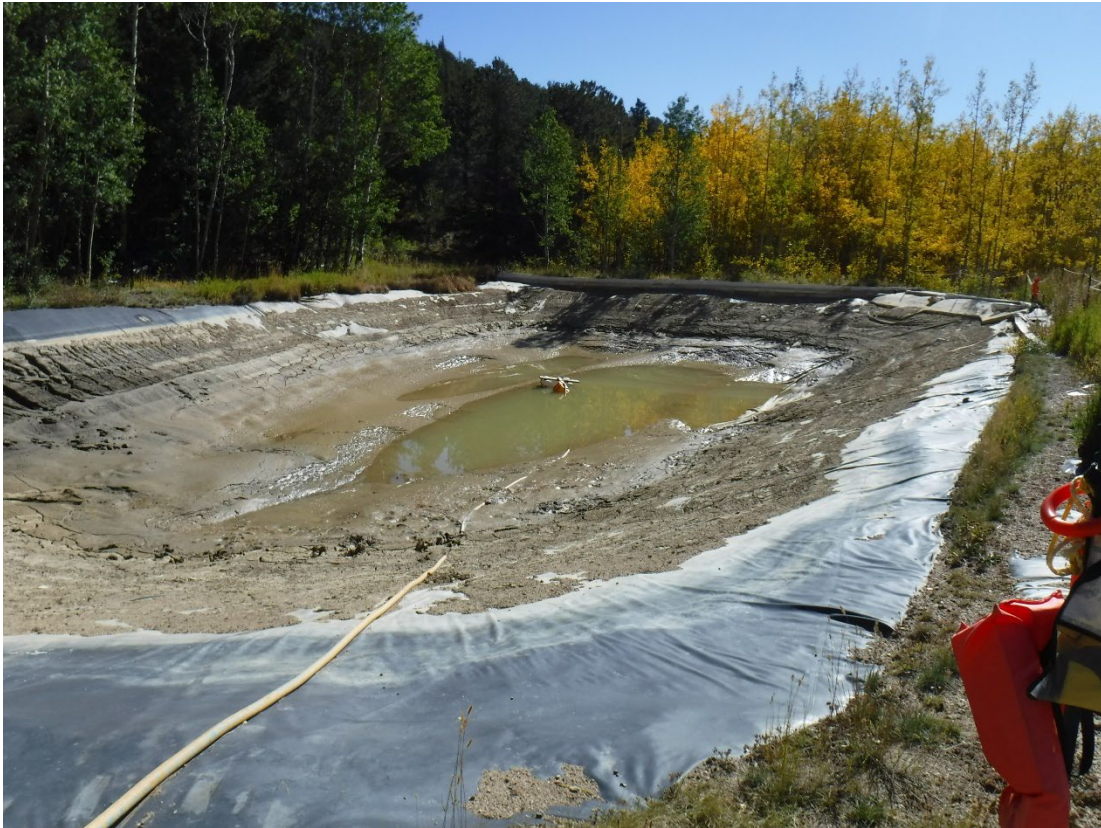
At the time of inspection Pond 2 was close to being completely dewatered. The Operator stated they were in the process of characterizing the sediment remaining in the pond. Initial indications show the sediment is not hazardous. The Operator is in the initial phases of determining how to decommission the pond. Since Pond 2 is part of approved TR-10, as an emergency over flow pond, decommissioning of the pond will need a Technical Revision. At a minimum, the revision shall detail water accounting of where overflow may be directed in case of emergencies and how the sediment will be disposed of properly. The Operator stated they are trying to evaluating whether or not using a wetland as a passive water treatment system might be an effective use of the pond area.

**Photo 7:** Dewatering of Pond 2 with sediment exposed

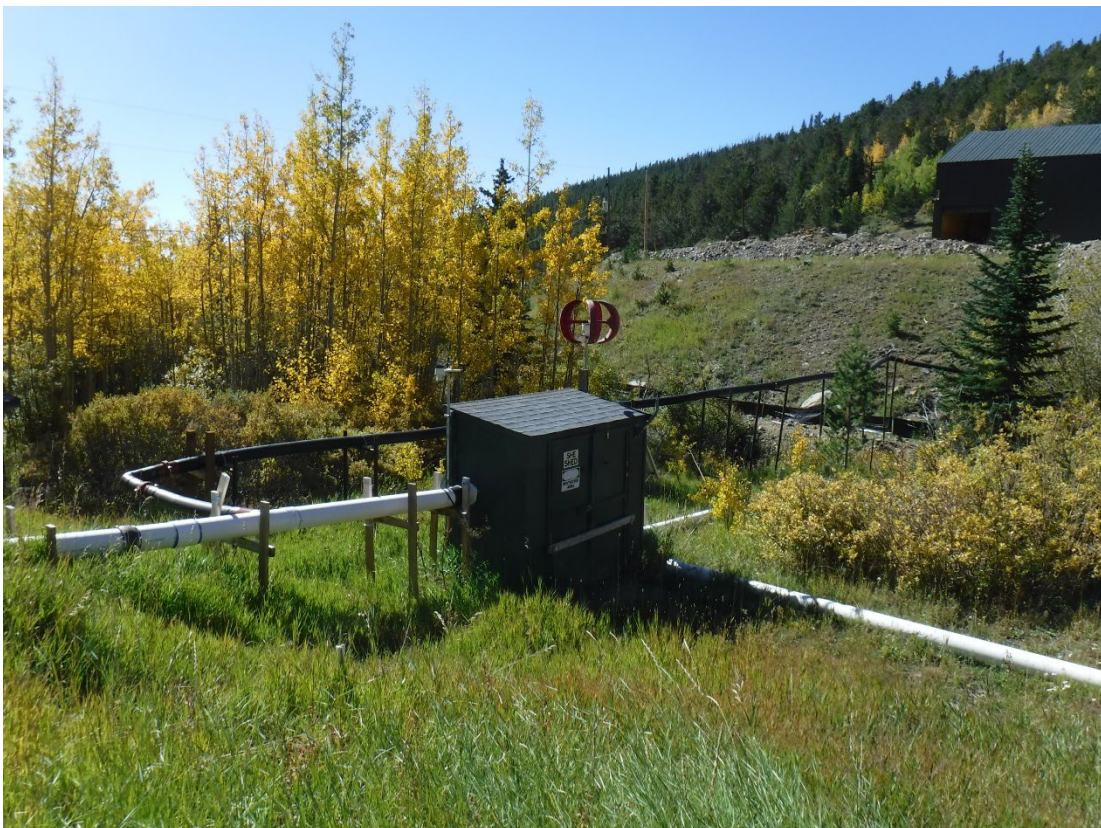
**Photo 8:** Permitted discharge point to Coon Track

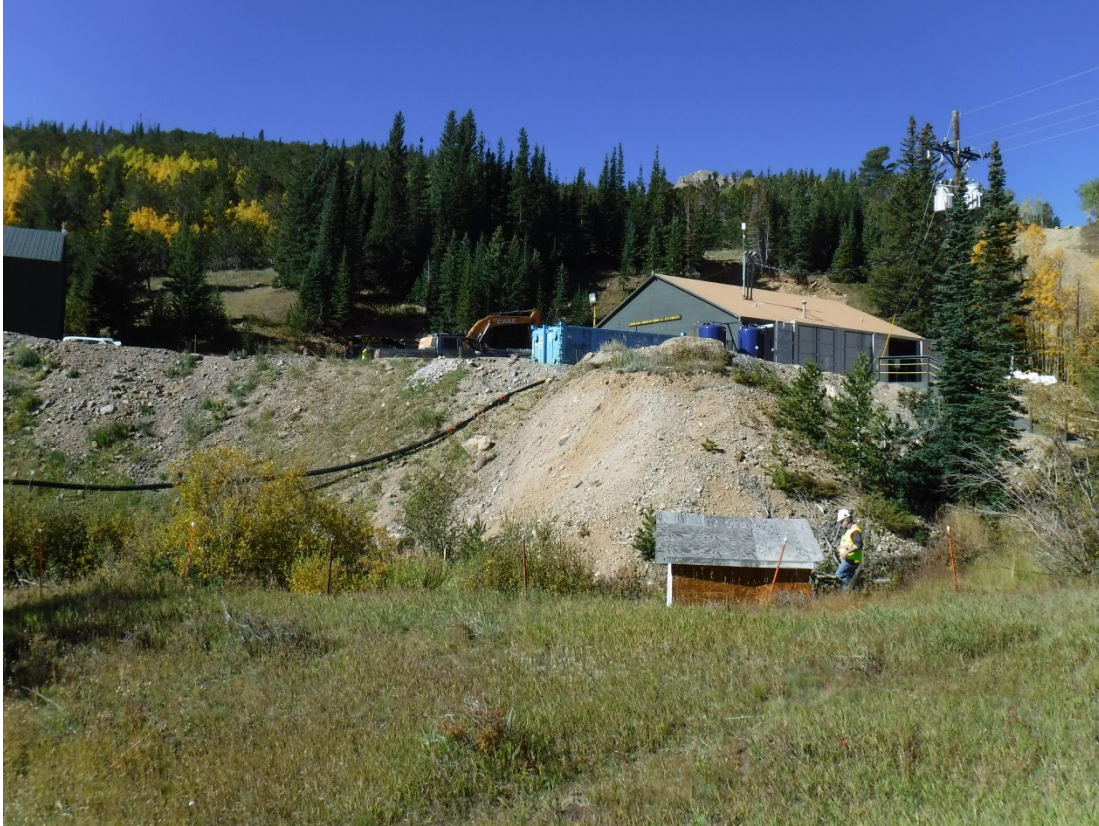
The Division observed the water treatment system which has been operating on site since December of 2021. The system is located inside an insulated Conex box located at the Cross Mine, and includes both filtration and heavy-metal polishing components. Discharge from the Caribou Mine is being routed via pipeline to Pond 1, after passing through Ponds 3a, 3b, and 3c located at the portal, where it combines with discharge from the Cross Mine. Water levels in the pond are being maintained via a pump and pressure transducer system. Water from Pond 1 is pumped via pipeline to the treatment system inside the Conex box. Water entering the treatment system goes through a series of bag filters (5-micron) before entering a vessel with adsorptive materials (MetSorb). A pipeline then routes the treated water from the Conex box to the existing monitoring shed near Pond 2, where it joins with the existing discharge pipeline to Coon Track Creek, the permitted discharge point (CO0032751). Pond 2 is not used to manage mine water under the current treatment regime.

**Photo 9:** Water treatment plant

The Operator inquired whether or not relocating the water treatment Conex box would require a technical revision. The Operator was informed, after the inspection, that indeed a technical revision would need to be submitted to update the maps approved in TR-10 to show where the treatment plant was relocated to and to account for piping configurations.

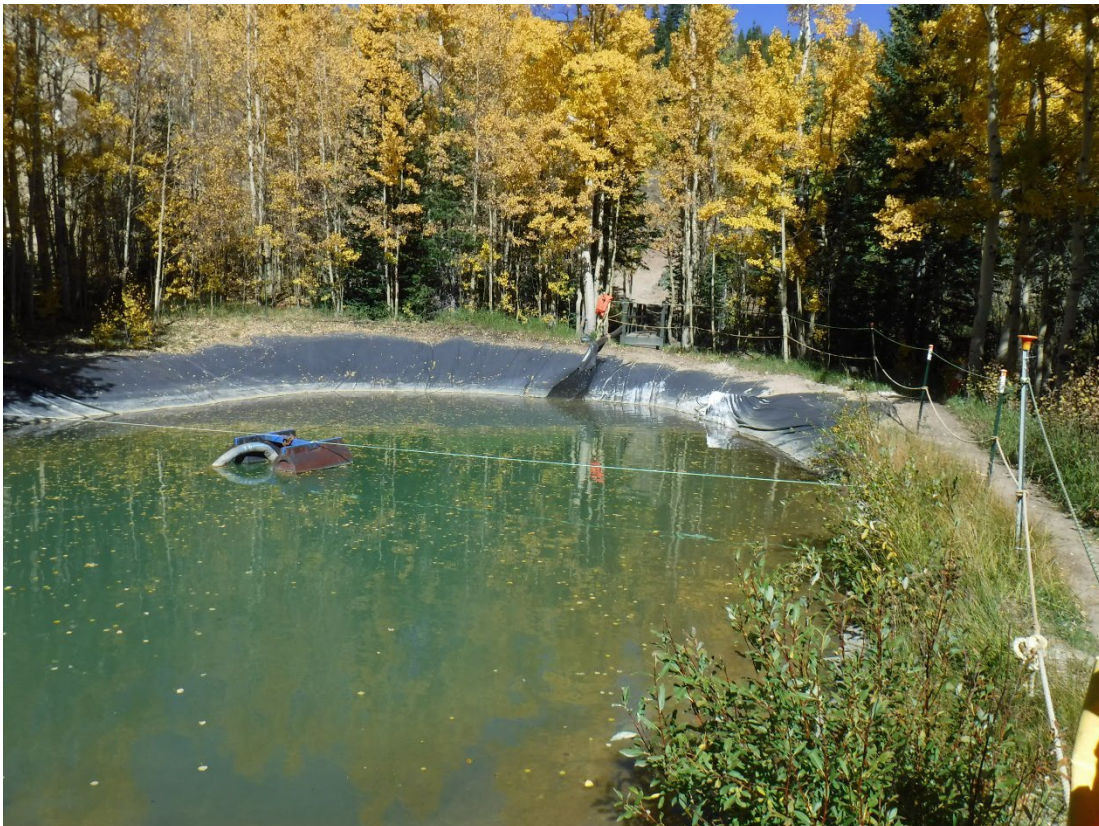
**Photo 10:** Pond 1

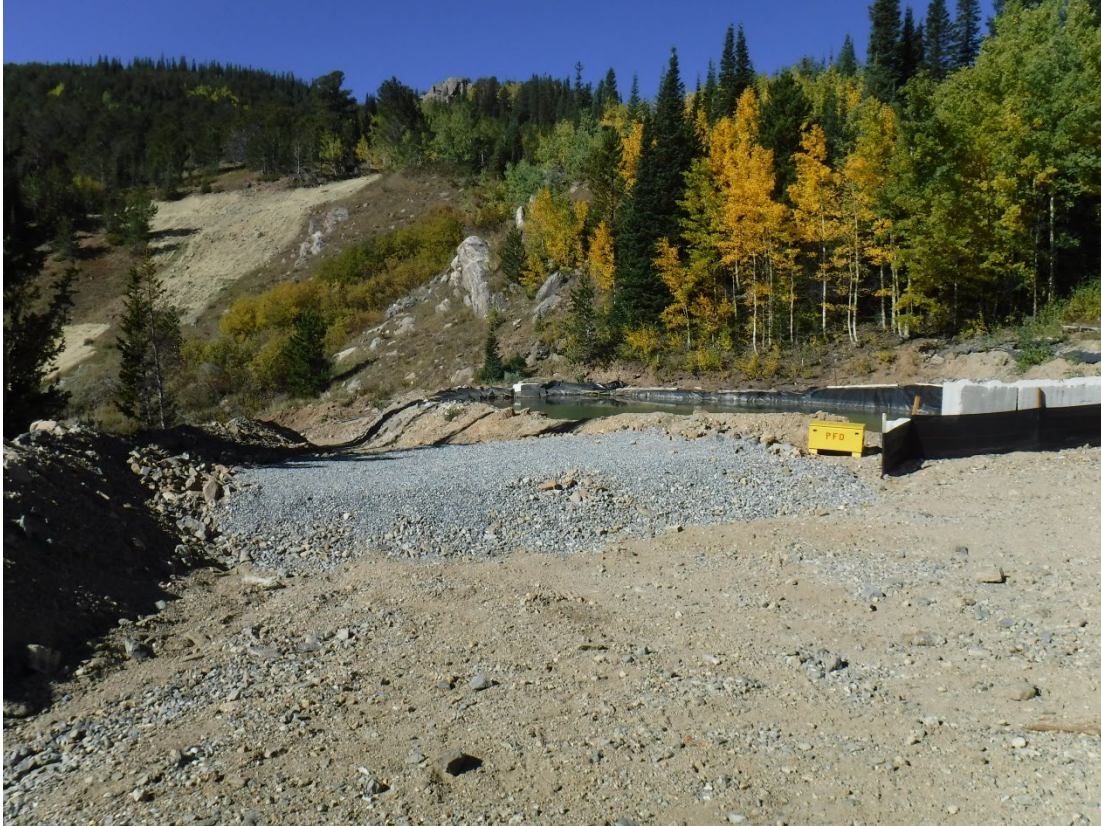
**Photo 11:** Rock check dam to aid in surface erosion control near Pond 3c

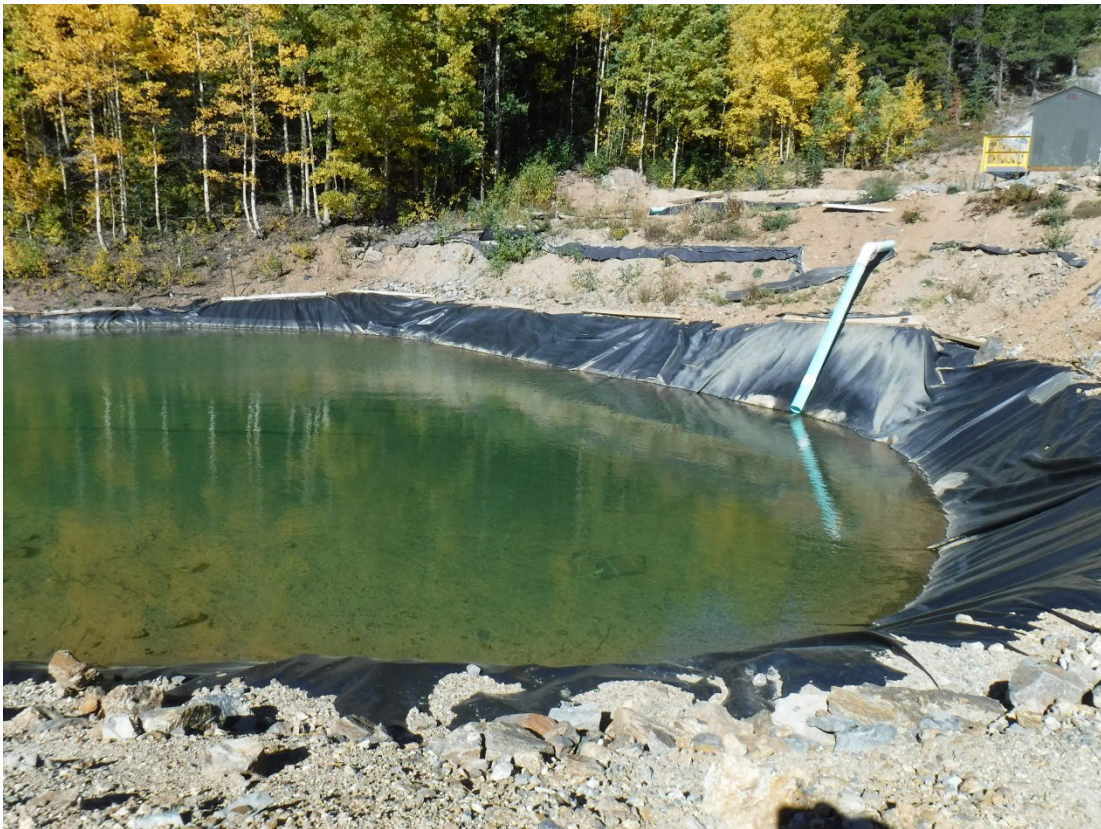
**Photo 12:** Pond 3c

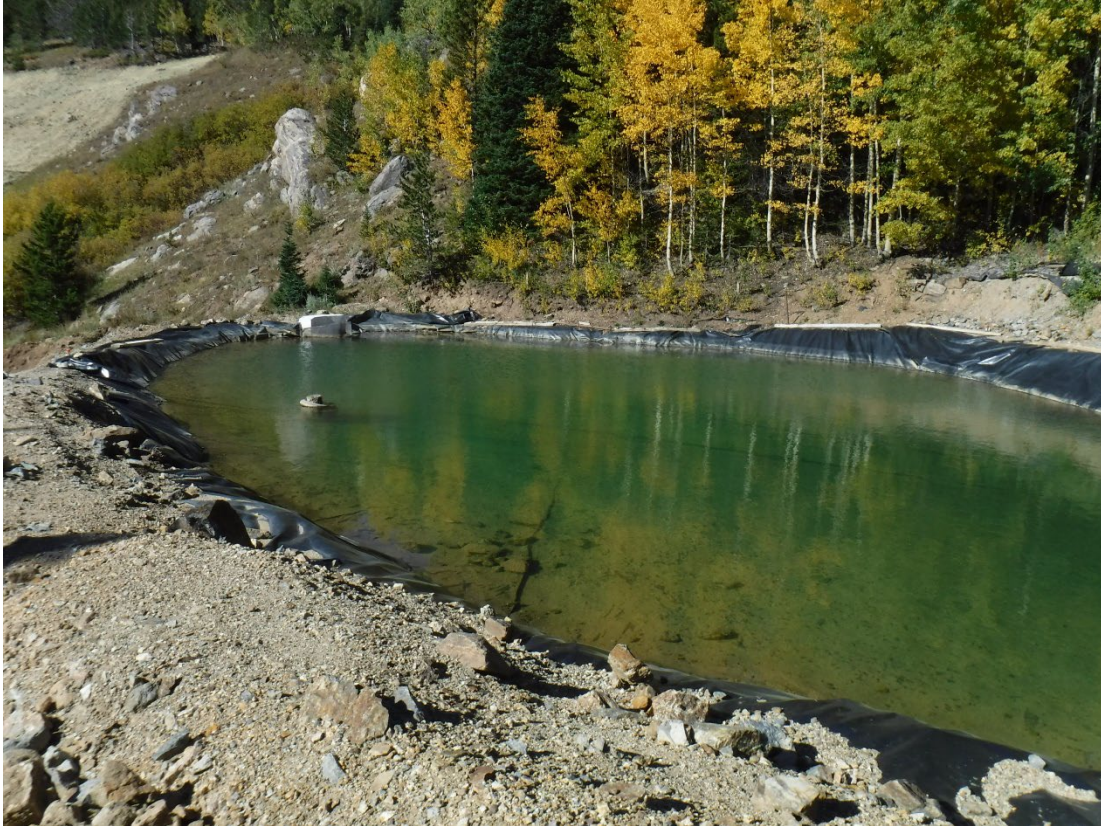
**Photo 13: Pond 3b**

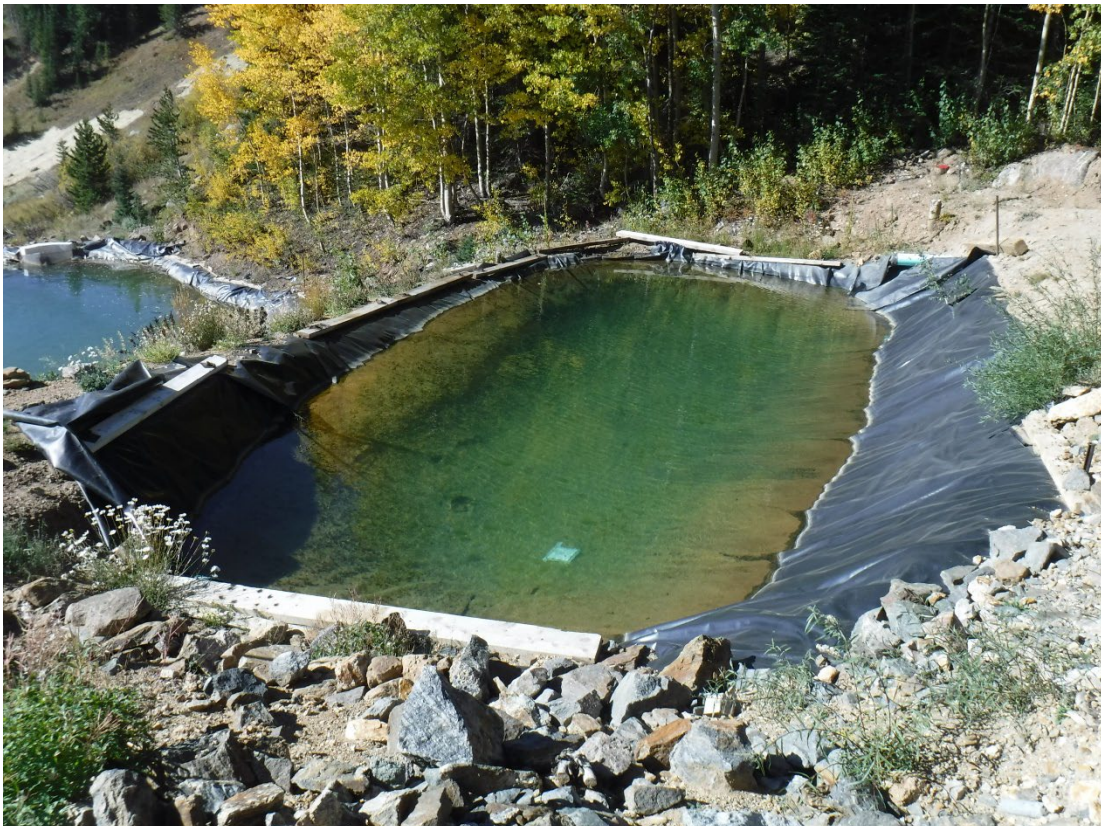
**Photo 14: Pond 3a**

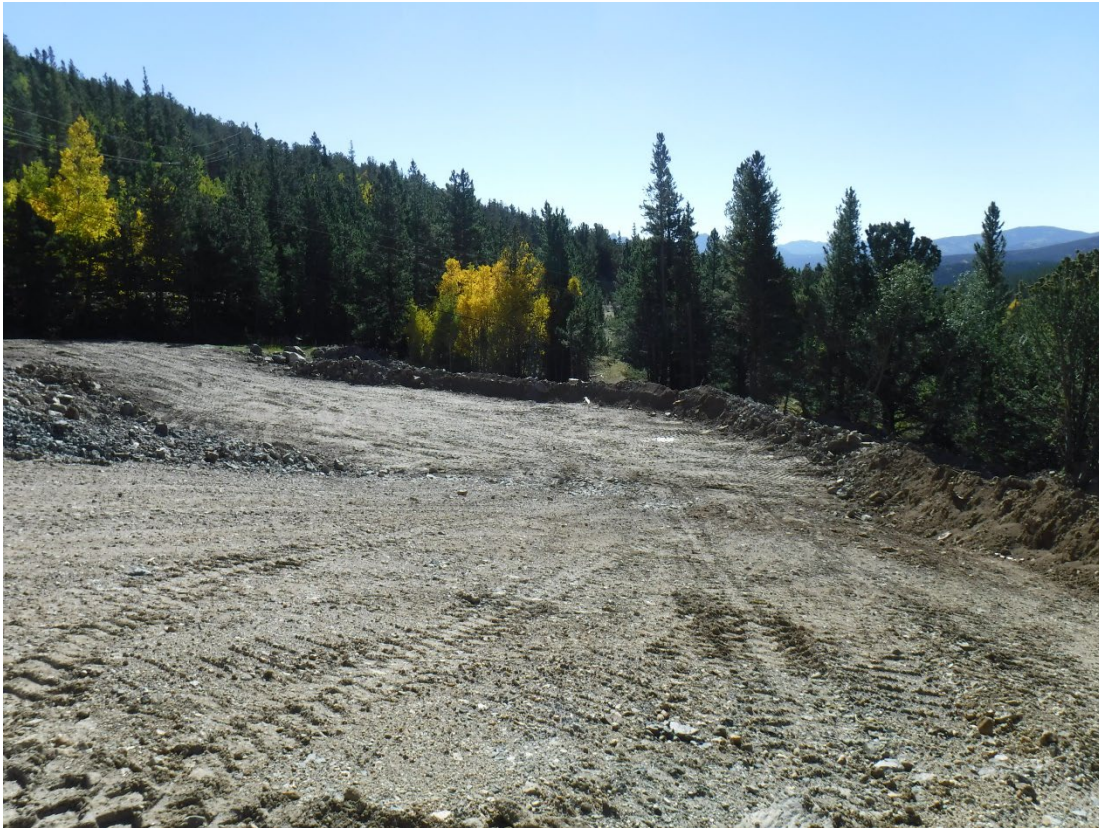
The site had ongoing surface activities at the time of inspection. Operations included reworking the waste rock pile near the entrance to the Caribou Mine. Reworking the pile created additional storage volume for waste rock and allowed the Operator to salvage potential ore material. The salvaged material was taken to the ore storage building adjacent to the Cross Mine entrance. Once in the building, assay samples were collected for further classification of material. After the assay sample results were received the material separated into waste rock and ore material. The ore material is stored in the building on a concrete pad and the waste rock is removed from the building. Surface activities are not prohibited under the Cease and Desist Order.

**Photo 15:** Reworked waste rock pile area

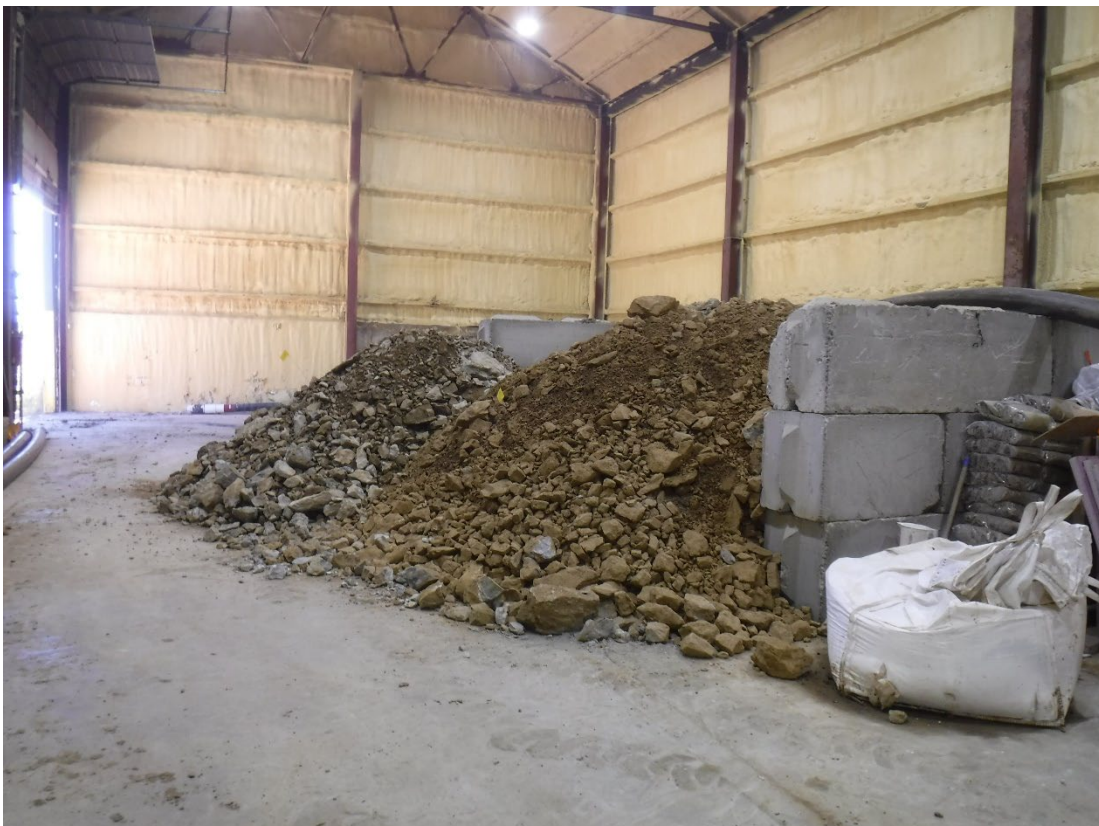
**Photo 16:** Assayed material available to be processed
