**MINERALS PROGRAM INSPECTION REPORT**  
**PHONE: (303) 866-3567**

| <b>MINE NAME:</b><br>Cross Gold Mine | <b>MINE/PROSPECTING ID#:</b><br>M-1977-410 | <b>MINERAL:</b><br>Gold, and silver | <b>COUNTY:</b><br>Boulder |
| <b>INSPECTION TYPE:</b><br>Monitoring | <b>WEATHER:</b> Clear | <b>INSP. DATE:</b><br>September 26, 2022 | <b>INSP. TIME:</b><br>09:00 |

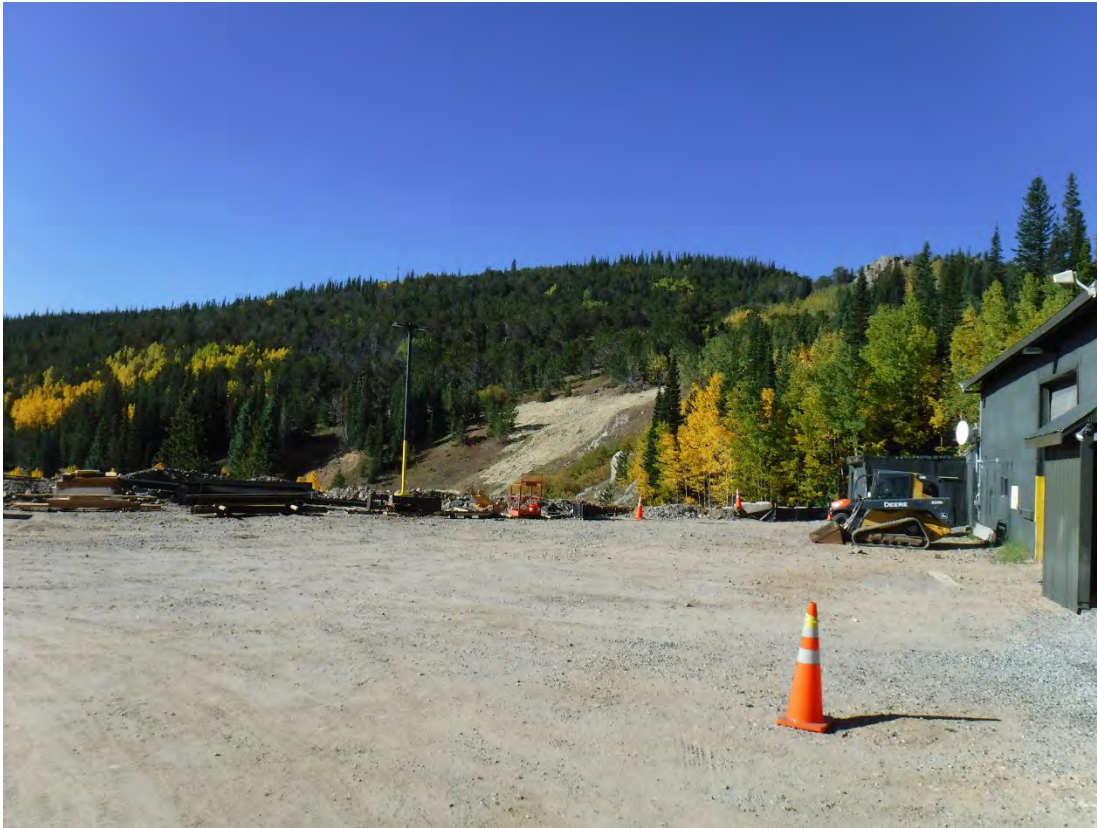
The Operator has recently completed Cross Shaft surface depression remediation and the activity was approved by the Division on June 23, 2022. The activities included filling in of a surface depression using locally sourced material, grading to match the surrounding topography, installation of erosion control mats, and revegetation. As part of the approval the Operator committed to submitting a brief summary report of activities including photographic documentation and approximate quantities of material used.

**Photo 3:** Looking west towards the Cross shaft remediation area from the main parking lot

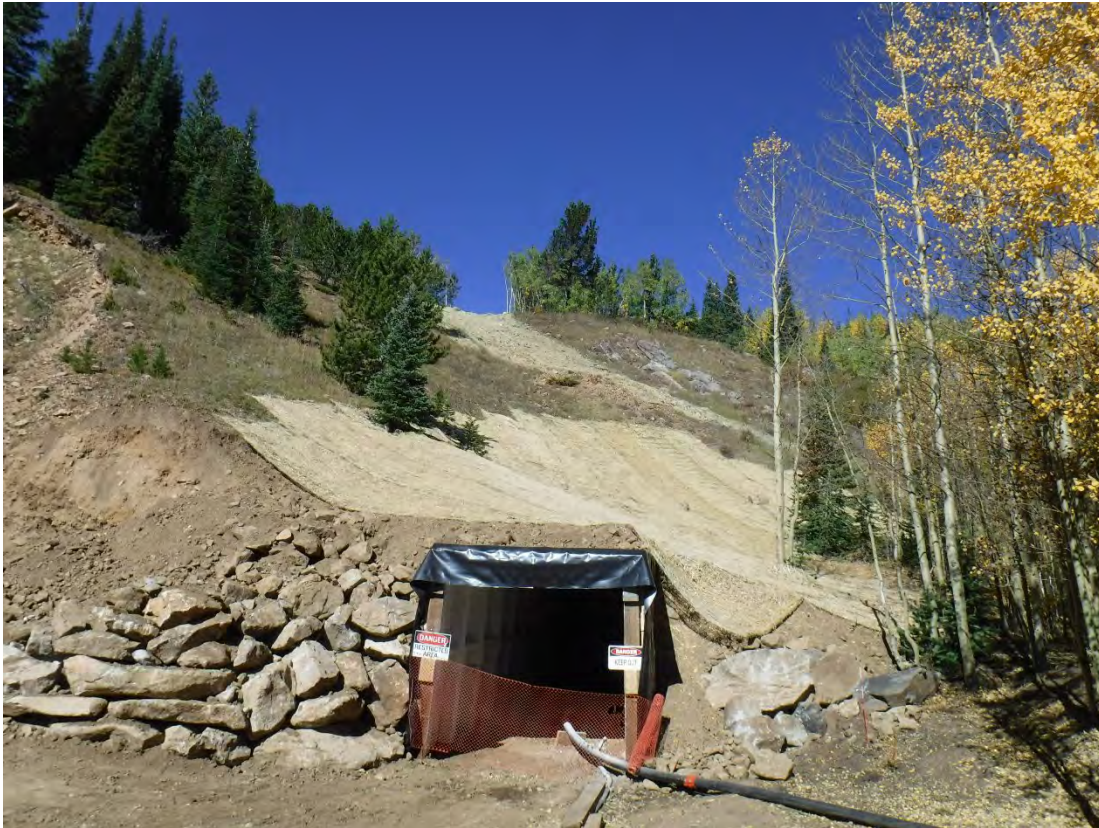
**Photo 5:** Looking up at Cross shaft remediation area from the Cross Mine portal

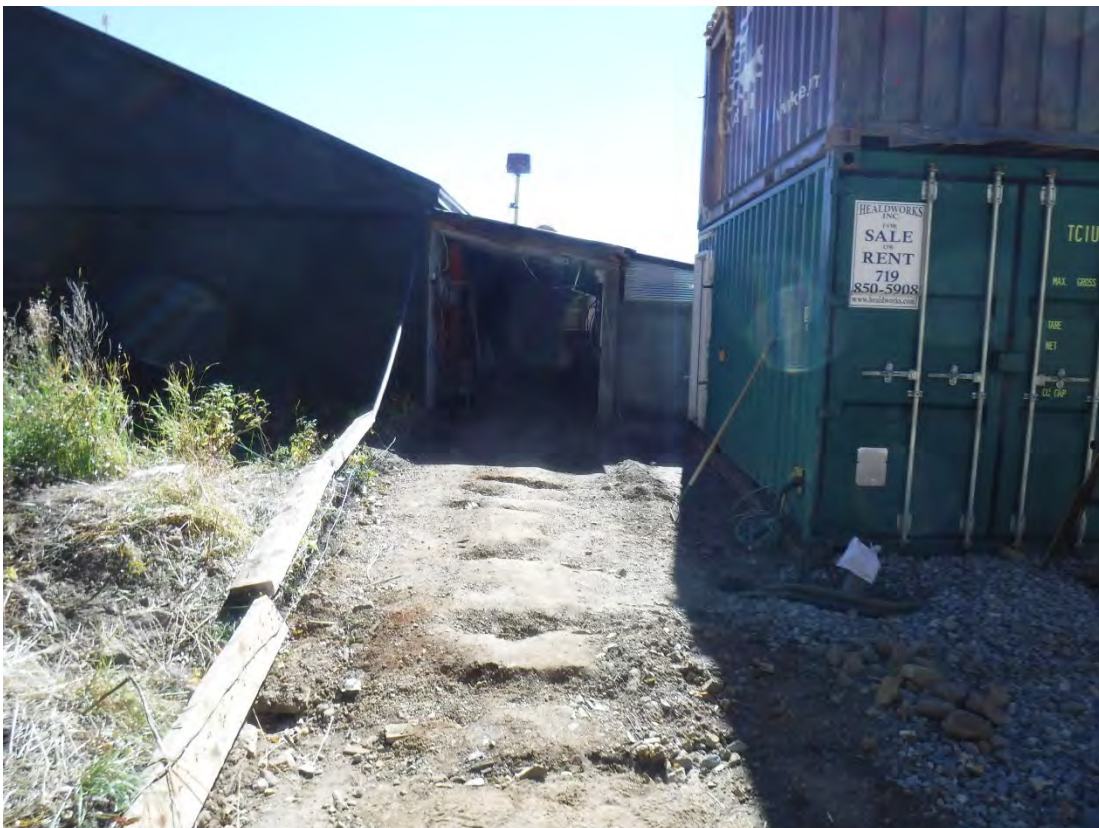
At the Cross Mine entrance the snow shed has been removed along with the associated narrow gauge railroad tracks and timbers. The Operator found the snow shed timbers were rotten and needed to be replaced for safety considerations. During the shed removal it was determined the timbers under the rails were also in very poor condition and need to be replaced. The shed and rails had been removed at the time of inspection and the Operator was waiting for delivery of timbers to begin reconstruction.

**Photo 6:** Snow shed and rail removal from the Cross Mine portal

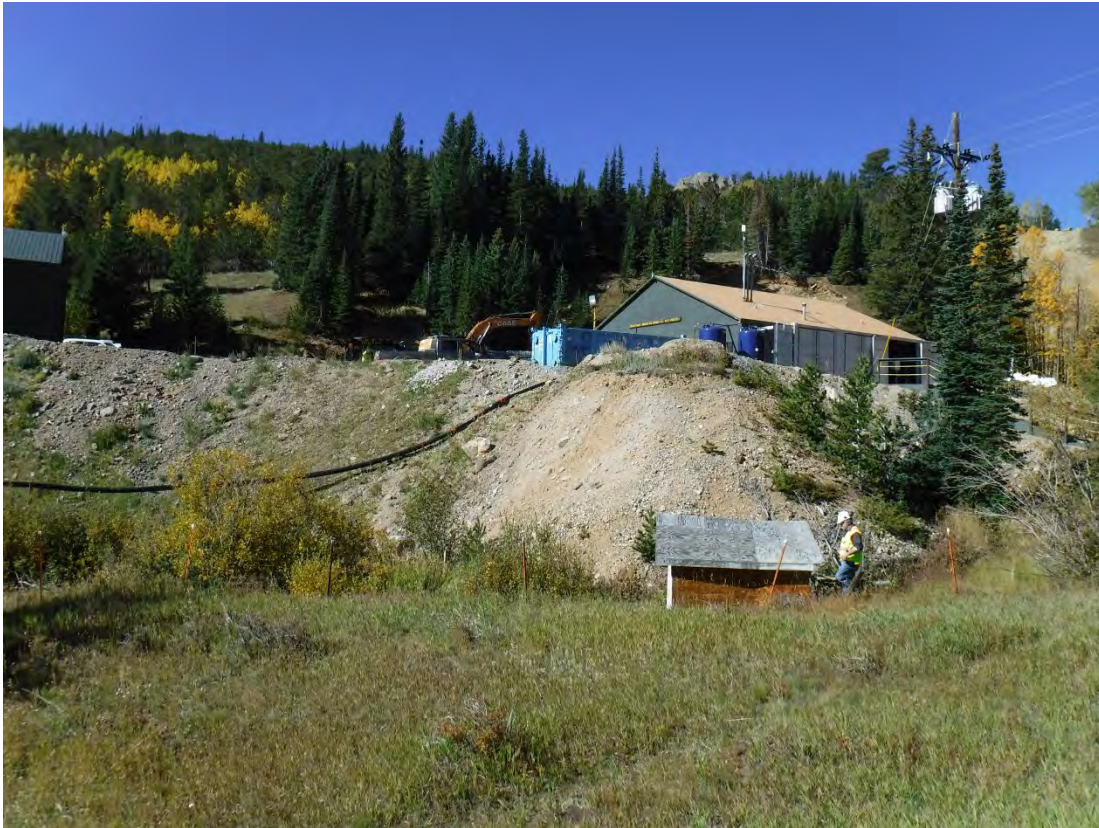
The Division observed the water treatment system which has been operating on site since December of 2021. The system is located inside an insulated Conex box located at the Cross Mine, and includes both filtration and heavy-metal polishing components. Discharge from the Caribou Mine is being routed via pipeline to Pond 1, after passing through Ponds 3a, 3b, and 3c located at the portal, where it combines with discharge from the Cross Mine. Water levels in the pond are being maintained via a pump and pressure transducer system. Water from Pond 1 is pumped via pipeline to the treatment system inside the Conex box. Water entering the treatment system goes through a series of bag filters (5-micron) before entering a vessel with adsorptive materials (MetSorb). A pipeline then routes the treated water from the Conex box to the existing monitoring shed near Pond 2, where it joins with the existing discharge pipeline to Coon Track Creek, the permitted discharge point (CO0032751). Pond 2 is not used to manage mine water under the current treatment regime.

**Photo 9:** Water treatment plant

The Operator inquired whether or not relocating the water treatment Conex box would require a technical revision. The Operator was informed, after the inspection, that indeed a technical revision would need to be submitted to update the maps approved in TR-10 to show where the treatment plant was relocated to and to account for piping configurations.

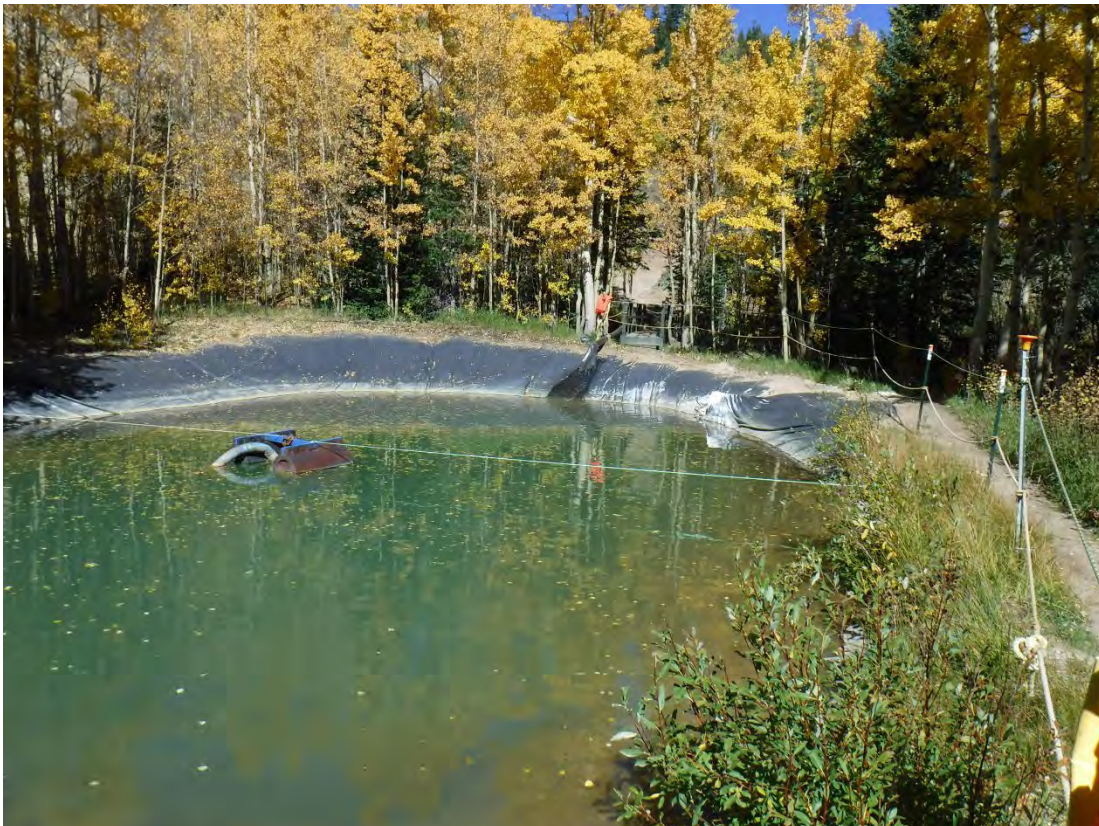
**Photo 10:** Pond 1

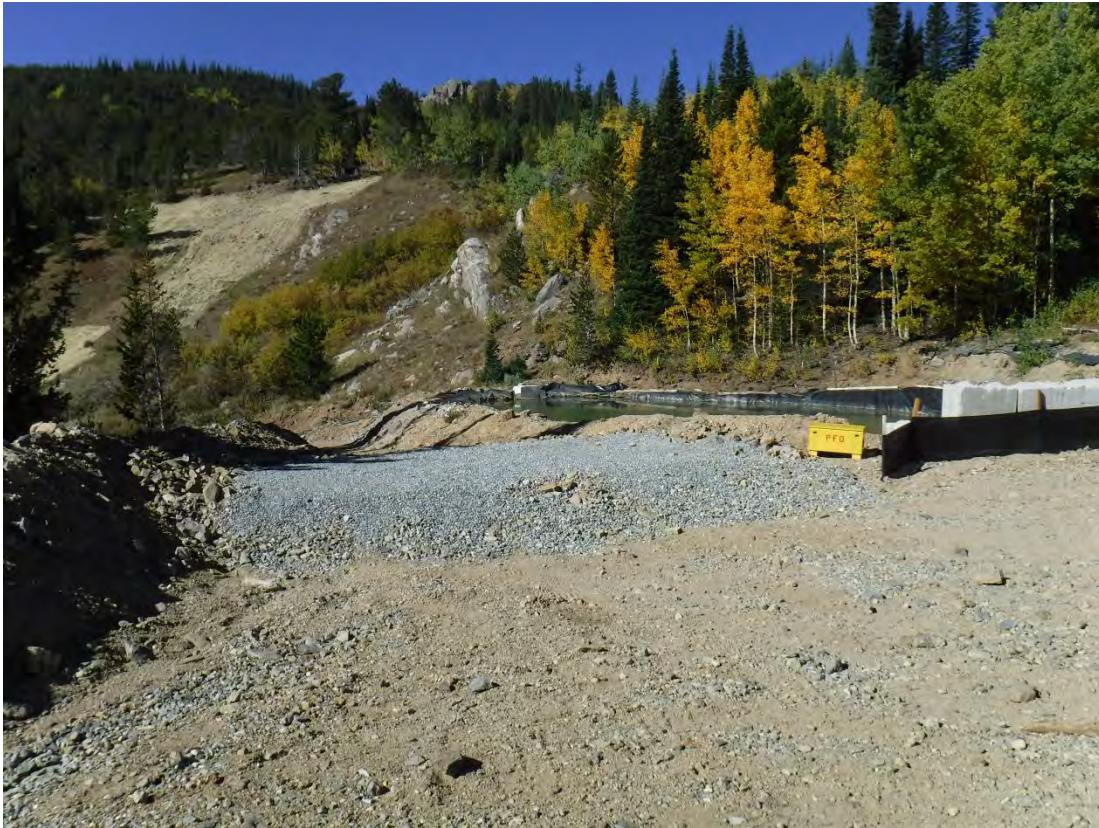
**Photo 11:** Rock check dam to aid in surface erosion control near Pond 3c

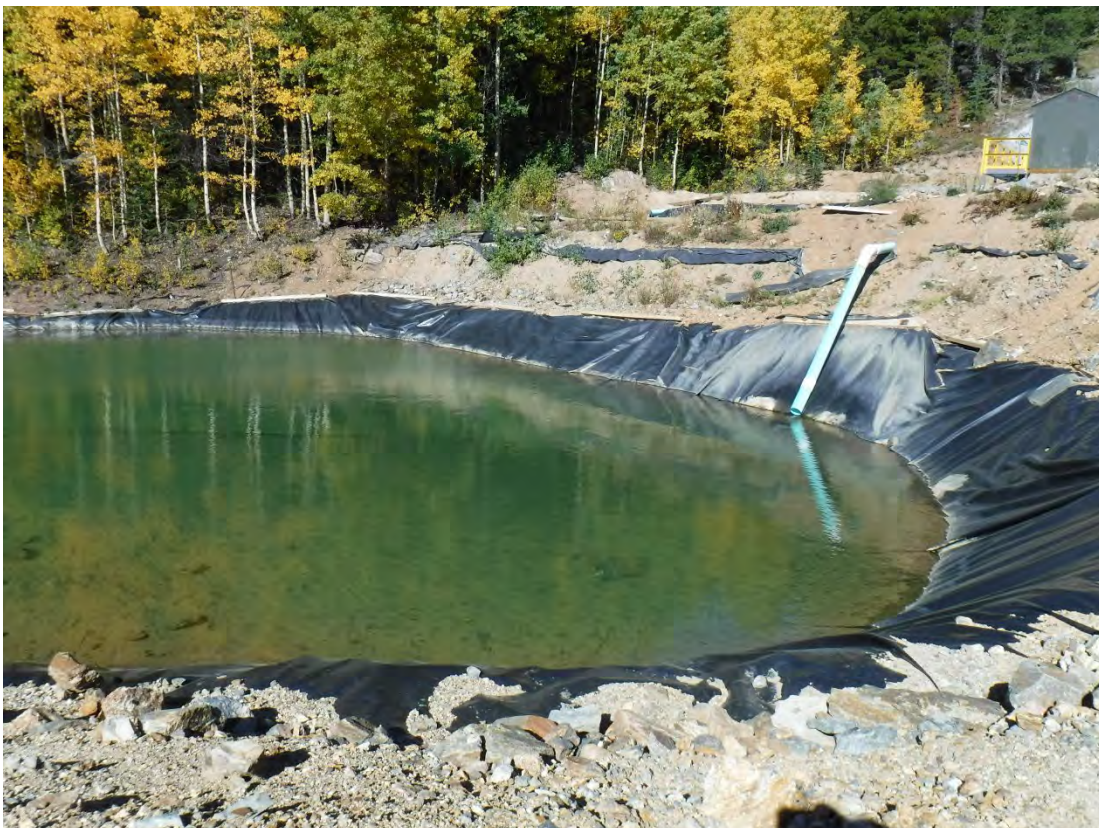
**Photo 12:** Pond 3c

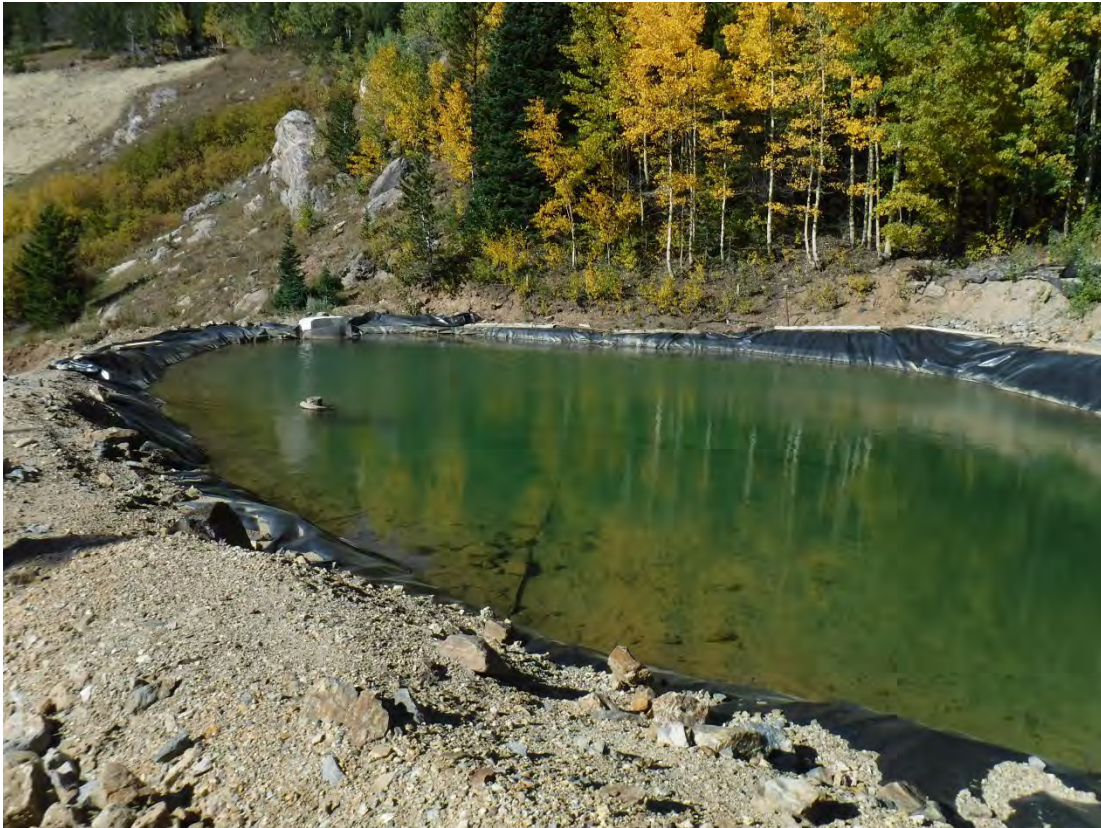
**Photo 13: Pond 3b**

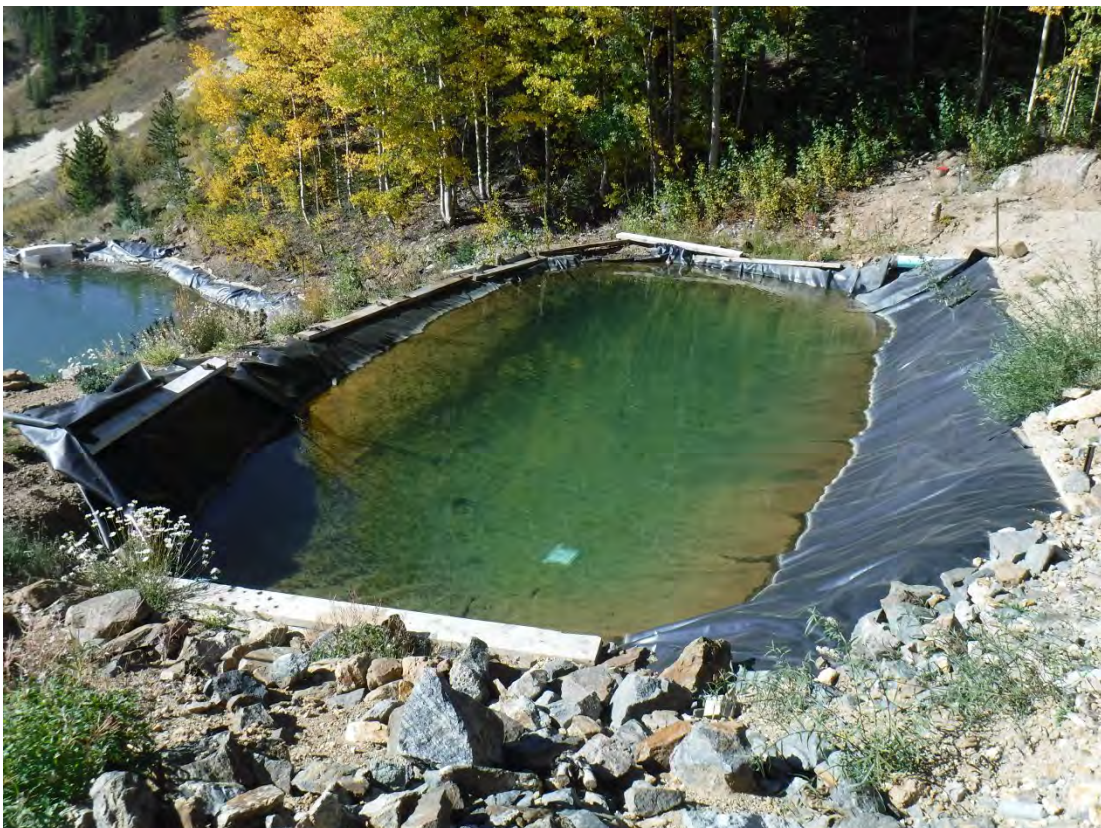
**Photo 14: Pond 3a**

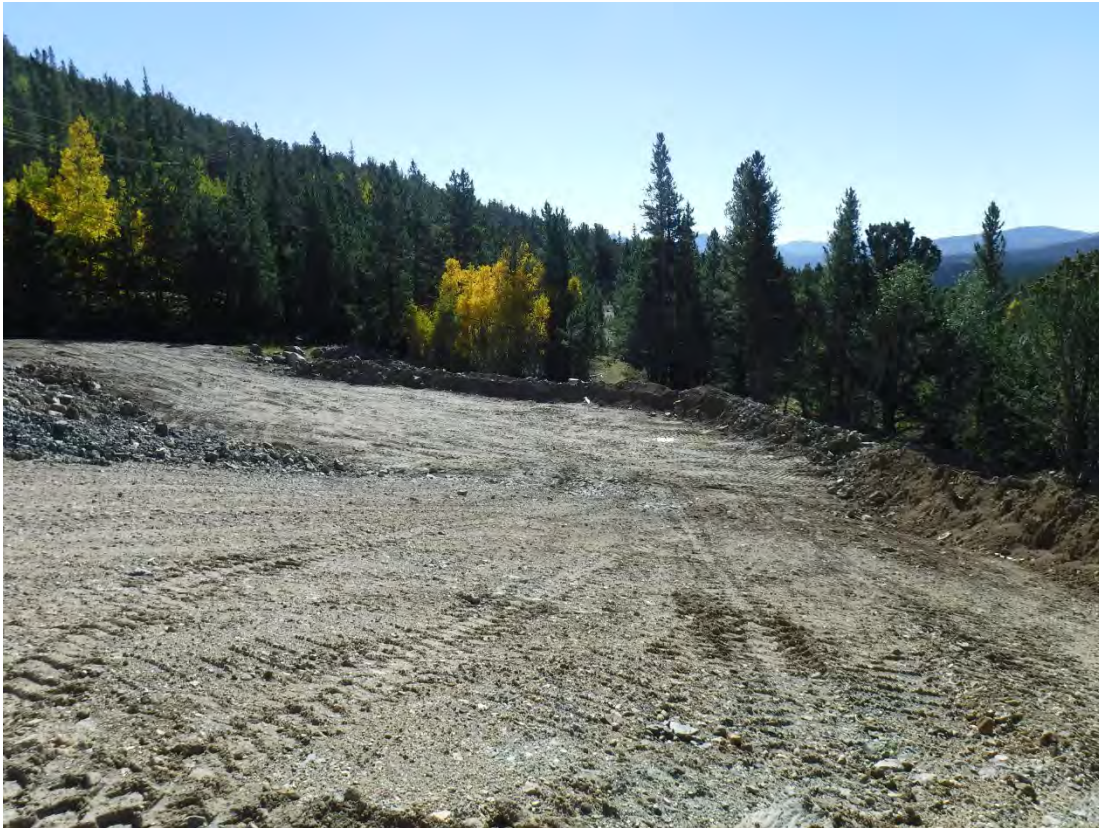
The site had ongoing surface activities at the time of inspection. Operations included reworking the waste rock pile near the entrance to the Caribou Mine. Reworking the pile created additional storage volume for waste rock and allowed the Operator to salvage potential ore material. The salvaged material was taken to the ore storage building adjacent to the Cross Mine entrance. Once in the building, assay samples were collected for further classification of material. After the assay sample results were received the material separated into waste rock and ore material. The ore material is stored in the building on a concrete pad and the waste rock is removed from the building. Surface activities are not prohibited under the Cease and Desist Order.

**Photo 15:** Reworked waste rock pile area

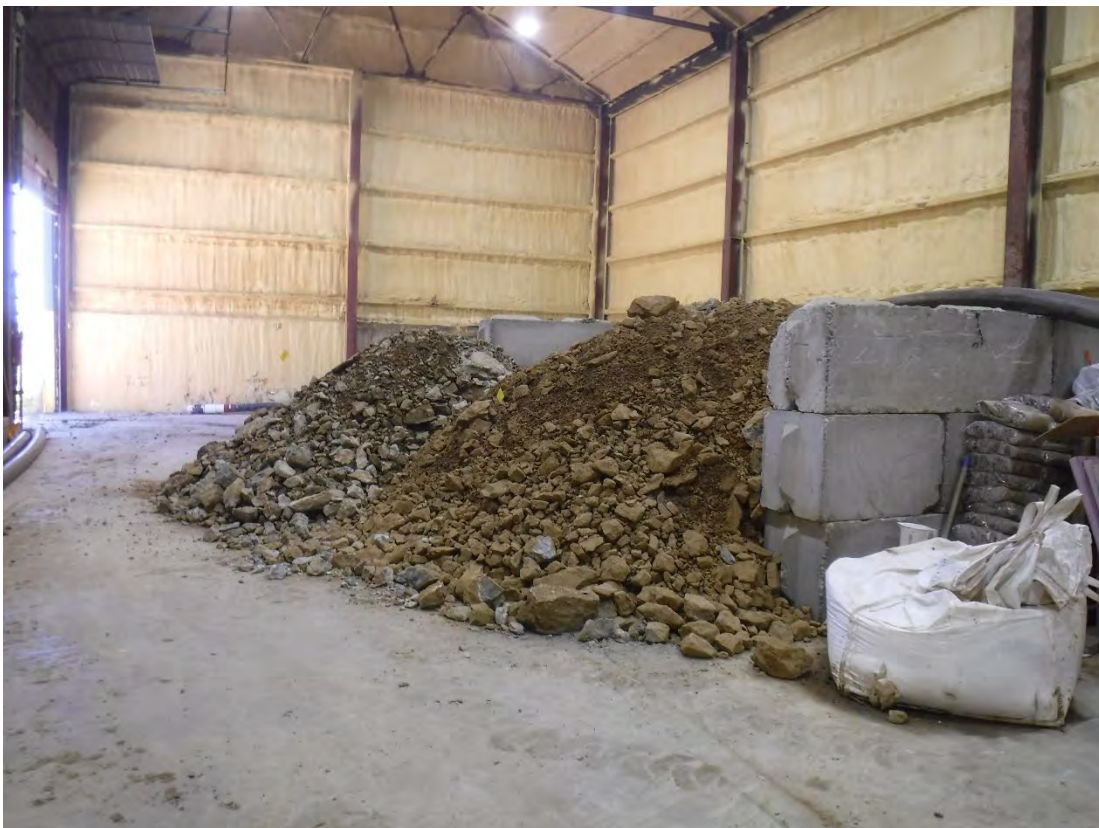
**Photo 16:** Assayed material available to be processed
