**RE: Citizens Complaint (CT-3), Cross Gold Mine; DRMS File No. M-1977-410;  
Dumping Mine Waste into Barker Reservoir**

**MINERALS PROGRAM INSPECTION REPORT**  
**PHONE: (303) 866-3567**

<b>MINE NAME:</b> Cross Gold Mine	<b>MINE/PROSPECTING ID#:</b> M-1977-410	<b>MINERAL:</b> Gold, and silver	<b>COUNTY:</b> Boulder
<b>INSPECTION TYPE:</b> Monitoring	<b>WEATHER:</b> Clear	<b>INSP. DATE:</b> September 26, 2022	<b>INSP. TIME:</b> 09:00
<b>OPERATOR:</b> Grand Island Resources LLC	<b>OPERATOR REPRESENTATIVE:</b> Richard Mittasch	<b>TYPE OF OPERATION:</b> 110(2) - Hard Rock Limited Impact	
<b>REASON FOR INSPECTION:</b> Normal I&E Program	<b>BOND CALCULATION TYPE:</b> None	<b>BOND AMOUNT:</b> \$546,751.00	
<b>DATE OF COMPLAINT:</b> NA	<b>POST INSP. CONTACTS:</b> None	<b>JOINT INSP. AGENCY:</b> None	
<b>INSPECTOR(S):</b> Patrick Lennberg	<b>INSPECTOR'S SIGNATURE:</b>

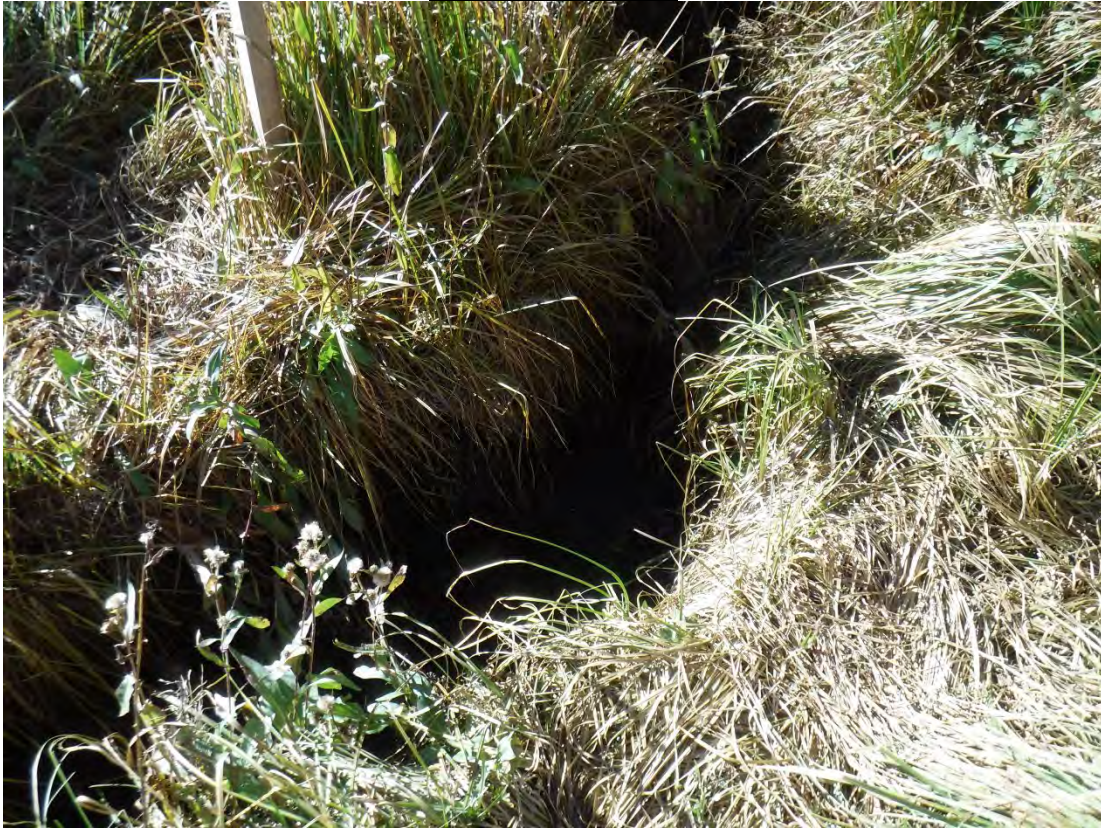
The Operator informed the Division during the inspection that a crew was in the process of collecting surface water samples. The Division was unable to observe sample collection. The Division did observe the upstream surface water location was dry. The downstream location did have water available to sample.

**Photo 1:** Upgradient surface water sampling location, adjacent to Caribou Road, dry

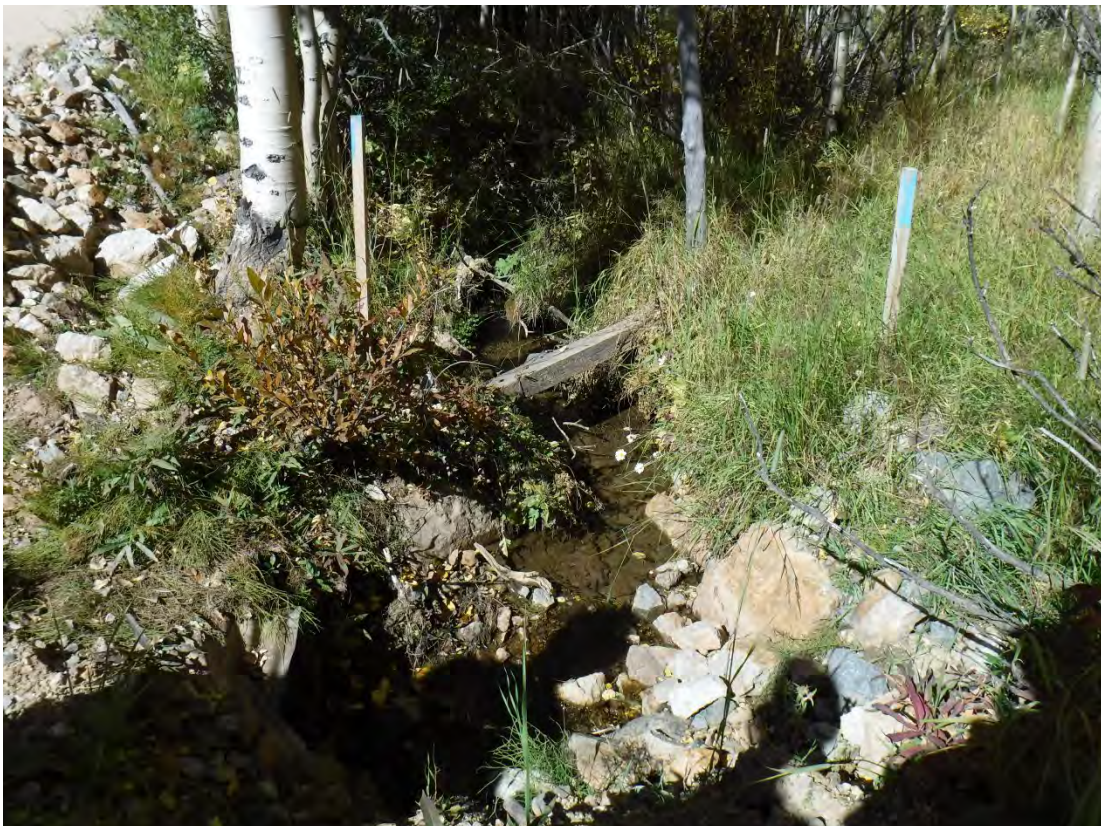
**Photo 2:** Downgradient surface water sampling location

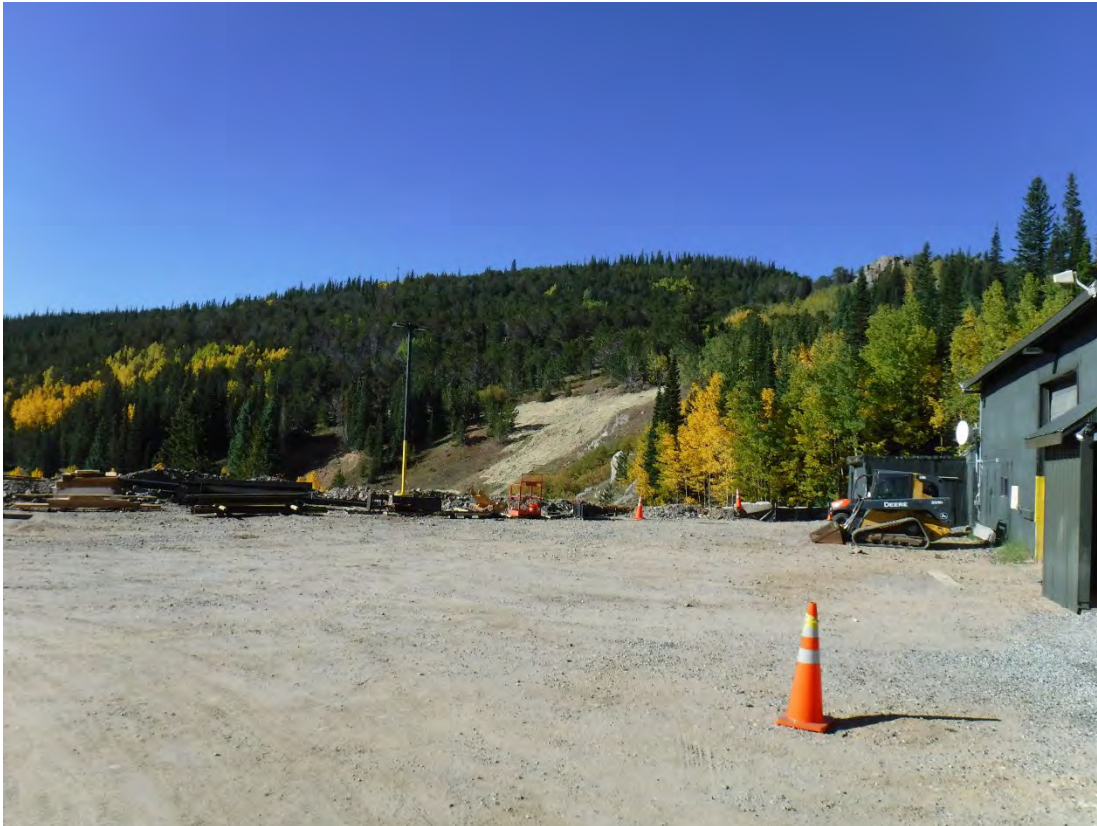
The Operator has recently completed Cross Shaft surface depression remediation and the activity was approved by the Division on June 23, 2022. The activities included filling in of a surface depression using locally sourced material, grading to match the surrounding topography, installation of erosion control mats, and revegetation. As part of the approval the Operator committed to submitting a brief summary report of activities including photographic documentation and approximate quantities of material used.

**Photo 3:** Looking west towards the Cross shaft remediation area from the main parking lot

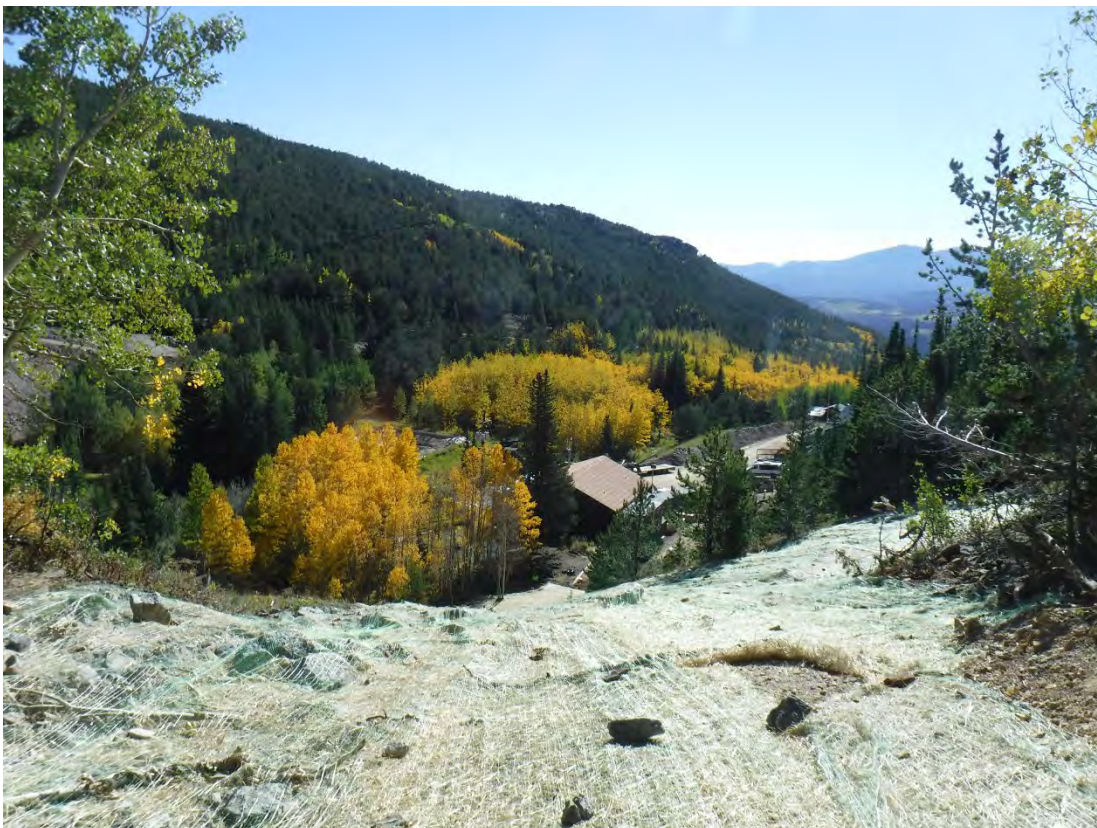
**Photo 4:** Looking down along the Cross shaft remediation area

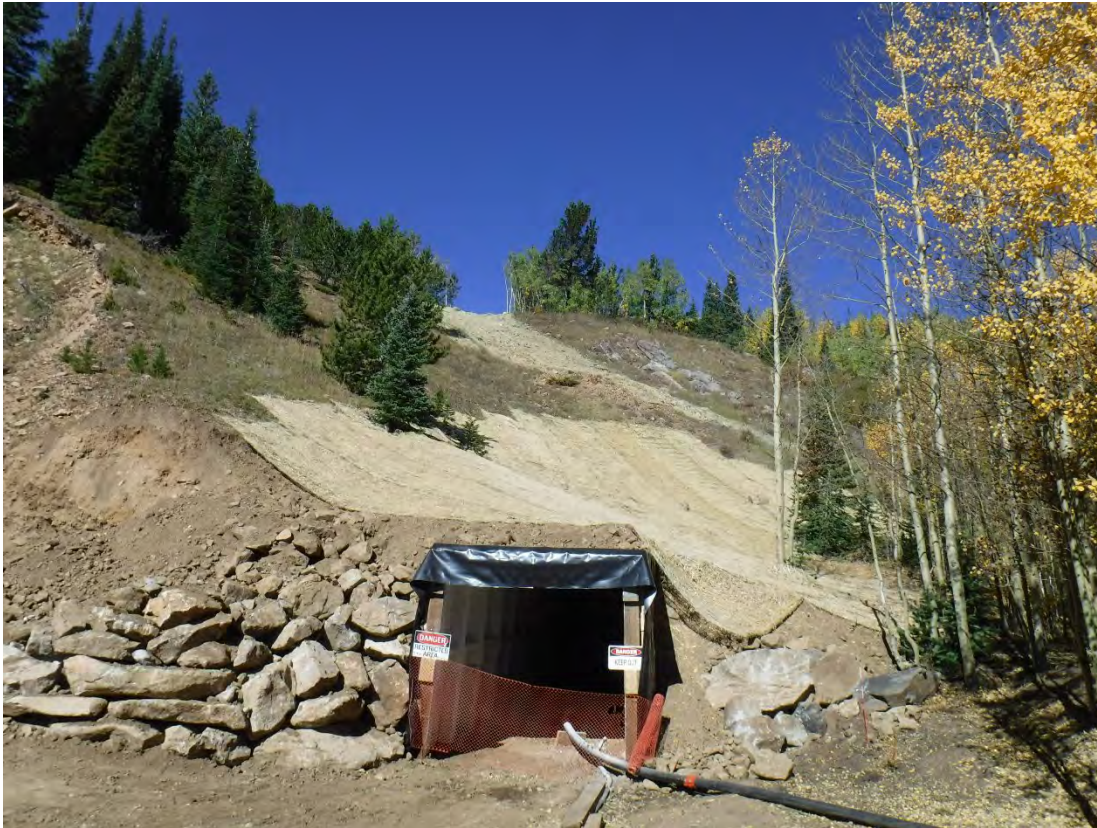
**Photo 5:** Looking up at Cross shaft remediation area from the Cross Mine portal

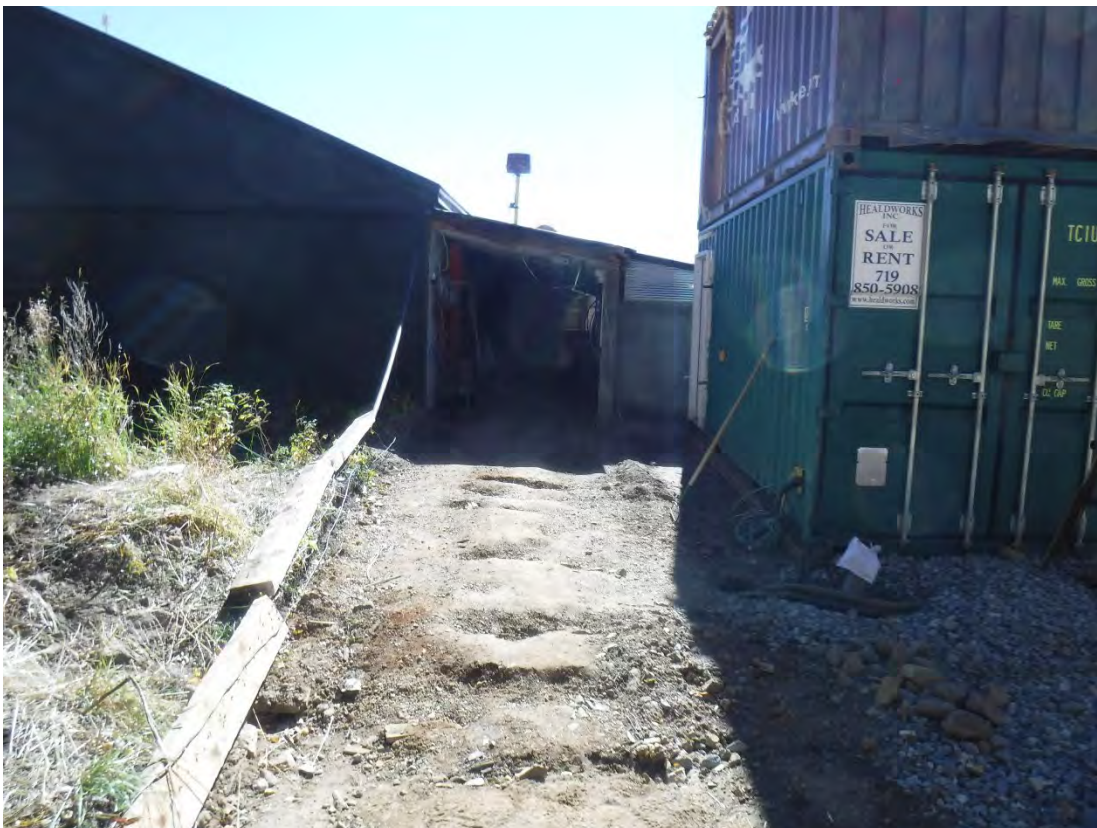
At the Cross Mine entrance the snow shed has been removed along with the associated narrow gauge railroad tracks and timbers. The Operator found the snow shed timbers were rotten and needed to be replaced for safety considerations. During the shed removal it was determined the timbers under the rails were also in very poor condition and need to be replaced. The shed and rails had been removed at the time of inspection and the Operator was waiting for delivery of timbers to begin reconstruction.

**Photo 6:** Snow shed and rail removal from the Cross Mine portal

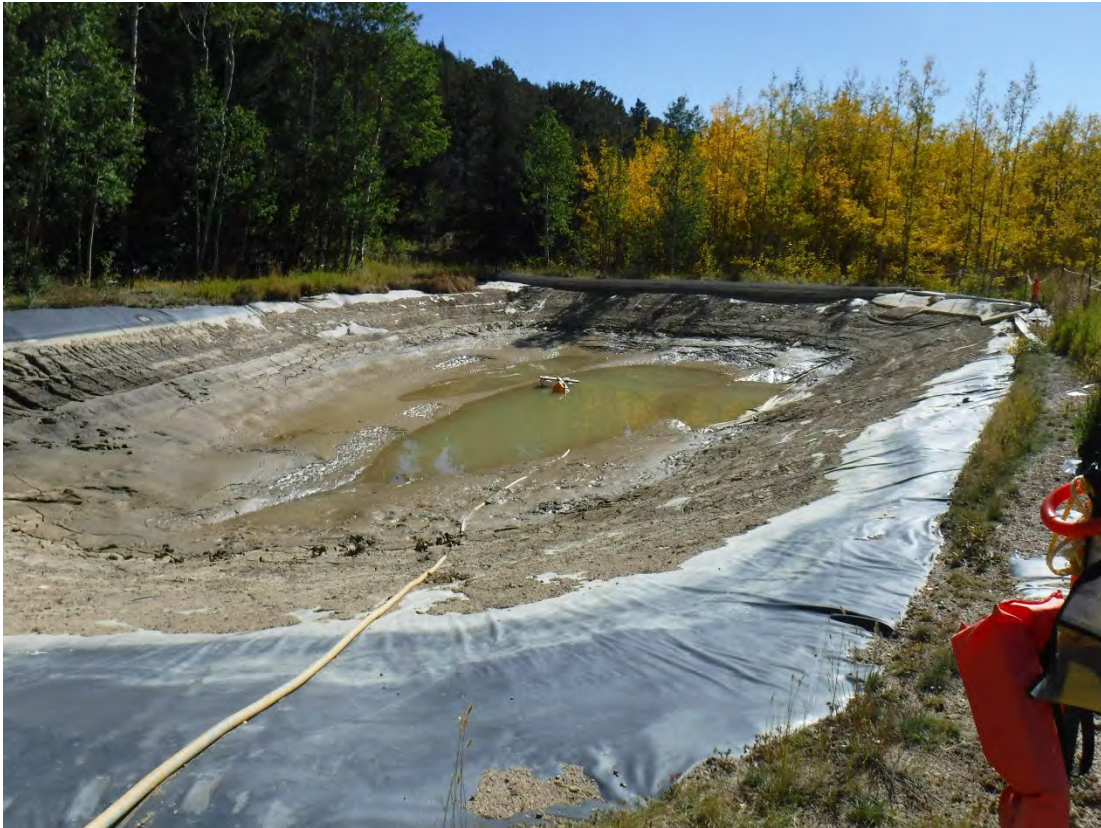
At the time of inspection Pond 2 was close to being completely dewatered. The Operator stated they were in the process of characterizing the sediment remaining in the pond. Initial indications show the sediment is not hazardous. The Operator is in the initial phases of determining how to decommission the pond. Since Pond 2 is part of approved TR-10, as an emergency over flow pond, decommissioning of the pond will need a Technical Revision. At a minimum, the revision shall detail water accounting of where overflow may be directed in case of emergencies and how the sediment will be disposed of properly. The Operator stated they are trying to evaluate whether or not using a wetland as a passive water treatment system might be an effective use of the pond area.

**Photo 7:** Dewatering of Pond 2 with sediment exposed

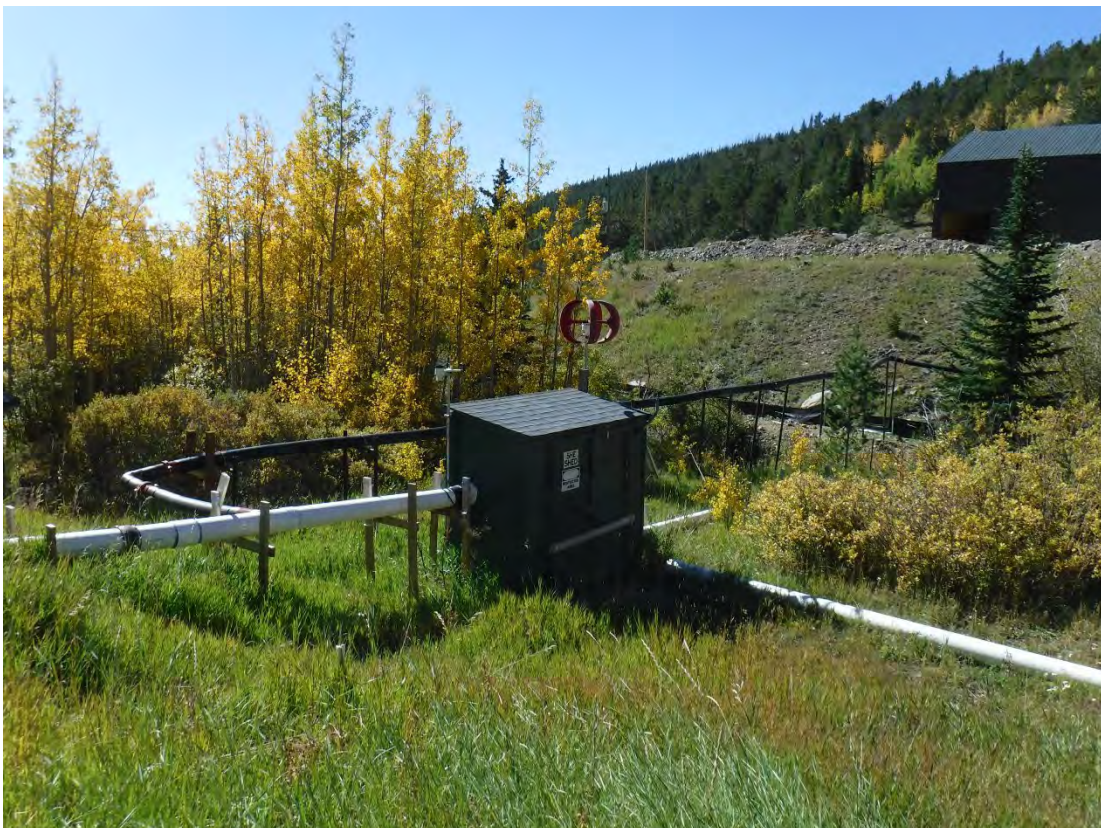
The Operator has been monitoring the outfall in accordance with their approved WQCD permit. Since March 2022 time they have been in compliance with their discharge permit.

**Photo 8:** Permitted discharge point to Coon Track

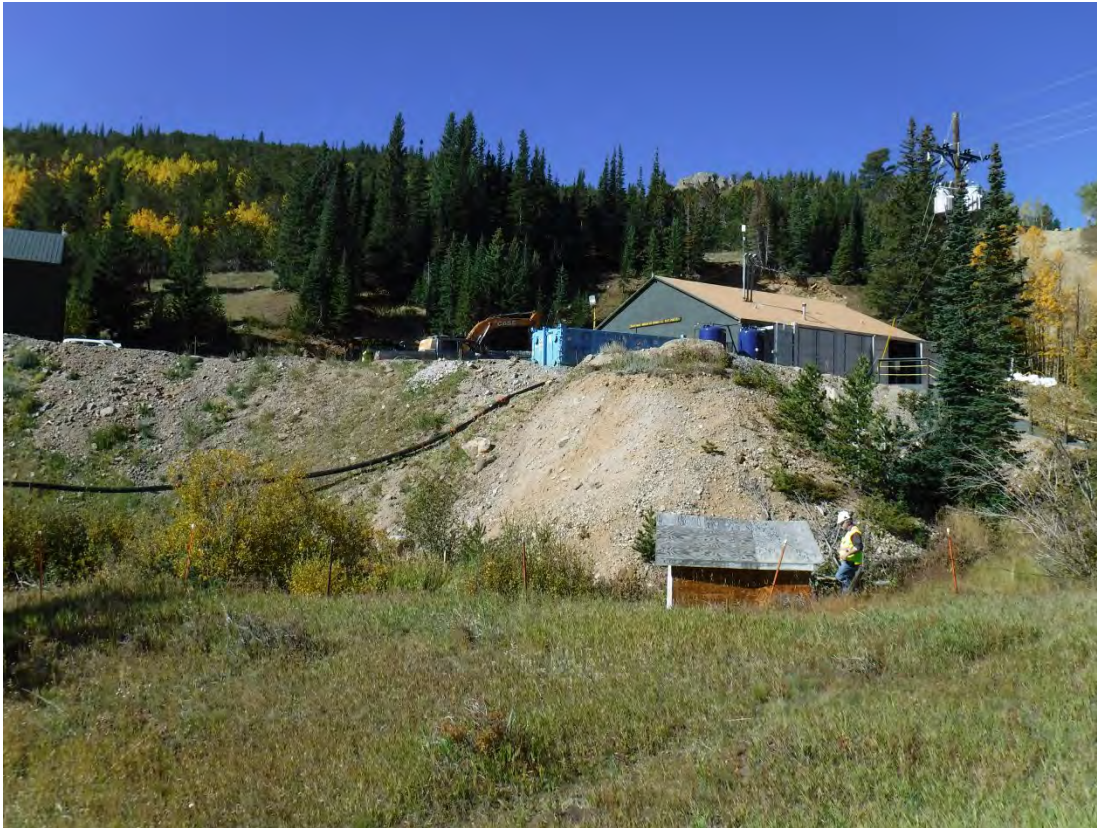
The Division observed the water treatment system which has been operating on site since December of 2021. The system is located inside an insulated Conex box located at the Cross Mine, and includes both filtration and heavy-metal polishing components. Discharge from the Caribou Mine is being routed via pipeline to Pond 1, after passing through Ponds 3a, 3b, and 3c located at the portal, where it combines with discharge from the Cross Mine. Water levels in the pond are being maintained via a pump and pressure transducer system. Water from Pond 1 is pumped via pipeline to the treatment system inside the Conex box. Water entering the treatment system goes through a series of bag filters (5-micron) before entering a vessel with adsorptive materials (MetSorb). A pipeline then routes the treated water from the Conex box to the existing monitoring shed near Pond 2, where it joins with the existing discharge pipeline to Coon Track Creek, the permitted discharge point (CO0032751). Pond 2 is not used to manage mine water under the current treatment regime.

**Photo 9:** Water treatment plant

The Operator inquired whether or not relocating the water treatment Conex box would require a technical revision. The Operator was informed, after the inspection, that indeed a technical revision would need to be submitted to update the maps approved in TR-10 to show where the treatment plant was relocated to and to account for piping configurations.

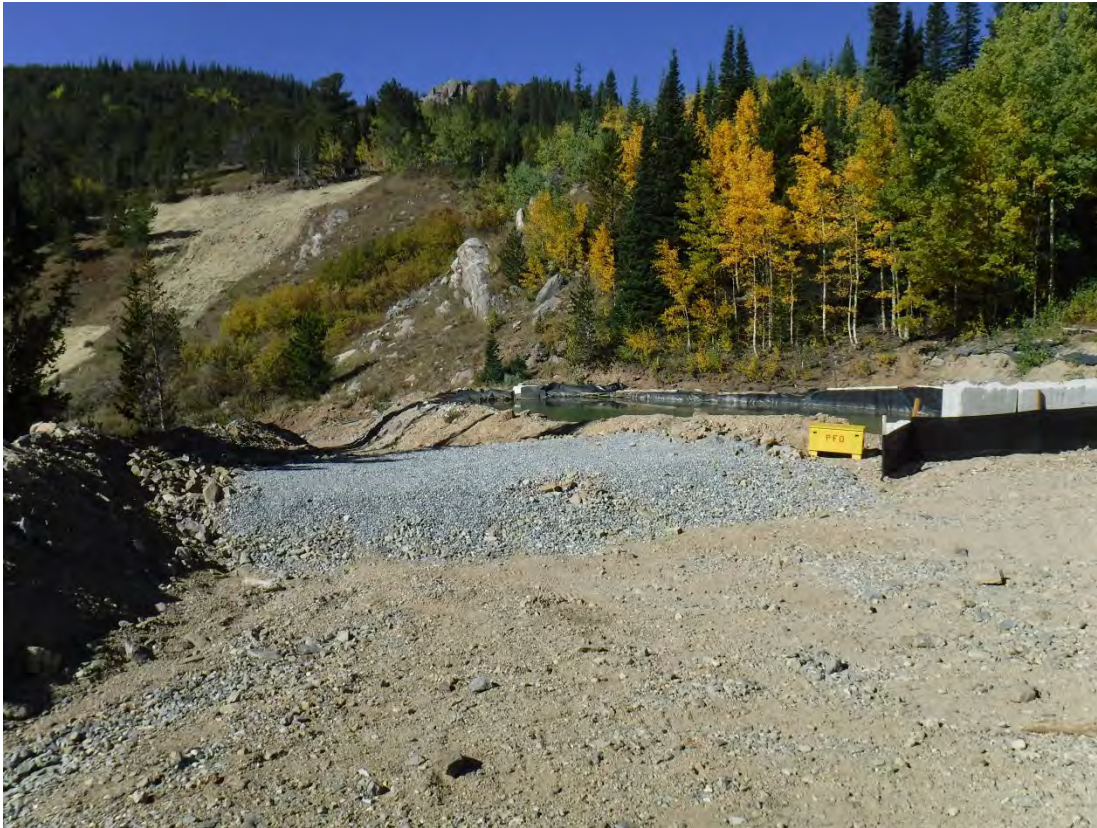
**Photo 11:** Rock check dam to aid in surface erosion control near Pond 3c

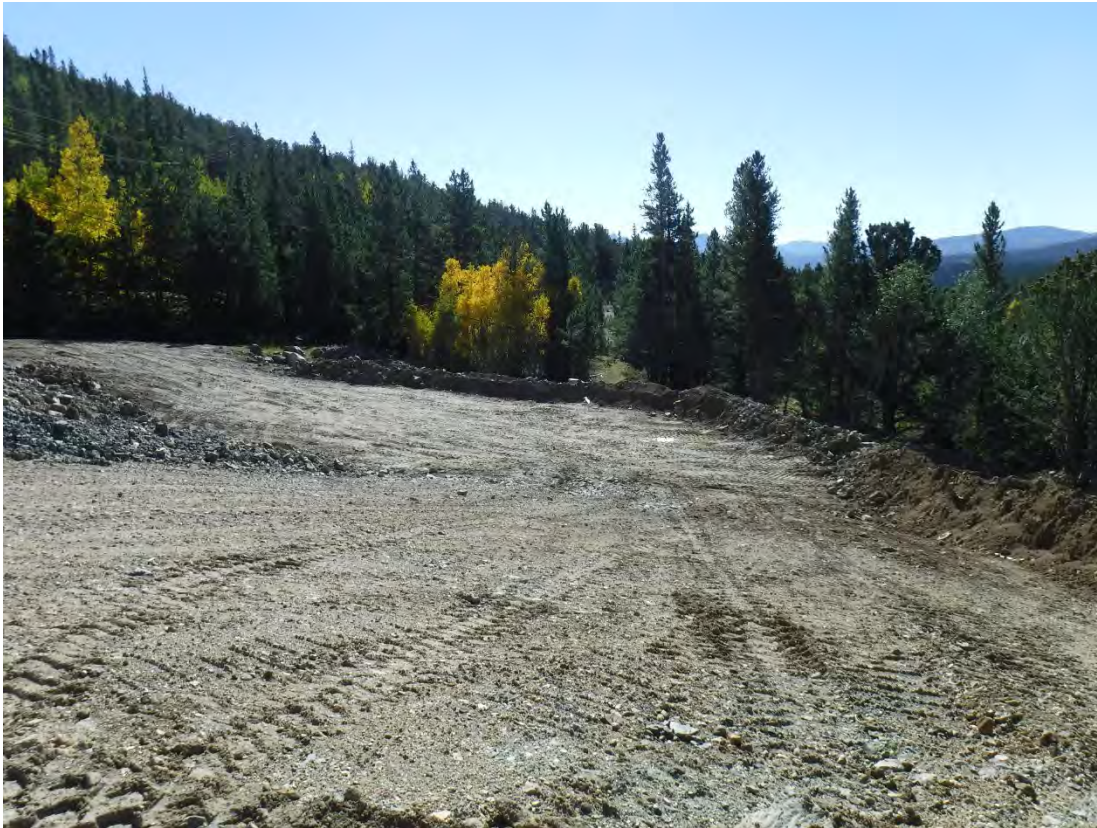
The site had ongoing surface activities at the time of inspection. Operations included reworking the waste rock pile near the entrance to the Caribou Mine. Reworking the pile created additional storage volume for waste rock and allowed the Operator to salvage potential ore material. The salvaged material was taken to the ore storage building adjacent to the Cross Mine entrance. Once in the building, assay samples were collected for further classification of material. After the assay sample results were received the material separated into waste rock and ore material. The ore material is stored in the building on a concrete pad and the waste rock is removed from the building. Surface activities are not prohibited under the Cease and Desist Order.

**Photo 15:** Reworked waste rock pile area

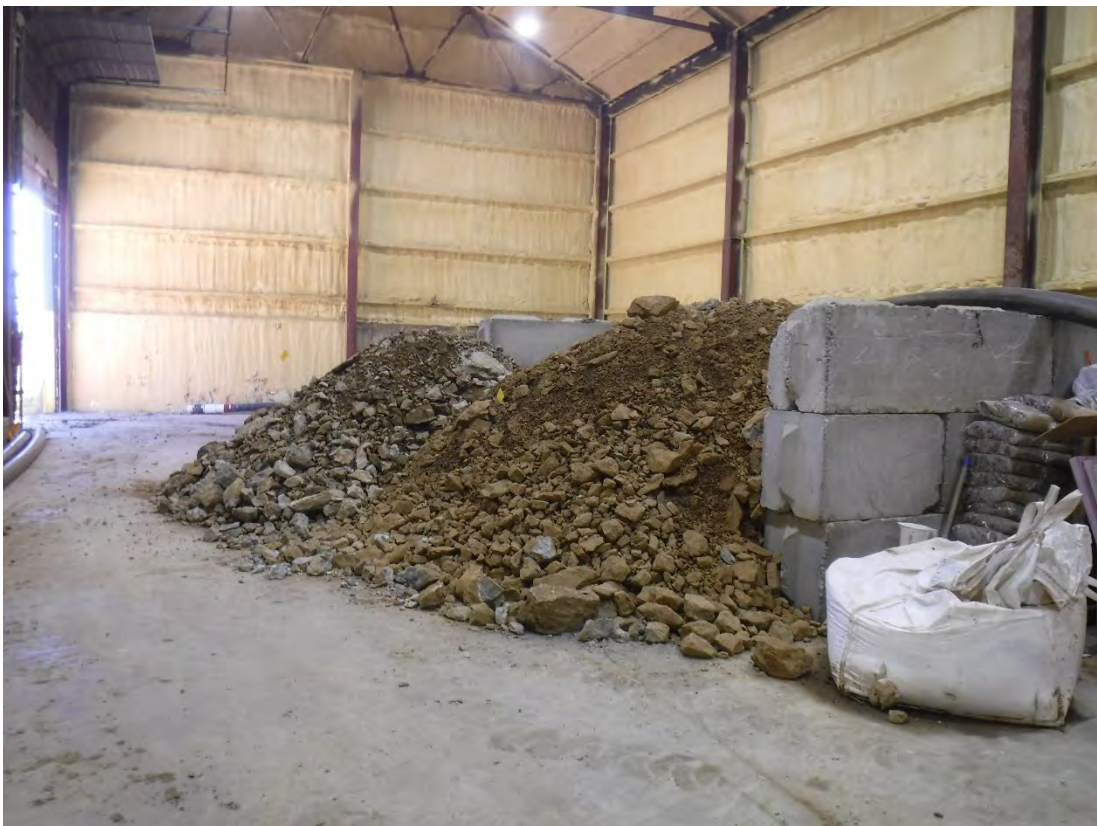
**Photo 16:** Assayed material available to be processed
