Permit Number: C-1981-012 Mine Name: New Elk Mine Operator: New Elk Coal Company, LLC Operator Address: Mr. Mark Gray 12250 Highway 12 Weston, CO 81091	County: Las Animas Operation Type: Underground Permit Status: Active Ownership: Private
	Operator Representative Present: Nick Mason
Operator Representative Signature: (Field Issuance Only)

Inspection Start Date: September 28, 2022 Inspection Start Time: 08:00 Inspection End Date: October 28, 2022 Inspection End Time: 13:00		Inspection Type: Coal Partial Inspection Inspection Reason: Normal I&E Program Weather: Cloudy	
Joint Inspection Agency: None		Joint Inspection Contacts:	
Post Inspection Agency: None		Post Inspection Contacts:	
Inspector(s): Brock Bowles	Inspector's Signature:

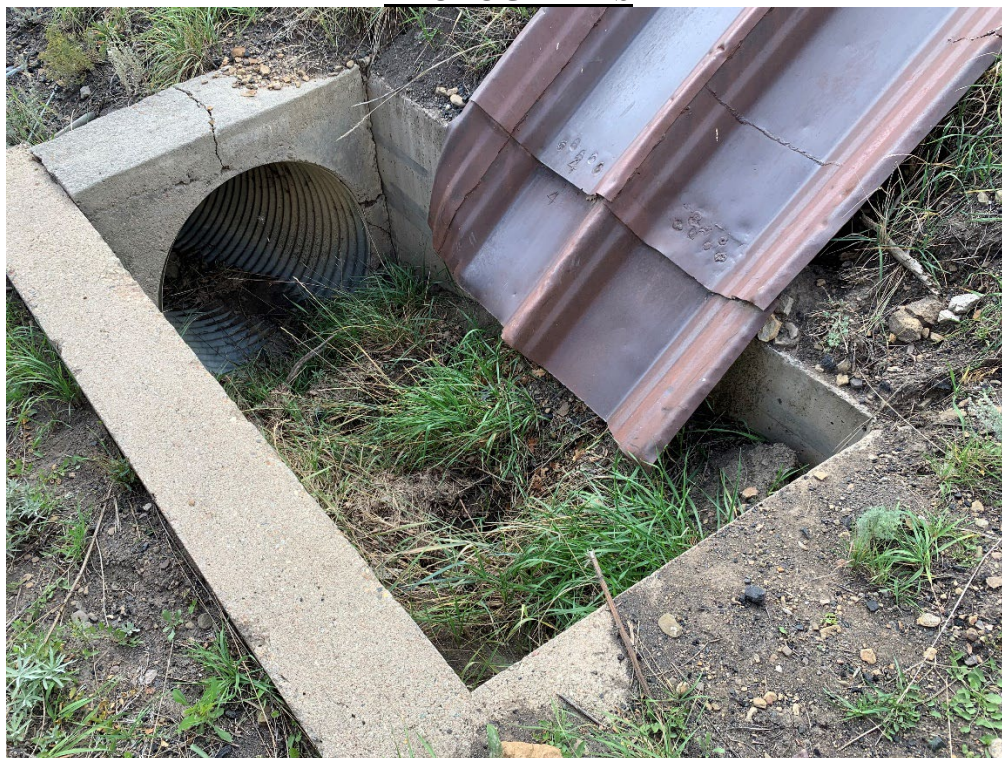
The flume at the east end of the clean water diversion ditch D26 was free of debris and appeared to be stable. The box at the bottom of the flume contained debris that needs to be removed (photo 1). Culvert C48 connecting the box and Ditch D26 needs to be cleaned (photo 2). Culvert C46 connecting ditches D24 and D24E needs to be cleaned (photo 3). Ditch D24 on the east end of the clean coal storage pile needs to be cleaned (photo 4). A dense stand of willows are impeding the flow of water.

Photo 1 – Box at bottom of Ditch D26 flume

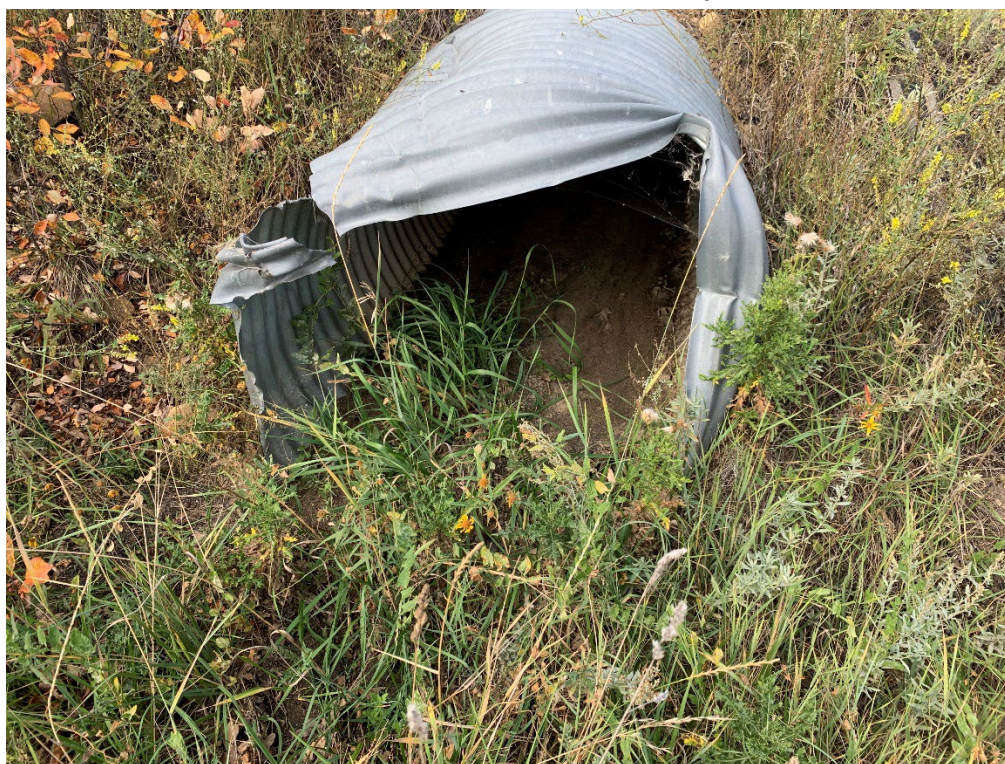
Photo 2 – Culvert C48 outlet side

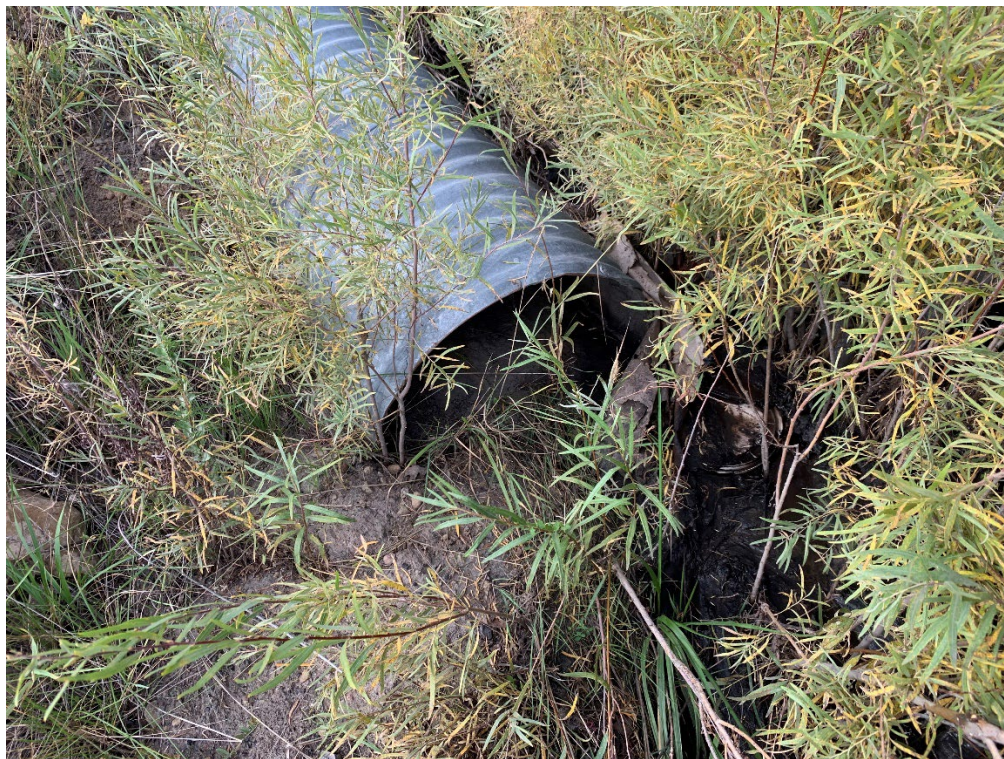
Photo 3 – Culvert C46 outlet side

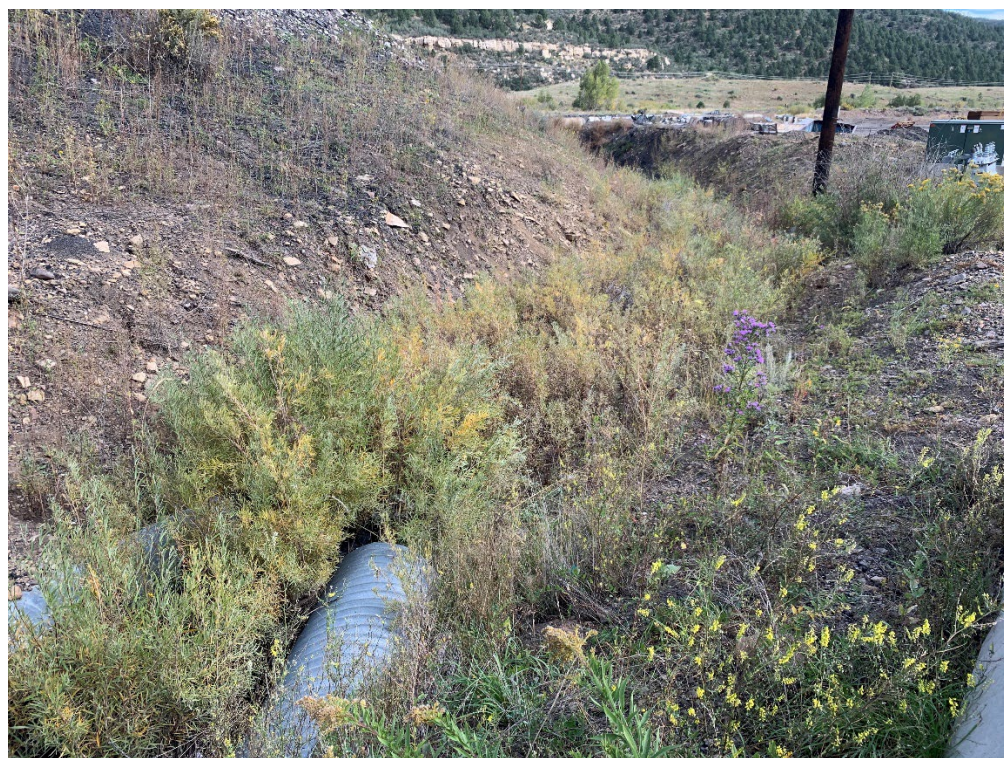
Photo 4 – Willows are impeding ditch flow

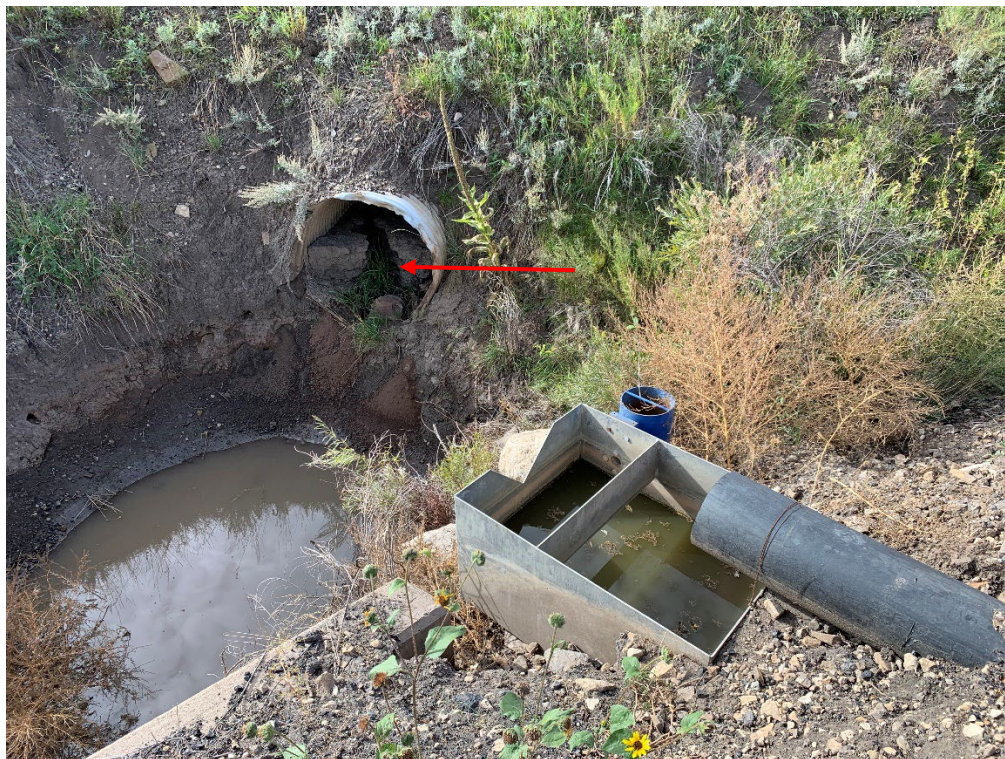
The silt fences in ditch D58, along the haul road going east, were in good condition. The east end of ditch D26 (clean water diversion) where it drains into Discharge No 10, the culvert is clogged and needs cleaning (photo 5). This culvert is about 24" diameter and is not labeled on Map 13. The culvert going under the haul road at Discharge No 10 contains some sediment and needs to be cleaned (photo 6). This culvert is about 36" diameter and is not labeled on Map 13.

Photo 5 – Clean water culvert needs cleaning

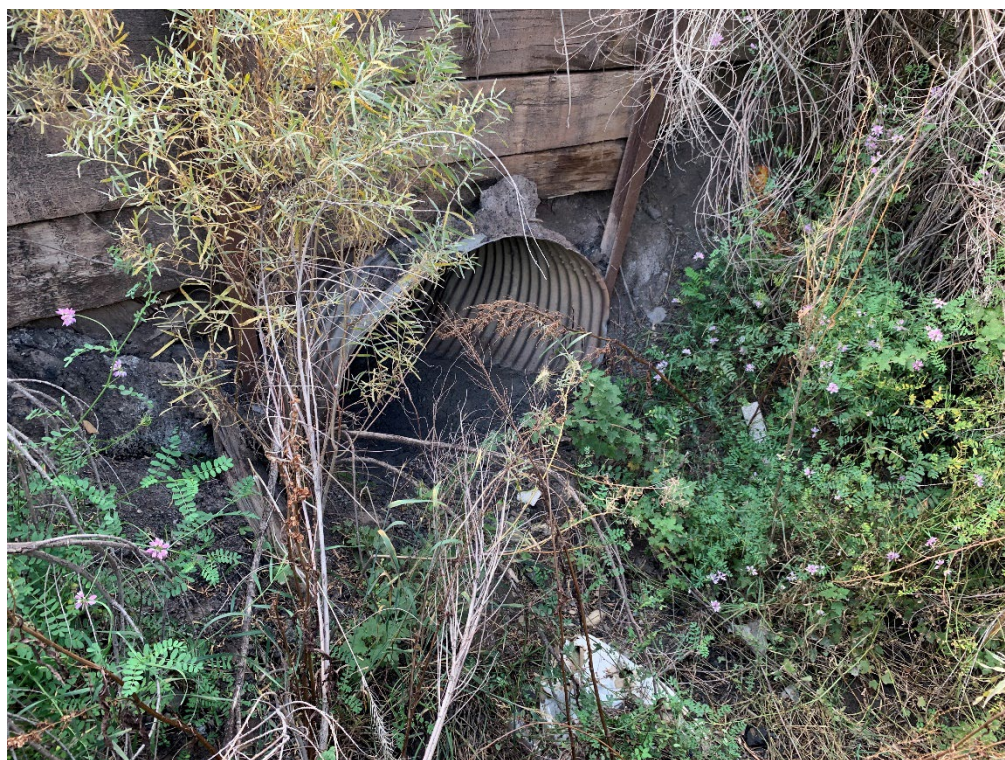
Photo 6 – Culvert at Discharge 10 under haul road

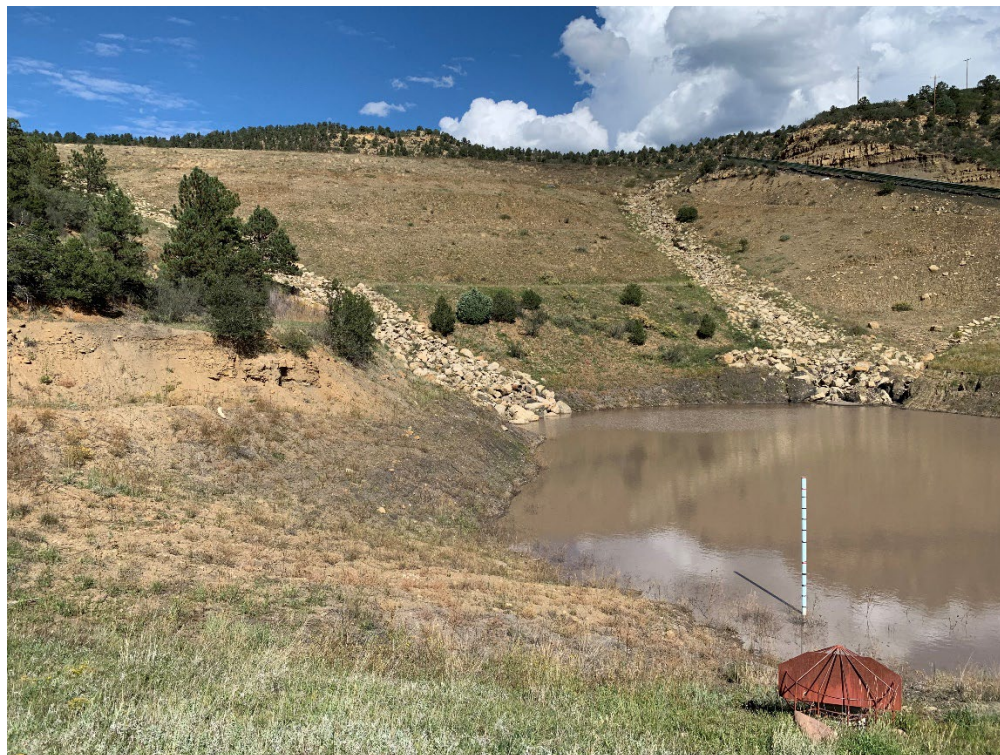
Ponds 7 and 8 (photo 7) contained water and were not discharging. The embankments of both ponds appeared stable. The primary and emergency spillways were clear of obstructions.

Photo 7 – Pond 8

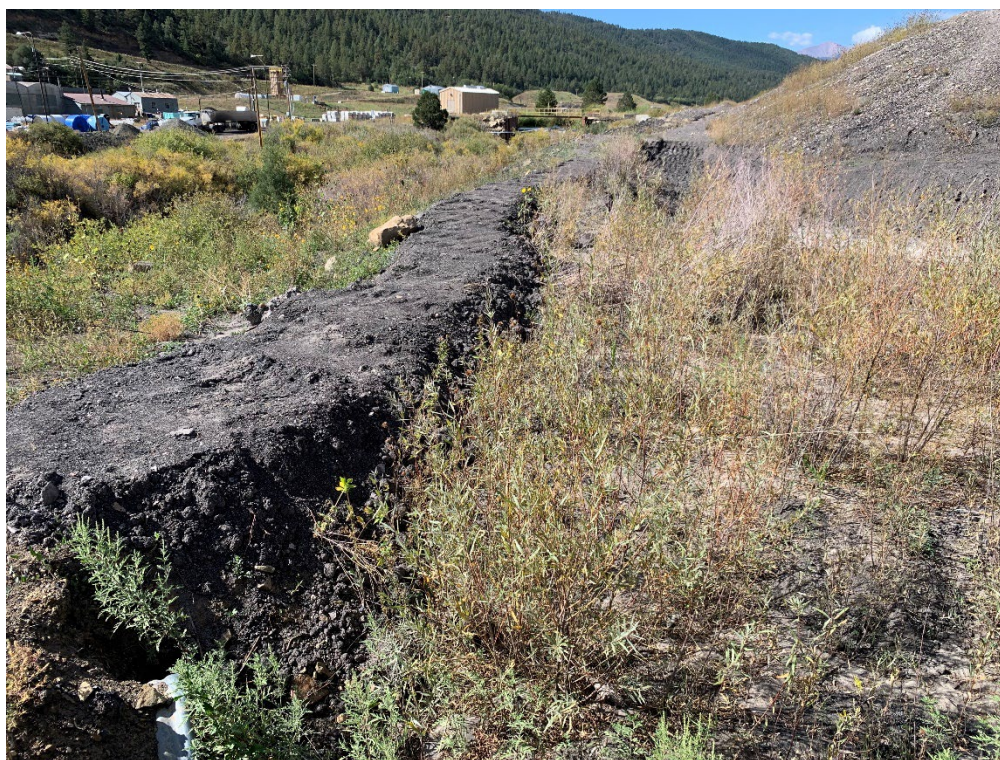
The check dams on top of the DWDA #2 were in good condition. Ditch D14 along the southern side of the pile was clear of obstructions and the eastern end of the ditch was recently cleaned. The berm of the sediment basin on the east end of the pile needs to be repaired. The southern berm needs to be have the side slopes graded to about 3h:1v and be compacted. Currently, the top of the berm has been compacted but not the sides (photo 8). This is not a stable condition. On the east side of culvert C13, a small gully has formed on the outside of the berm (photo 9). This is a sign of instability and that water was flowing over the top of the berm rather than through the culvert. This section of the berm needs to be repaired and compacted.

Photo 8 – Sediment basin berm needs sides sloped and compacted

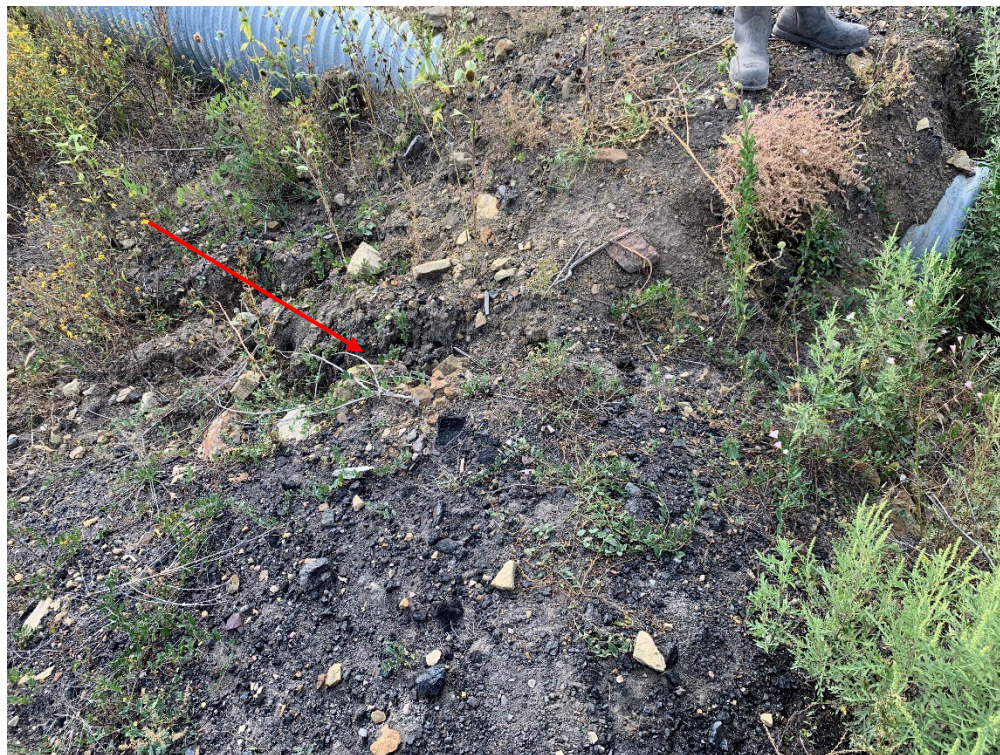
Photo 9 – Gullies forming on sediment basin berm

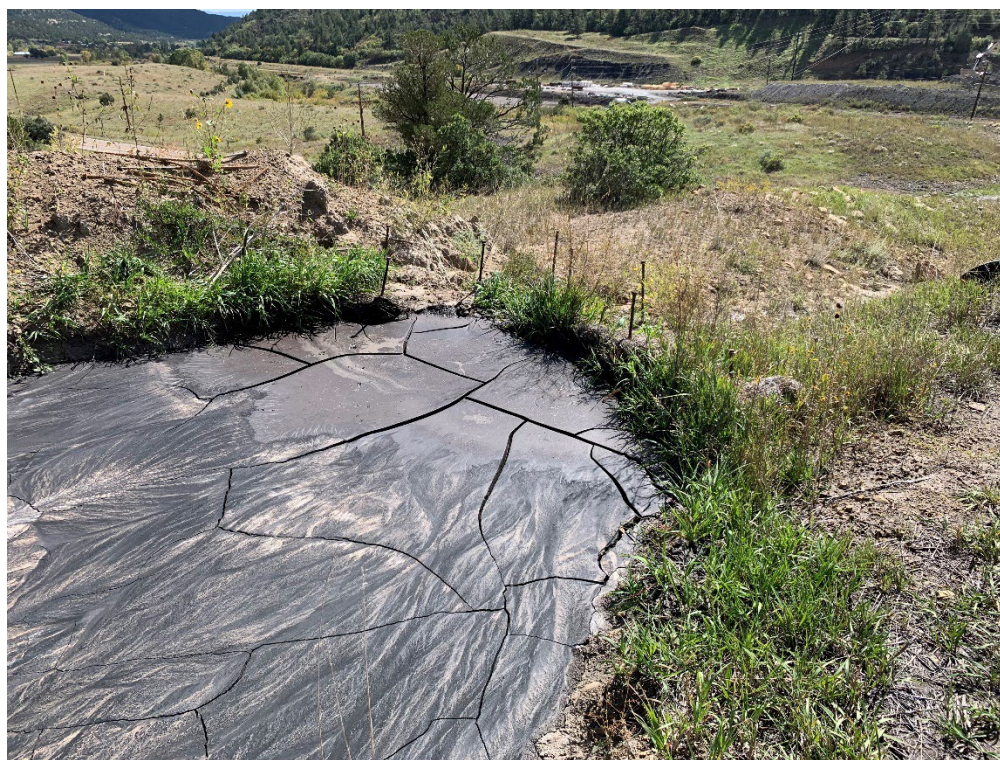
The catch basin in the drainage above containment pond 5 on the east side of the conveyor needs to be cleaned (photo 10).

Photo 10 – Catch basin on east side of conveyor above containment 5 pond

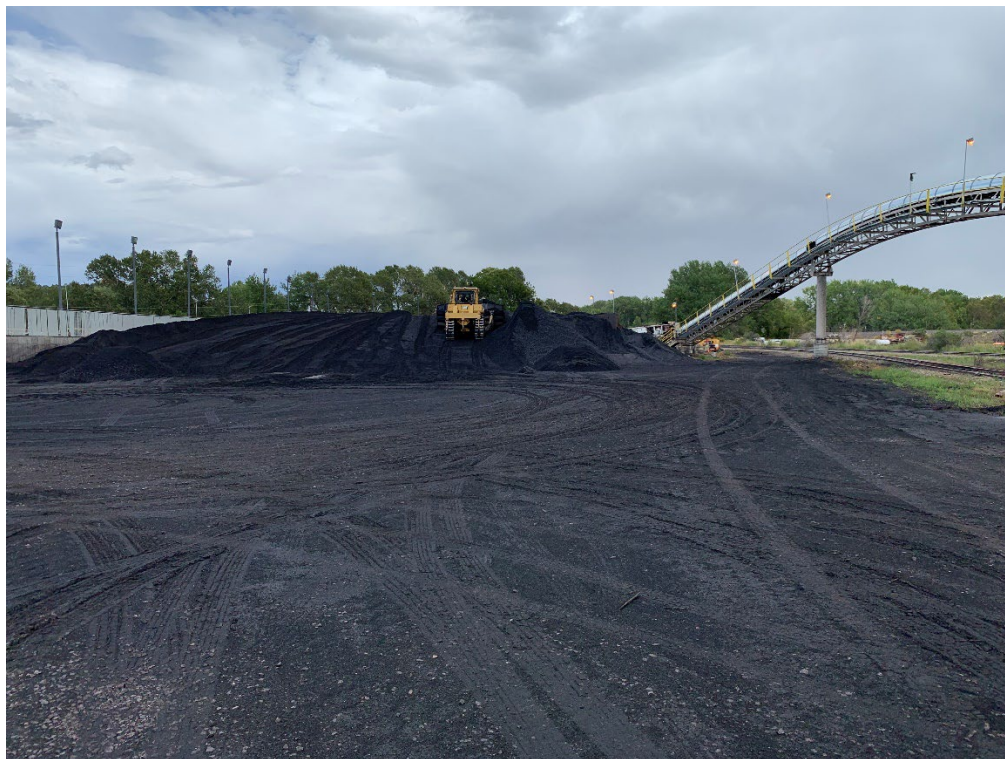
Coal was being stacked at the loadout. Trucks were hauling coal in while a bulldozer was positioning the coal around the conveyor belt (photo 11). The coal debris was contained within the disturbed area.

Photo 11 – Coal being stacked at the loadout

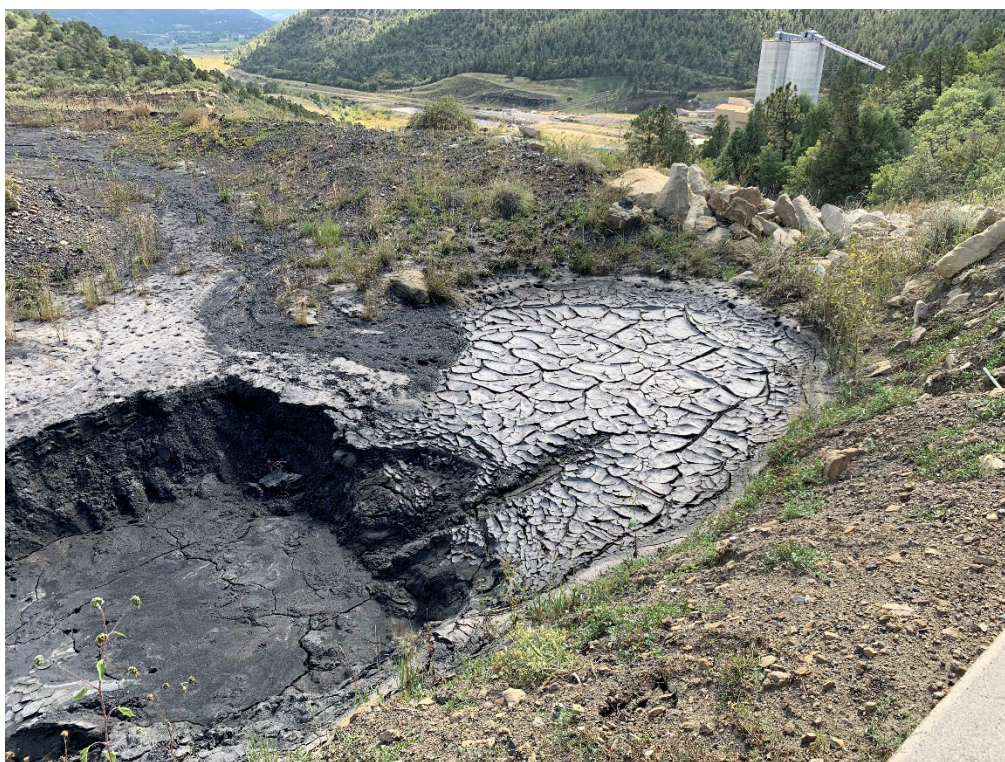
Culvert C18 and the sediment trap on the west side of the RDA needs to be cleaned (photo 12).

Photo 12 – Sediment trap on the RDA needs cleaning
