PERMIT INFORMATION

Permit Number: C-1996-084 Mine Name: Lorencito Canyon Mine Operator: New Elk Coal Company, LLC Operator Address: Mr Mark Gray 12250 Highway 12 Weston, CO 81091	County: Las Animas Operation Type: Surface Permit Status: Permanent Cessation Ownership: Private
	Operator Representative Present: Nick Mason
Operator Representative Signature: (Field Issuance Only)

Inspection Start Date: September 28, 2022 Inspection Start Time: 12:00 Inspection End Date: September 28, 2022 Inspection End Time: 13:00	Inspection Type: Coal Partial Inspection Inspection Reason: Normal I&E Program Weather: Cloudy
Joint Inspection Agency: None	Joint Inspection Contacts:
Post Inspection Agency: None	Post Inspection Contacts:
Inspector(s): Brock Bowles	Inspector's Signature:

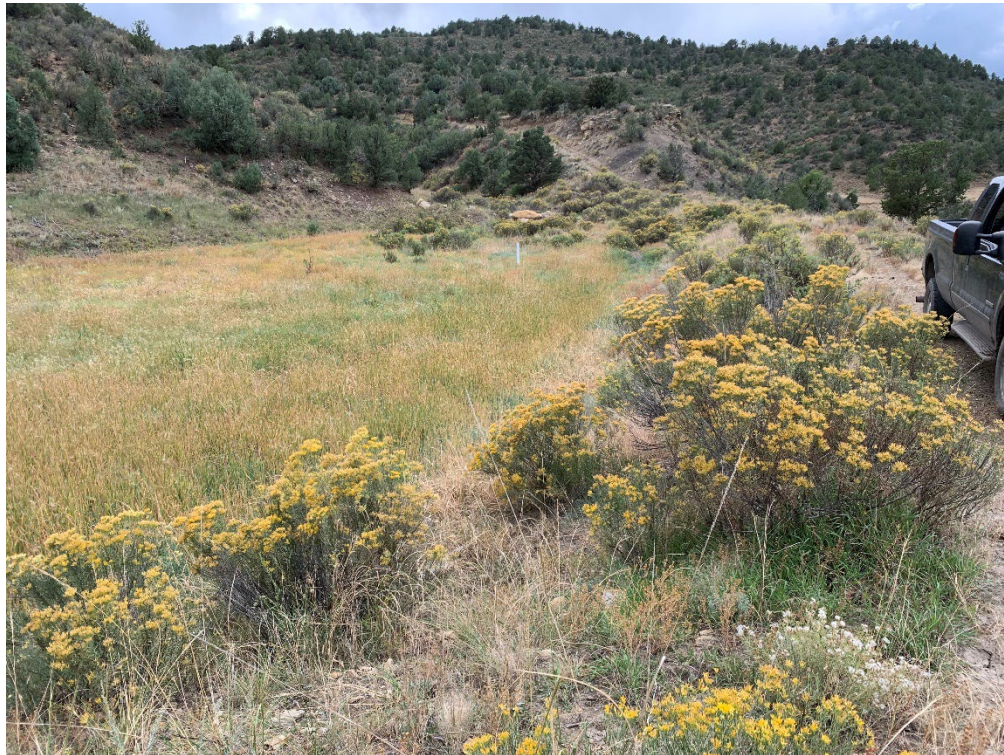
Photo 1 – Pond 5

Pond 5 did not contain water (photo 1). The bottom of the pond area was covered with grasses. The embankment was well vegetated. The primary spillway was clear of obstructions.

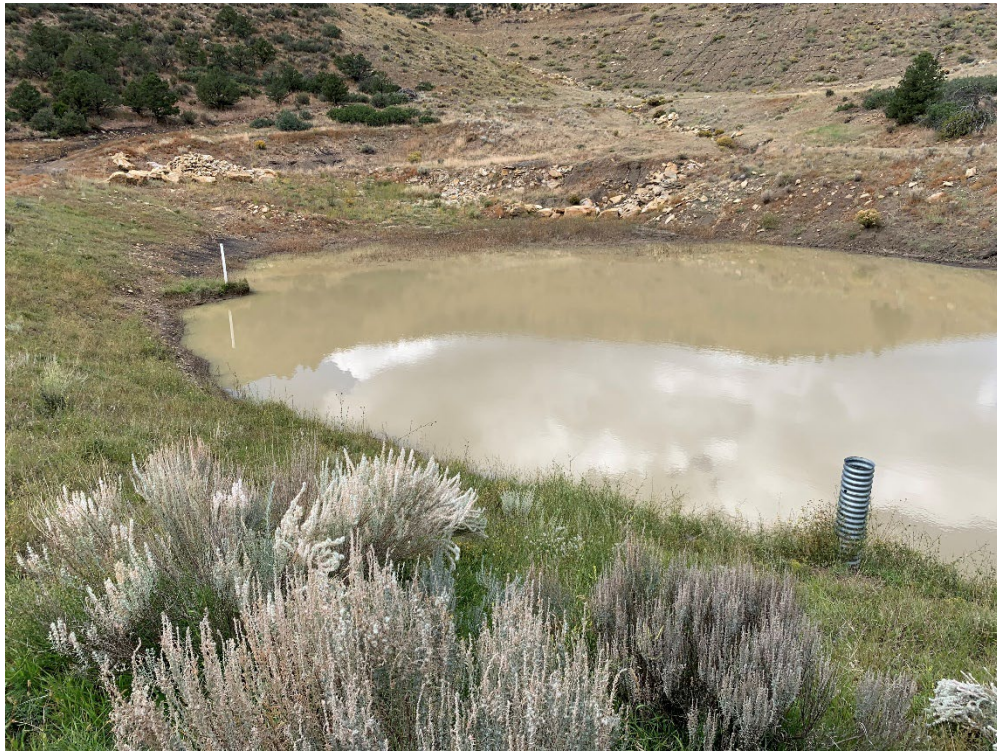
Photo 2 – Pond 6

Pond 6 contained water (photo 2). The primary spill way was clear of obstructions. The embankment was well vegetated and appeared to be stable.

The reclamation above pond 6 has been a difficult spot to reclaim. The operator is planning to redesign the slope and perform the work next spring.

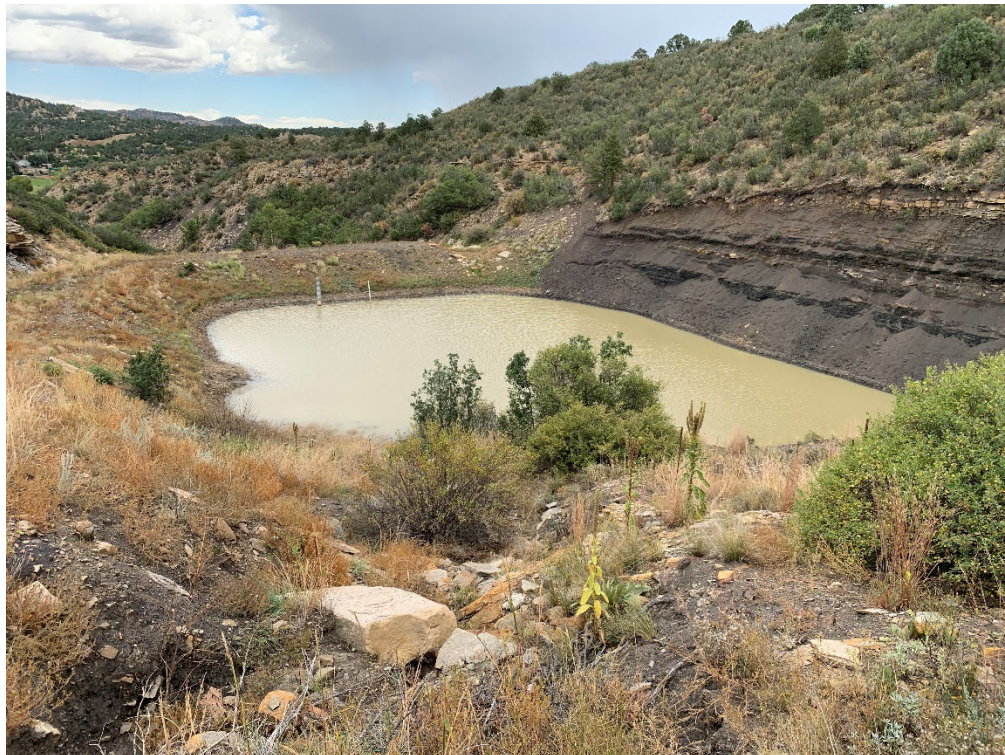
Photo 3 – Pond 8

Ponds 8 (photo 3) and 9 contained a small amount of water and were not discharging. The primary and emergency spillways were clear of obstructions. The embankments appeared to be stable.
