**MINERALS PROGRAM INSPECTION REPORT**  
**PHONE: (303) 866-3567**

<b>MINE NAME:</b> Green/Croissant Sand and Gravel Mine	<b>MINE/PROSPECTING ID#:</b> M-2001-022	<b>MINERAL:</b> Sand and gravel	<b>COUNTY:</b> Weld
<b>INSPECTION TYPE:</b> Surety Release Inspection	<b>WEATHER:</b> Clear	<b>INSP. DATE:</b> October 6, 2022	<b>INSP. TIME:</b> 10:00
<b>OPERATOR:</b> Loveland Ready-Mix Concrete, Inc.	<b>OPERATOR REPRESENTATIVE:</b> Stephanie Fancher-English	<b>TYPE OF OPERATION:</b> 112c - Construction Regular Operation	
<b>REASON FOR INSPECTION:</b> Surety Release Requested	<b>BOND CALCULATION TYPE:</b> None	<b>BOND AMOUNT:</b> \$209,700.00	
<b>DATE OF COMPLAINT:</b> NA	<b>POST INSP. CONTACTS:</b> None	<b>JOINT INSP. AGENCY:</b> None	
<b>INSPECTOR(S):</b> Peter Hays	<b>INSPECTOR'S SIGNATURE:</b>

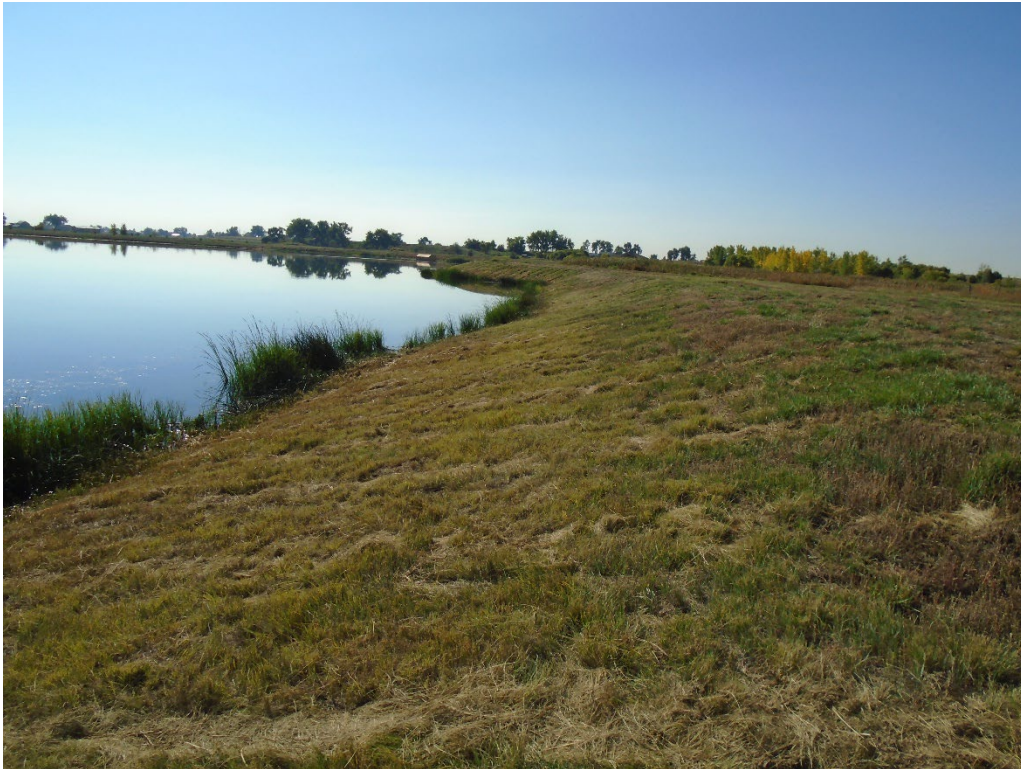
View of the northern portion of the western shoreline

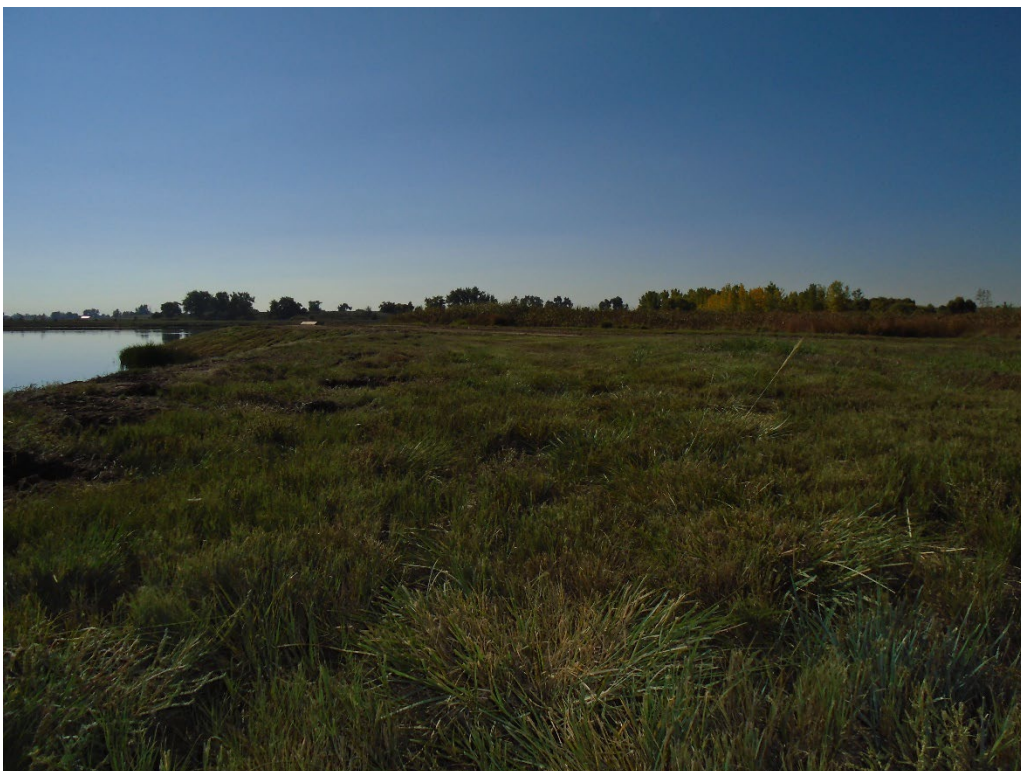
View of the vegetation along the western shoreline

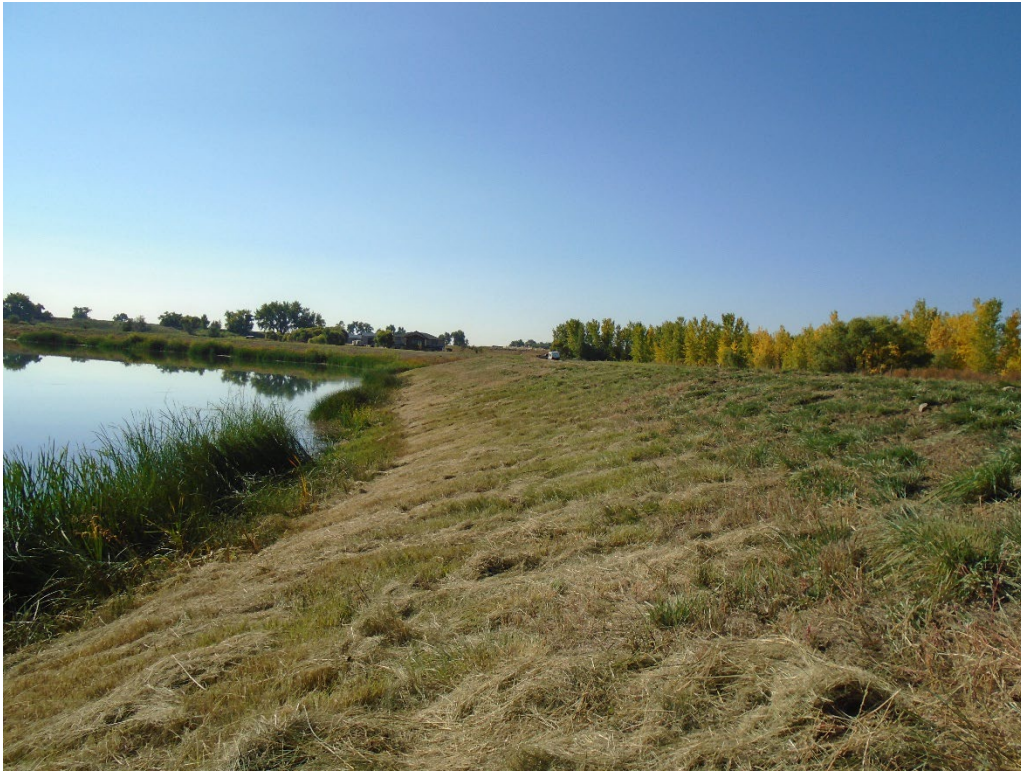
View of the southern portion of the western shoreline

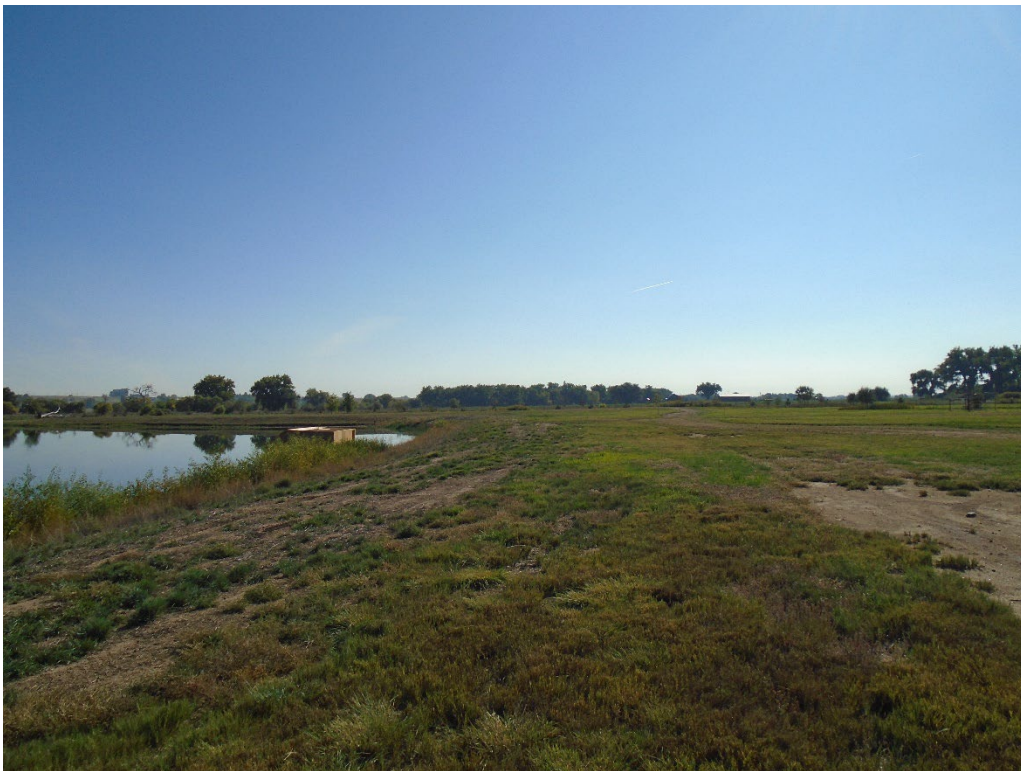
View of the southern shoreline from the southwest corner looking east

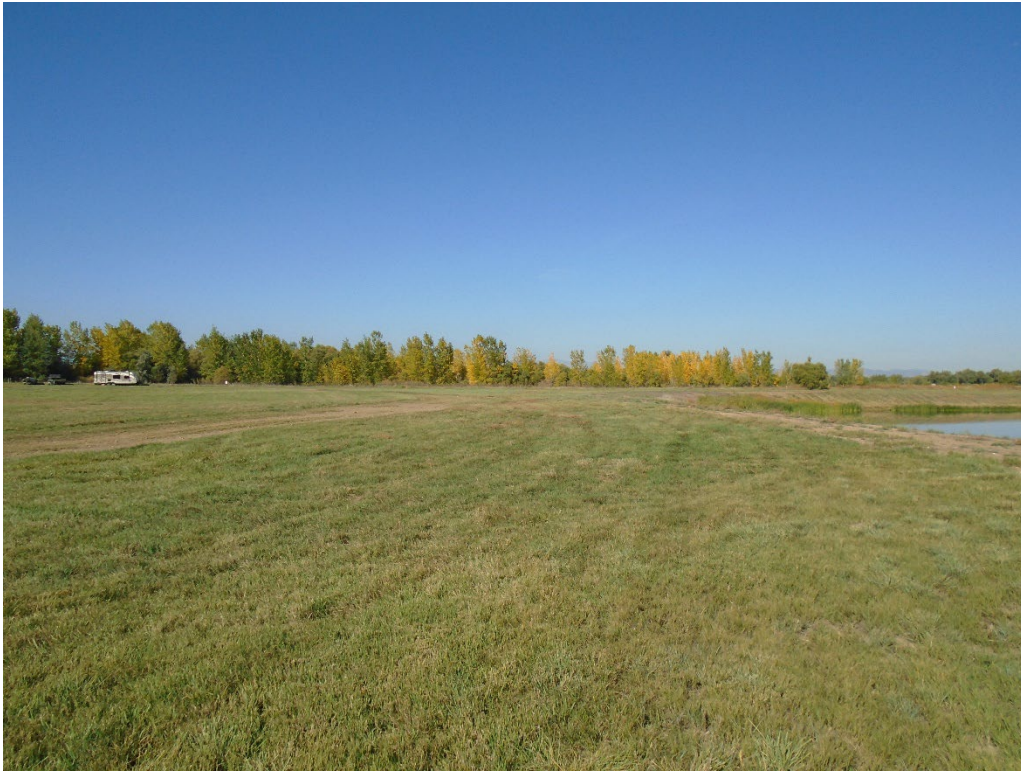
View of the southern shoreline looking west

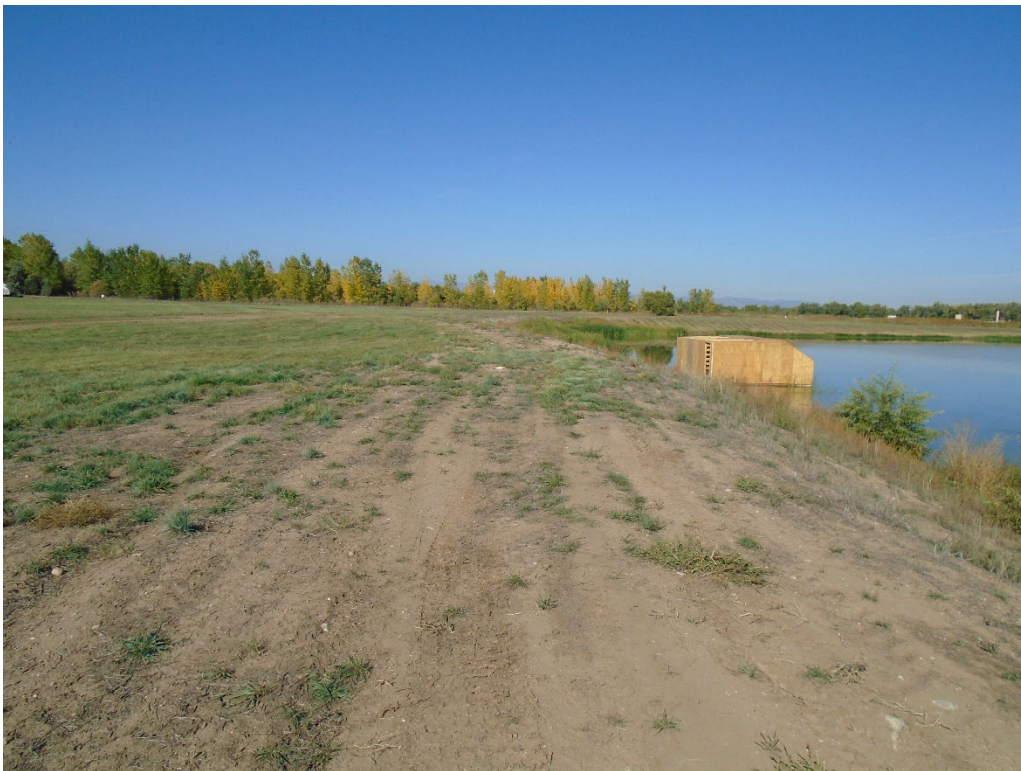
The western access road has seen substantial use by the landowners during the construction of their residence in the southwest corner of the property since the last inspection. The landowners planted trees along the eastern access road to their residence. The landowners installed a boat ramp and dock in the northeast corner of the lake. A fishing shed was observed along the southern shoreline. Tire tracks from vehicles and ATVs were observed along the shoreline, which is preventing the establishment of vegetation around the lake.

View of the fishing shed and tire tracks along the southern shoreline

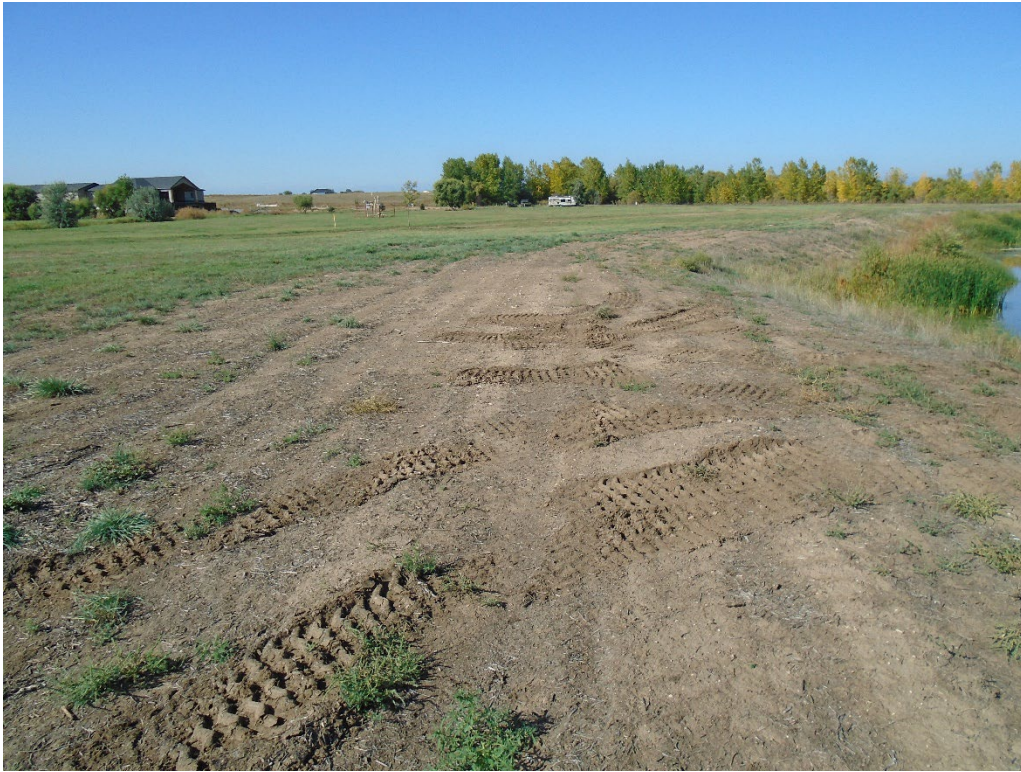
View of the southeast corner of the site

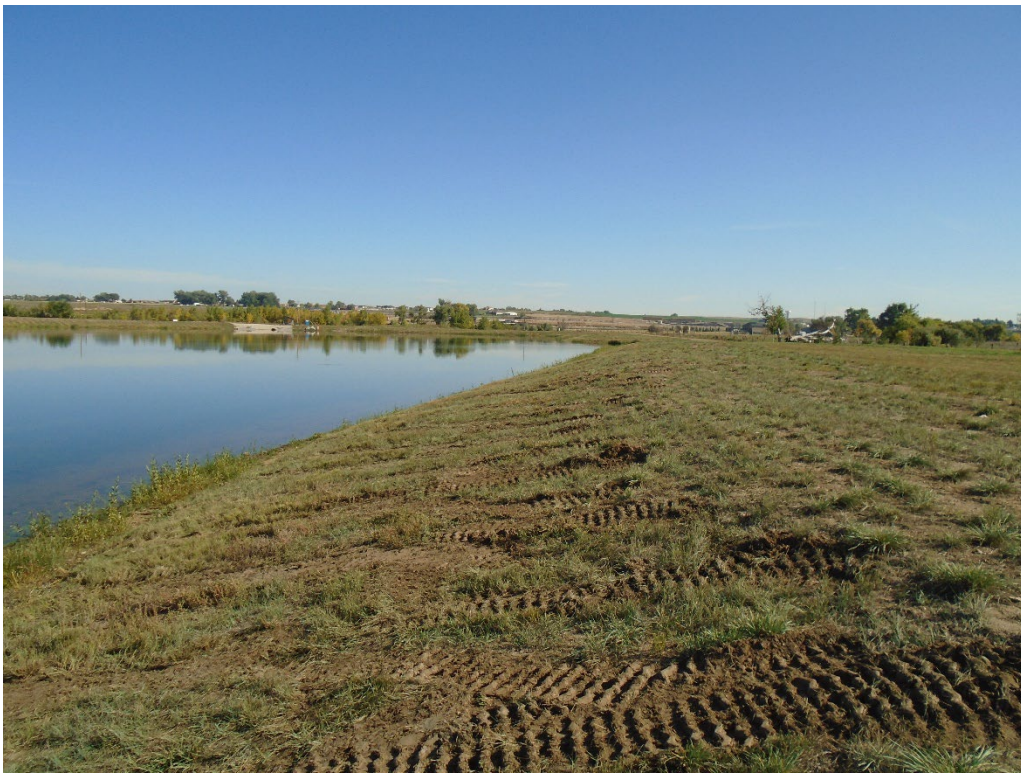
View of the southern portion of the eastern shoreline

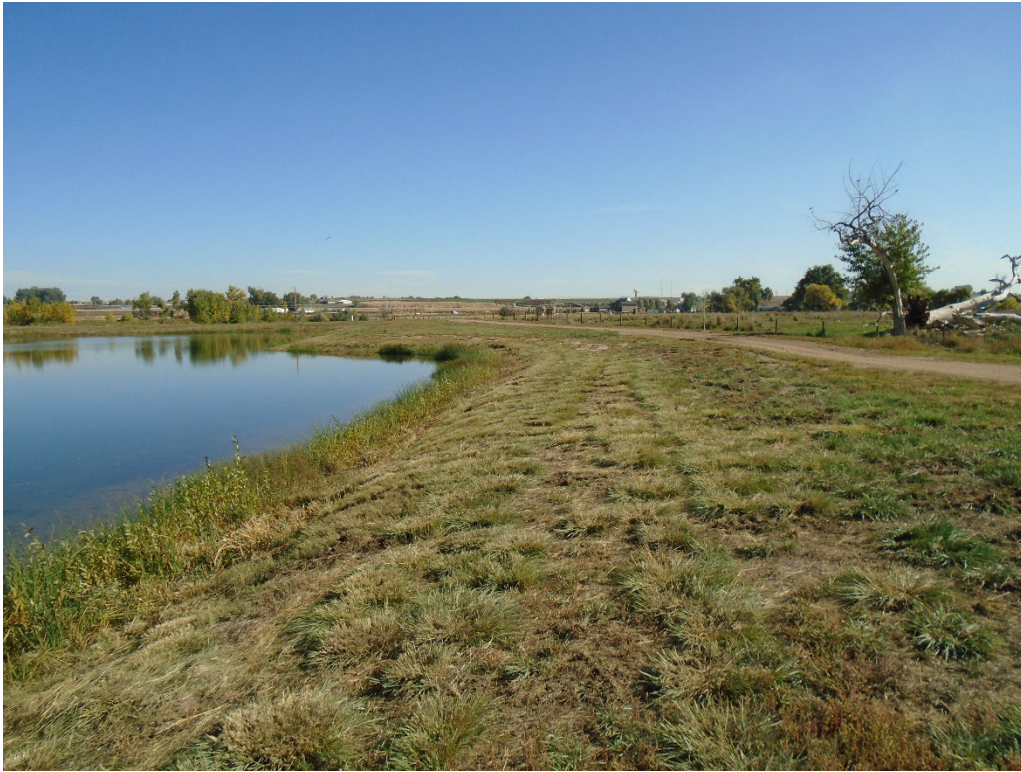
View of the northern portion of the eastern shoreline

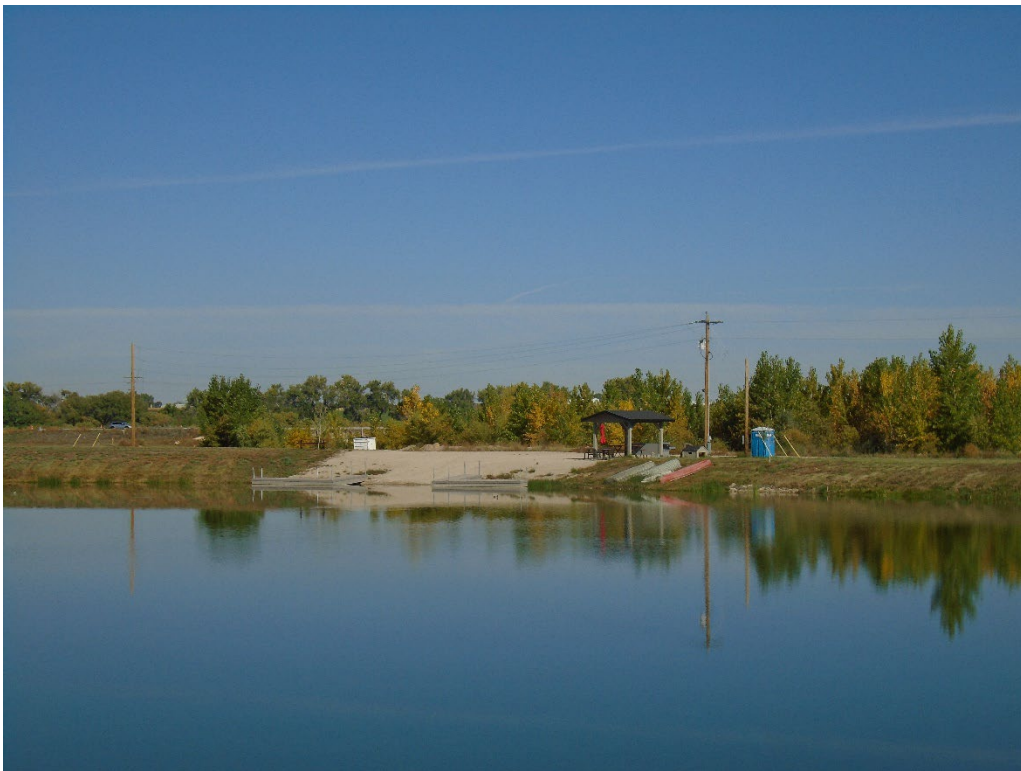
View of the boat dock in the northeast corner of the lake

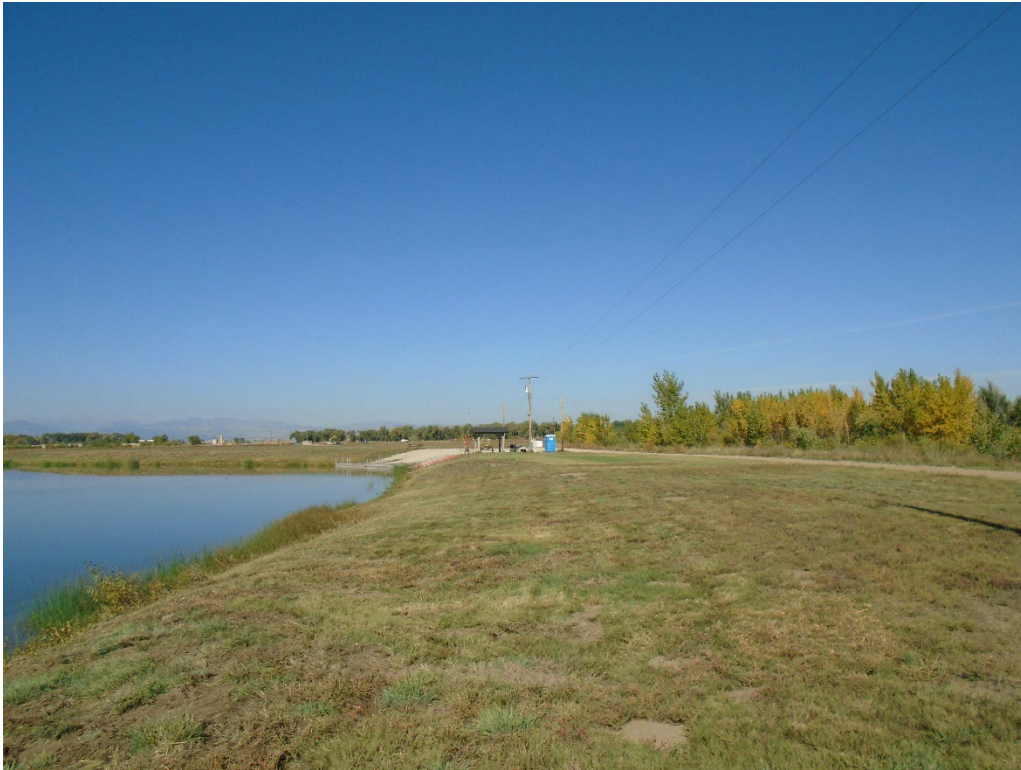
View of the northern shoreline from the northeast corner looking west

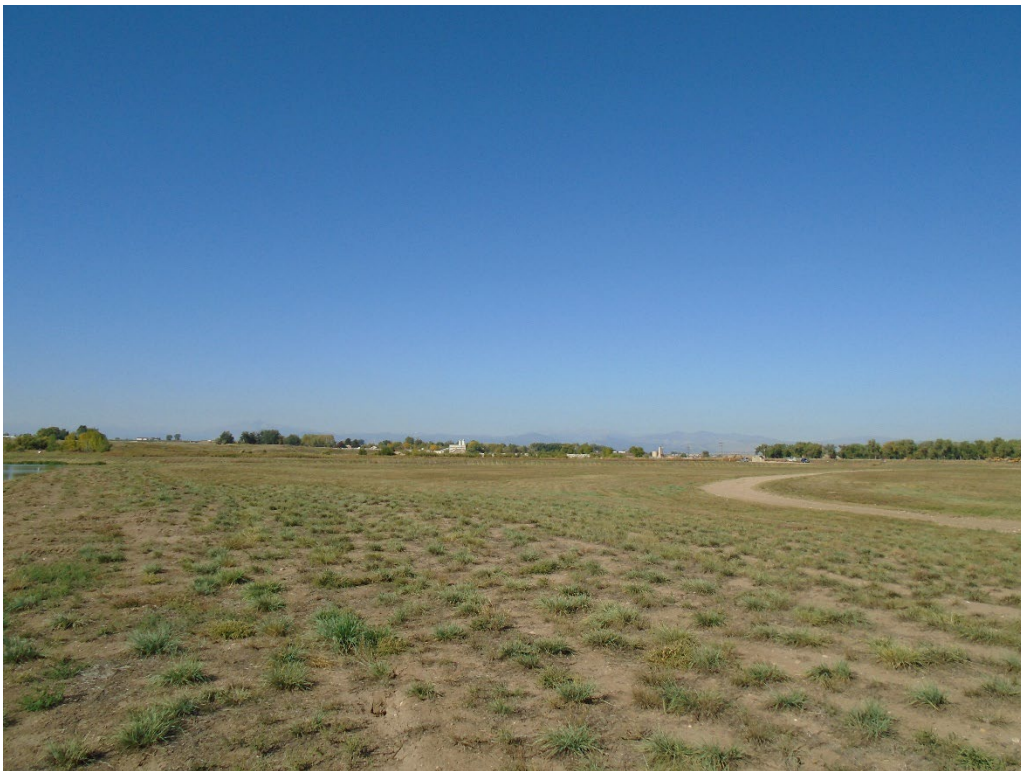
View of the northern shoreline, west of the boat dock, looking west

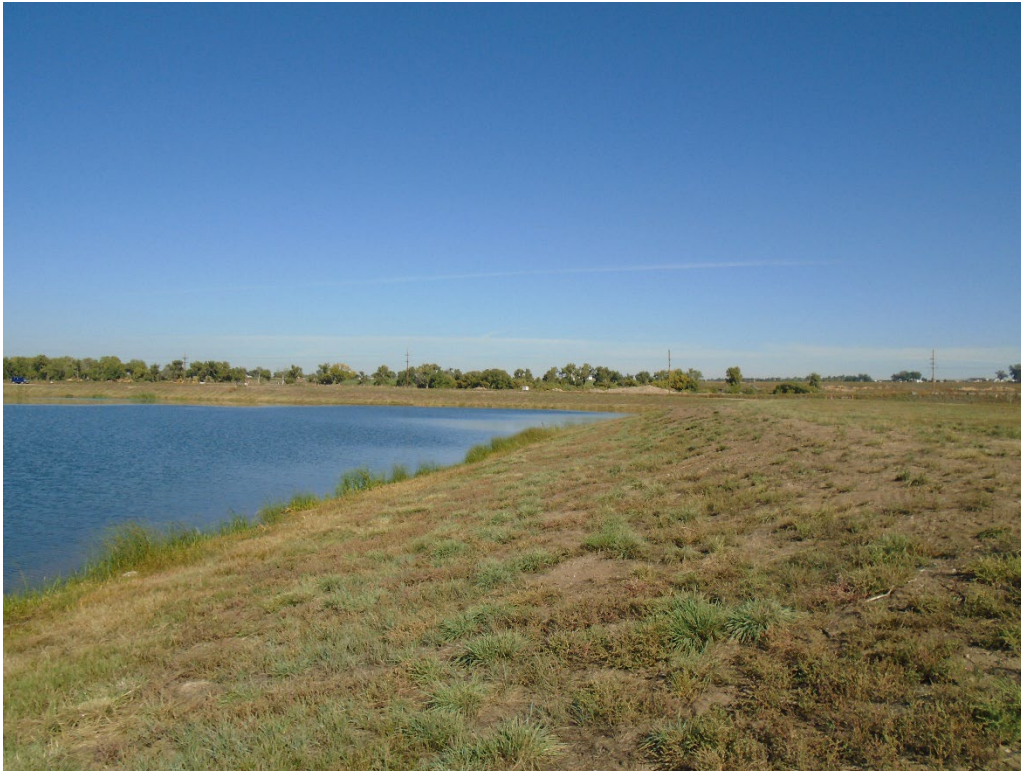
View of the northeast shoreline looking north
