**Re: Daniels Monthly Report**

October 11, 2022  
Project No.: 19125

Regarding: Daniels Sand Pit 2, Permit No. M-1973-007-SG  
Slope Stability Monthly Monitoring Report

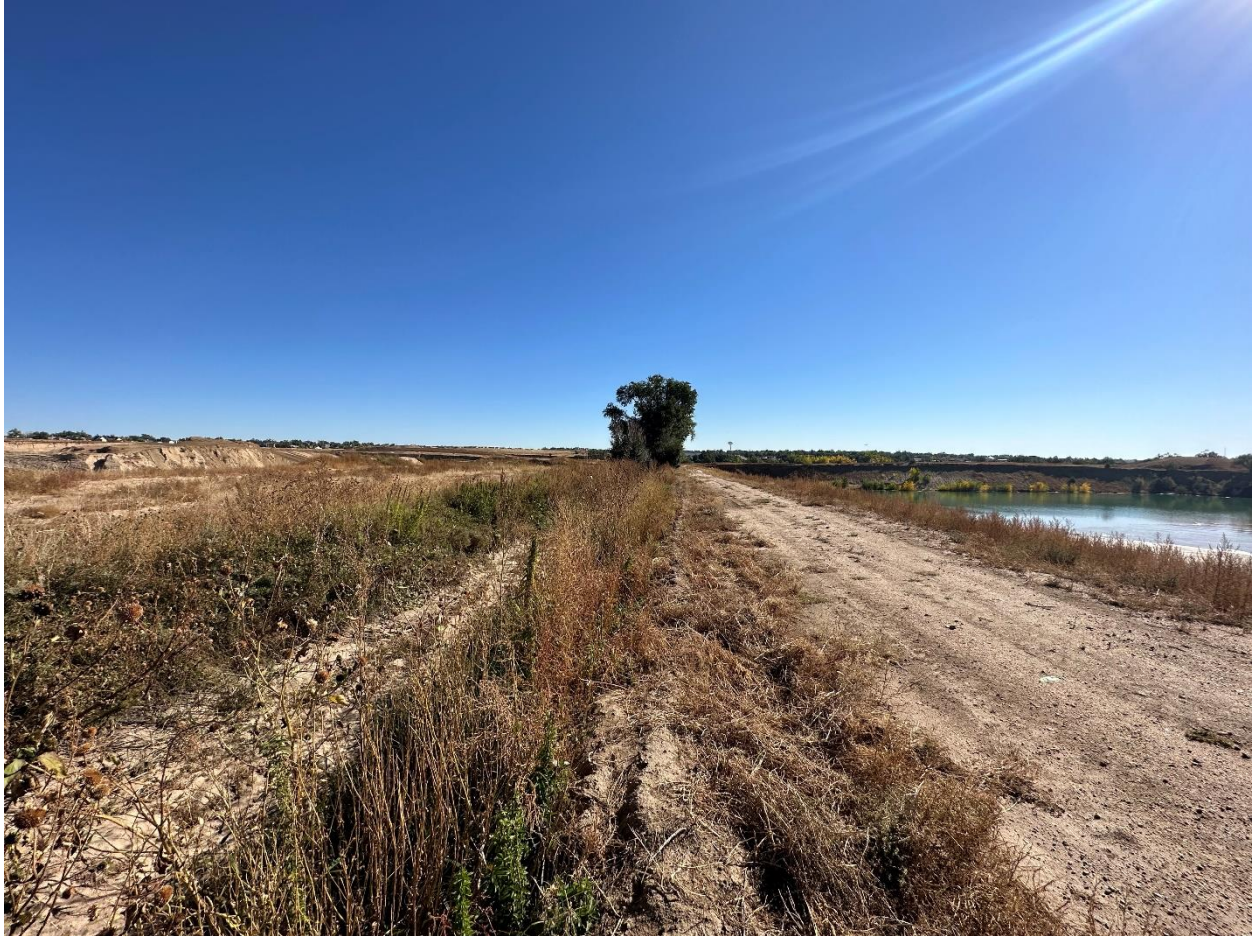
- Weather: 42-76°, sunny to partly cloudy, winds 15-25 mph
- Visual observation of the Fountain Mutual Ditch:
  - No tension cracks
  - No toe erosion that was visible
  - Vegetation growing on banks and at invert of ditch
  - No water flowing/dry ditch
  - No sloughed slope surfaces
  - The condition of the ditch is stable

Photo 1. Fountain Mutual Ditch looking east

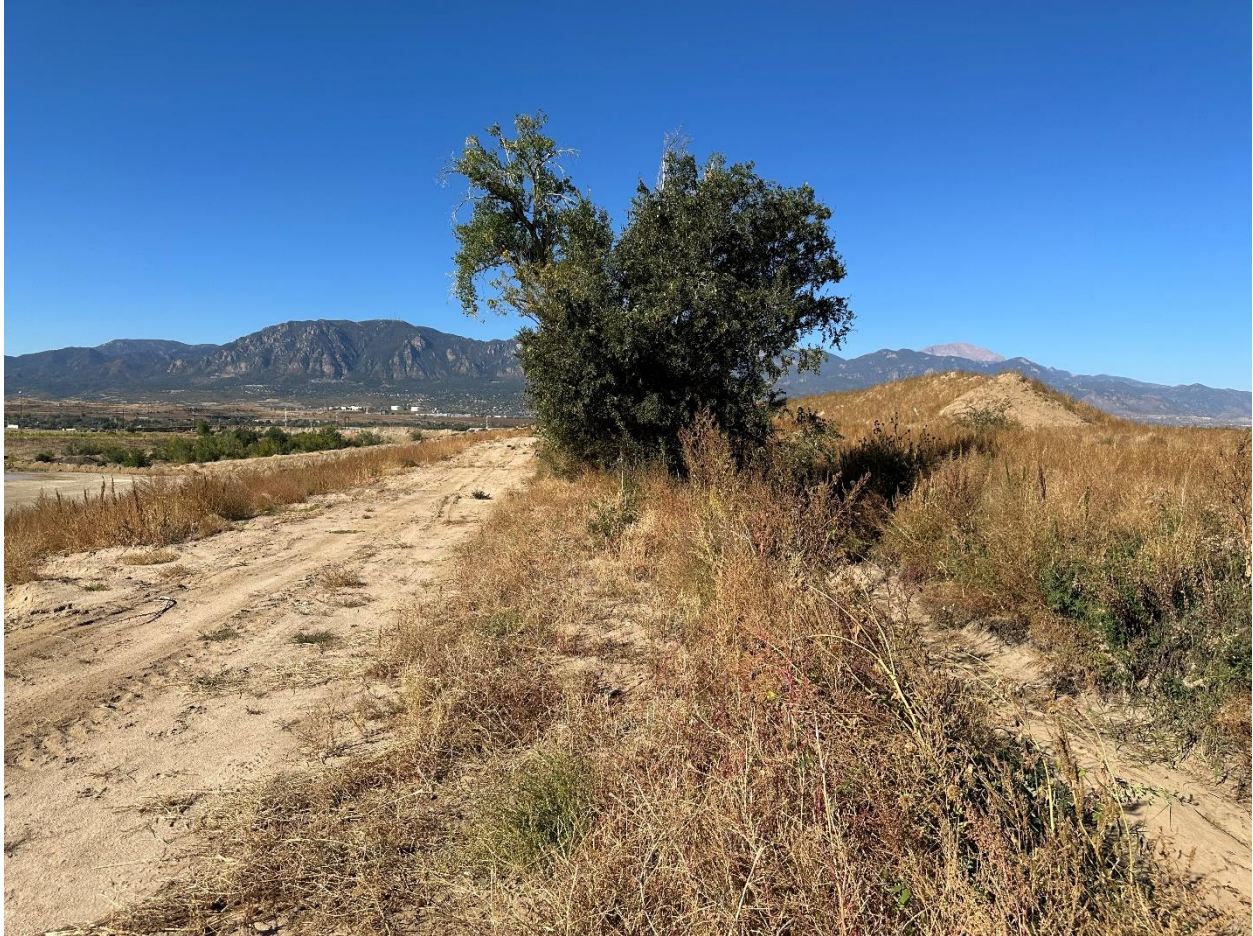
Photo 2. Fountain Mutual Ditch looking west

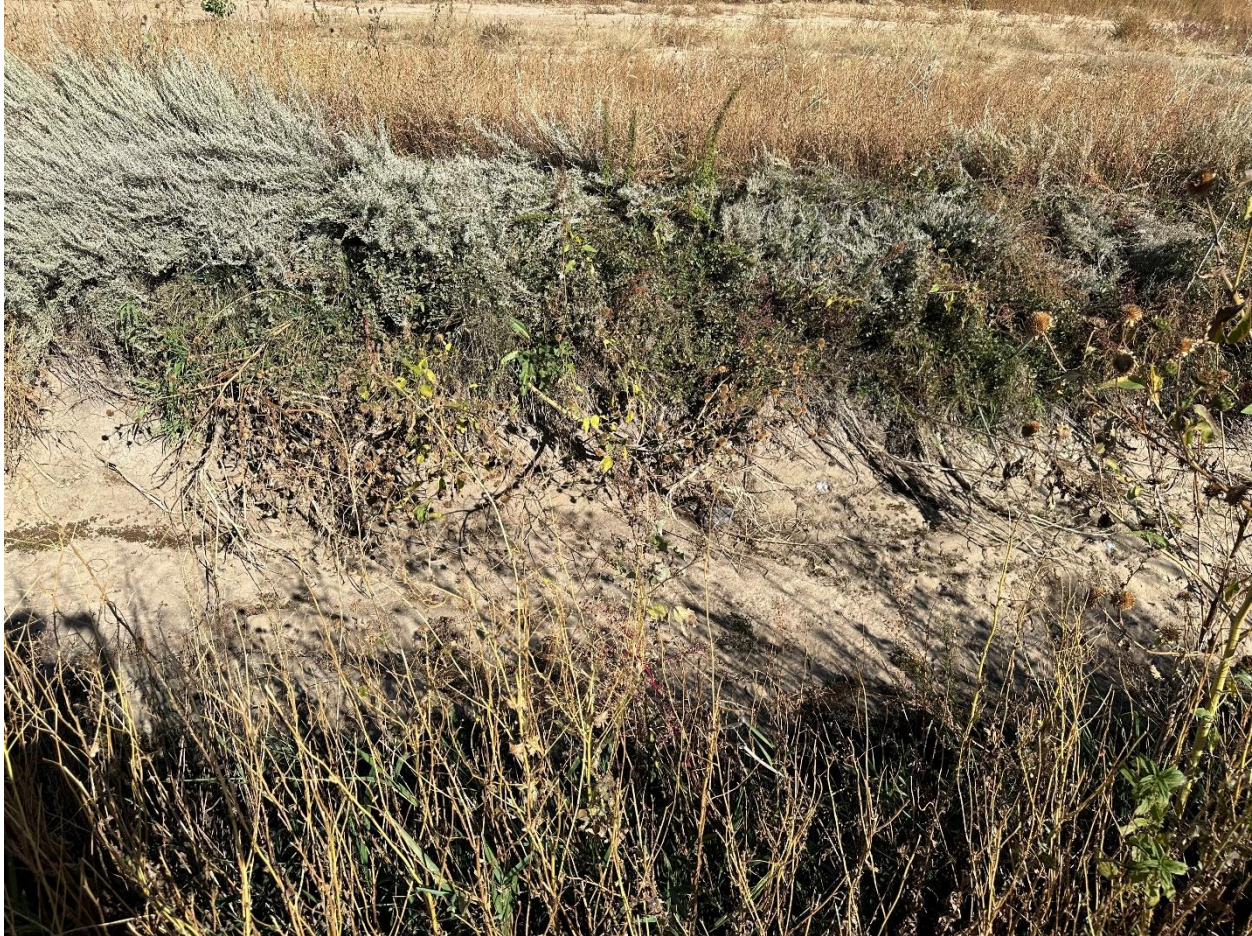
Photo 3. Fountain Mutual Ditch invert looking north (note vegetation)

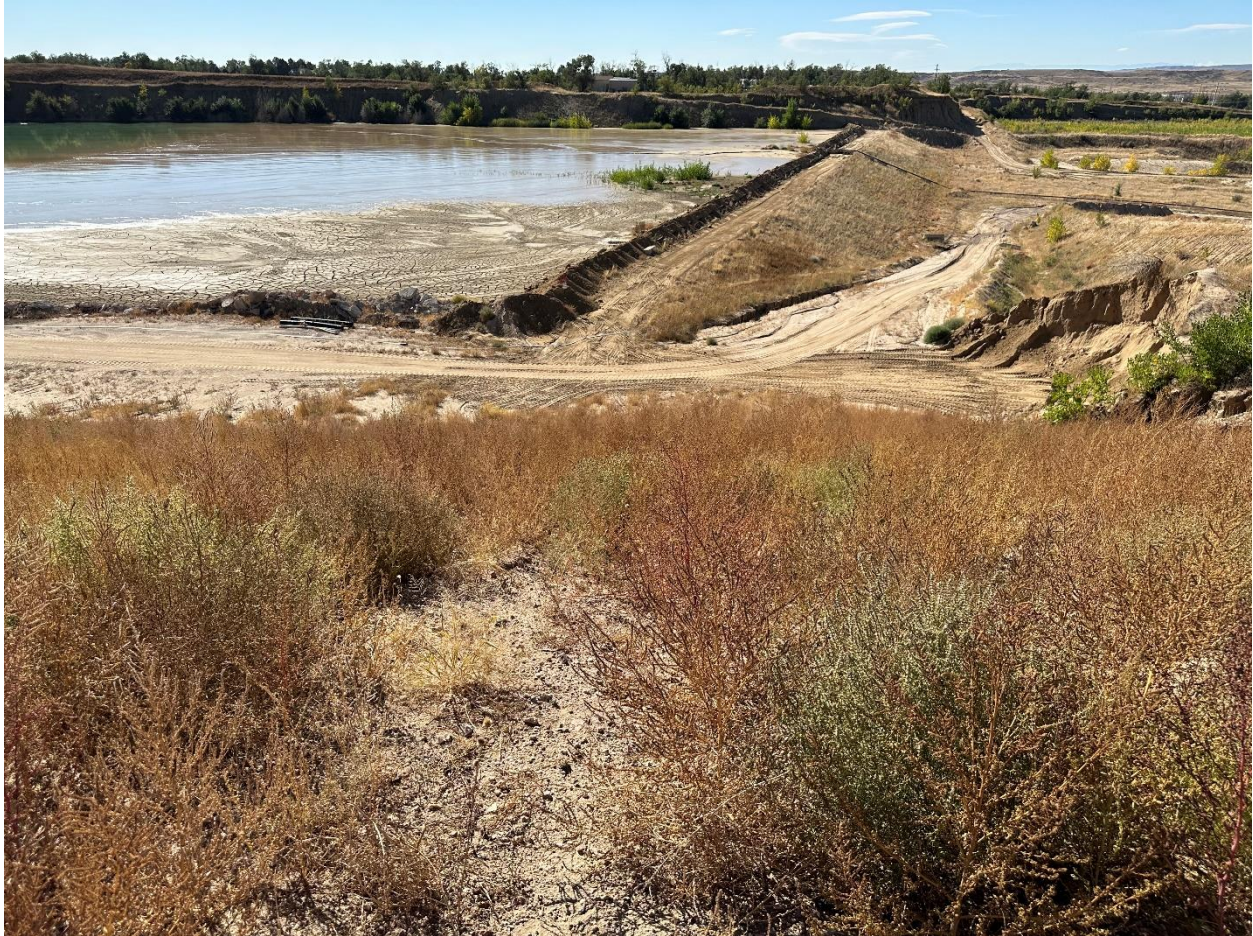
Photo 4. Butress slope looking south with weeds (western slope)

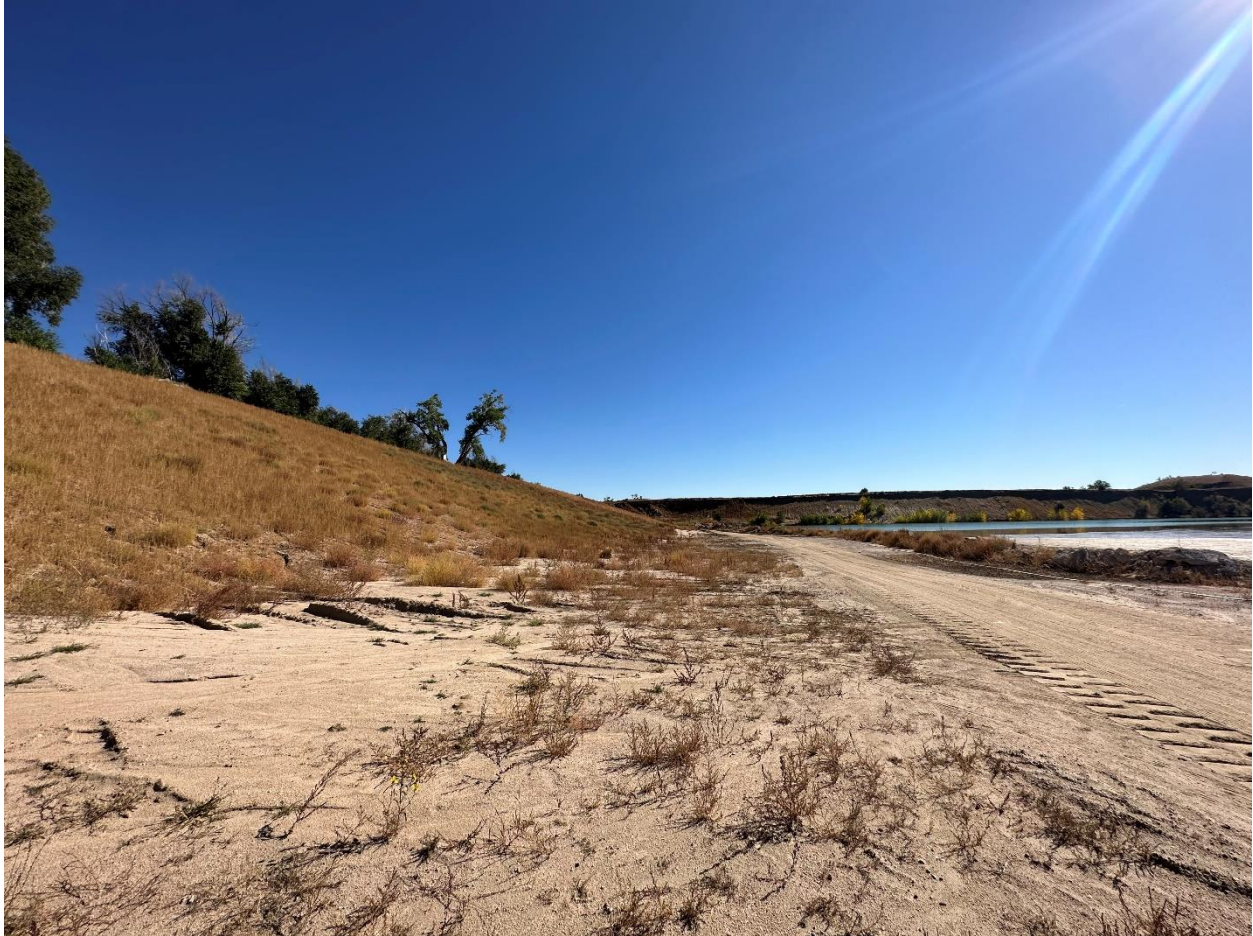
Photo 5. Buttress slope looking east from toe

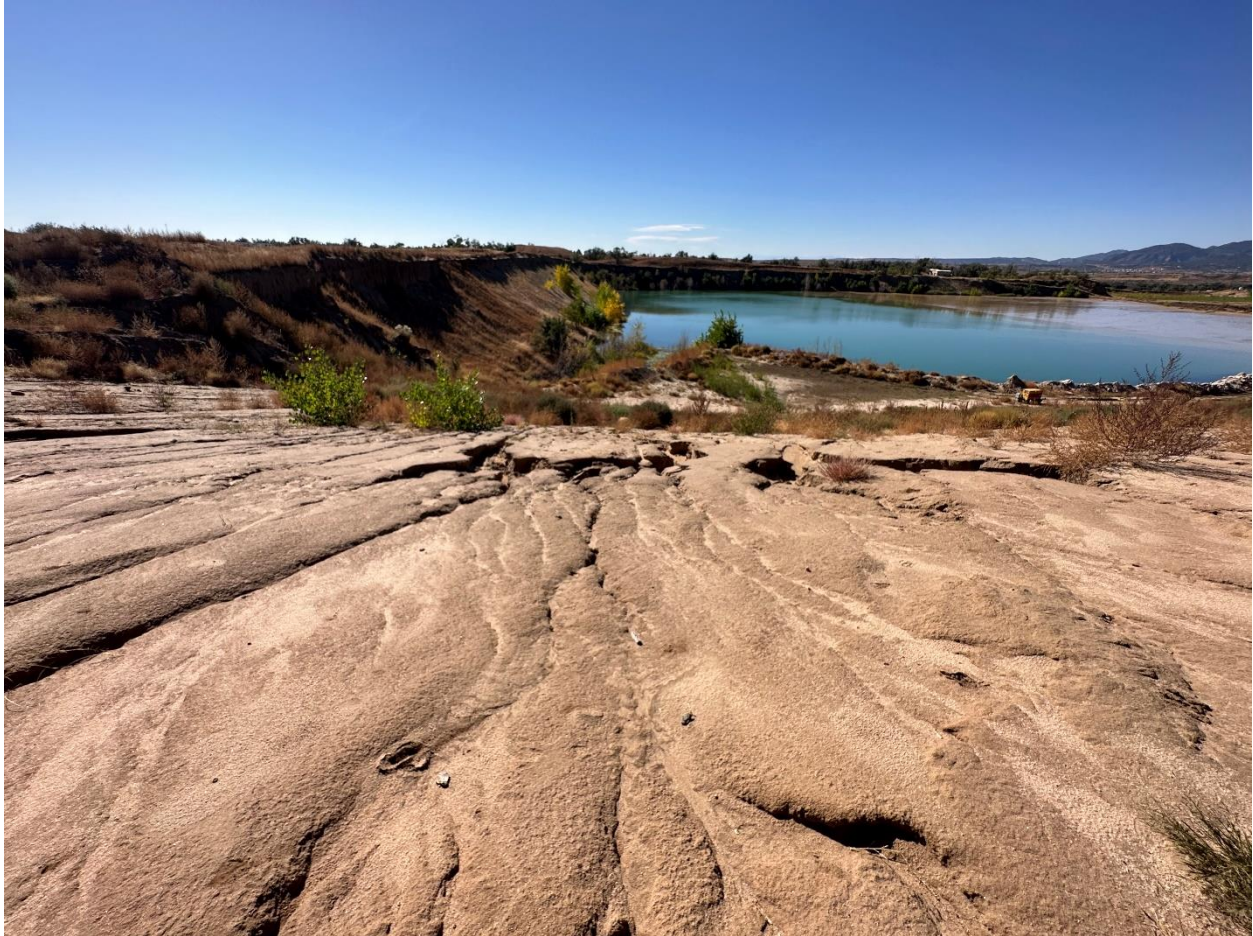
- Visual observations of the Buttress Slope
  - The buttress slope varies from 3H:1V to 4H:1V
  - Vegetation (mainly weeds) are growing in some locations on the buttress
  - Several locations visible evidence of surface water runoff and erosion gullies throughout alignment
  - On the eastern side of the buttress (less weeds), surface/drainage erosion is present approximately 15 feet from the ditch. Just south of the access road, the erosion gully is approximately 3 feet wide and 3 feet deep. Another gully is beginning to form, approximately 1 ft wide and 1.5 ft deep.

Photo 6. Buttress slope looking south, evidence of surface water drainage/erosion gully mid slope (eastern slope, less weeds)

Lithos Engineering (Lithos) has been retained by Aggregate Industries to implement a slope stability monitoring plan for the Fountain Mutual Ditch within Daniels Sand Pit 2. Monthly monitoring will occur for the first year after construction completion. Lithos Engineering (Lithos) visited the site on October 11, 2022. **The ditch appears to be stable but the buttress slope is severely gullied in one location and moderately gullied in other locations. The gullies appear to have been formed from erosion due to runoff from the ditch road. In addition, erosion extending upward from the toe is visible in several locations along the alignment. We recommend that the gullies be backfilled with compacted soil within the next several weeks. We also recommend a drainage diversion berm be constructed along the crest of the berm such that runoff is directed toward the ditch. Per the approved design, the buttress slope should be vegetated per the reclamation plan.** Site notes and photographs are presented below:

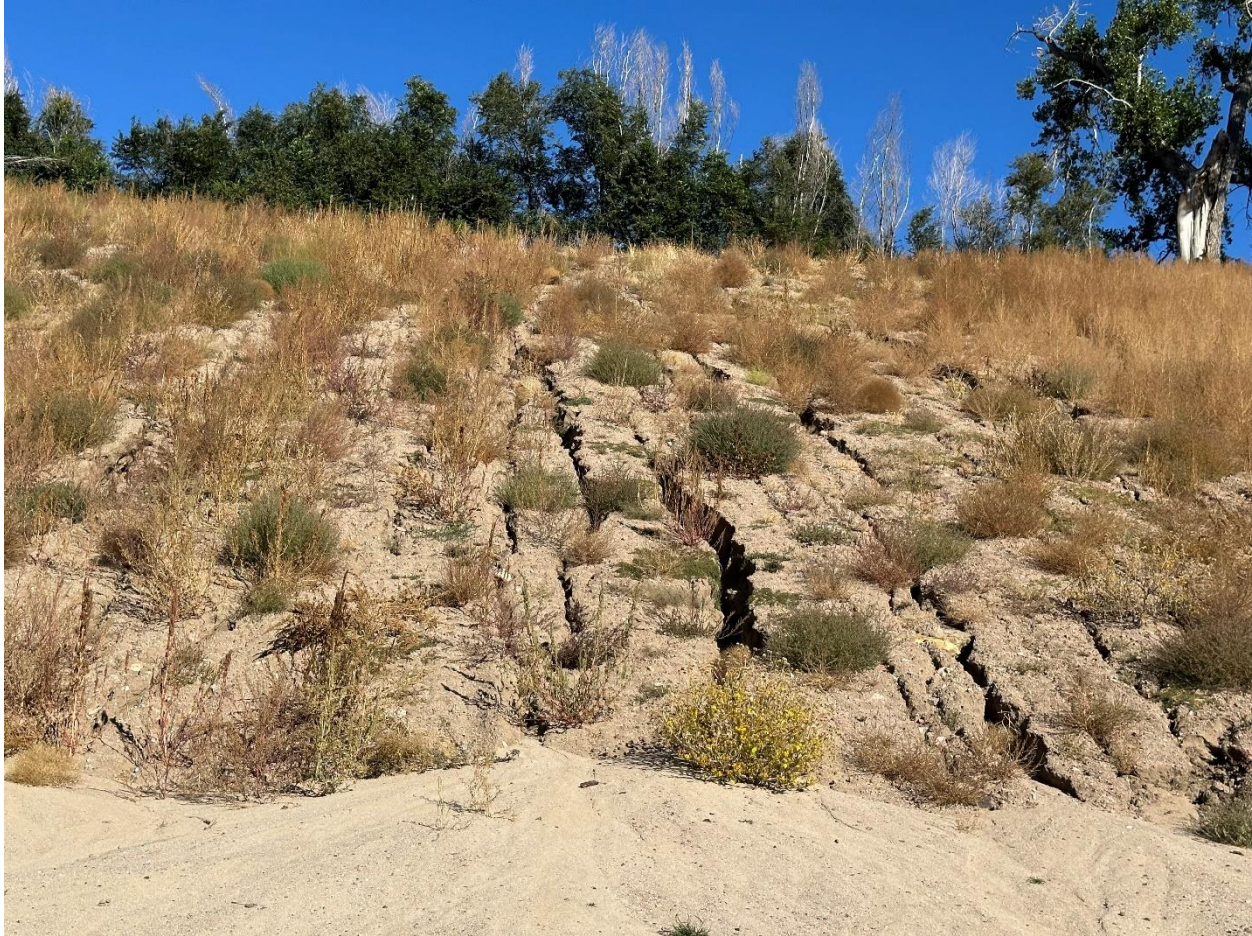
Photo 7. Buttress slope looking north, note expanding evidence of drainage/erosion gullies forming.  
More sediment near toe

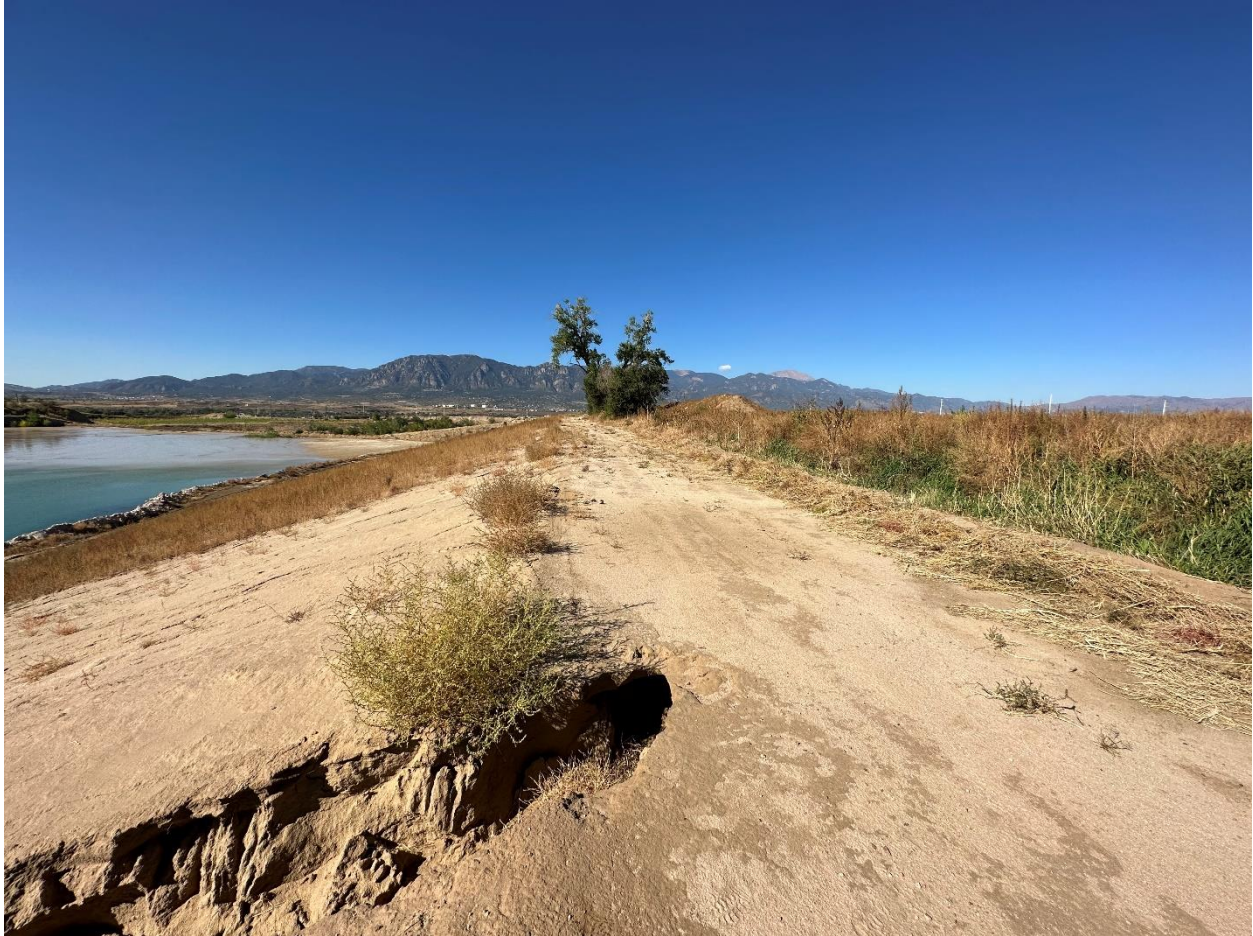
Photo 8. Erosion gully in relation to access road and ditch

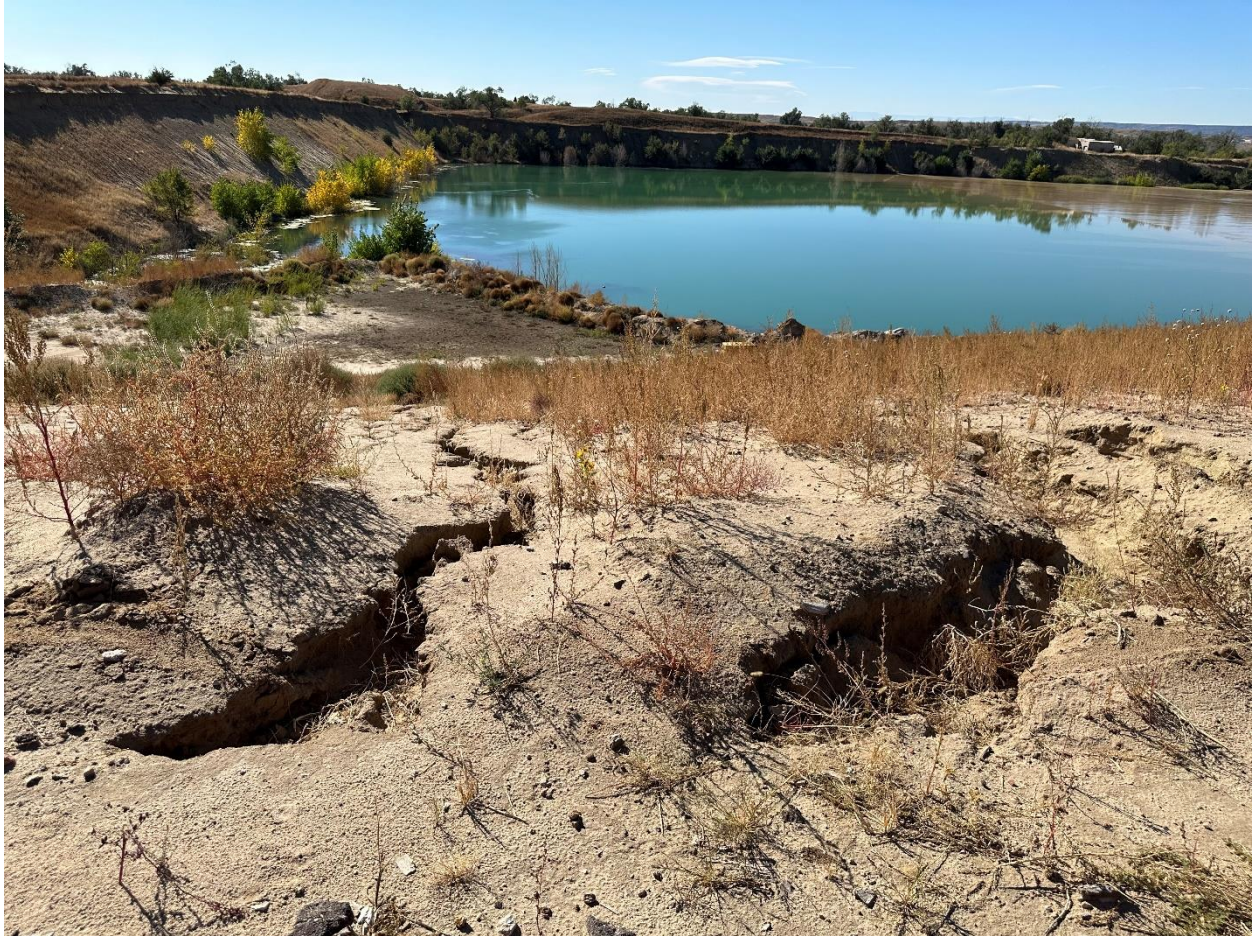
Photo 9. Zoomed in erosion gully south of access road (eastern slope)

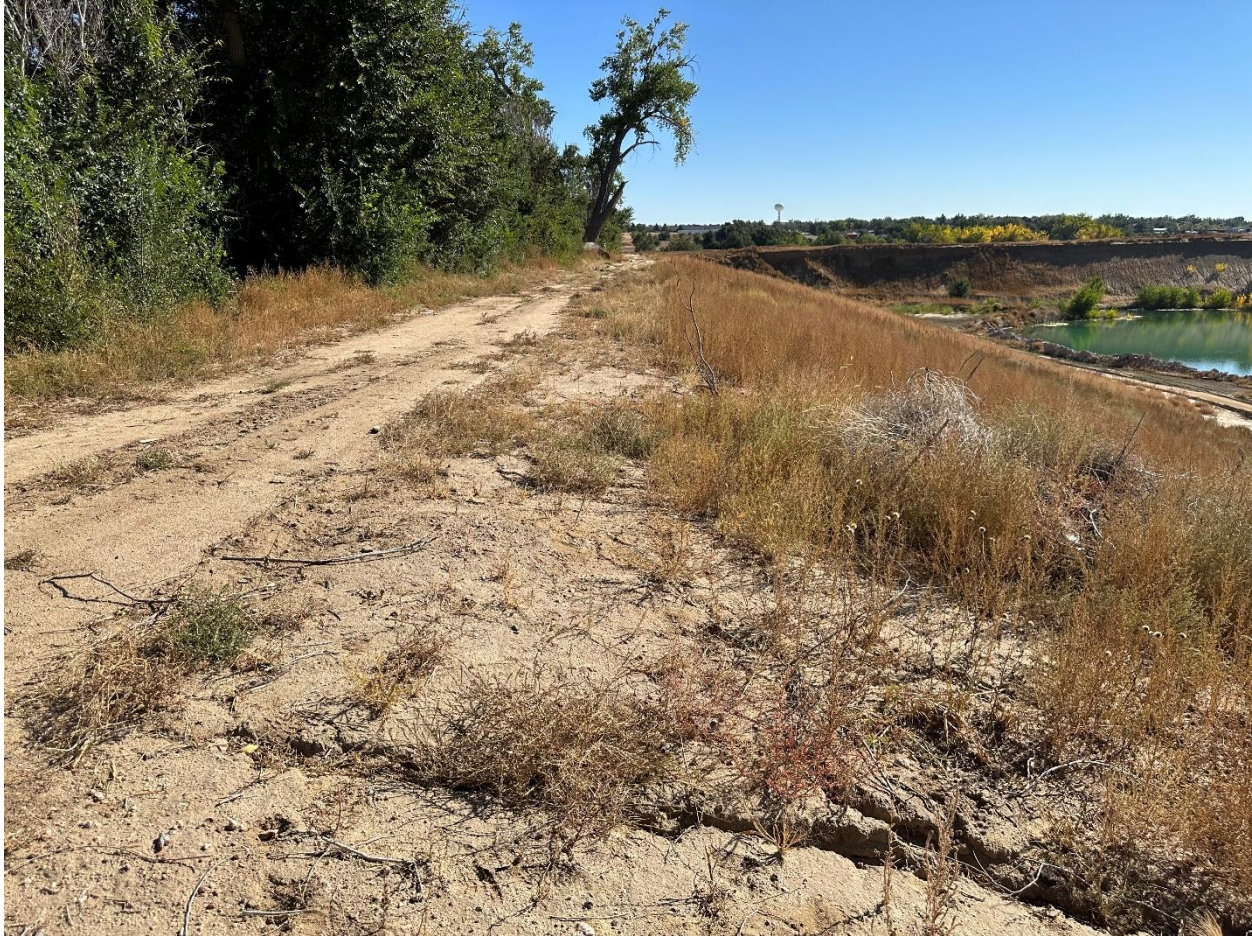
Photo 10. New surface drainage/erosion on access road (shallow), located middle alignment
