Lorencito Canyon Mine, C-1996-084, Inspection Report

PERMIT INFORMATION

Permit Number: C-1996-084 Mine Name: Lorencito Canyon Mine Operator: New Elk Coal Company, LLC Operator Address: Mr. Mark Gray 12250 Highway 12 Weston, CO 81091	County: Las Animas Operation Type: Surface Permit Status: Permanent Cessation Ownership: Private
	Operator Representative Present: Nick Mason
Operator Representative Signature: (Field Issuance Only)

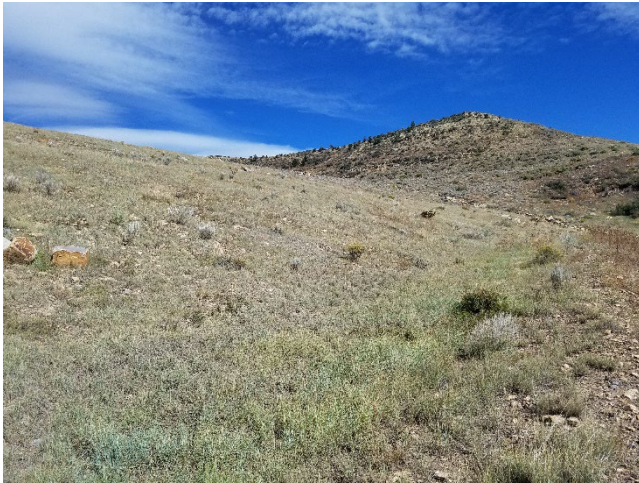
Fill 007 was observed. No signs of instability or structural weakness was observed. The face of the fill is stable and vegetated. A small rill has formed near where ditch D6 discharges into ditch D74 on the eastern side of the D74 on the face of the fill. NECC should continue to monitor this rill and take corrective action should it continue to erode.

Figure 1. Fill 007 from west looking northeast.

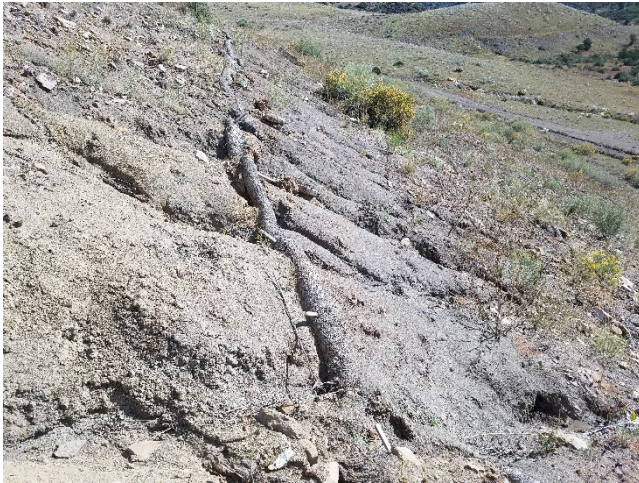
The steep slope above Pond 006 on the northwest side of the access road was observed. NECC has constructed a ditch at the top of the slope at the edge of the affected land. This area has sparse vegetation established in places and significant rills and gullies were observed. NECC has attempted to stabilize this area in the past using brush, and the installation of straw waddles perpendicular to the slope. NECC is exploring methods of stabilizing this area in the future.

Figure 2. Slope above Pond 006
