Re: GCC Energy, LLC, King II Mine
CDRMS Permit # C-1981-035
Stoner Engineering: Quarterly Inspection: Refuse Pile
3rd Quarter 2022

Re: King Coal I – Quarterly Waste Pile/Embankment Inspection

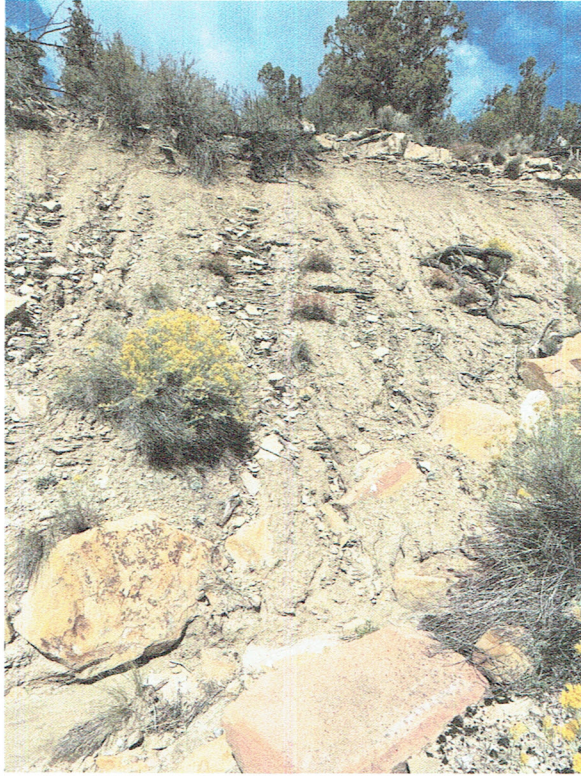
The south treated water ditch (Reach 10) and the north clear water ditch (Reach 1) are in generally good condition. The sedimentation at the culvert inlet under the haul road located under the vertical face has been cleaned out since the last inspection. There has been some additional sedimentation of the north clear water ditch as a result of the recent storm events. This needs to be cleaned out to maintain ditch capacities (see Pic. 1).

Pic. 1 –Reach 1, sedimentation of channel due to recent storms.

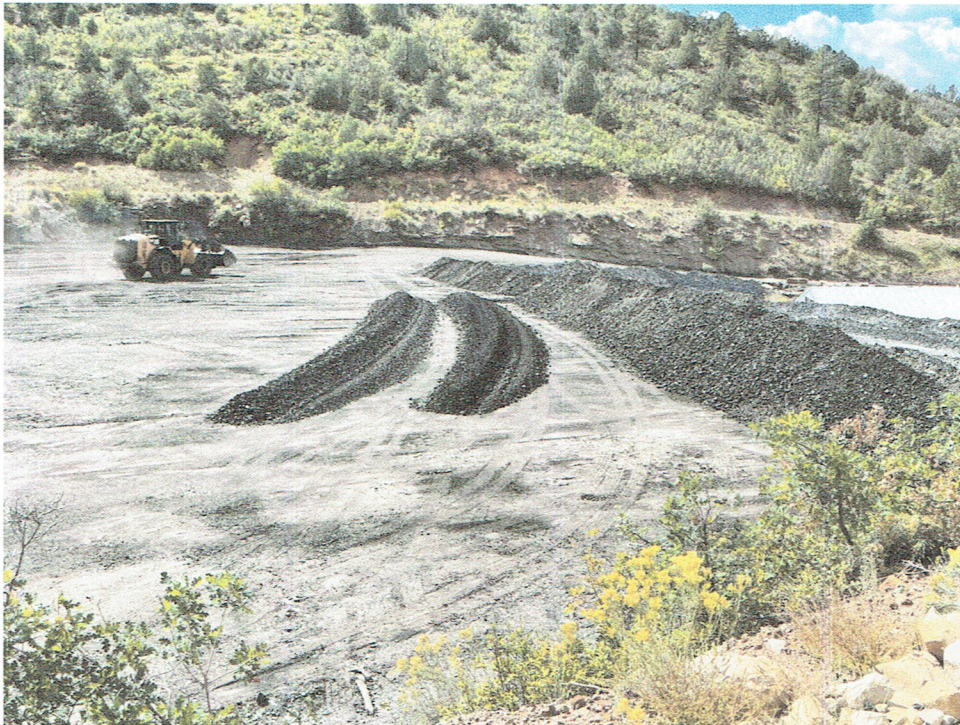
There has been a limited amount of waste material placed at the top of the main waste embankment pile since the previous inspection. There has been additional material placed on the lower pile (see Pic. 2). The slope of the top of the existing pile is closer to that defined in the Waste Bank Design produced by Don May, 1997.

Pic. 2 –Additional waste material, lower pile.

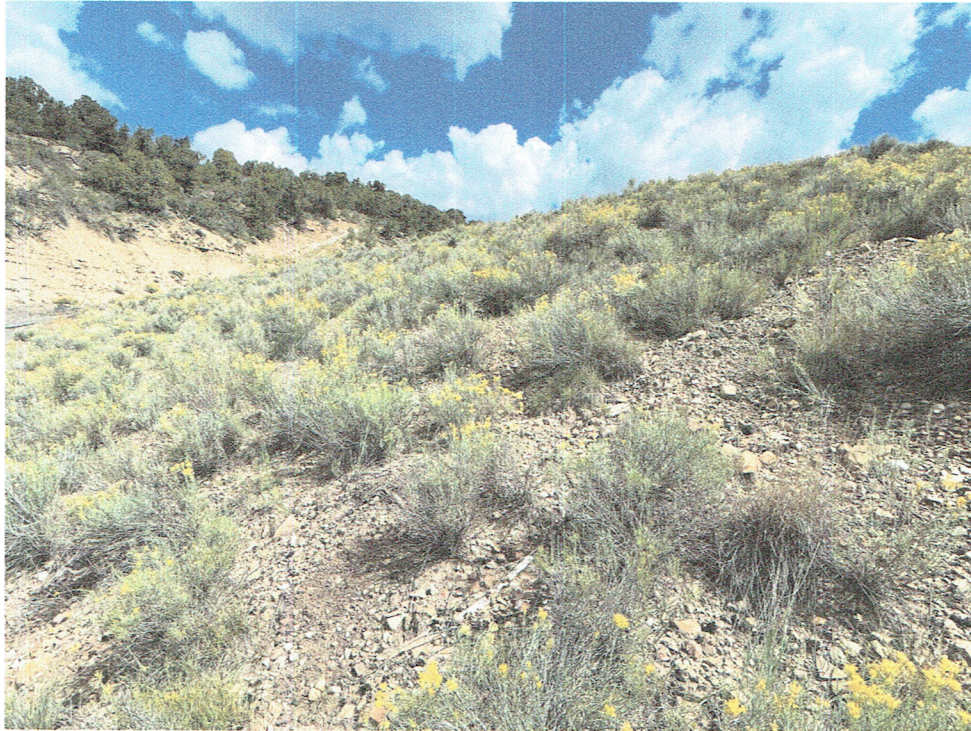
The face of the main embankment appeared to be in generally good condition. There were no signs of excessive erosion, instability, sloughing or weakness observed on the face of either of the waste embankment piles at the time of the inspection (see Pic. 3).

Pic. 3 – Face of main embankment waste pile, typical.

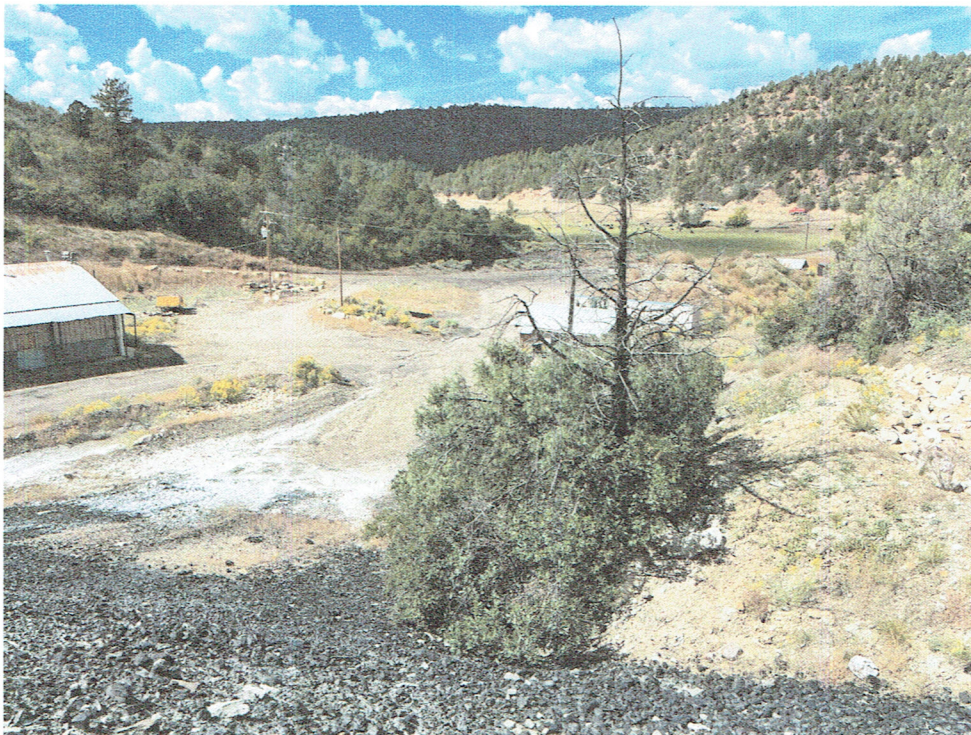
The only structure with any proximity to the embankment material is the old, abandoned bath house which is no longer utilized. The temporary construction/project office trailer and fueling station that had been located in the area of the mine rescue training area (south of the east sediment pond) have been removed (see Pic. 4).

Pic 4 – Temporary construction office and fueling station removed from site.
