Re: GCC Energy, LLC, King II Mine CDRMS Permit # C-1981-035 Stoner Engineering: Quarterly Inspection: Water Quality Improvements 3rd Quarter 2022

Date: October 4, 2022

Re: King Coal I – Quarterly Water Quality Improvements Inspection

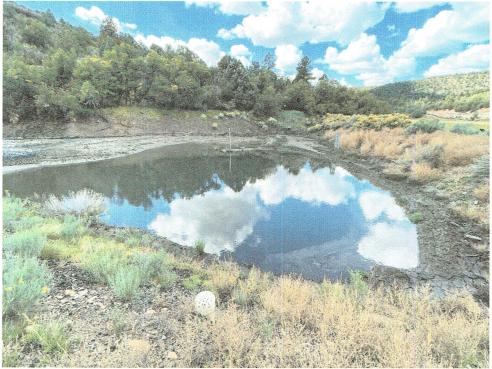
Both ponds held water at the time of the inspection due to recent storms. Additional sediment removal from the west pond does not appear to have taken place since the previous inspection (see Pic. 1). The east pond water level was at a level slightly higher that during the previous inspection (see Pic. 2). The ponds should continue to be monitored after storm events to ensure that excess sediment does not reduce the required storage capacity available for storm water runoff. When conditions permit, the removal of the excess sediment in the west pond should be completed.

Pic. 1 – Sediment removal appears unchanged, West pond.

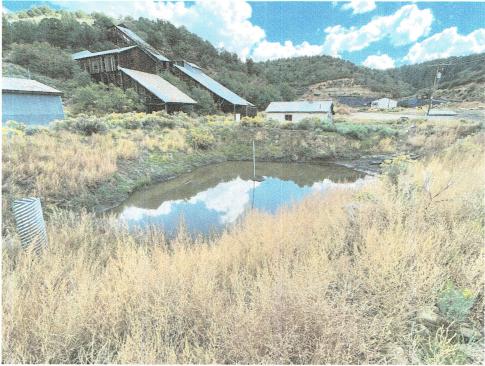
Pic. 2 – Water level slightly higher since previous inspection, East pond.

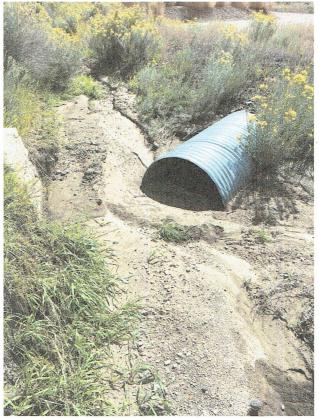
Pic. 3 – South clear water ditch (Reach 3& 4) outlet at tie to north clear water ditch (Reach 5).

There has been sedimentation of the clear water ditch (Reach 5) at the outlet of the south clear water ditch (Reach 3 & 4) where it was rerouted to account for the construction of the lower waste embankment pile (see Pic. 3). This sediment should be cleared to prevent the culvert from backing up and/or reducing the capacity of the north clear water ditch. Reduced outflow of the culvert (Reach 3 & 4) could result in south clear water flows entering the west detention pond during a large storm event. All the culverts located on the site should be checked and any excess sediment cleared/cleaned after seasonal storm events.

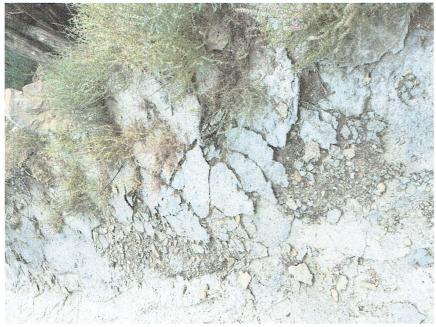
Pic. 4 – Grouted section, north clear water ditch (Reach 1).

The side of the grouted channel along the upper portion of the north clear water ditch (Reach 1) is has experienced some cracking (see Pic. 4). This channel section should be monitored after storm events to minimize the potential of excessive erosion and loss of channel section during future storm events.
