# MINERALS PROGRAM INSPECTION REPORT PHONE: (303) 866-3567

MINE NAME:	MINE/PROSPECTING ID#:	MINERAL:	COUNTY:
Dawson Gold Project	P-2020-002	Gold	Fremont
INSPECTION TYPE:	INSPECTOR(S):	INSP. DATE:	INSP. TIME:
Surety Release Inspection	Timothy Cazier, P.E.	September 7, 2022	12:00
OPERATOR:	OPERATOR REPRESENTATIVE:	TYPE OF OPERATION:	
Zephyr Gold USA Ltd	None	MP - Mineral Prospecting

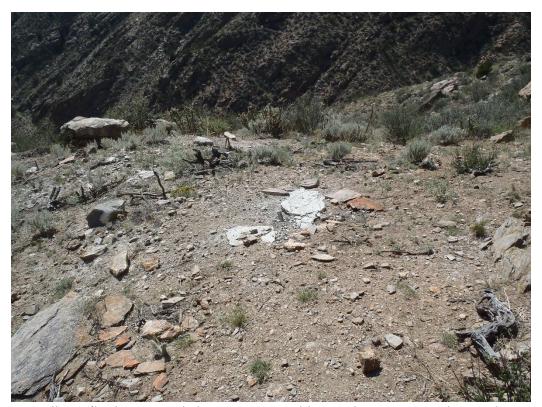
<u>Reclamation Success:</u> The holes appeared to be adequately capped and backfilled (see **Photo 1**). No discernable disturbance was observed at the pump house location (see **Photo 2**), nor along the rout the water lines were located (see **Photo 3**).

<u>Revegetation:</u> No noxious weeds were observed. The drilling program minimized surface disturbance at the drill site and vegetation was comparable to that in the surrounding undisturbed areas (see **Photo 1**).

Photo 1. Drill site (looking SW – light gray caps visible, similar to surrounding rock outcrops).

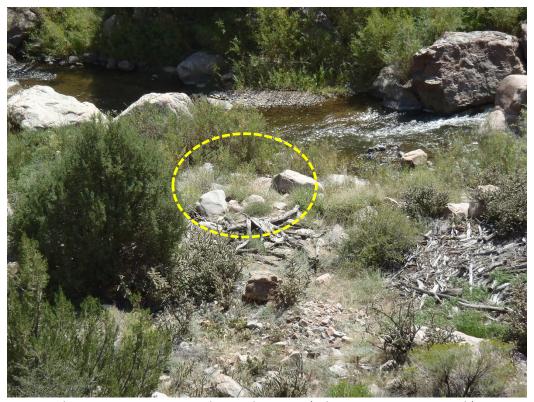
Photo 2. Former pump house location (adjacent to Grape Creek).

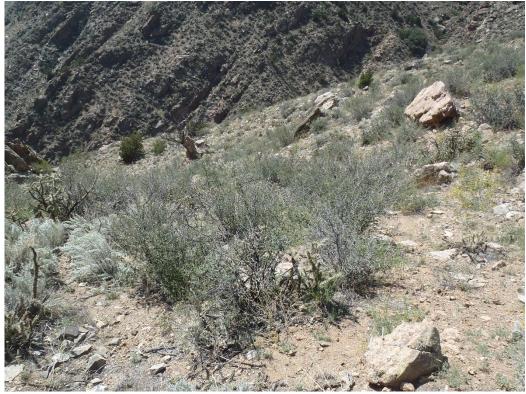
Photo 3. Partial water line rout – no discernable disturbance.
