MINERALS PROGRAM INSPECTION REPORT
PHONE: (303) 866-3567

MINE NAME: Idarado Mining Co	MINE/PROSPECTING ID#: M-1977-403-HR	MINERAL: Lead, zinc, copper, c gold	COUNTY: San Miguel
INSPECTION TYPE: Monitoring	WEATHER: Clear	INSP. DATE: September 29, 2022	INSP. TIME: 11:05
OPERATOR: Idarado Mining Company	OPERATOR REPRESENTATIVE: Karen DeAgüero	TYPE OF OPERATION: 112d-3 - Designated Mining Operation	
REASON FOR INSPECTION: Normal I&E Program	BOND CALCULATION TYPE: Complete Bond	BOND AMOUNT: \$226,600.00	
DATE OF COMPLAINT: NA	POST INSP. CONTACTS: None	JOINT INSP. AGENCY: None	
INSPECTOR(S): Lucas West	INSPECTOR'S SIGNATURE:

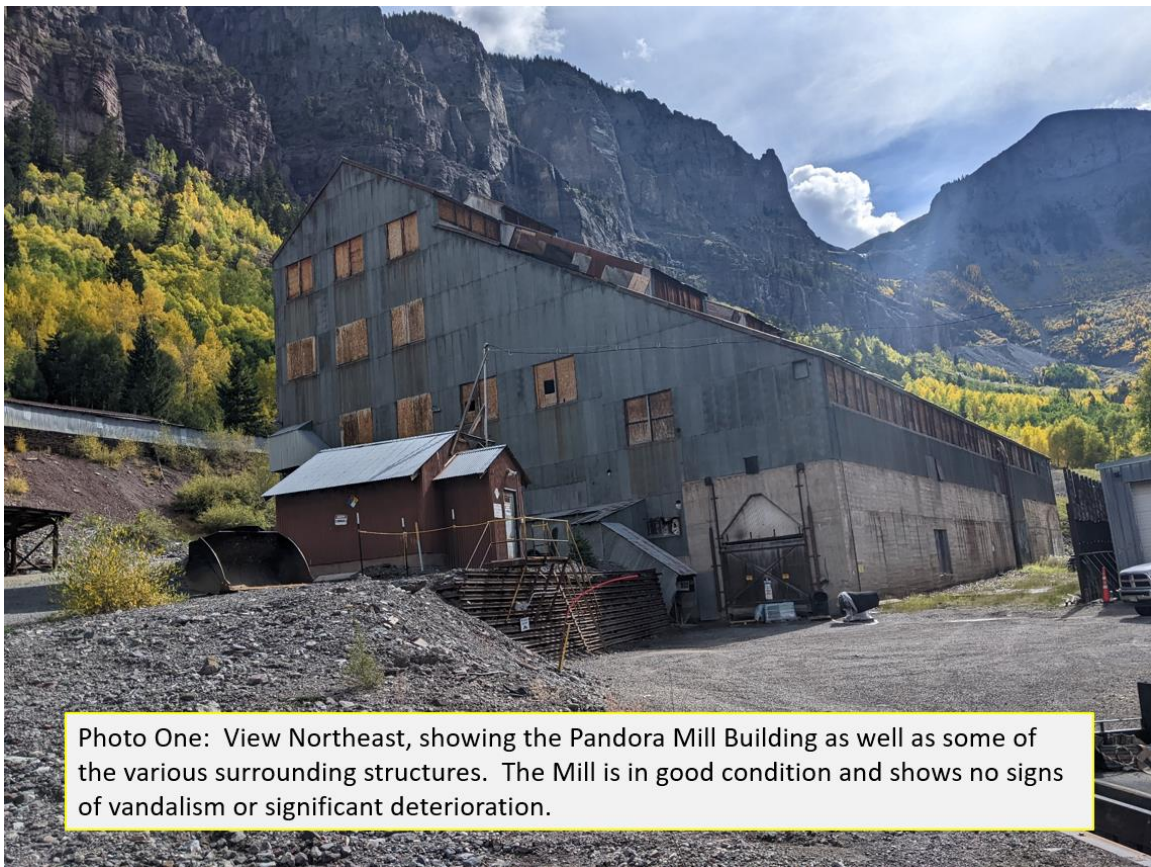
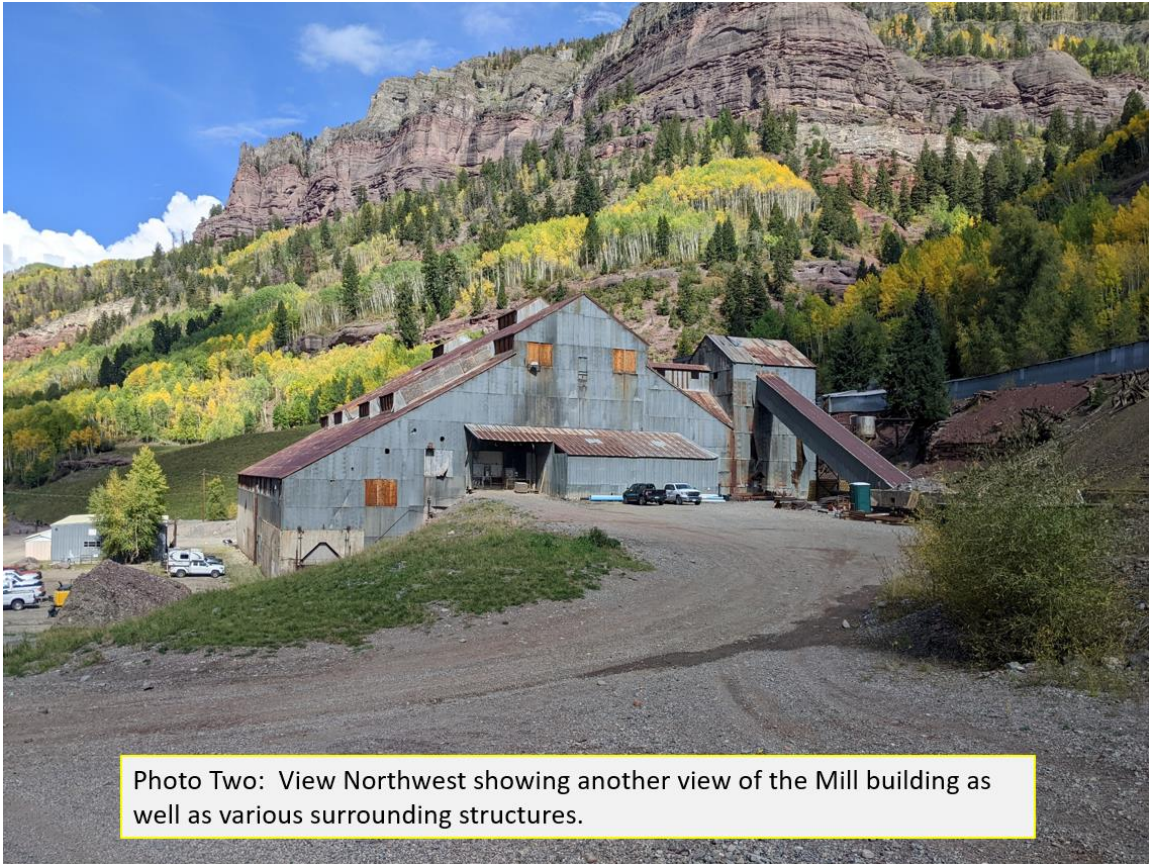
Telluride Facilities: The Telluride Facilities were not active during the inspection. This permitted area consists mostly of the Pandora Mill Building, Mill Level Portal, as well as various out structures and tailings impoundments. The Mill Building seen in Photos One and Two, appears to be stable and in good condition. The mill, train shed, shops and the various other outbuildings in the area are in similar condition as the previous inspection conducted by the Division. Examples of the various outbuildings and structures can be seen in Photos Three and Four. The Mill Level Portal was observed to be secured at the time of the inspection and discharging to the lagoons. The gated closure, seen in Photo Five, showed no signs of vandalism or attempted unauthorized entry. Also located in the Telluride permitted area are the tailings storage facilities referred to as Telluride Tailings (TT). The storage facilities are mostly reclaimed with the exception of a small open cell in number 5/6 that has been utilized by the EPA to deposit excavated material from their Valley Floor Cleanup Project. The scope of this project involved excavating material from the valley floor area outside the Permit Boundary and depositing that material in the Tailings Storage Facility. The excavated material can be seen in Photos Six and Seven, is approximately 4 feet deep and is surrounded by silt fencing to prevent offsite migration of material. Outside of the newly deposited material, the Tailings Storage Facilities are well vegetated and appeared stable at the time. The out slopes are also well vegetated and were stable at the time of the inspection. Photo Eight shows an example of the well vegetated Tailings Storage Facility. The vegetative cover on all cells and out slopes is dense and diverse, and show multiple year's biomass indicating they are capable of self-regeneration. All storm water control structures and features around the Telluride Facility were observed to be free from obstruction and able to function as designed.

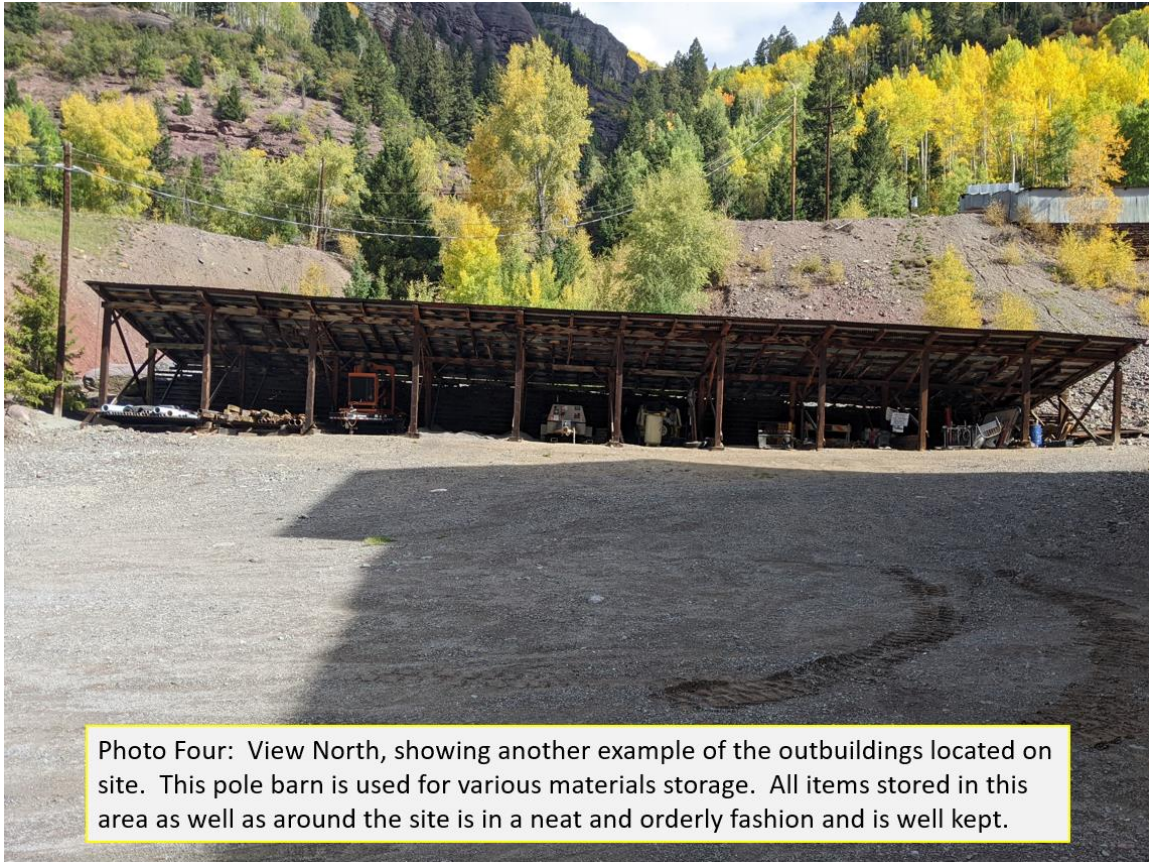
Photo Four: View North, showing another example of the outbuildings located on site. This pole barn is used for various materials storage. All items stored in this area as well as around the site is in a neat and orderly fashion and is well kept.

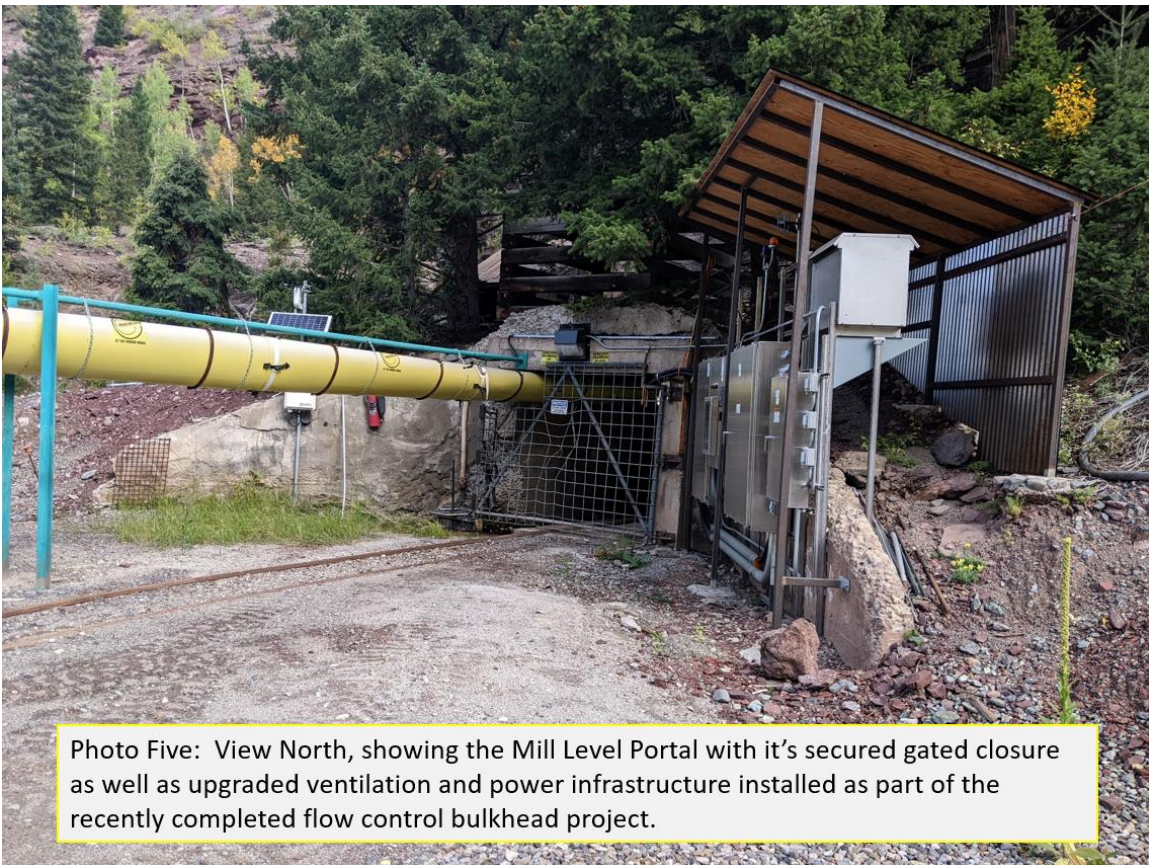
Photo Five: View North, showing the Mill Level Portal with it's secured gated closure as well as upgraded ventilation and power infrastructure installed as part of the recently completed flow control bulkhead project.

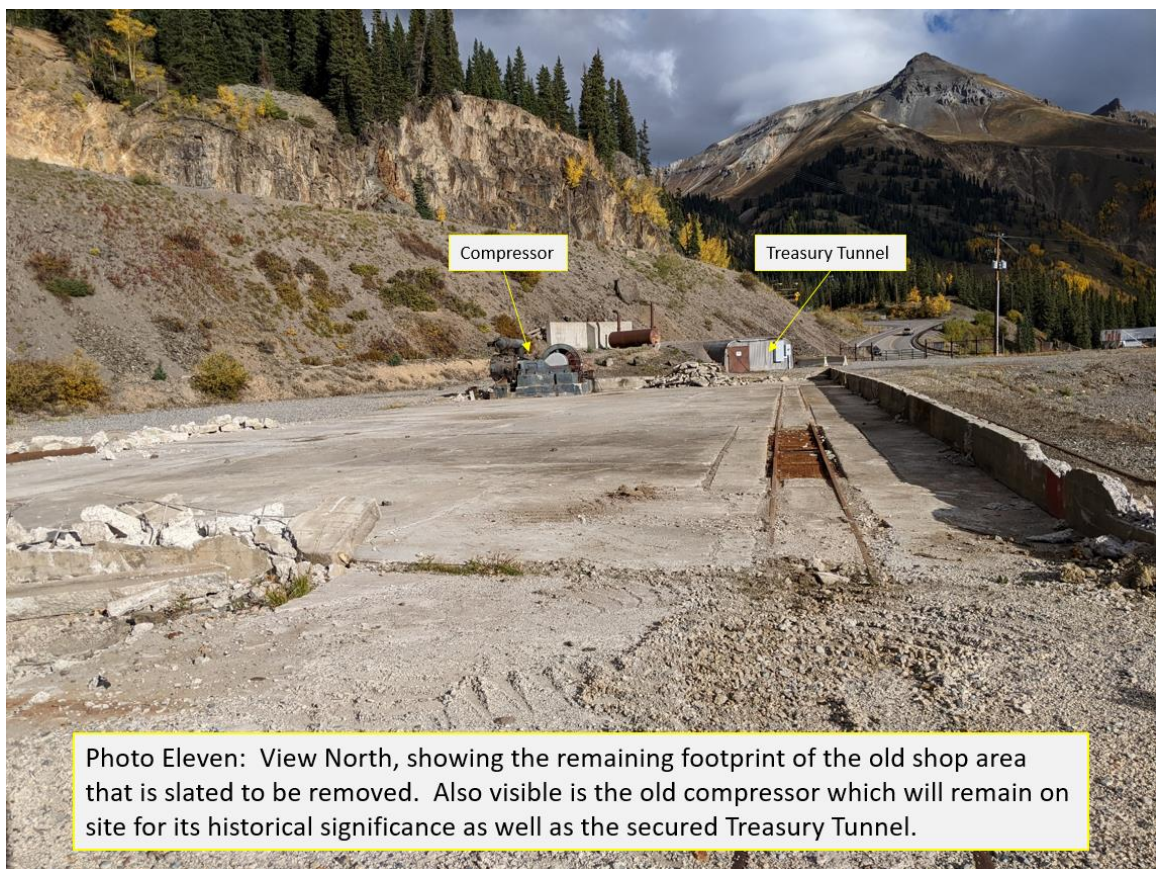
Red Mountain Facilities: The Red Mountain Permit area was also not active during the inspection. The permit area includes all facilities in the vicinity of the Treasury Tunnel, this area can be seen in Photos Nine and Ten as well as the borrow pit that is located on the West side of Highway 550. The site has experienced ongoing maintenance and reclamation activities in the form of the final removal of several structures, and routine property maintenance. The ongoing property maintenance includes monitoring and repair of storm water controls, monitoring for erosional features and other maintenance activities. The most significant work that has been completed is the demolition and removal of the old shop facility and the construction of the new shop in a different portion of the Permitted Area. The old shop has been completely demolished and removed, the only remaining portion of the shop is the concrete foundation which is slated for removal. Located within the shop was a historical air compressor used when the site was active. The compressor has been permitted to remain as historic feature. The footprint of the old shop and compressor can be seen in Photo Eleven.
