MINERALS PROGRAM INSPECTION REPORT
PHONE: (303) 866-3567

MINE NAME: Katrina Springs Road Pond	MINE/PROSPECTING ID#: M-2022-038	MINERAL: BORROW	COUNTY: San Miguel
INSPECTION TYPE: Illegal(Unpermitted Operation)	WEATHER: Clear	INSP. DATE: October 13, 2022	INSP. TIME: 10:54
OPERATOR: Malte Asmus	OPERATOR REPRESENTATIVE: John Young	TYPE OF OPERATION: ILL - Illegal	
REASON FOR INSPECTION: Citizen Complaint	BOND CALCULATION TYPE: None	BOND AMOUNT: No Bond Held	
DATE OF COMPLAINT: NA	POST INSP. CONTACTS: Citizen	JOINT INSP. AGENCY: None	
INSPECTOR(S): Lucas West	INSPECTOR'S SIGNATURE:

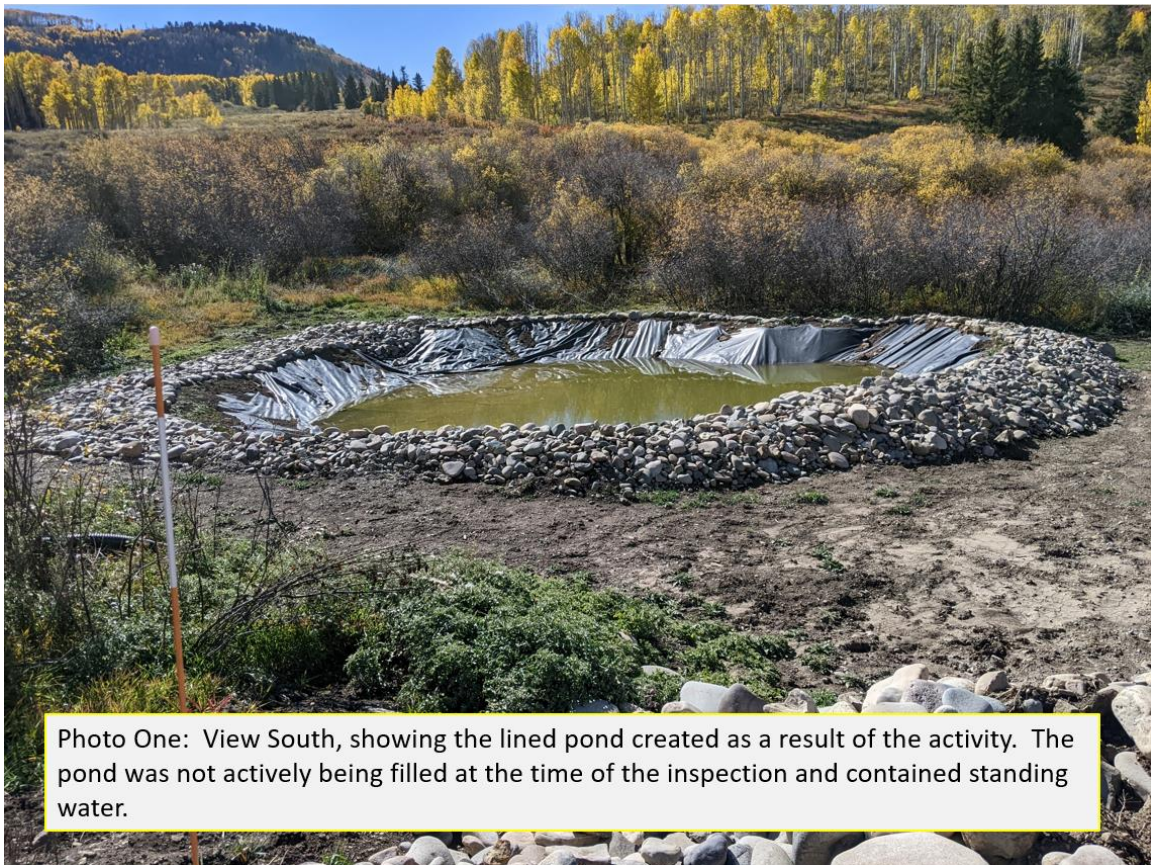
Photo One: View South, showing the lined pond created as a result of the activity. The pond was not actively being filled at the time of the inspection and contained standing water.

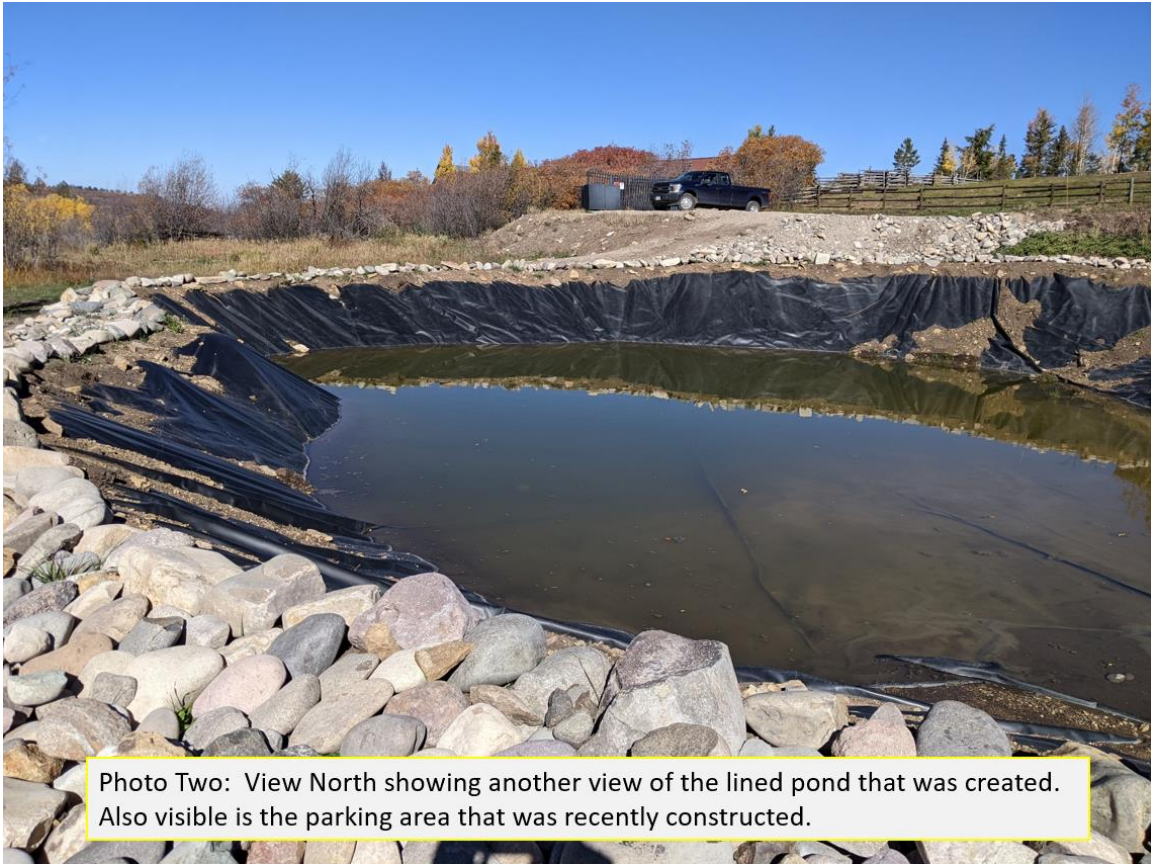
Photo Two: View North showing another view of the lined pond that was created. Also visible is the parking area that was recently constructed.

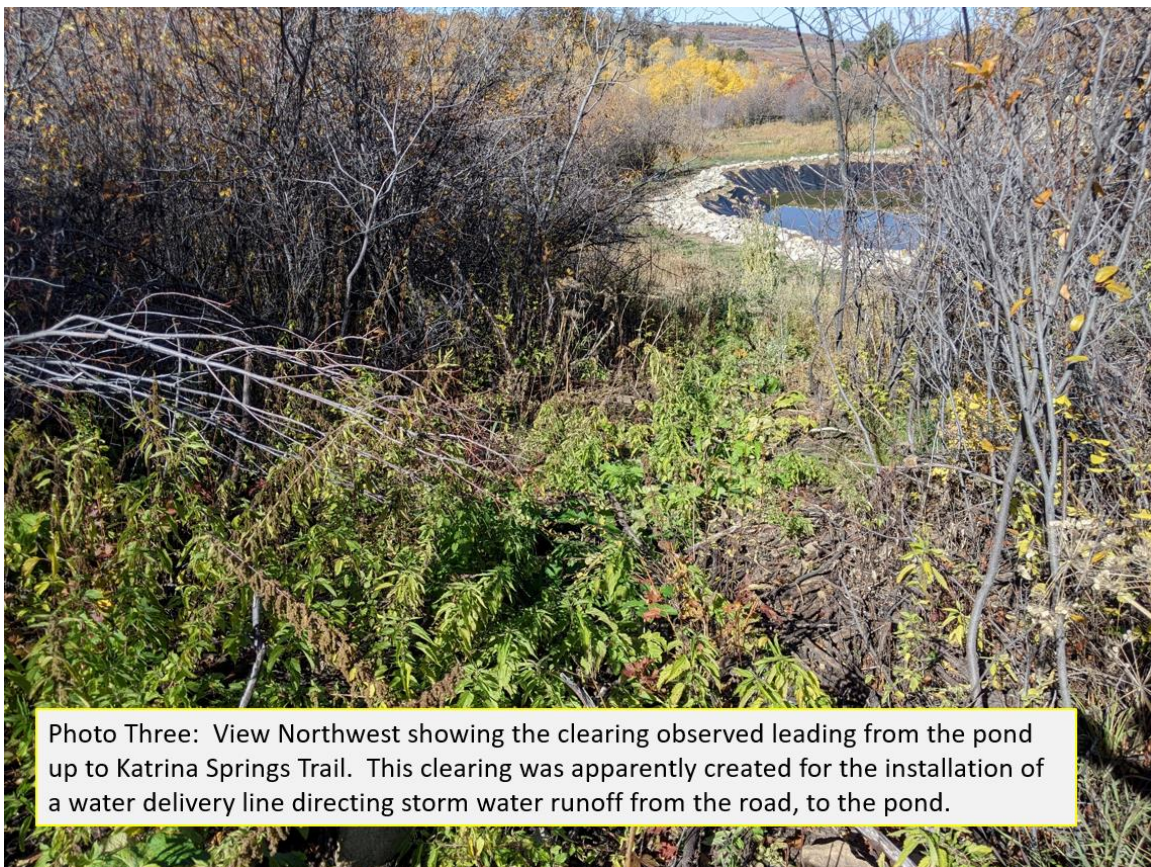
Photo Three: View Northwest showing the clearing observed leading from the pond up to Katrina Springs Trail. This clearing was apparently created for the installation of a water delivery line directing storm water runoff from the road, to the pond.

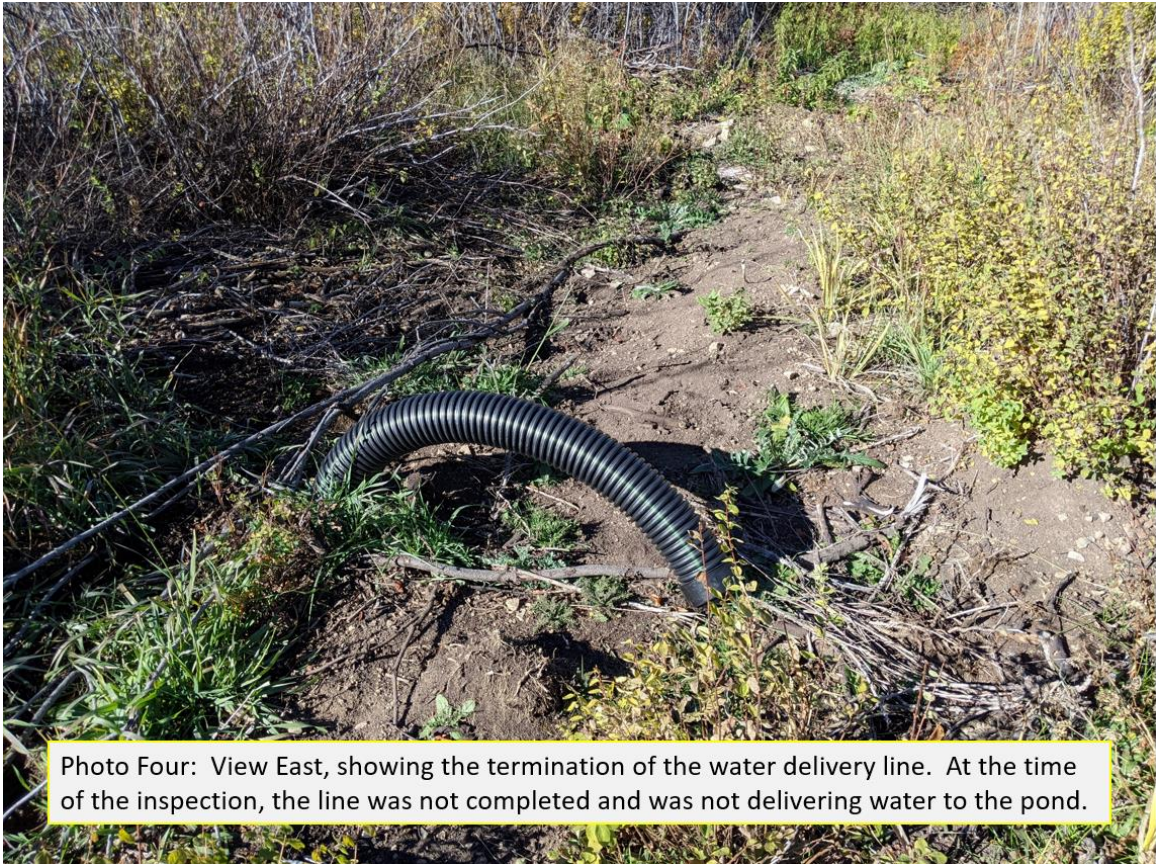
Photo Four: View East, showing the termination of the water delivery line. At the time of the inspection, the line was not completed and was not delivering water to the pond.

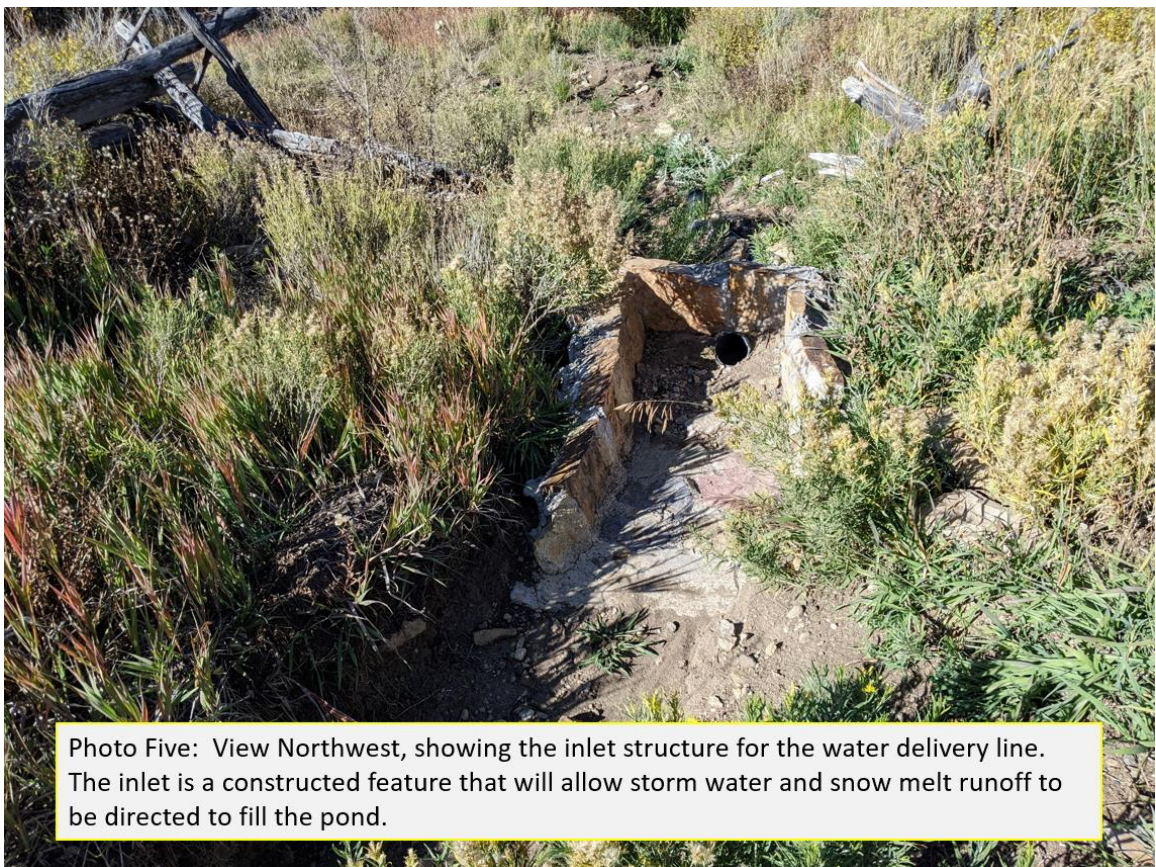
Photo Five: View Northwest, showing the inlet structure for the water delivery line. The inlet is a constructed feature that will allow storm water and snow melt runoff to be directed to fill the pond.
