October 14, 2022
Project#01349-0001

Subject: Summary of Instrumentation Monitoring
3rd Quarter 2022
Bowie Coal Waste Disposal Area No. 2
Paonia, Colorado

SUBJECT: Summary Report, 3rd Quarter 2022, Inclinator and Active Vibrating Wire Piezometer Data July through September 2022, Bowie Mine #2 Coal Waste Disposal Area (CWDA) #2

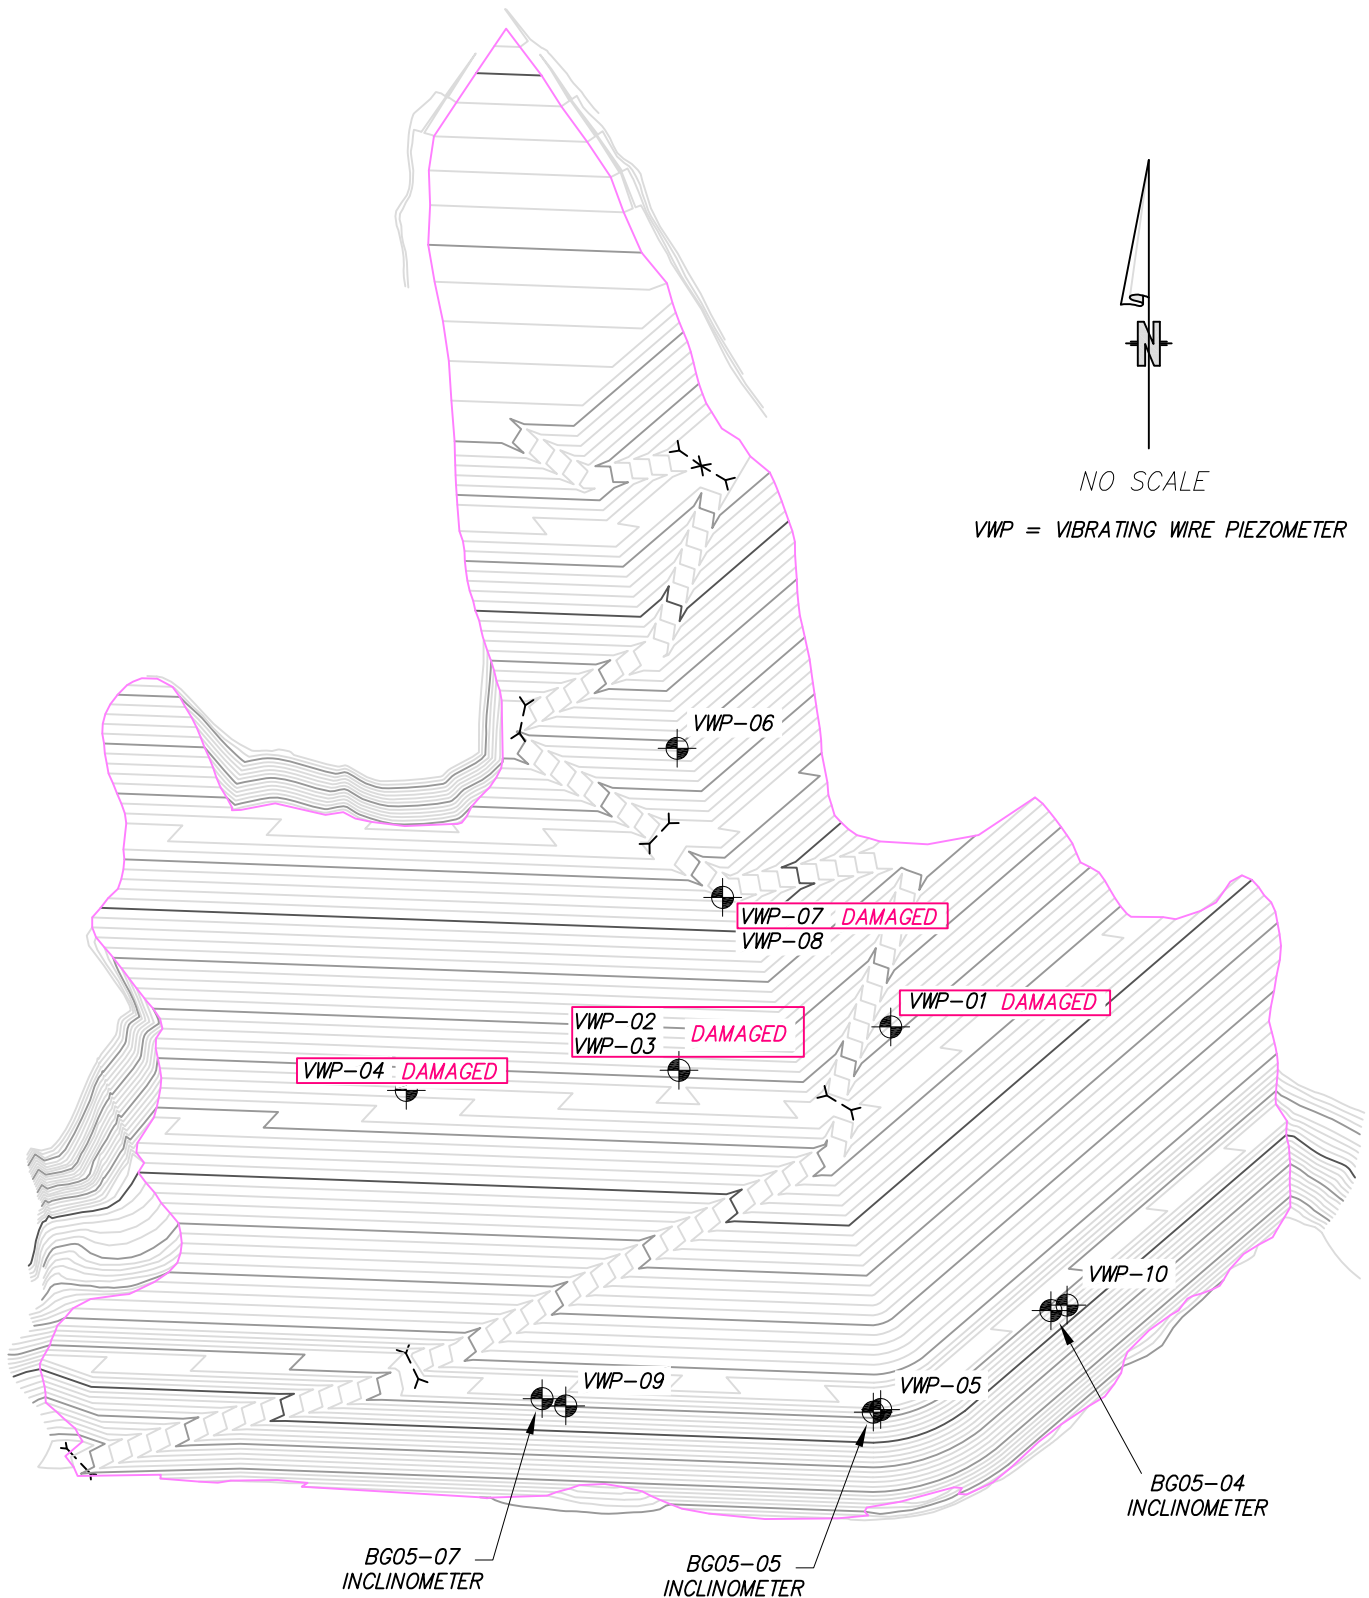
INSTRUMENTATION SITE PLAN

The physical locations of the piezometers are shown on the attached Instrumentation Site Plan (Map 1). As seen on this map, five of the original piezometers were damaged, and some were replaced. Currently, there are five active VWP's, and three of them are adjacent to inclinometers. The graph of historical VWP data from May 16, 2005 through May 21, 2014 is presented in Figure 1. A graph of measured pore pressures of active piezometers is presented on the attached Figure 2 and is presented numerically in Table 1 below.

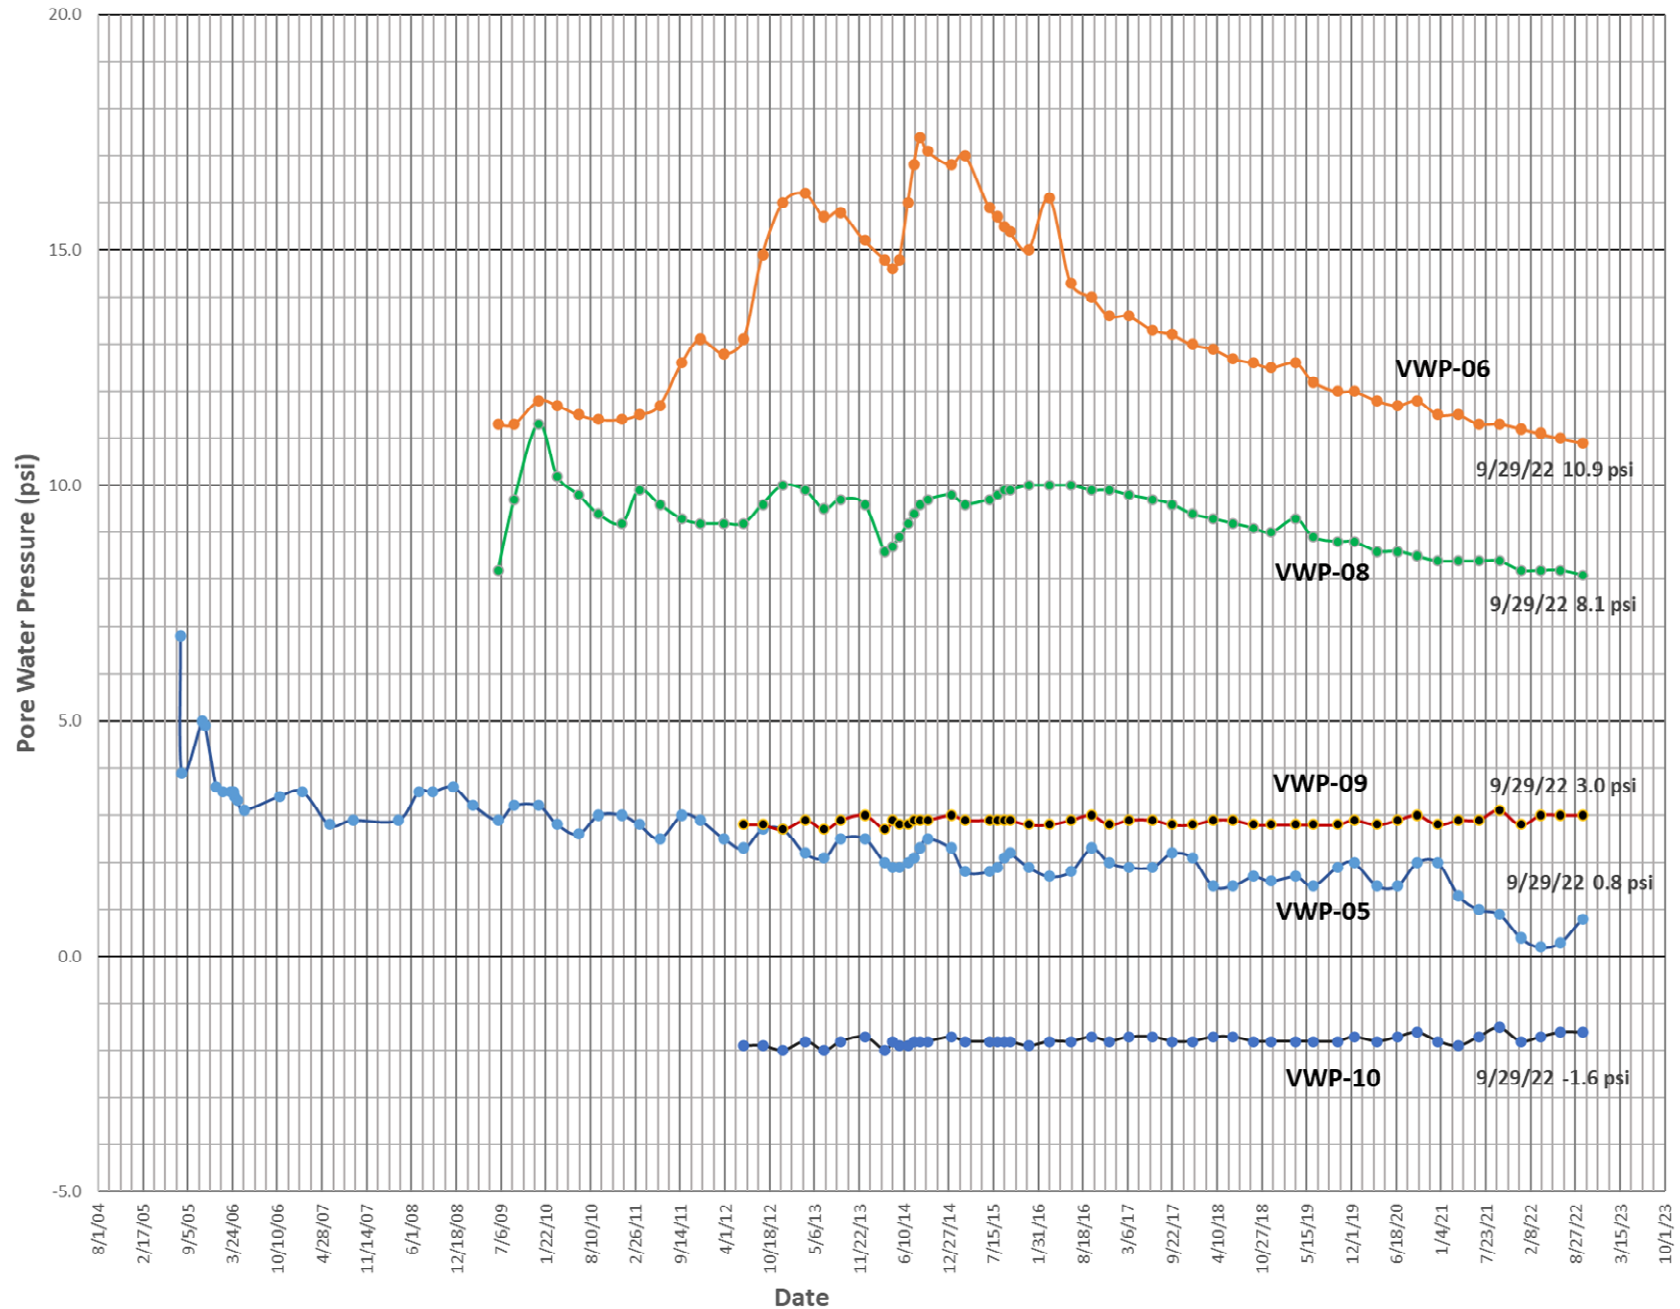
Figure 2 - Bowie Mine #2 - CWDA #2
Active Vibrating Wire Piezometer Data

As indicated in the referenced *Stability Evaluation* report, the stability of CWDA No. 2 is sensitive to increases in pore pressures in VWP-08. An increase in the pore pressure of 7 psi in VWP-08 would result in a reduction of the Factor of Safety to below 1.5.

The current pore pressure reflects a piezometric surface elevation of approximately 6095 feet which is much less than the critical elevation of 6113 feet. As a result, HBET does not believe that the measured pore pressures in VWP-08 are any indication of instability in CWDA No. 2.

As seen on Table 1 and Figure 2, the VWP readings and trends are consistent with recent and historic readings. Pore pressure readings changed by small amounts (0.1 to -0.4 psi) for the five VWP's since the readings one year ago (Q3 2021). When compared with last quarter (Q2 2022), pore pressures also changed by relatively small amounts (0 to -0.1 psi) in four of the five VWP's, while VWP-05 changed by +0.5 psi. Although four of the five VWP's remain steady or have general declining trends in pore pressure over the life of the VWP's, one of the piezometers (VWP-05) has exhibited pronounced seasonal cyclical behavior for its lifespan. This piezometer generally (but not always) shows low pore pressures for Q1 and Q2 and higher pressures for Q3 and Q4, with a net loss of 6.0 psi over the lifetime of that VWP. The other four VWP's have experienced net changes of +/-0.5 psi or less since installation, meaning current readings are very similar to initial readings. For VWP-09 and VWP-10, pressures have been consistent throughout the lifetime of the piezometers; however, for VWP-06 and VWP-08, they experienced wild fluctuations in pore water pressure in the first half of their lifetimes, but have settled to pressures similar to the installation pressures in the past several years.

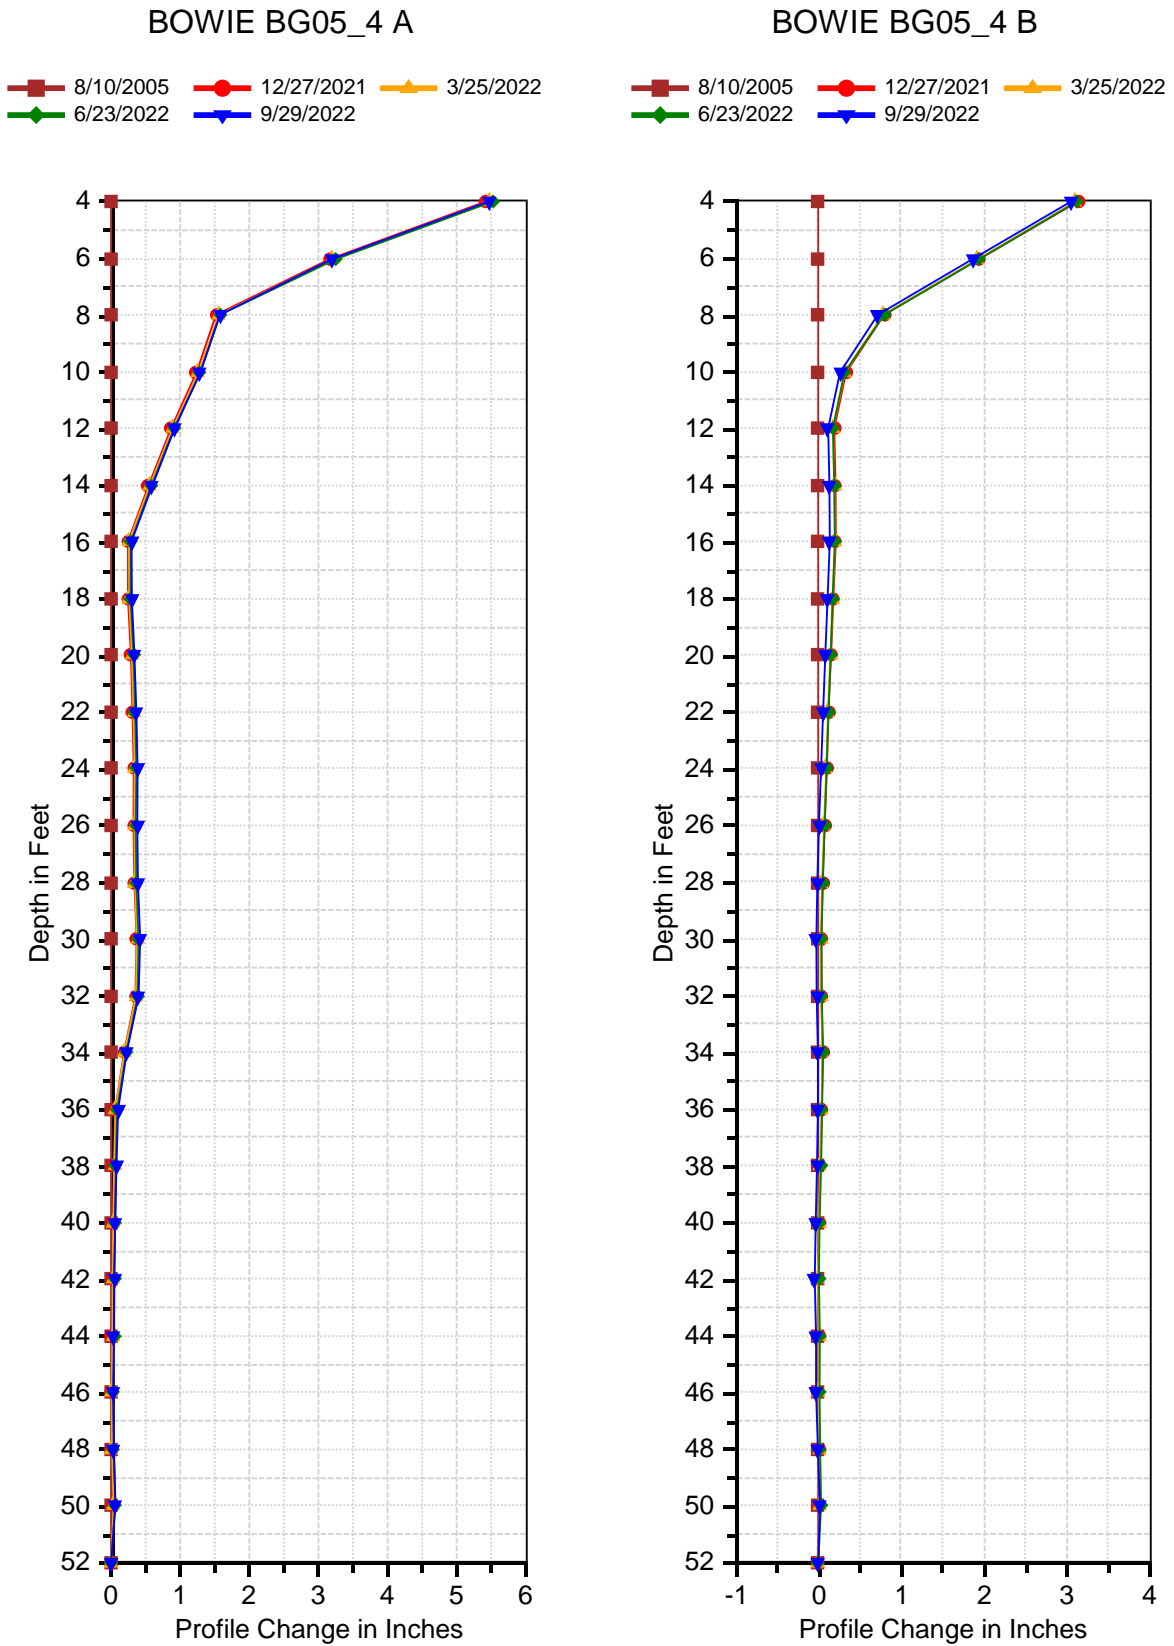
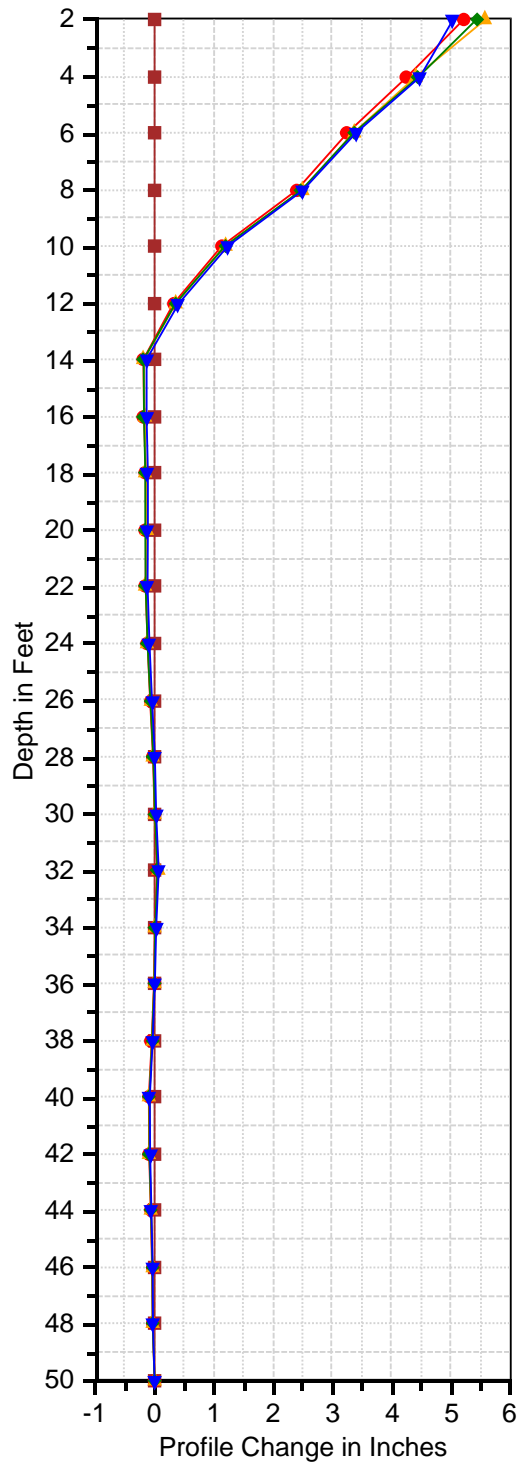
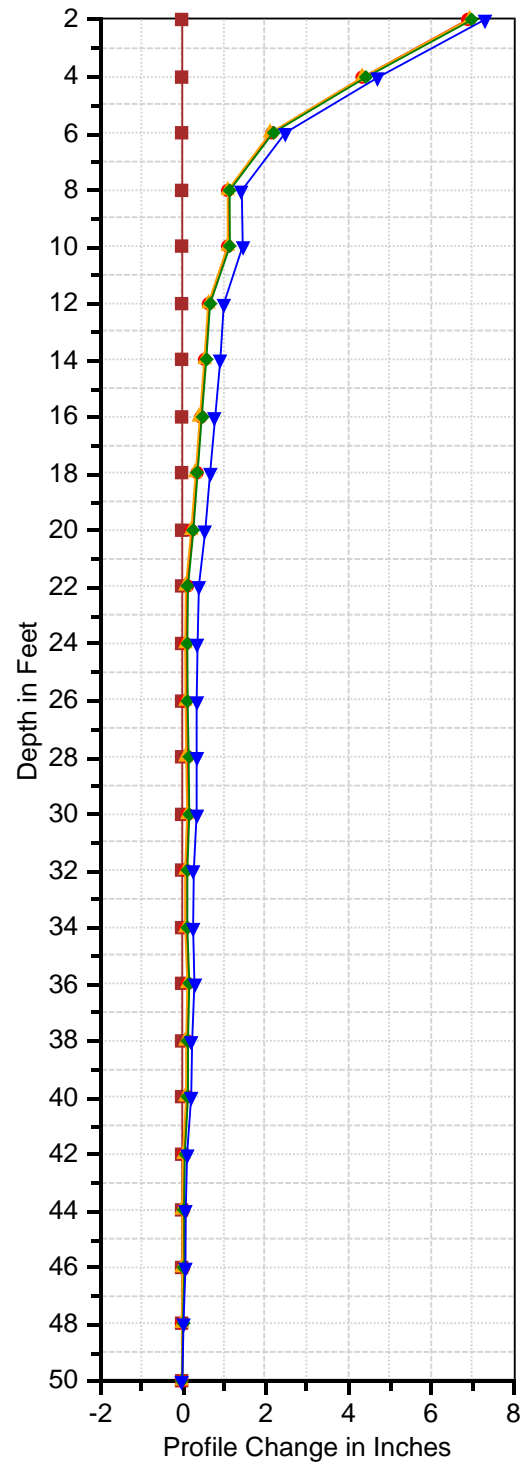
Figure 3 - Inclinometer Displacement Curves

As described in previous reports, historic displacements indicated on the plots for the approximate upper 12-14 feet of the inclinometers since installation in 2005 are due to placement of cover soil on the face of the waste pile during revegetation operations in late 2006 and early 2007. This man-caused displacement is documented in a report by Buckhorn Geotech dated December 22, 2008 to Bowie Resources called *Revised Stability Evaluations for Coal Mine Waste Disposal Area No. 2, Bowie No. 2 Mine*.

Based on the current inclinometer readings, there has not been evidence of significant downslope movement (Axis A) in any of the inclinometers since 2007 and they are generally consistent with previous readings. Some "noise" which is understood to be relatively common in orthogonal direction (Axis B) readings, was observed over the past few years for all three inclinometers. This can be due to various mechanical or installation causes that are unrelated to slope movement. For example, grout voids, poor grout coverage, or soil settlement around the instrument can all contribute to vibrations and pipe movement that impacts inclinometer readings. Software bias adjustments were applied which filtered this noise. All readings were

consistent with previous ones and the "displacement" error was within equipment tolerances and not deemed to be due to slope movement.
