MINERALS PROGRAM INSPECTION REPORT
PHONE: (303) 866-3567

MINE NAME: Climax Mine	MINE/PROSPECTING ID#: M-1977-493	MINERAL: Molybdenum	COUNTY: Lake, Summit
INSPECTION TYPE: Monitoring	WEATHER: Clear	INSP. DATE: October 17, 2022	INSP. TIME: 14:15
OPERATOR: Climax Molybdenum Company	OPERATOR REPRESENTATIVE: Diana Kelts	TYPE OF OPERATION: 112d-3 - Designated Mining Operation	
REASON FOR INSPECTION: Normal I&E Program	BOND CALCULATION TYPE:	BOND AMOUNT: \$91,011,850.00	
DATE OF COMPLAINT: NA	POST INSP. CONTACTS: None	JOINT INSP. AGENCY: None	
INSPECTOR(S): Lucas West	INSPECTOR'S SIGNATURE:

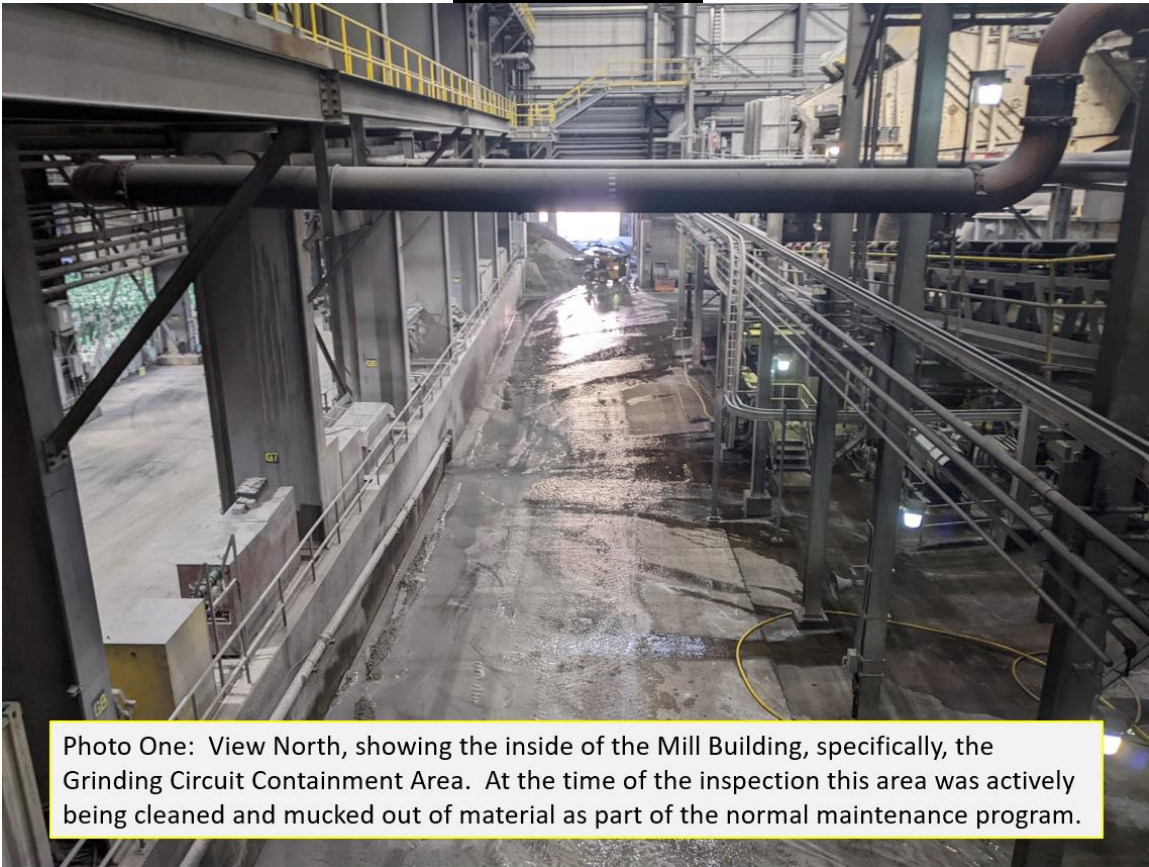
The Mill Facility secondary containment is broken into three areas, the grinding circuit containment, the flotation circuit containment and tailings thickener containment. The grinding circuit containment area was observed and was actively being mucked out of dust and debris at the time of the inspection. Photo One shows the area with its active cleaning operations. The containment area has been volumetrically verified to be able to contain a catastrophic failure in the grinding circuit. The concrete floor area all drains to a separate sump, which after containment is pumped back into the circuit at the resumption of operations. The area is well kept, and no evidence of compromise was noted. The flotation circuit containment area was also observed. Separated by a concrete wall from the grinding circuit containment area, the flotation containment area acts in the very same way. The concrete floor is sloped to sumps which after containment can be recycled back into the system. The volumes of containment has been verified and the containment area was neat, well-kept and clean. Photos Two and Three show examples of the flotation circuit containment areas. Stored within the containment area are several IBC Totes of various non-hazardous reagents. All reagents stored in this area are orderly, labeled and well kept. No evidence of leaks or spills was noted from the reagent containers. Following the flow of materials, tailings are delivered to the Tailings Thickener within the Mill Building. The tailings thickener is contained by the thickener containment area which is the concrete structure around the thickener. The containment area showed no signs of compromise and has been volumetrically verified to contain a catastrophic failure. The Sump and containment area can be seen in Photos Four and Five. From the sump, material can either be recycled back into the system or in an emergency situation be fed directly to the tailings delivery line and out to the Mayflower Tailings Storage Facility. All areas of the thickener containment area are clean, well-kept and appear to be able to function as designed.

Photo One: View North, showing the inside of the Mill Building, specifically, the Grinding Circuit Containment Area. At the time of the inspection this area was actively being cleaned and mucked out of material as part of the normal maintenance program.

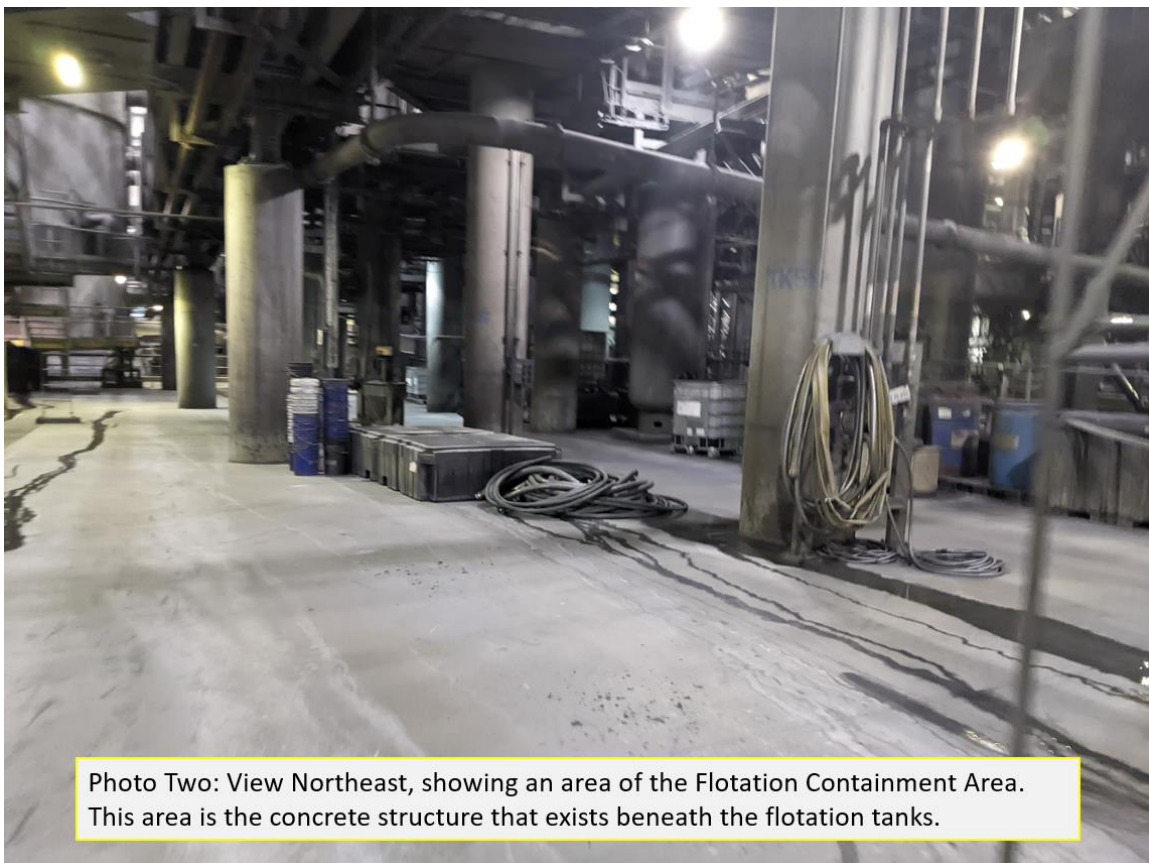
Photo Two: View Northeast, showing an area of the Flotation Containment Area. This area is the concrete structure that exists beneath the flotation tanks.

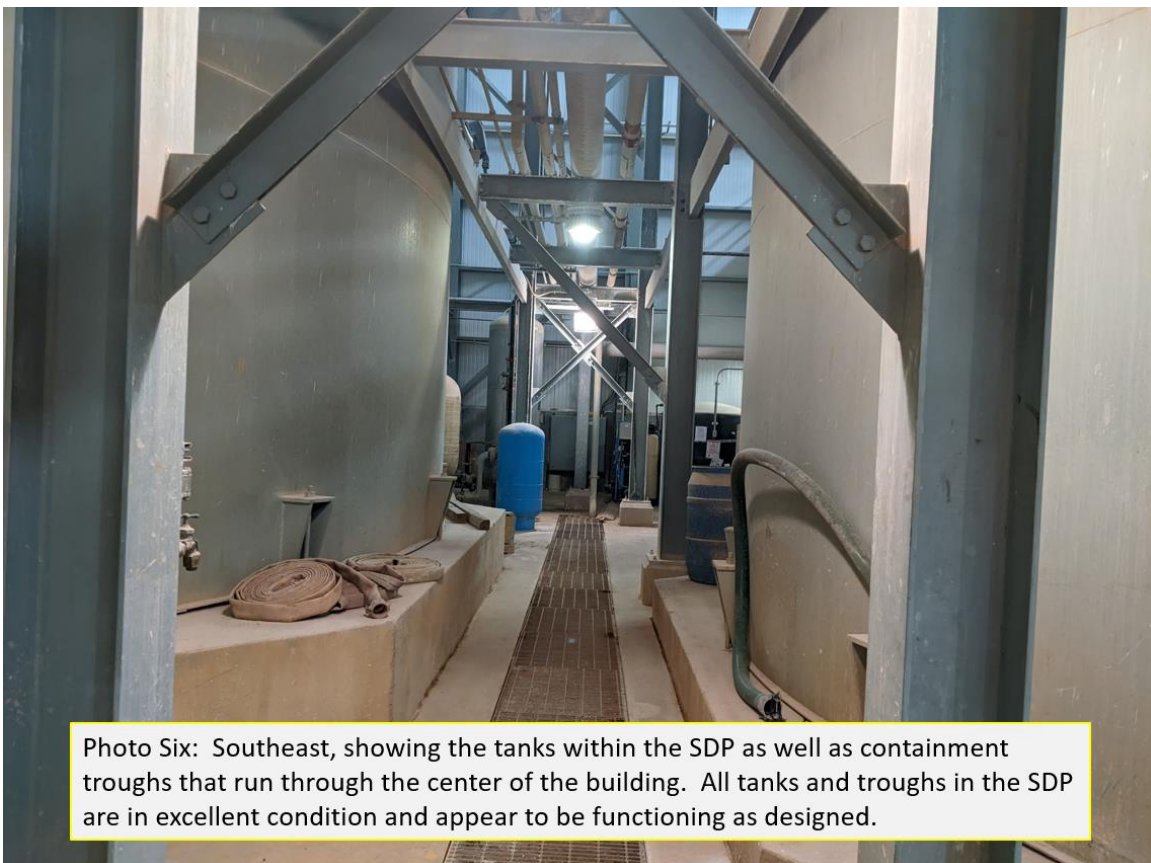
The Sludge Densification Plant (SDP) is a 2 part facility consisting of a lime storage and mixing facility, and the treatment facility. Both facilities are located adjacent to the Tenmile Tailings Storage Facility (TSF). The lime storage and mixing facility is the ancillary facility, referred to as the McNulty Lime Station and is used for storing large quantities of hydrated lime, where it is mixed with makeup water and fed to the SDP to be used in the treatment facilities. The lime slurry is directed to the SDP, where it is mixed with seepage water in a series of neutralization tanks. The neutralization tanks are large steel tanks set on concrete foundations with agitators and pumps to lower the pH. All tanks appeared to be in excellent condition. An example of the

tanks can be seen in Photo Six. Once the target pH is achieved a polymer flocculent is added to assist in metals precipitation and the slurry pumped to the clarifier. The polymer flocculent is stored and mixed for use in the plant. A small steel containment berm is located on the floor surrounding the tanks to contain minor spillage. No evidence of spillage was observed in that area. Within the SDP several locations are used for fuel and oil storage, as well as containing a backup generator station. All fuels and oils are stored properly with secondary containment, and the generator set is in good working condition. Additionally, a small tank of chlorine used in potable water treatment is stored within the SDP. The tank and all components are in excellent condition and no evidence of spillage was noted. Like the lime storage facility, secondary containment of the SDP is achieved by way of a series of troughs and sumps. Greater secondary containment is achieved by its proximity to the Tenmile TSF meaning that any catastrophic failure would report directly to TSF. Throughout the SDP, the facility is well kept, clean, neat and organized. The SDP Sludge Cell was observed and noted to be at its lowest observed water level shown in Photo Seven. The waters have evaporated off allowing the sludge in the cell to begin drying out. The sludge, Cell and all embankments are in good condition.

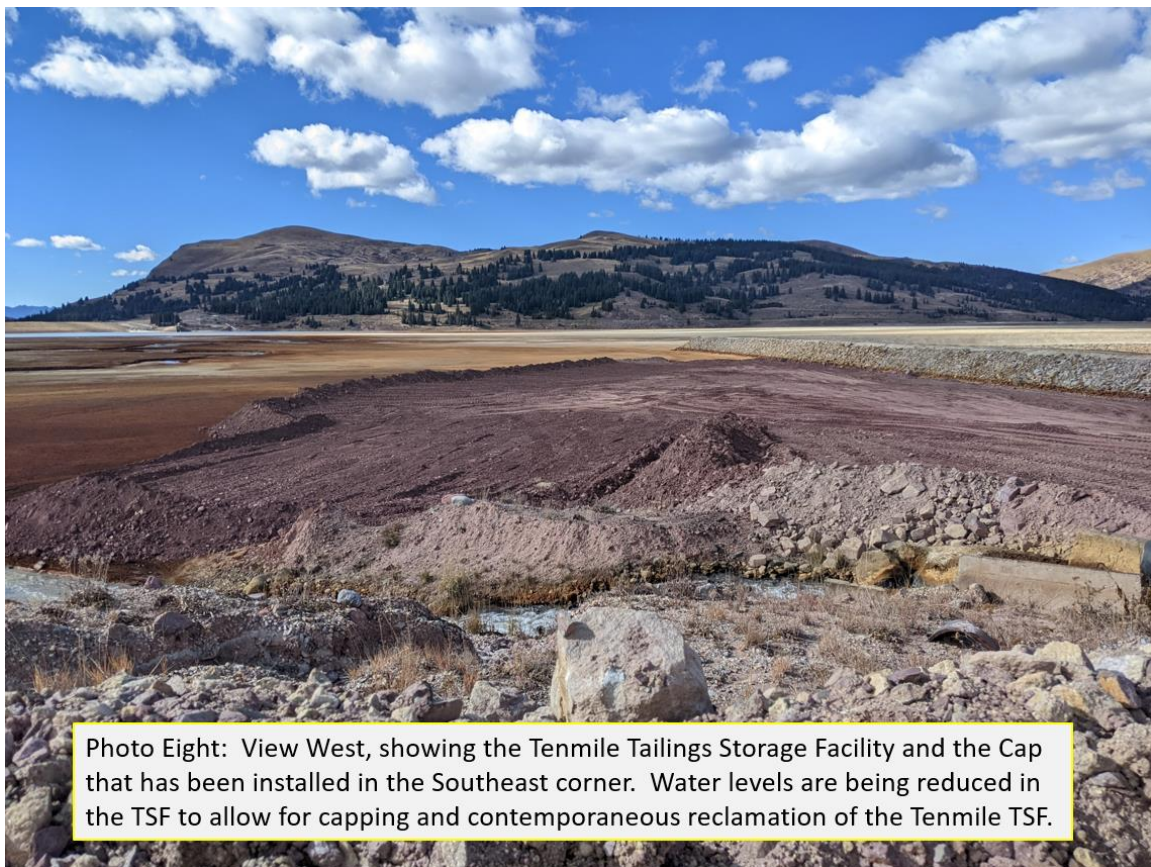
Surrounding the SDP Sludge Cell is the Tenmile Tailings storage Facility. At the time of the inspection the water is being pumped from the TSF at the Tenmile Decant to create a smaller pool at the Southwest Corner. Due to the reduced water level, the Operator has begun importing cap material to begin contemporaneous reclamation of the surface of the TSF. The cap material is being imported and deposited in the Southeast corner of the facility. The plan is to continue the reclamation to the extent possible as the TSF water level is reduced. The capped area can be seen in Photo Eight.

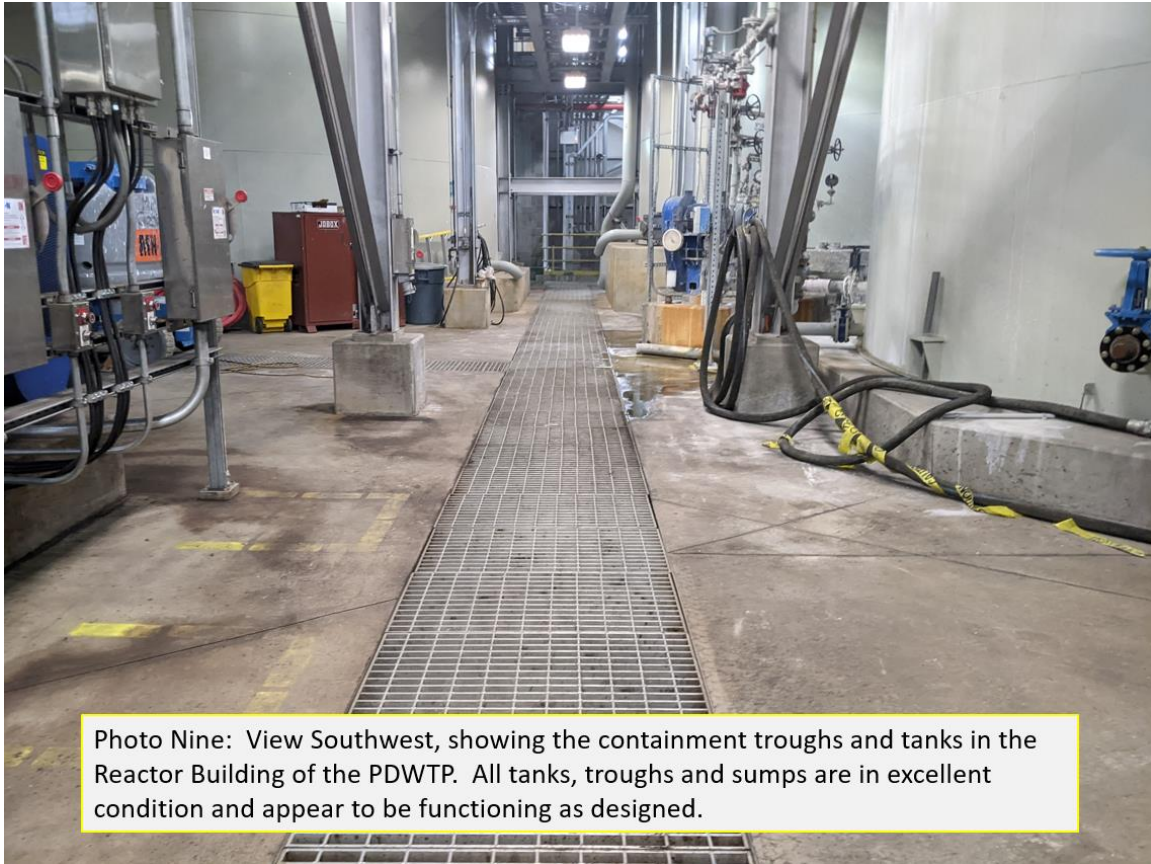
Photo Nine: View Southwest, showing the containment troughs and tanks in the Reactor Building of the PDWTP. All tanks, troughs and sumps are in excellent condition and appear to be functioning as designed.
