STATE OF  
COLORADO

Cazier - DNR, Tim <tim.cazier@state.co.us>

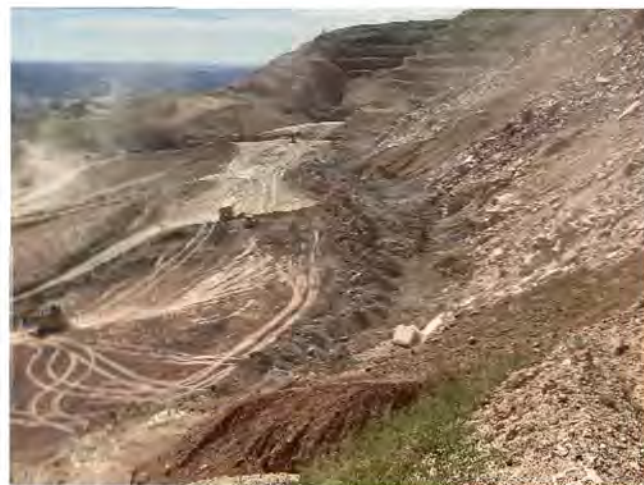
6. View to the south of the pit floor.

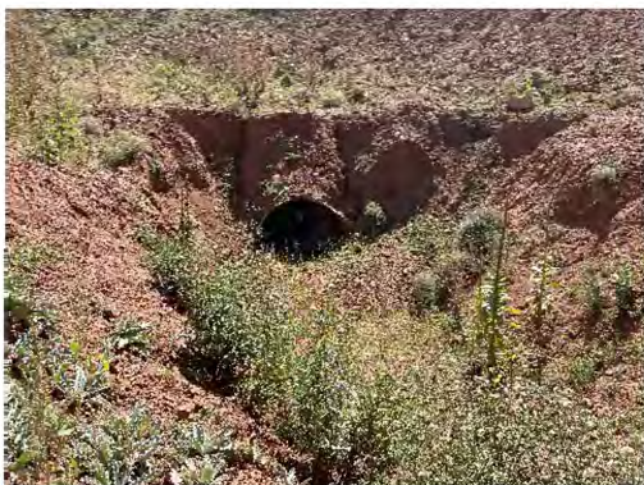
5. Dry above culvert.

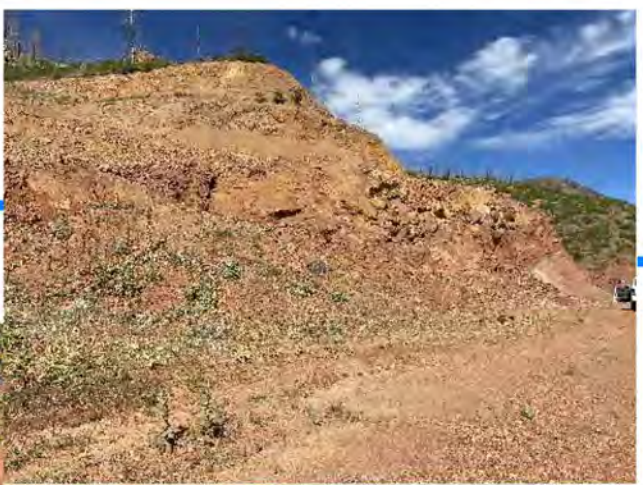
4. Stable granite slopes above landslide.

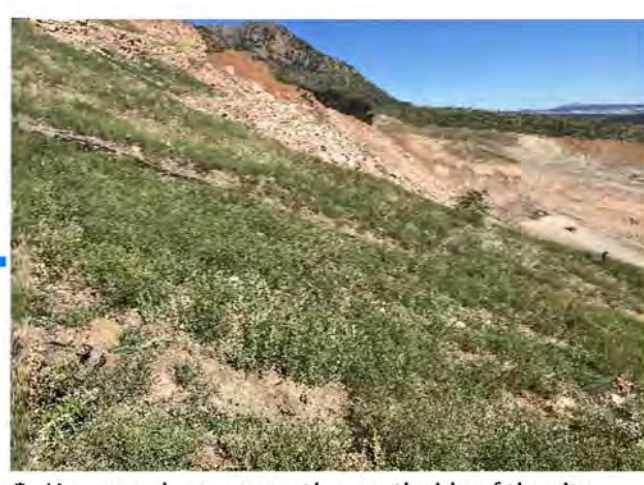
3. Hummocky area on the south side of the site remains stable without new cracks.

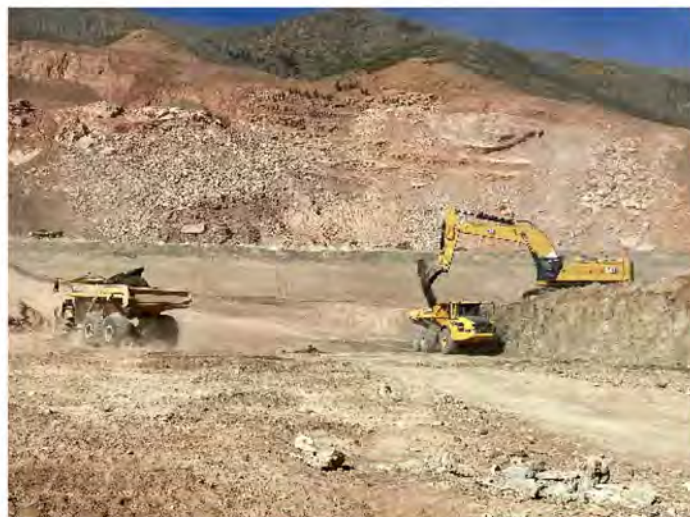
7. Excavator loads haul trucks at north borrow area.
