**MINERALS PROGRAM INSPECTION REPORT**  
**PHONE: (303) 866-3567**

<b>MINE NAME:</b> Cresson Project	<b>MINE/PROSPECTING ID#:</b> M-1980-244	<b>MINERAL:</b> Gold and silver	<b>COUNTY:</b> Teller
<b>INSPECTION TYPE:</b> Monitoring	<b>WEATHER:</b> Clear	<b>INSP. DATE:</b> September 14, 2022	<b>INSP. TIME:</b> 08:00
<b>OPERATOR:</b> Cripple Creek & Victor Gold Mining Company	<b>OPERATOR REPRESENTATIVE:</b> Johnna Gonzalez, Maria Bujenovic	<b>TYPE OF OPERATION:</b> 112d-3 - Designated Mining Operation	
<b>REASON FOR INSPECTION:</b> Normal I&E Program	<b>BOND CALCULATION TYPE:</b> None	<b>BOND AMOUNT:</b> \$209,491,188.00	
<b>DATE OF COMPLAINT:</b> NA	<b>POST INSP. CONTACTS:</b> None	<b>JOINT INSP. AGENCY:</b> None	
<b>INSPECTOR(S):</b> Patrick Lennberg	<b>INSPECTOR'S SIGNATURE:</b>

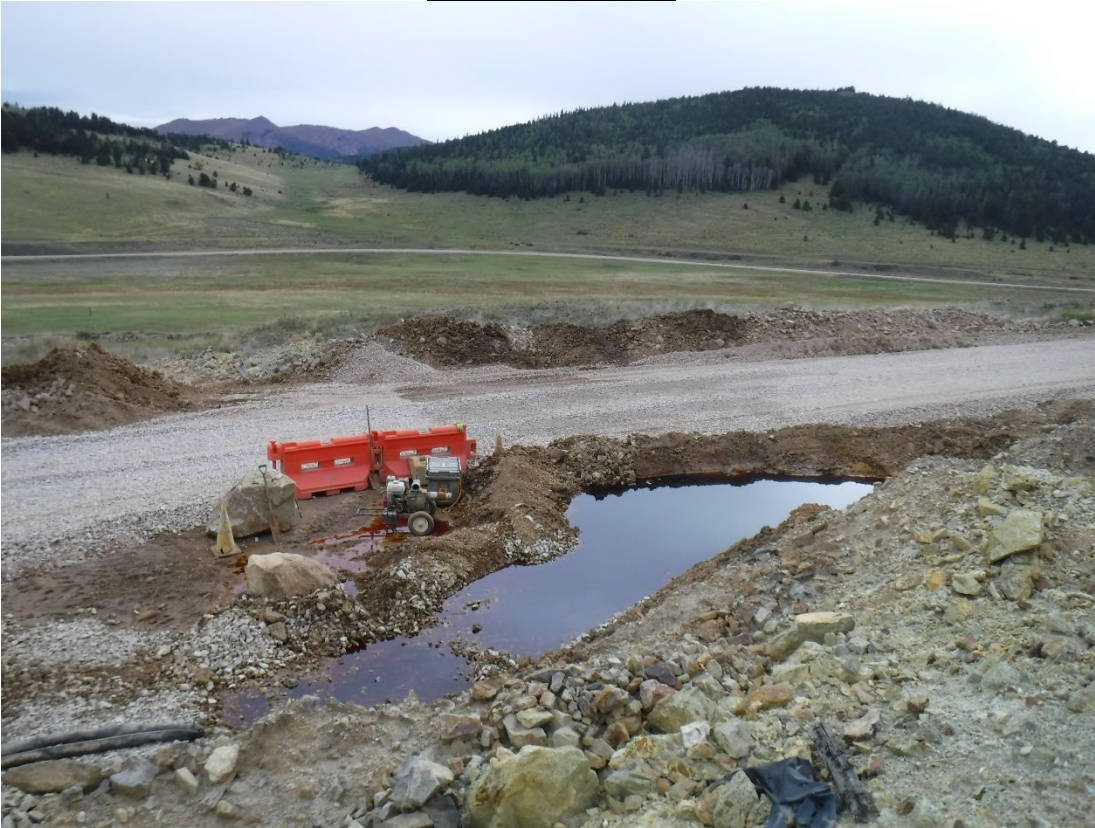
The Division inspected the seep areas located along the eastern toe of the ECOSA. Both seep locations were holding water. The water was reddish-brown in color at both locations and for the north location it was difficult to determine the depth of water. The southern seep area has been reconfigured since that last time the inspector was at the ECOSA in June 2022. The southern seep has been regraded for safety reasons and better volume tracking of seep water accumulation. The new seep configuration has a capacity of 2,305 cubic feet or 17,200 gallons. The staff gauge that was present indicated there was approximately 1 foot of water in the basin. Water was observed flowing into the trench from the south/southeast. The second seep, furthest to the north, was holding water at the time of inspection. The Operator indicated there were plans to reconfigure the north seep area much like the southern seep area. Pumping of both seeps had increased to daily and depending on weather the seep collection basins were pumped twice a day. Water removed from the seeps is transported and dumped onto a lined facility (one of the valley leach facilities). The Operator indicated the seeps to react to precipitation events and over the past couple of months the area has received more precipitation than the same time as last year.

**Photo 1:** Looking at the north seep along the toe of the ECOSA

Following this inspection the Operator submitted their monthly GVMW-25 sampling results on September 26, 2022 for samples collected in August. On September 30, 2022 the Division issued a problem citation for failure to minimize disturbances to the prevailing hydrologic balance. Corrective actions included monthly sampling of water from both seeps, GVMW-25, and a new surface water location down-gradient of GVMW-25 near the permit boundary, GV-06. Additionally, the Operator is to submit a Technical Revision to revise the surface water sampling plan and map to incorporate the new creek monitoring location, and a detailed monitoring and reporting program for the ECOSA seeps. This revision must also include a short term plan for management of the seep during active mining operations and a long term plan for final closure of the mine which prevents or minimizes any further impacts to the hydrologic balance by the ECOSA

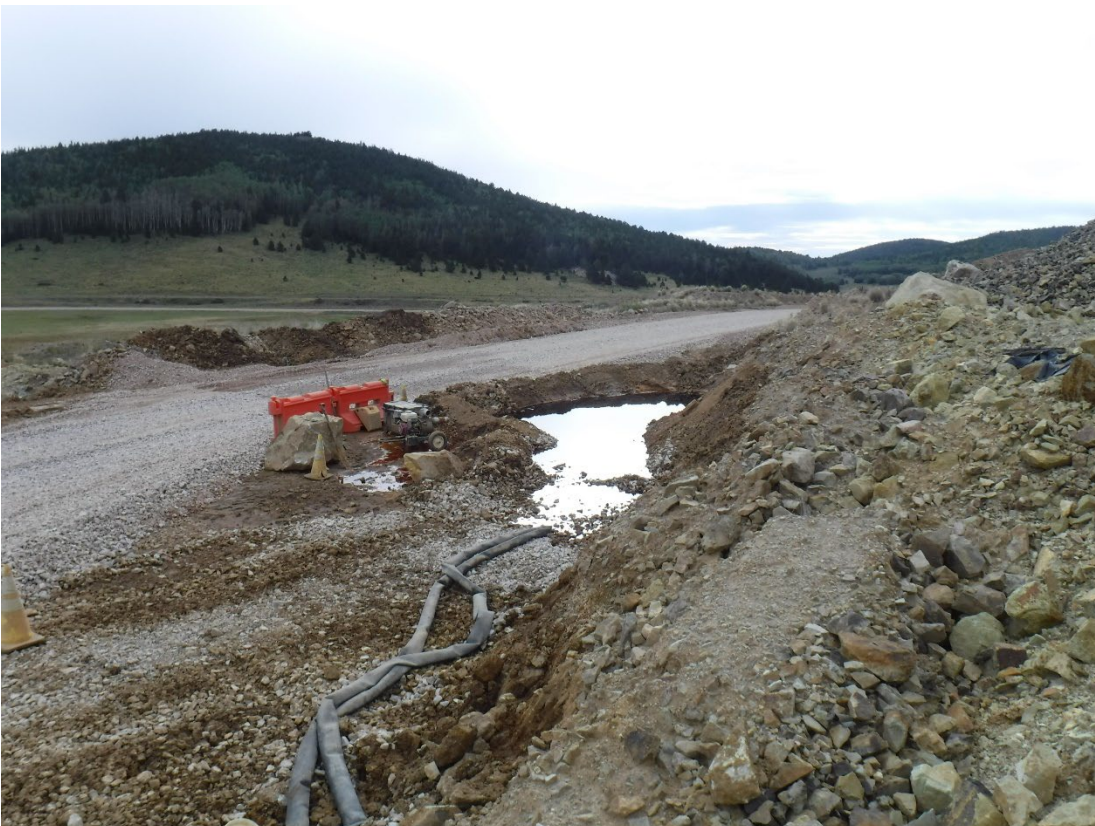
**Photo 2:** Looking at the north seep along the toe of the ECOSA

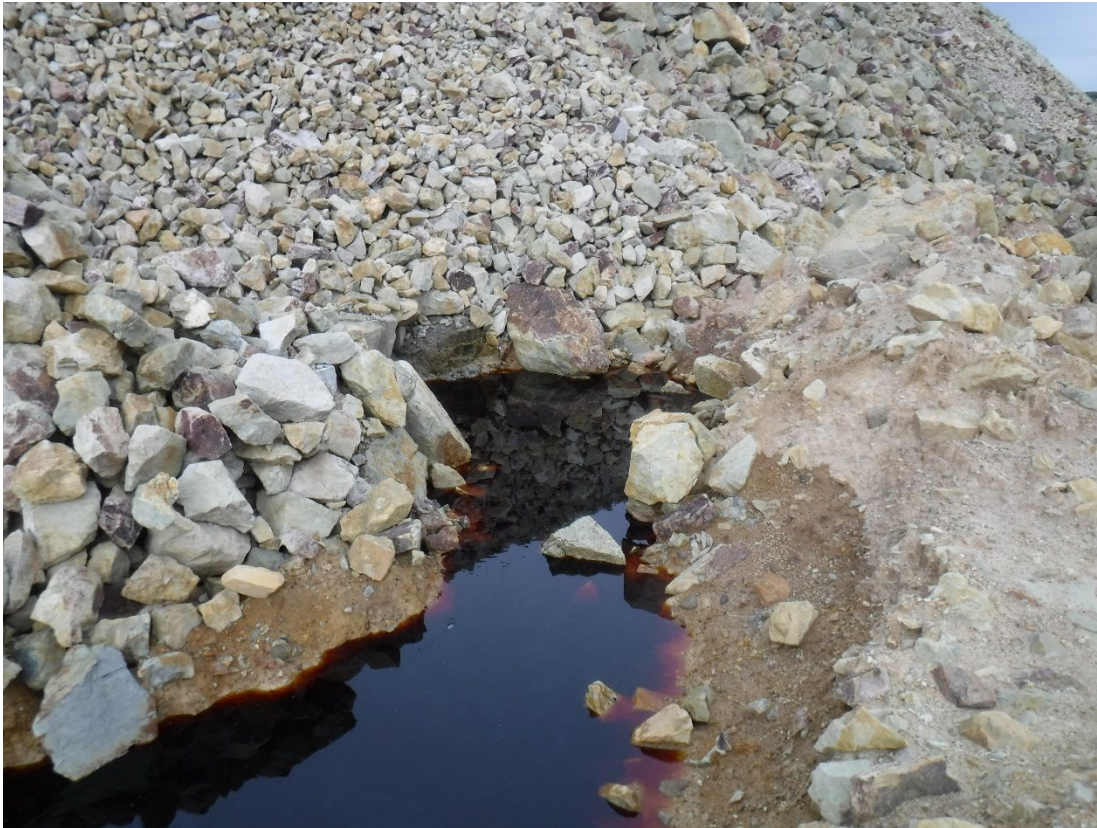
**Photo 3:** An adjacent north seep pond area that conveys seep water to the seep pond pictured above to allow for safe pumping conditions

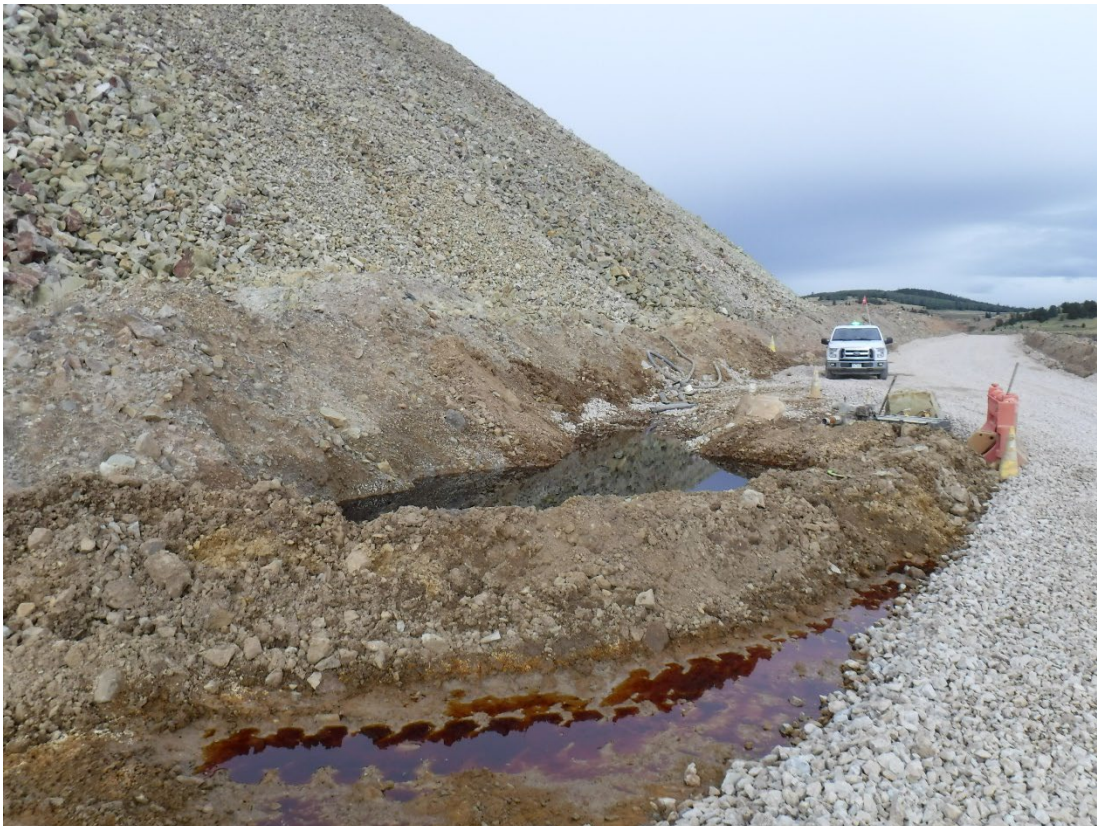
**Photo 4:** North seep complex

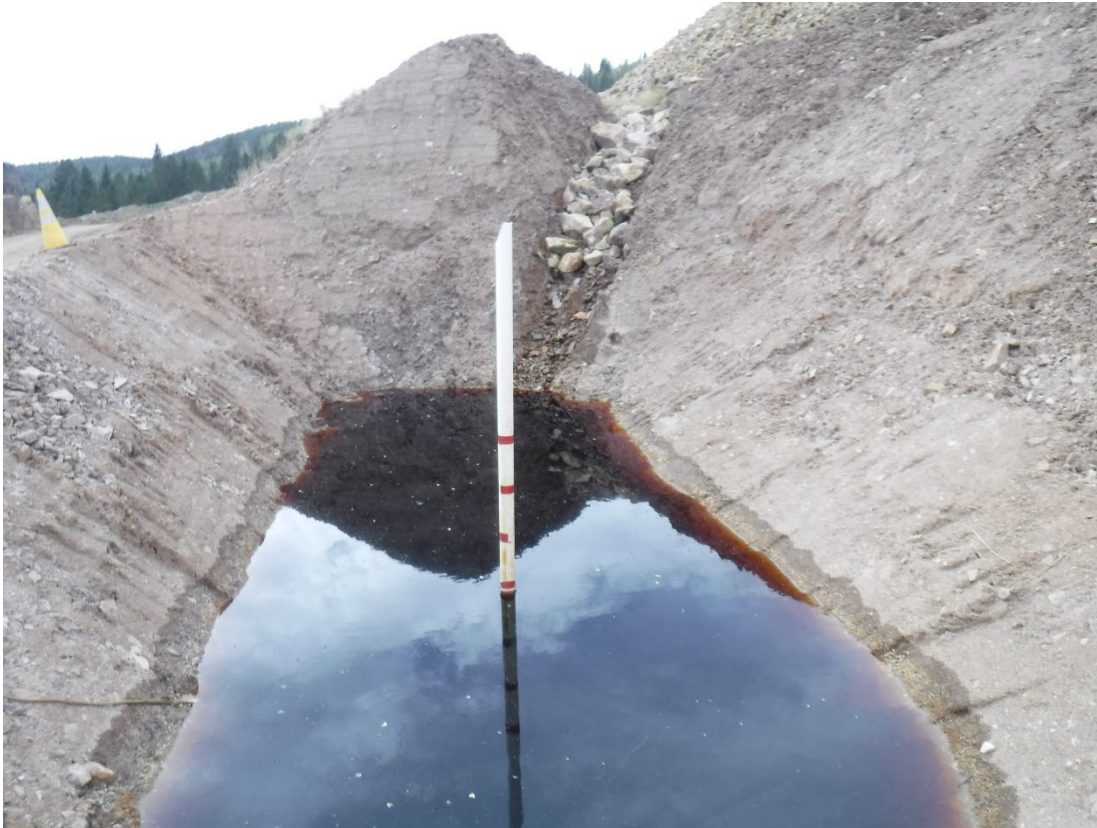
**Photo 5:** Reconfigured south seep area

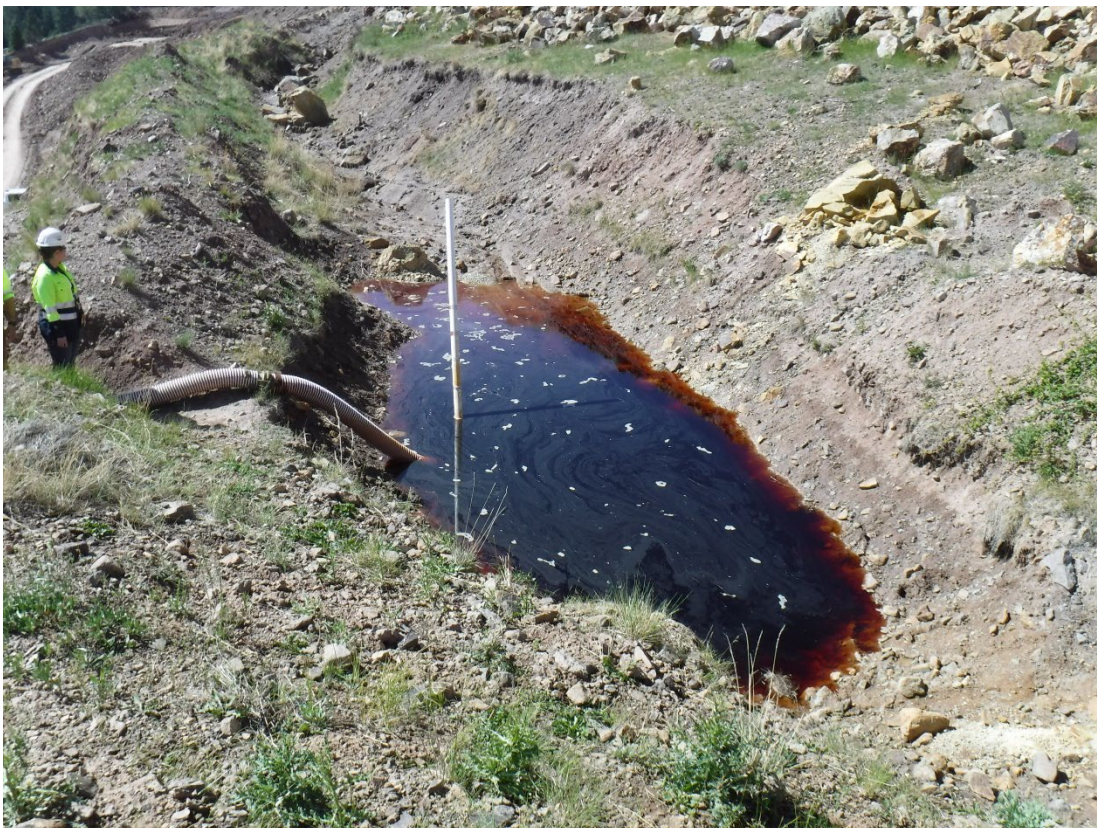
**Photo 6:** South seep area in June 2022

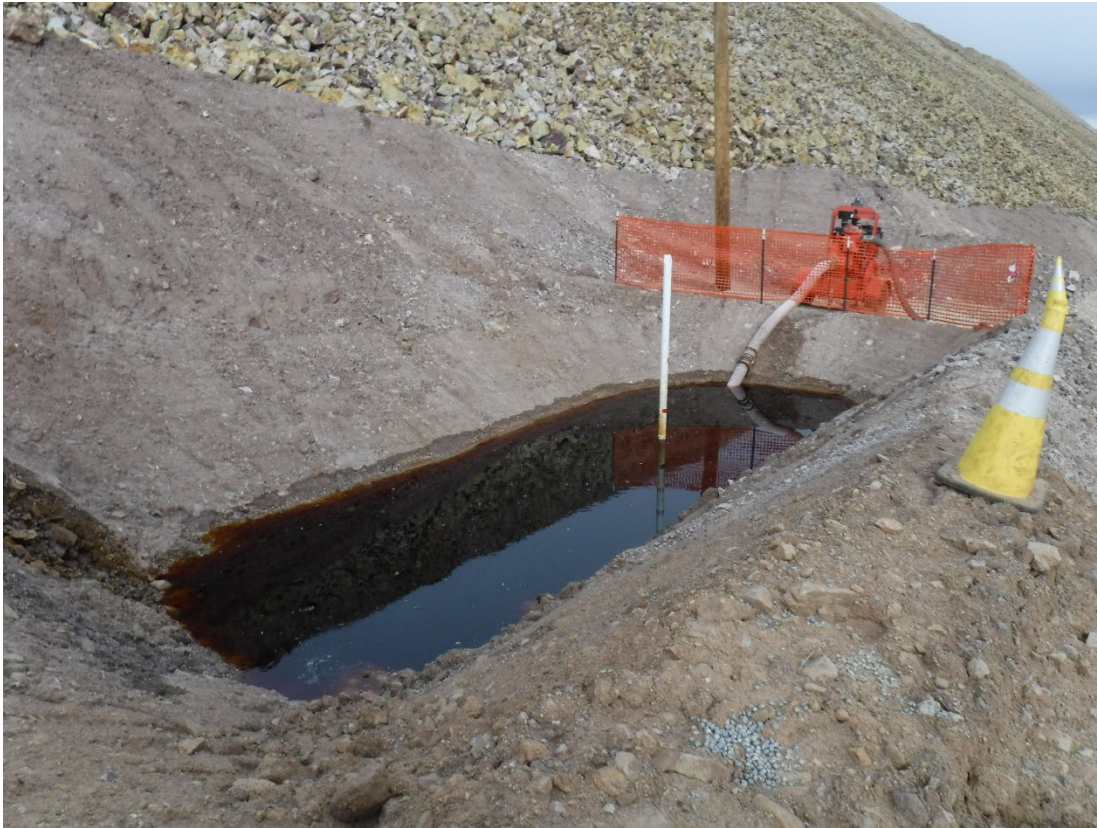
**Photo 7:** Reconfigured south seep area, looking north

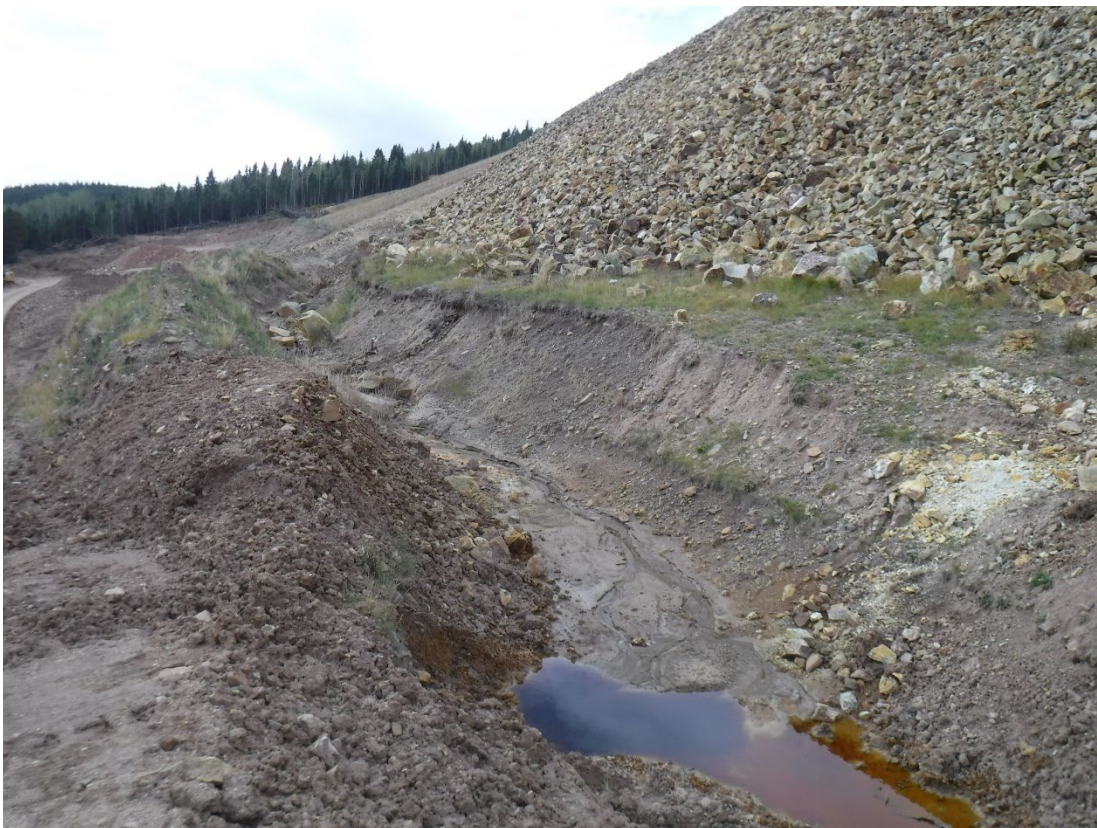
**Photo 8:** Toe ditch collecting seep water and directing it to the southern seep, looking south

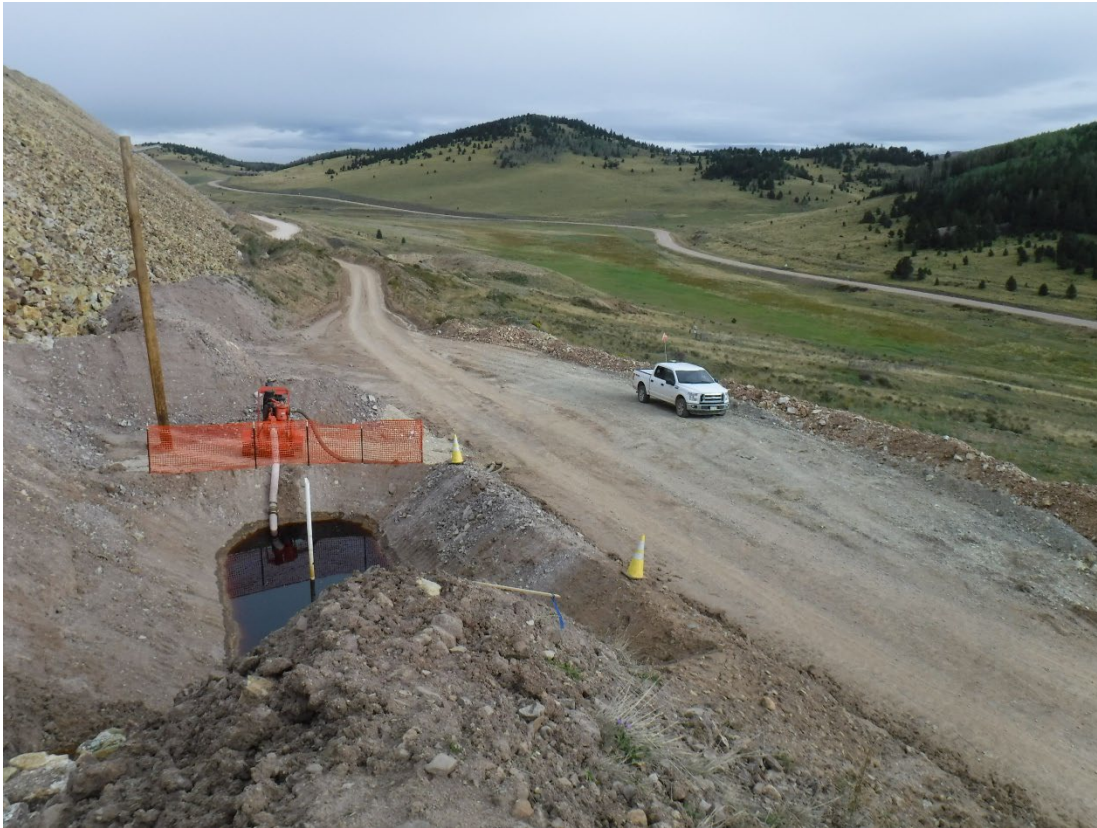
**Photo 9:** Overview of the southern seep area, looking northwest

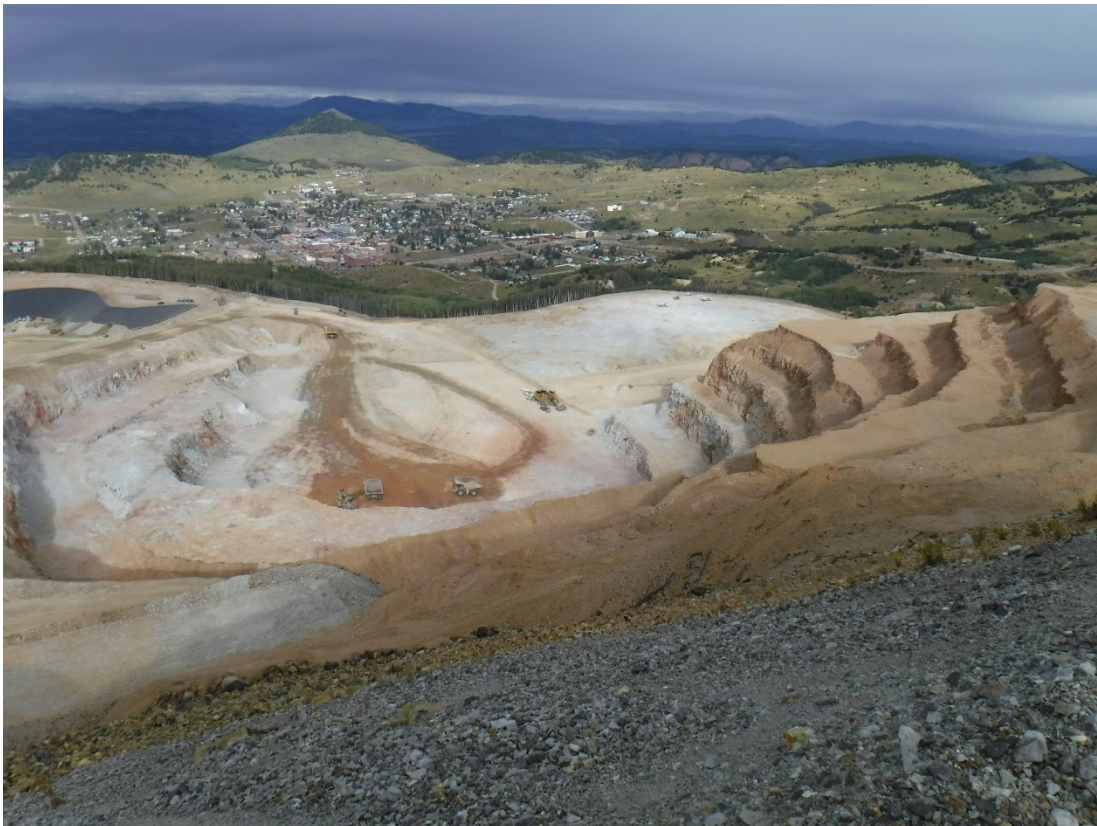
**Photo 10:** Schist Island Phase II mining area

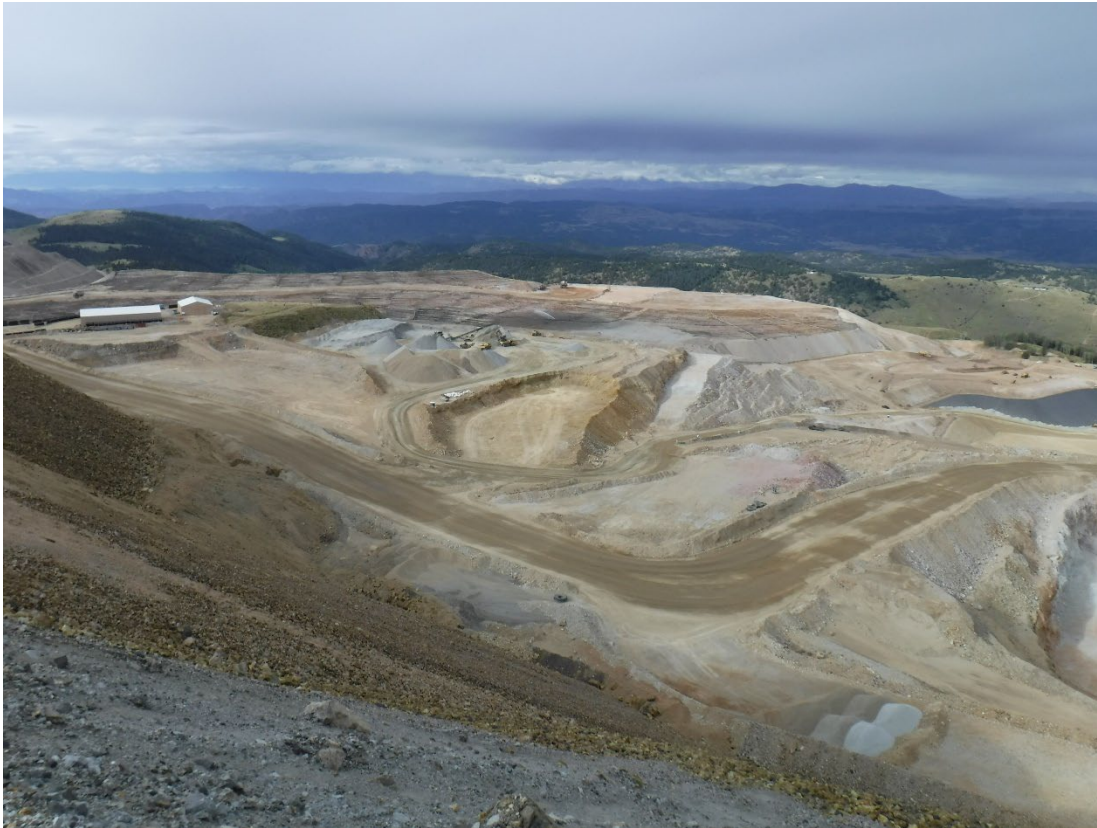
The Division observed, from a distance, the placement of drain rock material that is being placed over 100 mil liner. The area observed is the VLF2 Phase III PSSA and is main collection area for leached solution that is then pumped to the ADR. The area is constructed of a multilayered system consisting of; first layer is one foot minimum layer of soil fill (clay), second is a sheet of 100 mil double sided LLDPE, third is a 3 foot thick (minimum) layer of drain cover fill (DCF) material that drains to the low volume solution collection system, forth is another layer of 100 mil LLDPE, and the final layer is 2 feet (minimum) layer of DCF to protect from ore material placement. The Division observed the first layer of DCF material being placed over 100mil liner.

**Photo 11:** DCF processing area for VLF2 Phase III PSSA construction

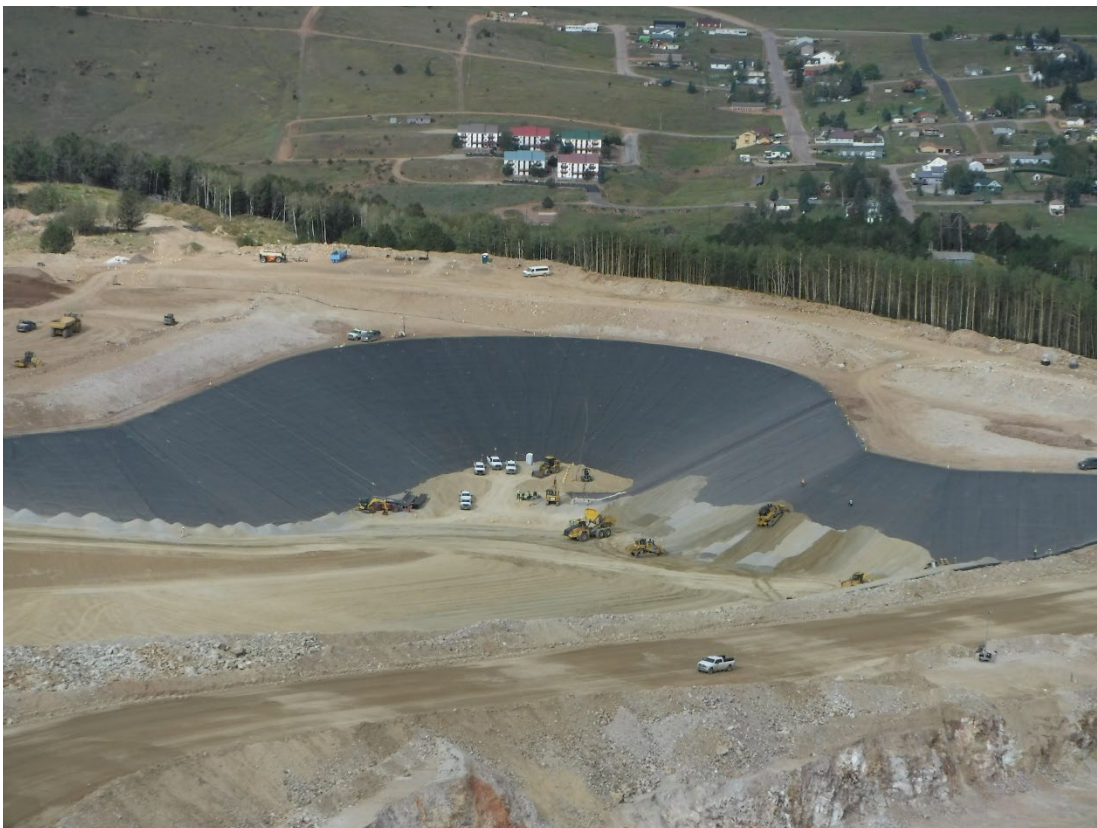
**Photo 12:** DCF placement on the Phase III PSSA construction area

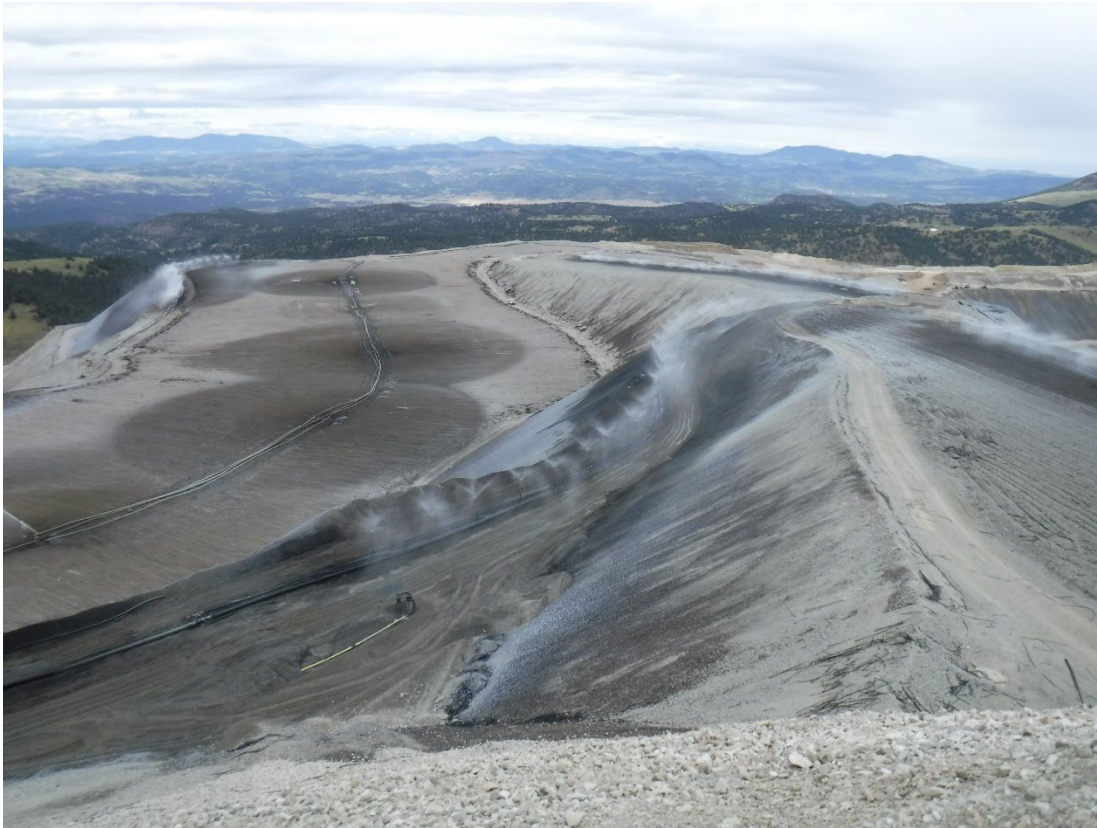
**Photo 13:** A view looking north from VFL1 10,400' level down to the 10,200 level

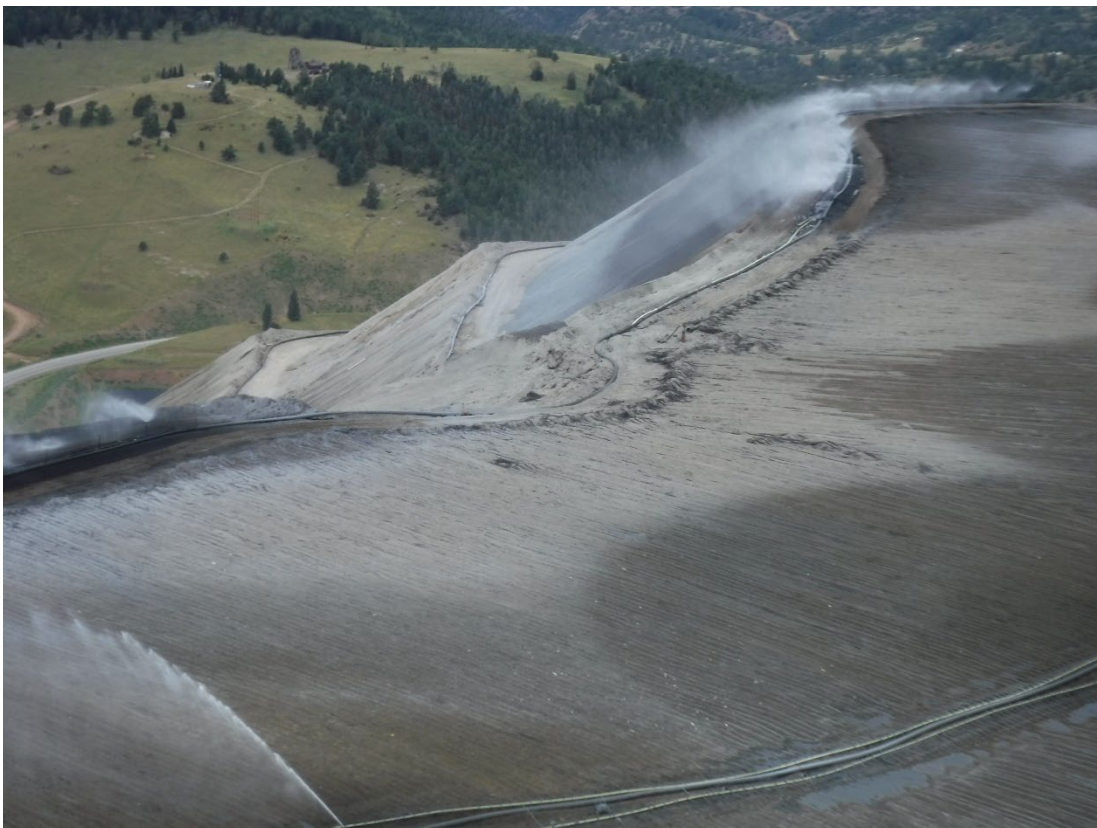
The current and maximum elevation of ore placement in the AGVLF is 10,400 feet (for Phase V). The Division inspected active leaching surfaces on the AGVLF. These surfaces were well saturated and ponding of leachate, greater than 3 feet by 3 feet, was common. In addition, ponding of leachate was observed on the lower 10,200 foot level. At that time the Operator indicated they were getting close to taking down the misters and sprinklers because seasonal weather conditions changing and freezing conditions becoming common. At the time of writing this inspection report the Operator indicated the areas were ripped to eliminate the ponding areas and winter weather conditions are common at the site now, therefore the Division will not cite a problem for ponding leachate.

**Photo 14:** A view looking north from VFL1 10,400' level down to the 10,200 level note ponding areas.
