TRAPPER MINING INC.  
CRAIG, COLORADO

HORSE GULCH FILL  
QUARTERLY FILL CERTIFICATION

# **Horse Gulch Fill Quarterly Inspection Report**

**Fourth Quarter 2022**

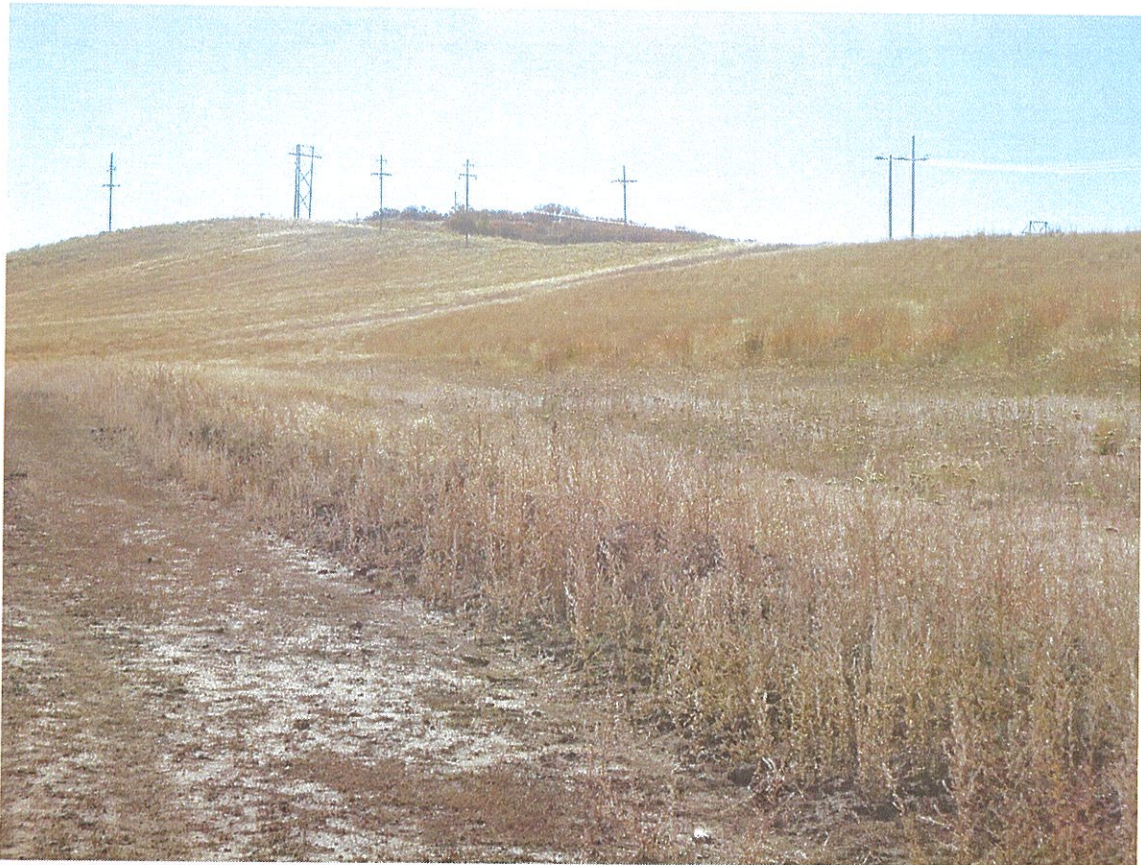
No appearances of instability, structural weakness, or other hazardous conditions were observed. Both the southeast side of the fill and the northeast side of the fill were inspected this quarter (Photographs 1 and 2). The area where cracks were detected on the top south portion of the dump during the first quarter of 2013 inspection was checked. There was no additional cracking found.

Photograph 1: North Side Looking South (10/19/2022)

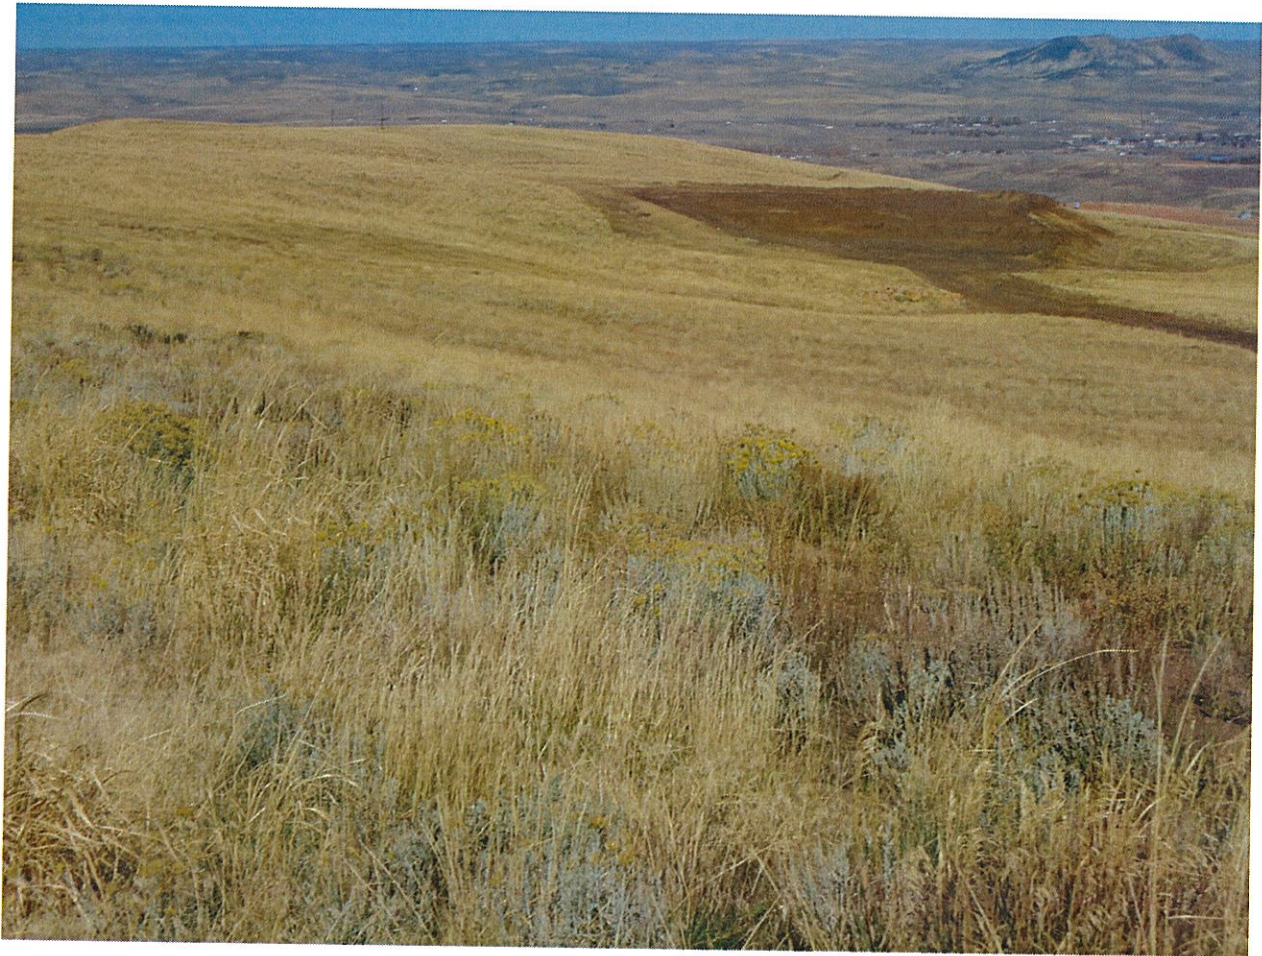
*Photograph 2: South Side Looking North (10/19/2022)*

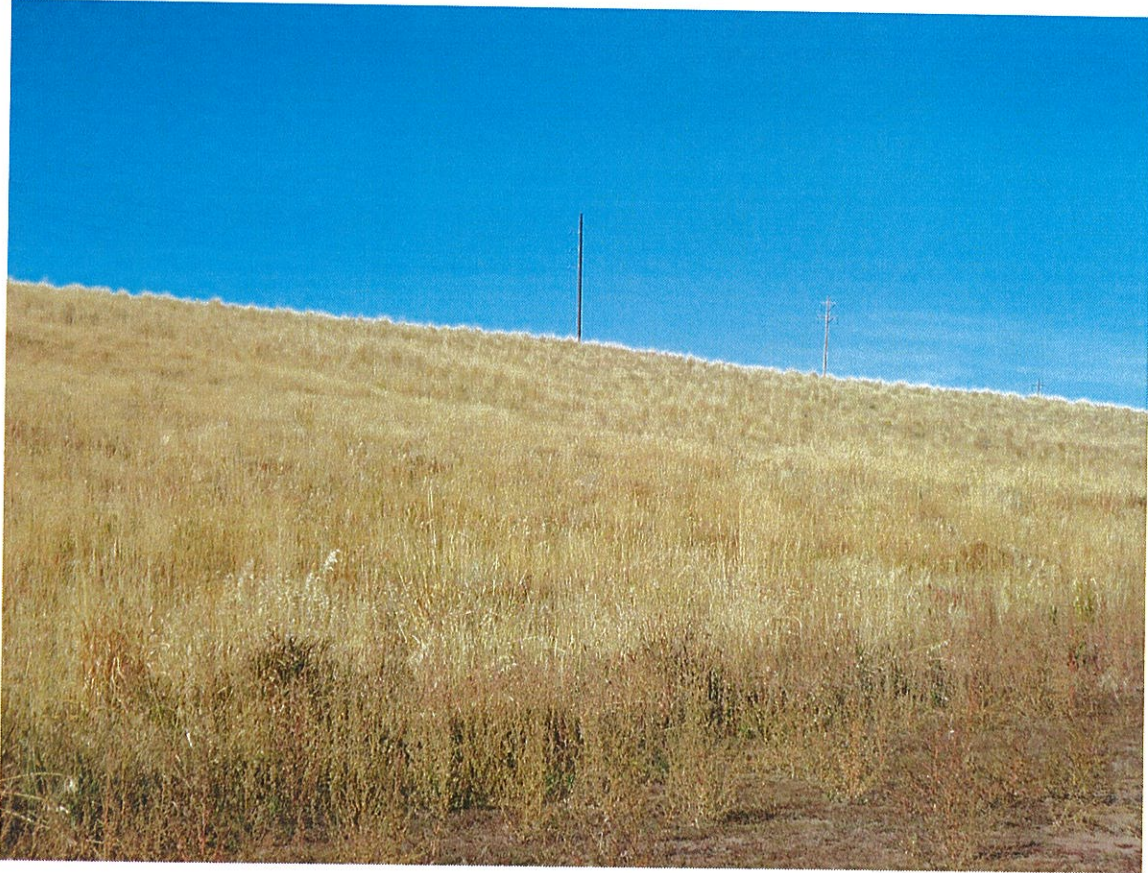
There was no placement of material or contour work done on the fill this quarter. All of the required material for the fill has been placed and compacted. It's anticipated there will be no more additional fill material placed on the fill.

Photograph 3 depicts the east facing slope of the fill.

*Photograph 3: East Side of the Fill Looking North-west (8/24/2022)*
