## MINERALS PROGRAM INSPECTION REPORT

<b>MINE NAME:</b> Phantom Canyon Pit	<b>MINE/PROSPECTING ID#:</b> M-1994-118	<b>MINERAL:</b> Gravel	<b>COUNTY:</b> Teller
<b>INSPECTION TYPE:</b> Monitoring	<b>INSPECTOR(S):</b> Timothy Cazier, P.E.	<b>INSP. DATE:</b> June 28, 2022	<b>INSP. TIME:</b> 12:30
<b>OPERATOR:</b> Fremont County	<b>OPERATOR REPRESENTATIVE:</b> Sterling Rife	<b>TYPE OF OPERATION:</b> 110c - Construction Limited Impact	
<b>REASON FOR INSPECTION:</b> Normal I&E Program	<b>BOND CALCULATION TYPE:</b>	<b>BOND AMOUNT:</b> \$0.00	
<b>DATE OF COMPLAINT:</b> NA	<b>POST INSP. CONTACTS:</b> None	<b>JOINT INSP. AGENCY:</b> None	
<b>WEATHER:</b> Clear	<b>INSPECTOR'S SIGNATURE:</b>

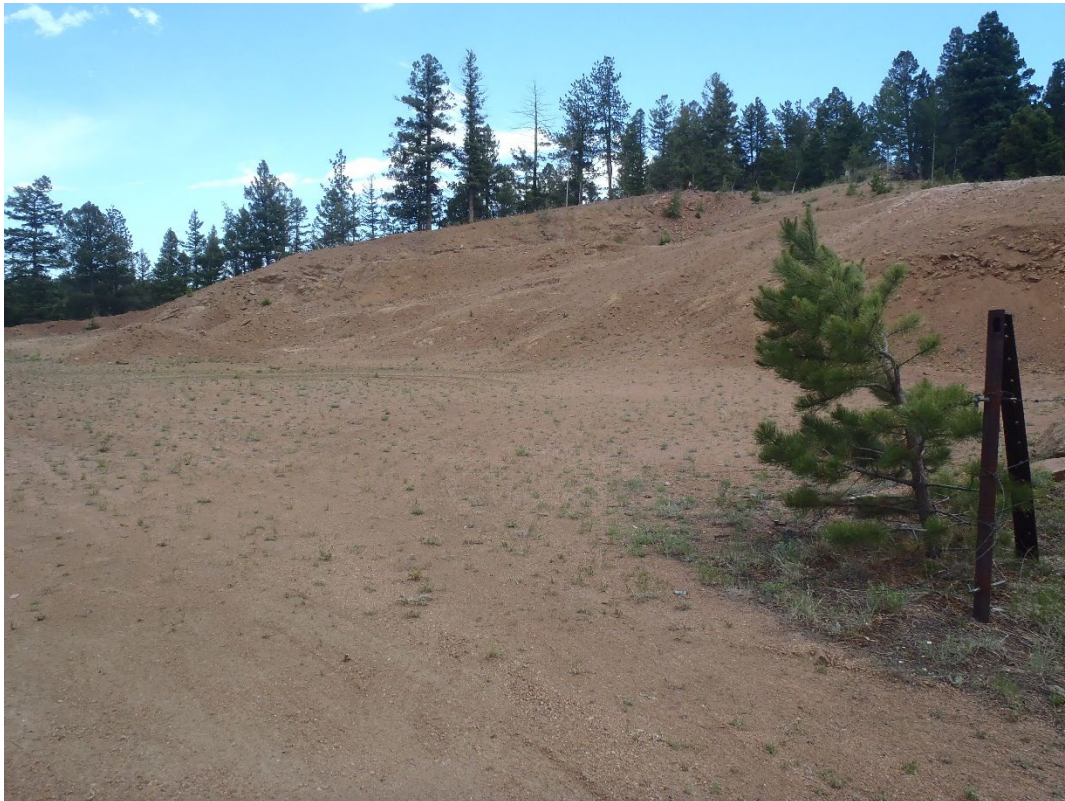
Gen. Compliance with Mine Plan: The operation appeared to be in compliance with the approved mine plan. Google Earth was used to measure the disturbed area, which was estimated to be 1.16 acres, based on 2019 imagery. Highwalls were estimated to vary between 30 and 35 feet in height and appeared stable (see **Photo 1**).

Photo 1. Active highwall (looking SE from site entrance).

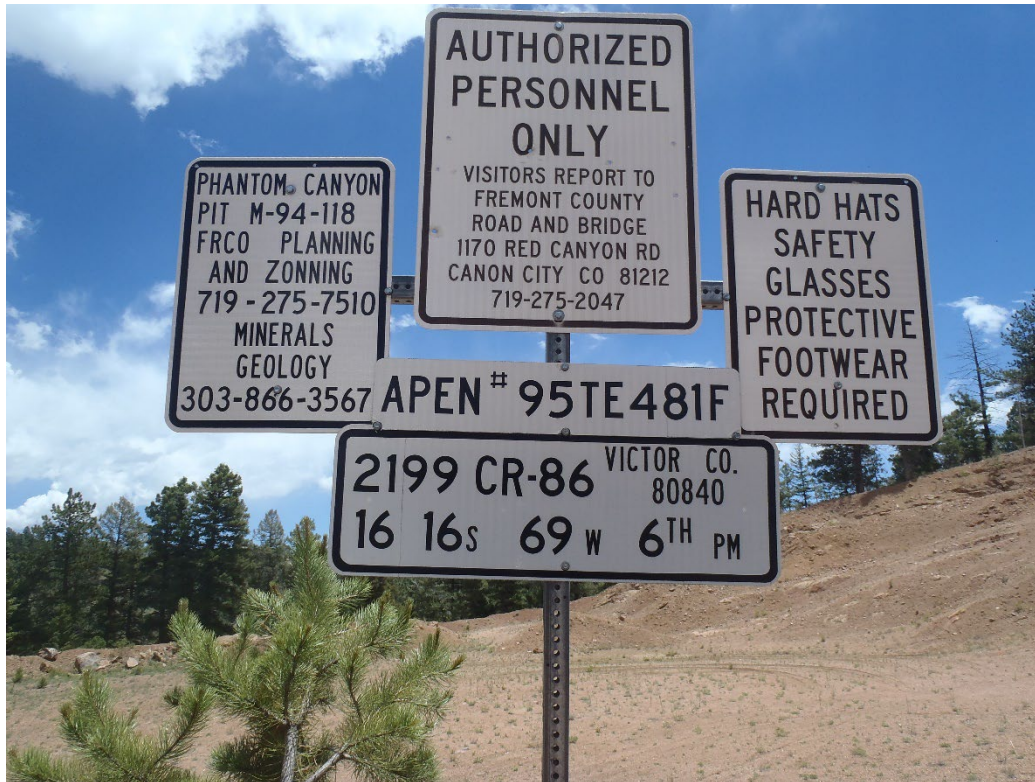
Signs and Markers: The permit sign was properly posted (see **Photo 2**) and boundary marker locations were collected delineating the permit boundary (see **Photo 3** and **Figure 1**).

Photo 2. Permit sign at entrance.

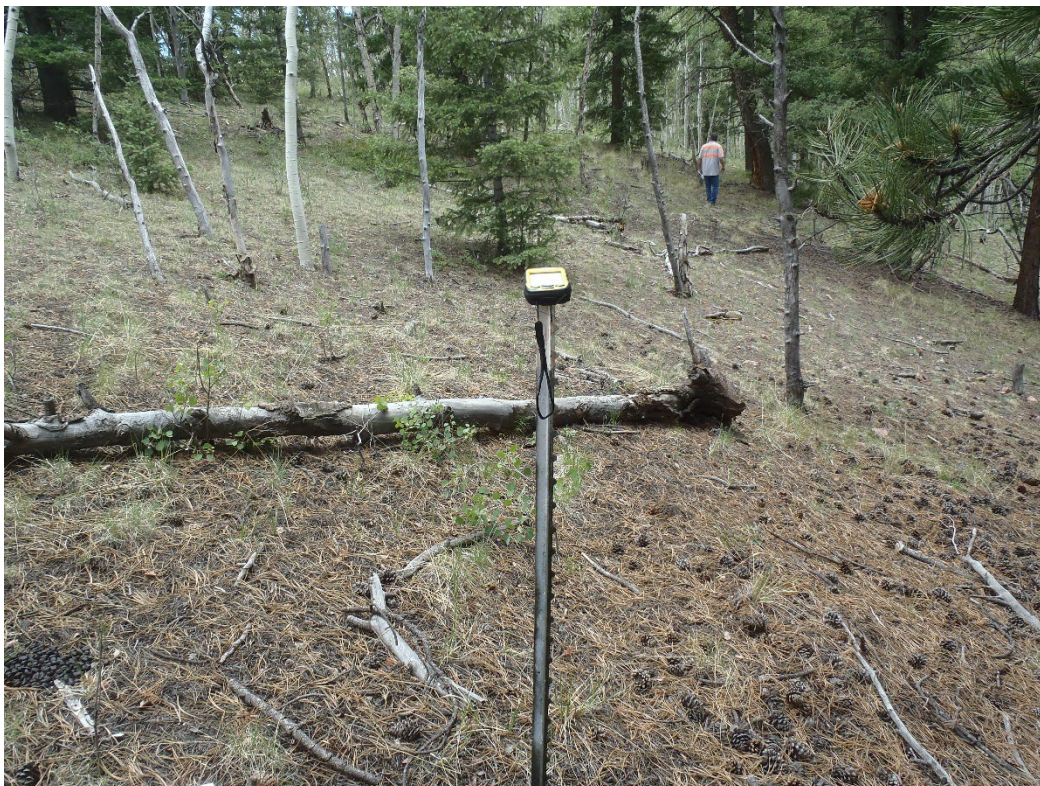
Photo 3. Typical permit boundary marker (western-most corner).

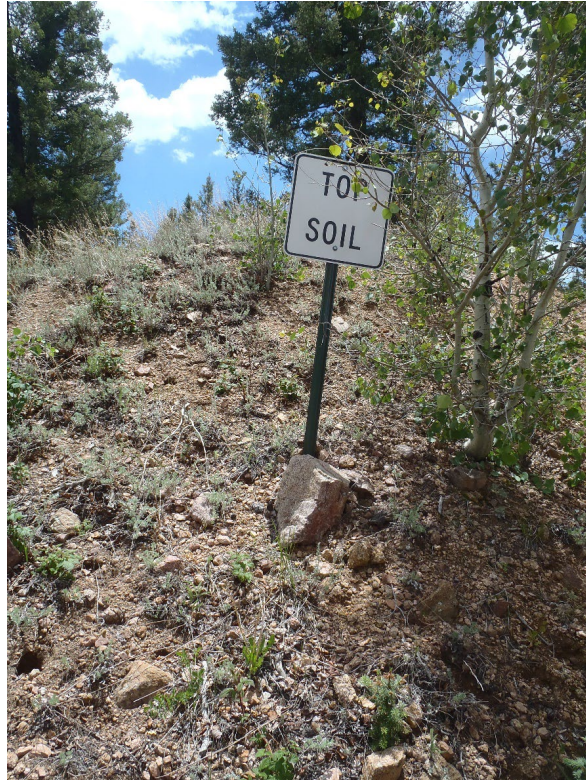
Topsoil: A topsoil stockpile is in the southwest corner of the pit and labeled as such (see **Photo 4**).

Photo 4. Topsoil stockpile with sign.
