MINERALS PROGRAM INSPECTION REPORT
PHONE: (303) 866-3567

MINE NAME: Bootleg Quarry	MINE/PROSPECTING ID#: M-2015-022	MINERAL: Sand and overburden	COUNTY: Adams
INSPECTION TYPE: Monitoring	WEATHER: Clear	INSP. DATE: October 12, 2022	INSP. TIME: 10:00
OPERATOR: Lazy H Inc	OPERATOR REPRESENTATIVE: Sandie Havengar	TYPE OF OPERATION: 111 - Construction by Government Agency	
REASON FOR INSPECTION: Normal I&E Program	BOND CALCULATION TYPE: Full Bond	BOND AMOUNT: \$34,000.00	
DATE OF COMPLAINT: NA	POST INSP. CONTACTS: None	JOINT INSP. AGENCY: None	
INSPECTOR(S): Nikie Gagnon	INSPECTOR'S SIGNATURE:

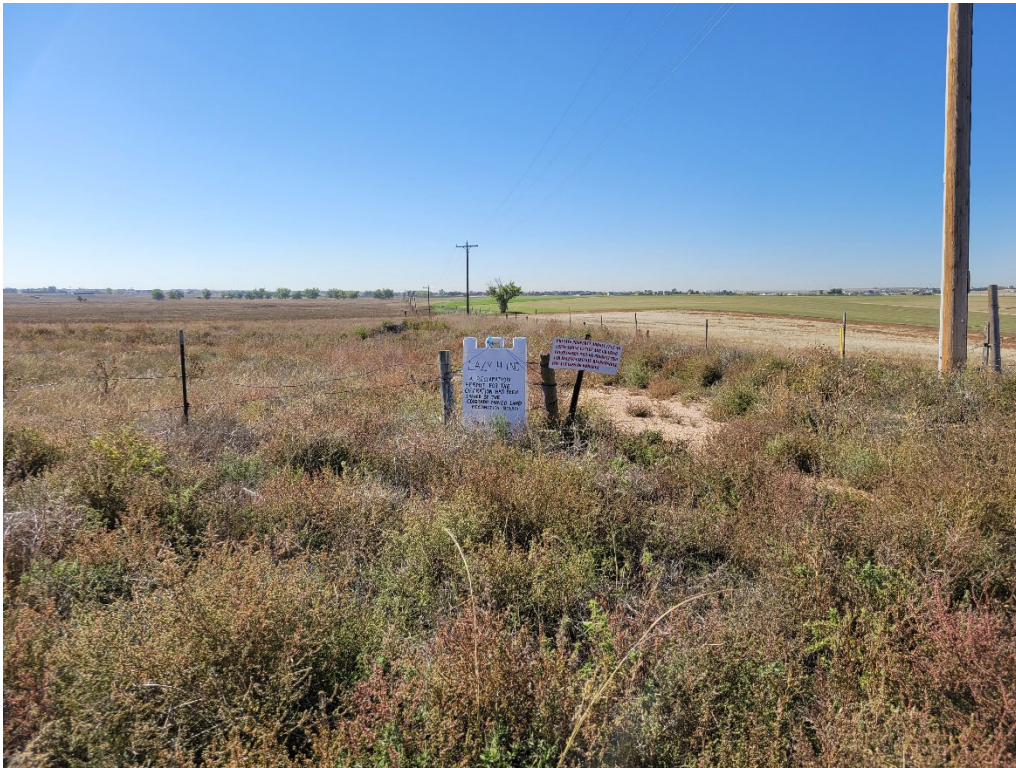
A short access road leads into and around the pit. Annual weeds, cheat grass and thistles are encroaching on the road and around the front entrance.

Front entrance and access road. Barbed wire fence runs along the west and northern permit boundary.

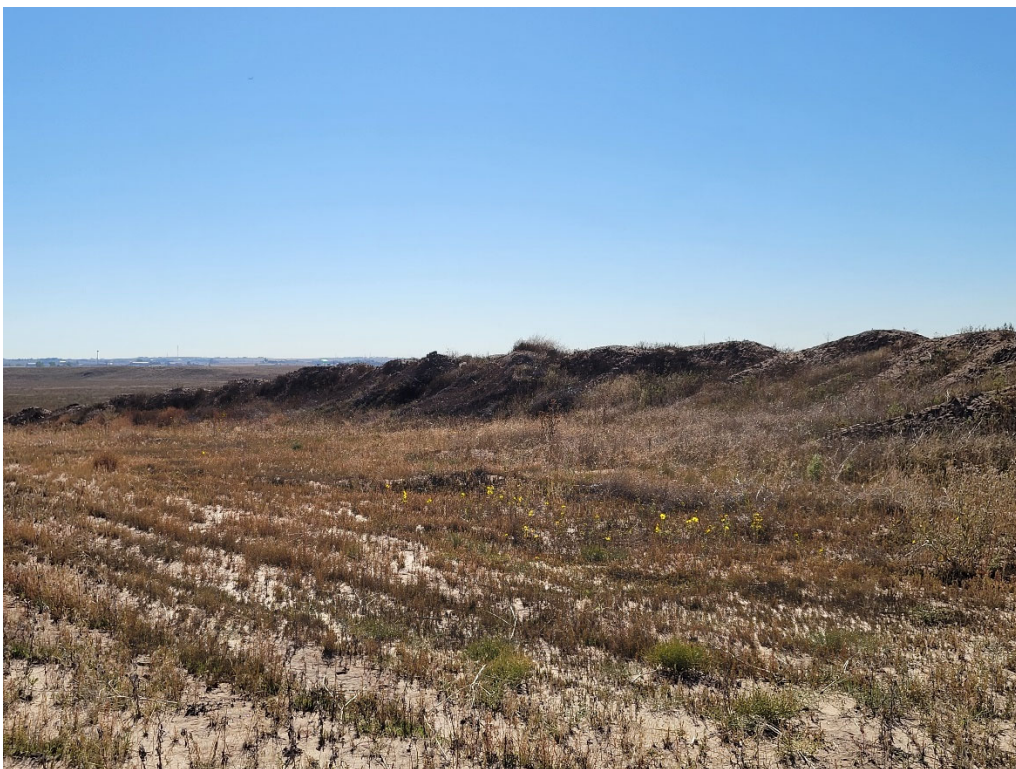
Topsoil is stockpiled is above the southern and northern highwalls. During the inspection, these piles appeared stable and vegetated.

Topsoil pile along the south side of the excavation.

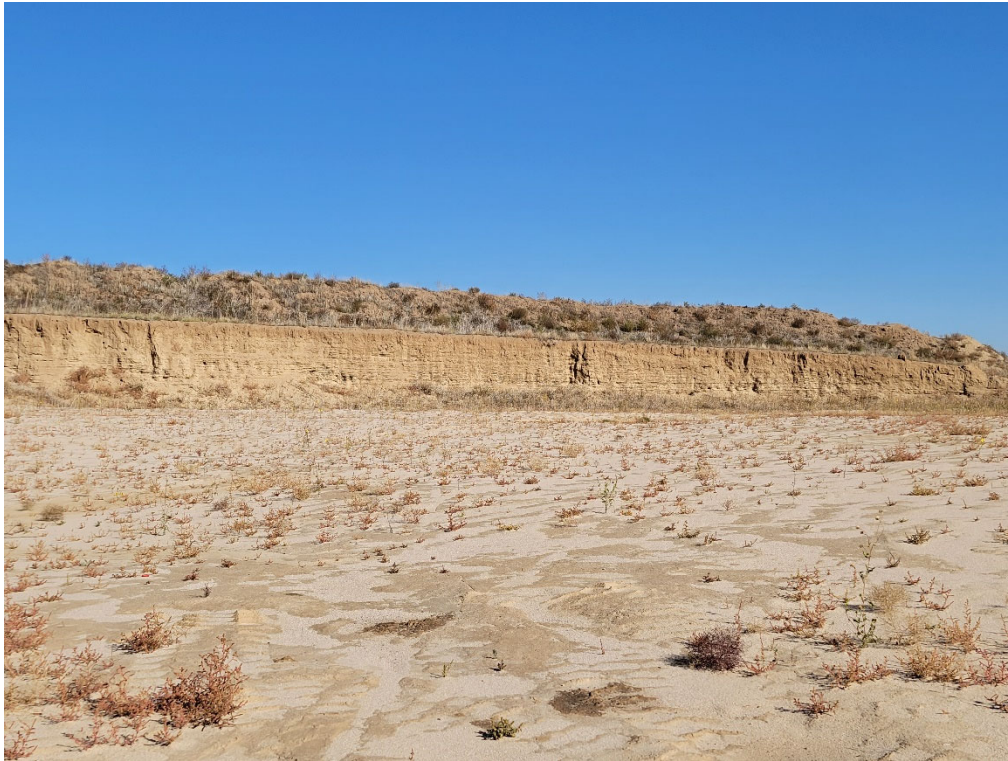
Looking north at highwall, no recent mining here. Topsoil stored about the northern highwall.

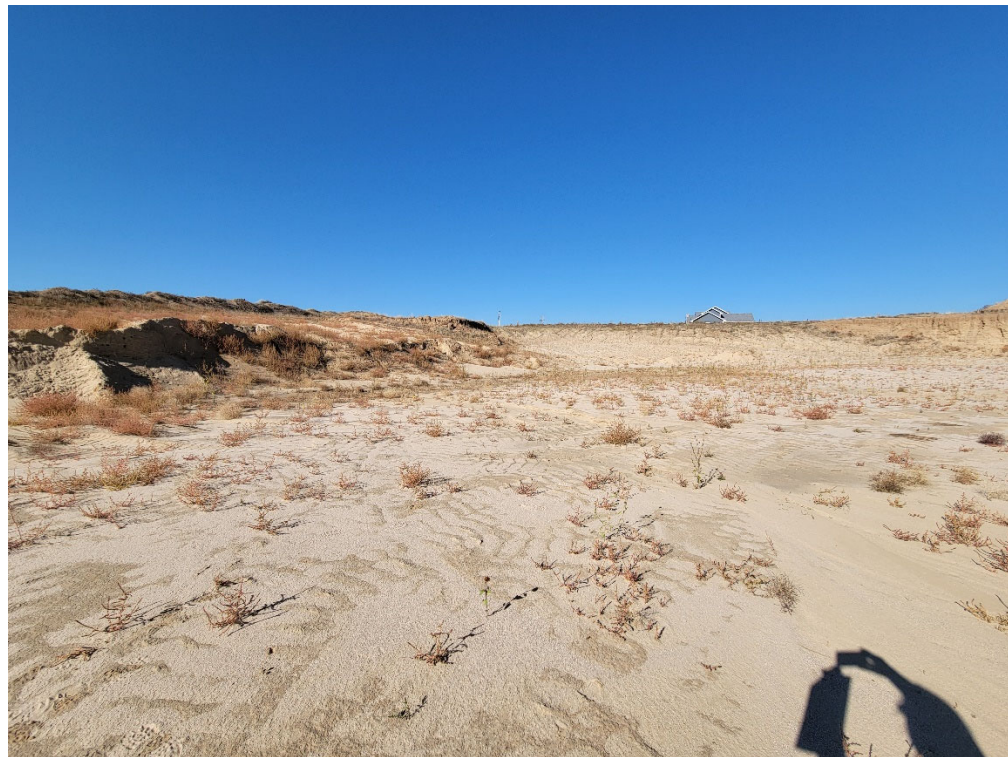
Looking west from the pit bottom. Slopes to the east at a shallow 3H:1V ratio or less.

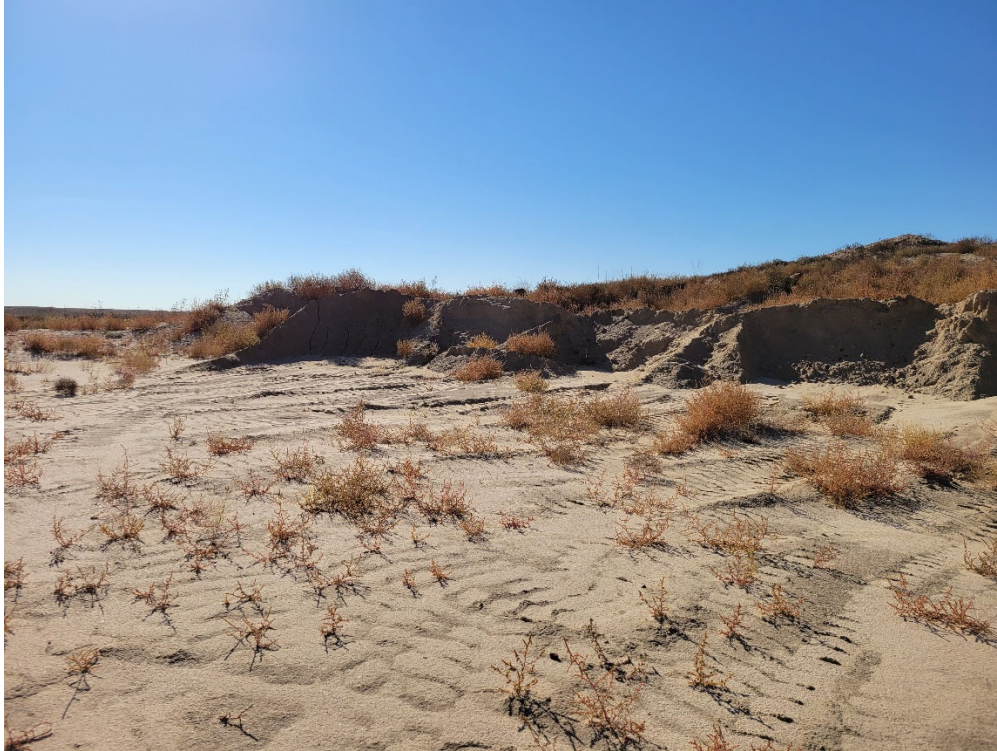
The affected area is approximately 3.5 acres. The mine was inactive during this inspection. No equipment was on site. During the inspection, evidence of recent excavation was noted in the southeast corner of the pit and a review of Google Earth photos dated May 2022 shows mining activity at the site. The operator indicated mining last occurred in June 2022. The north and south sides of the pit area are vertical with highwalls approaching 10 to 15 feet in height. The excavation daylights to the east while the western side of the pit has been graded to a 4:1 shallow slope.

Southeast wall of the pit. Area where recent mining occurred.

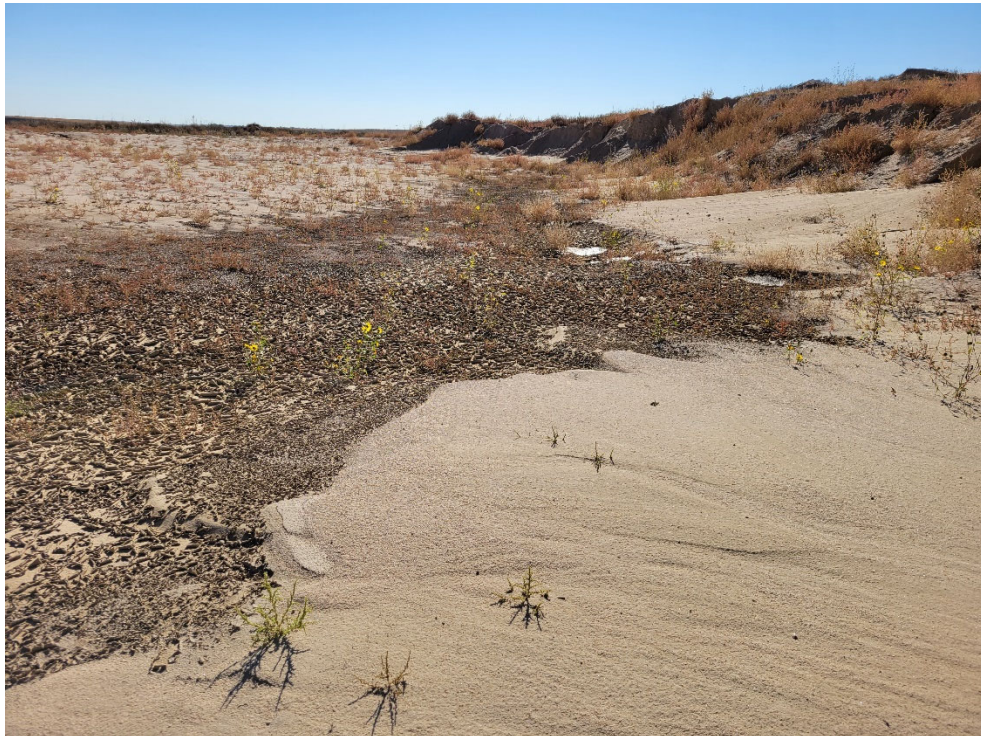
The pit was dry during the inspection. Evidence of recent standing water was noted in the bottom of the pit. The operator indicated water flows into the pit during heavy rain and infiltrates into the ground relatively quickly.

Looking east at the pit floor. Water flows into the center of the pit and infiltrates here.
