PERMIT INFORMATION

Permit Number: C-1981-038 Mine Name: Bowie No. 1 Mine Operator: Bowie Resources, LLC Operator Address: Mr. Basil R Bear P.O. Box 1488 Paonia, CO 81428	County: Delta Operation Type: Underground Permit Status: Active Ownership: Private
	Operator Representative Present: None
Operator Representative Signature: (Field Issuance Only)

Inspection Start Date: October 26, 2022 Inspection Start Time: 09:50 Inspection End Date: October 26, 2022 Inspection End Time: 10:50		Inspection Type: Coal Partial Inspection Inspection Reason: Normal I&E Program Weather: Snowing	
Joint Inspection Agency: None		Joint Inspection Contacts: 	
Post Inspection Agency: None		Post Inspection Contacts: 	
Inspector(s): Robert Zuber, P.E.	Inspector's Signature: <i>Robert D. Zuber</i>		Signature Date: 10/28/2022

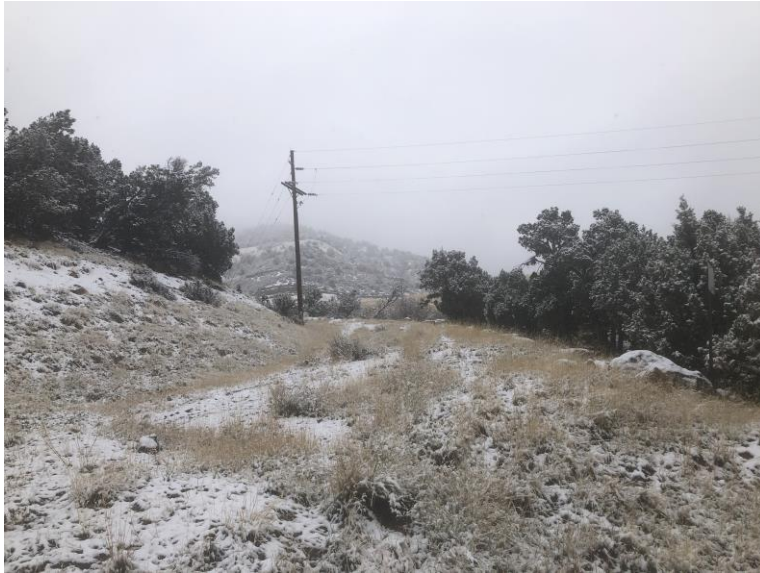
Powerline and old road west of Refuse Disposal Area

At the first switchback in the haul road west of the RDA, the slope below the road was inspected. No erosion control practices are in place here, but the slope is generally stable.

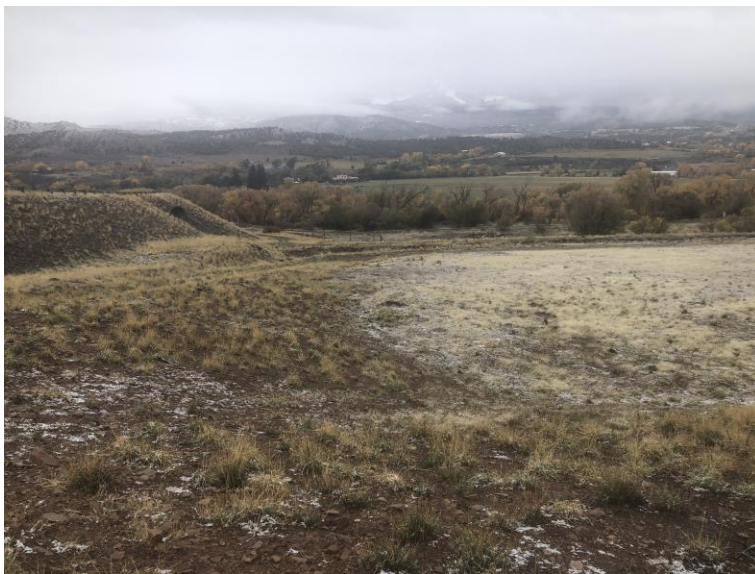
**Coal Storage Area at Hwy 133 and Black Bridge Road
(east end with pond)**

No problems were seen with the coal storage area by Black Bridge Road.

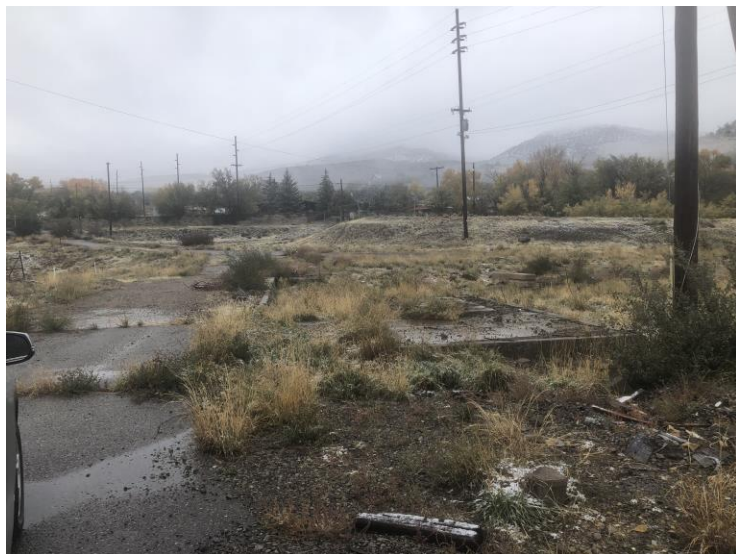
Loadout – west side

The pond at the loadout was dry, and no problems were identified.

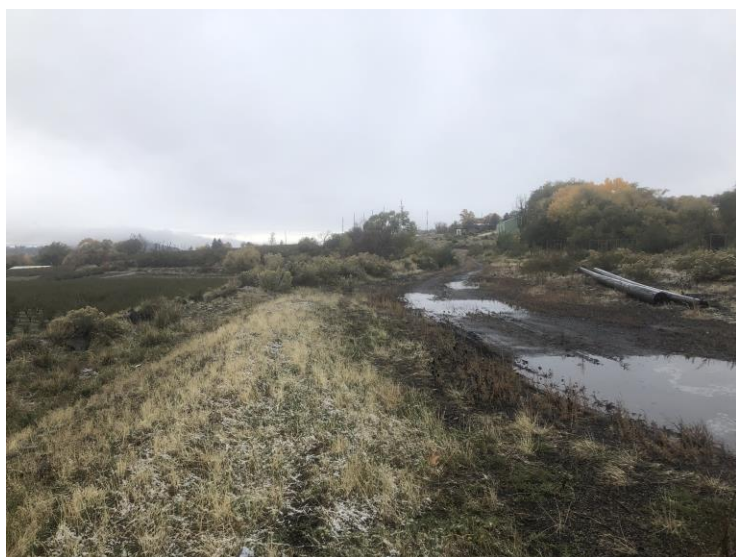
Loadout – slope on south side

The slope below the loadout is stable. No erosion was seen at the loadout.
