PERMIT INFORMATION

Permit Number: C-1981-033 Mine Name: Bear Mine Operator: N/A Operator Address: N/A	County: Gunnison Operation Type: Underground Permit Status: Revoked Ownership: Private
	Operator Representative Present: N/A
Operator Representative Signature: (Field Issuance Only)

INSPECTION INFORMATION

The Bear mine permit is revoked, the site has been reclaimed, and the required inspection frequency has been reduced to quarterly.

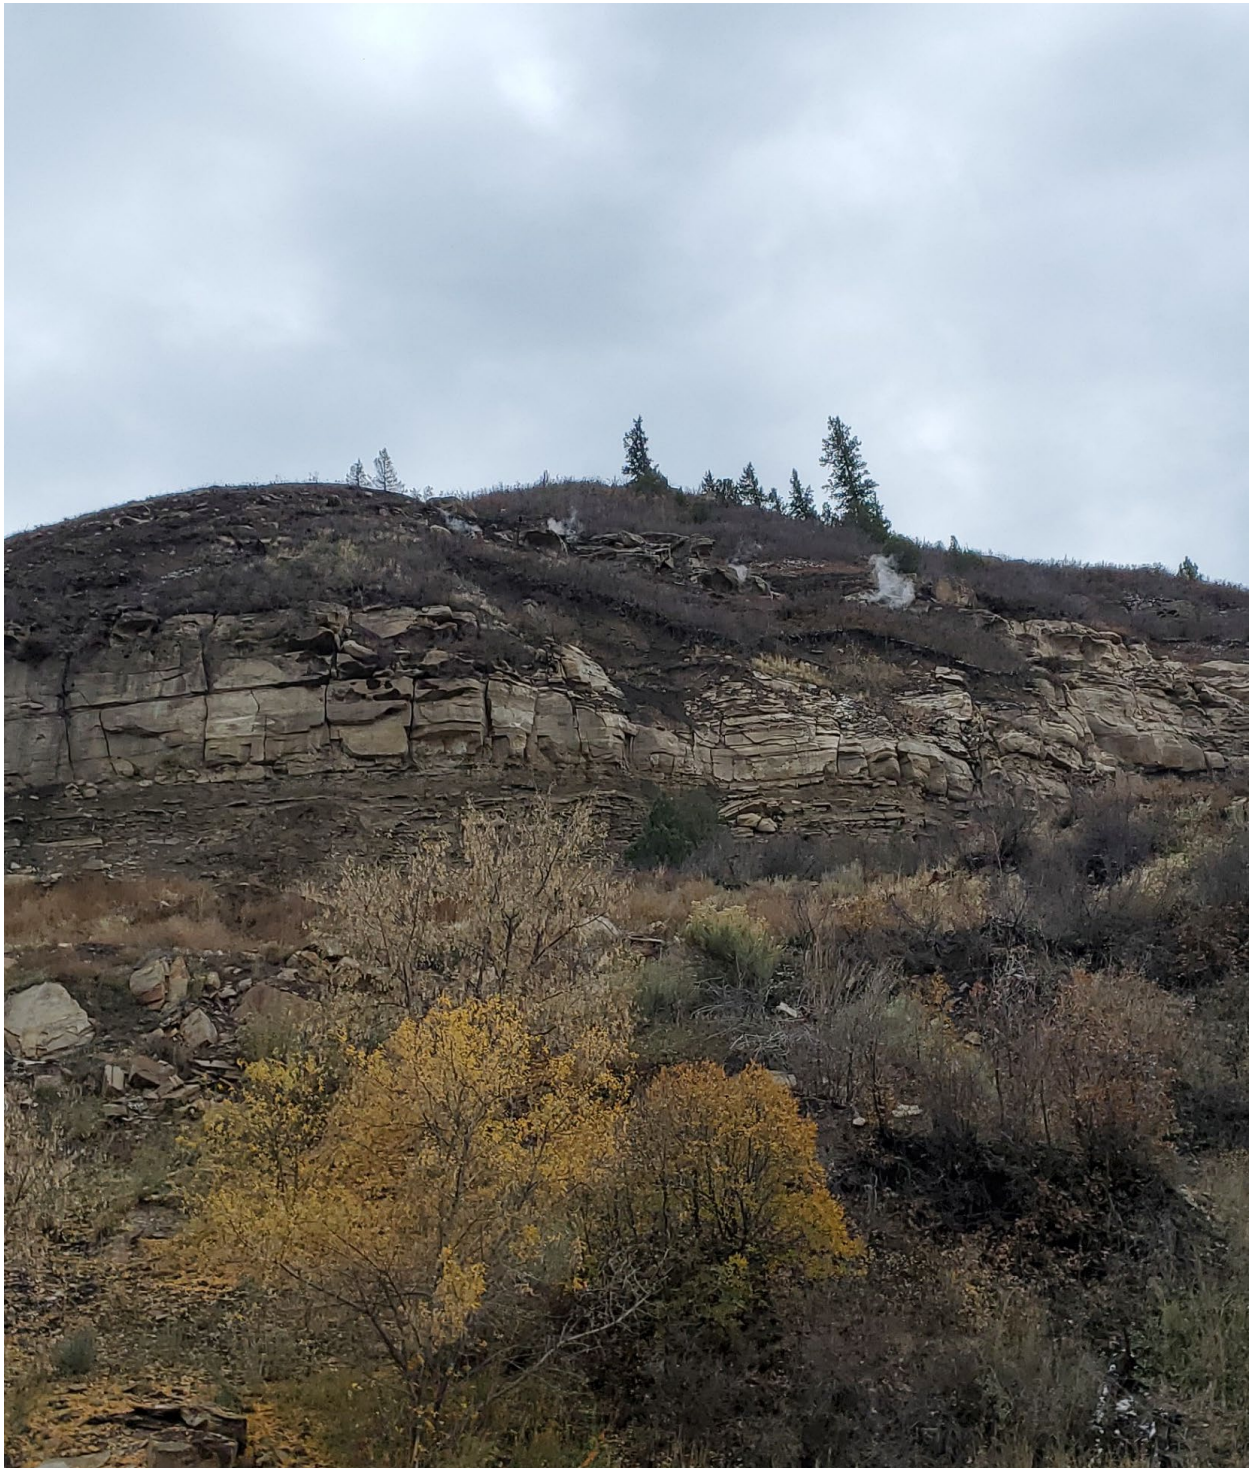
Smoke and steam was clearly visible from a series of vents below the top of the newly constructed road, but there was no visible sign of any change in fire activity since the last inspection.

Figure 1: Smoke/steam visible from below

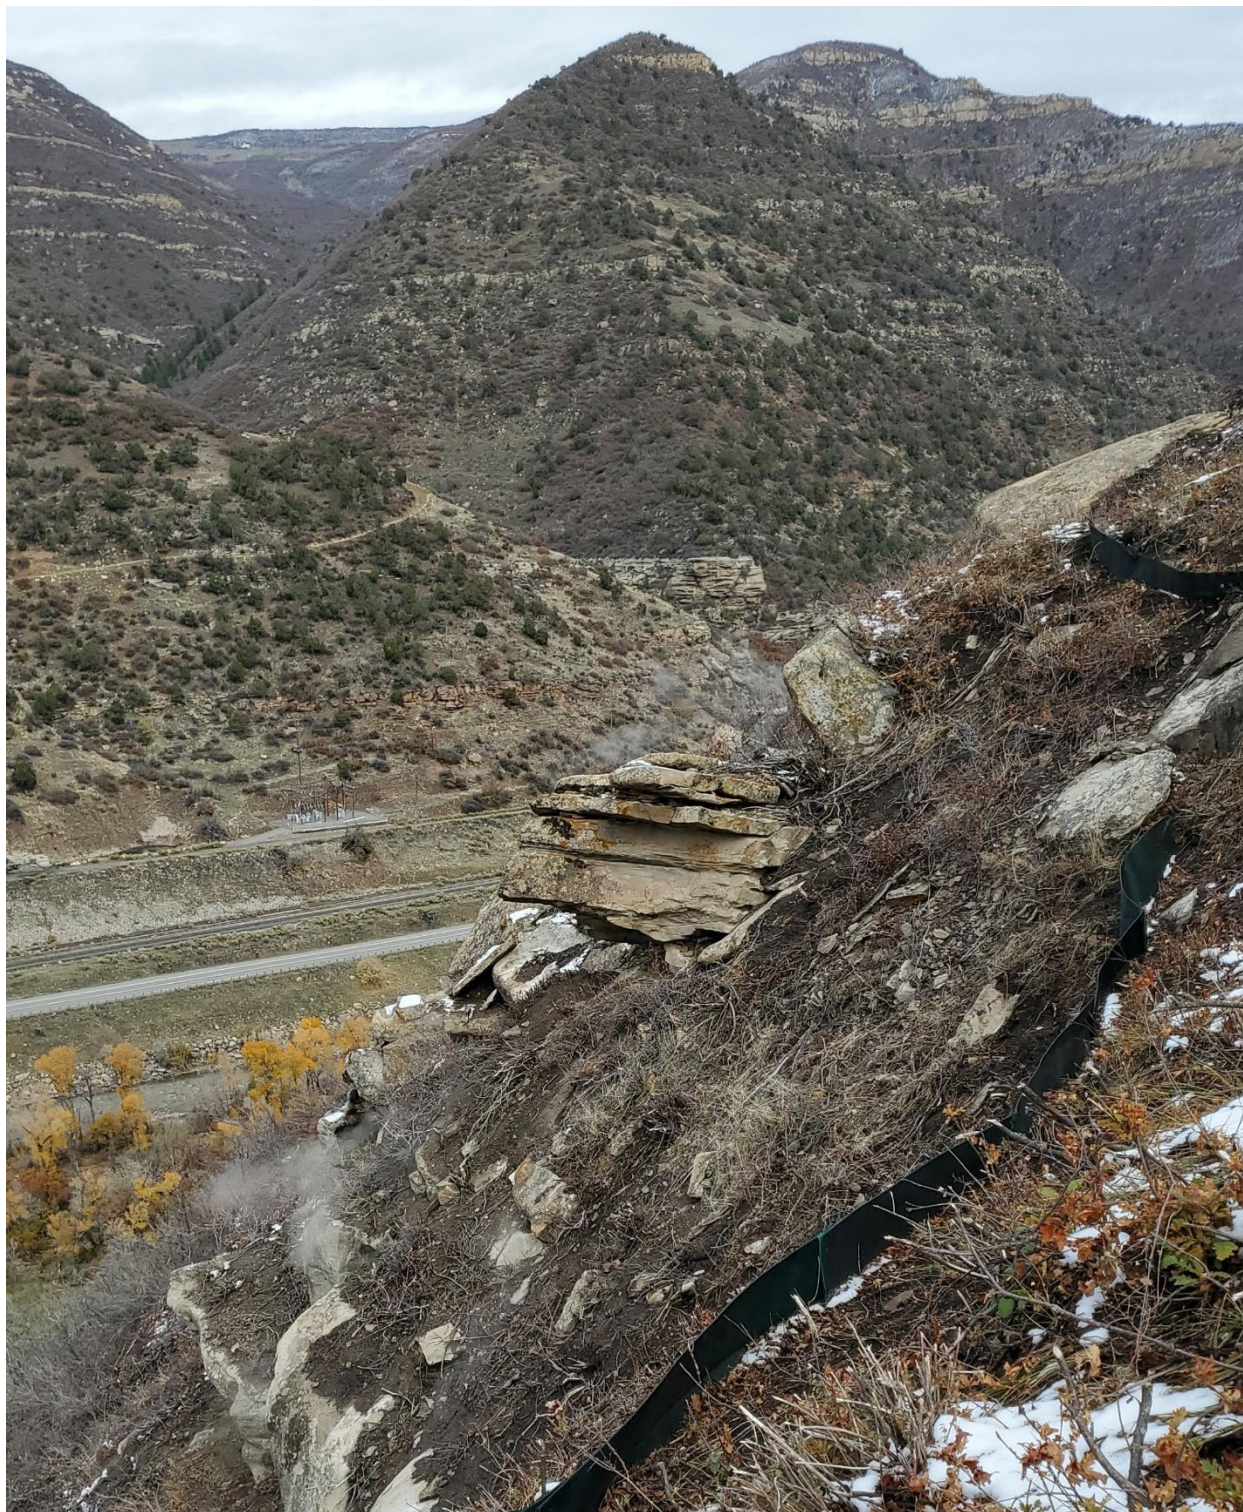
Figure 2: Vents below top of new road (1 of 2)

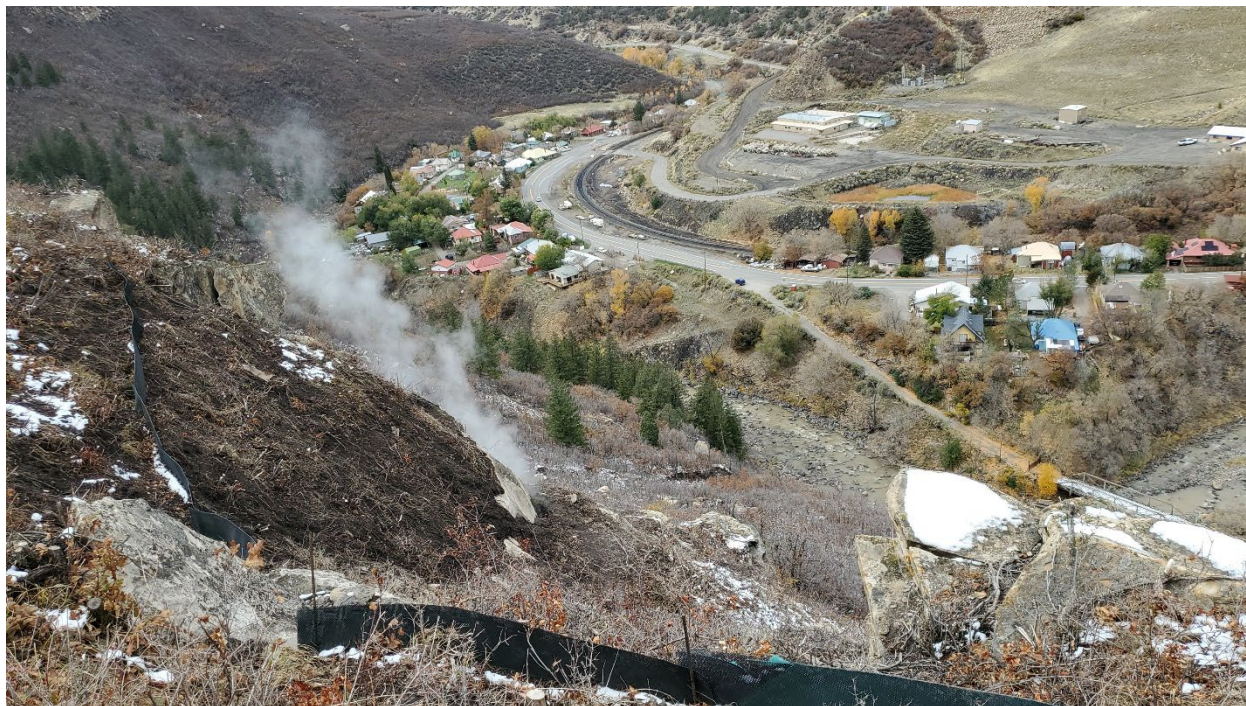
Figure 3: Vents below top of new road (2 of 2)

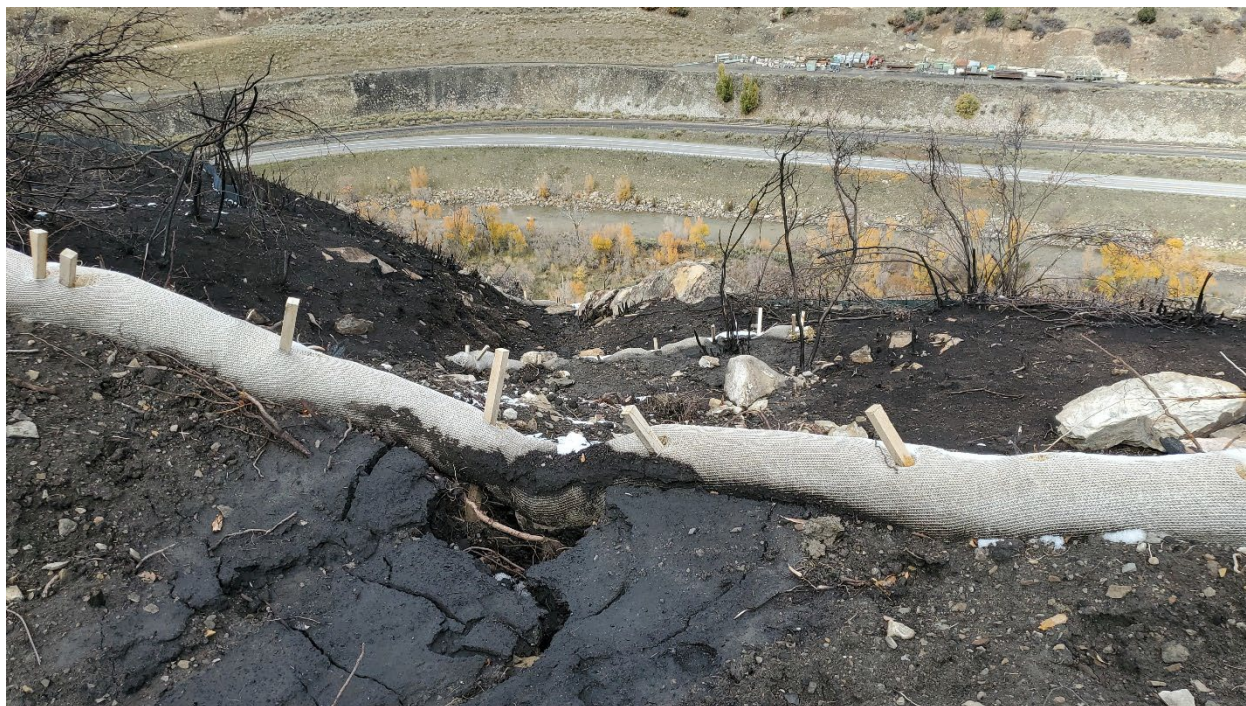
The surface of the new road was soft and muddy in the wet conditions. There were signs of some surface erosion in places, with gaps appearing under straw wattles. Some of the straw wattles also appeared to have been nibbled by animals.

Figure 4: Evidence of surface erosion

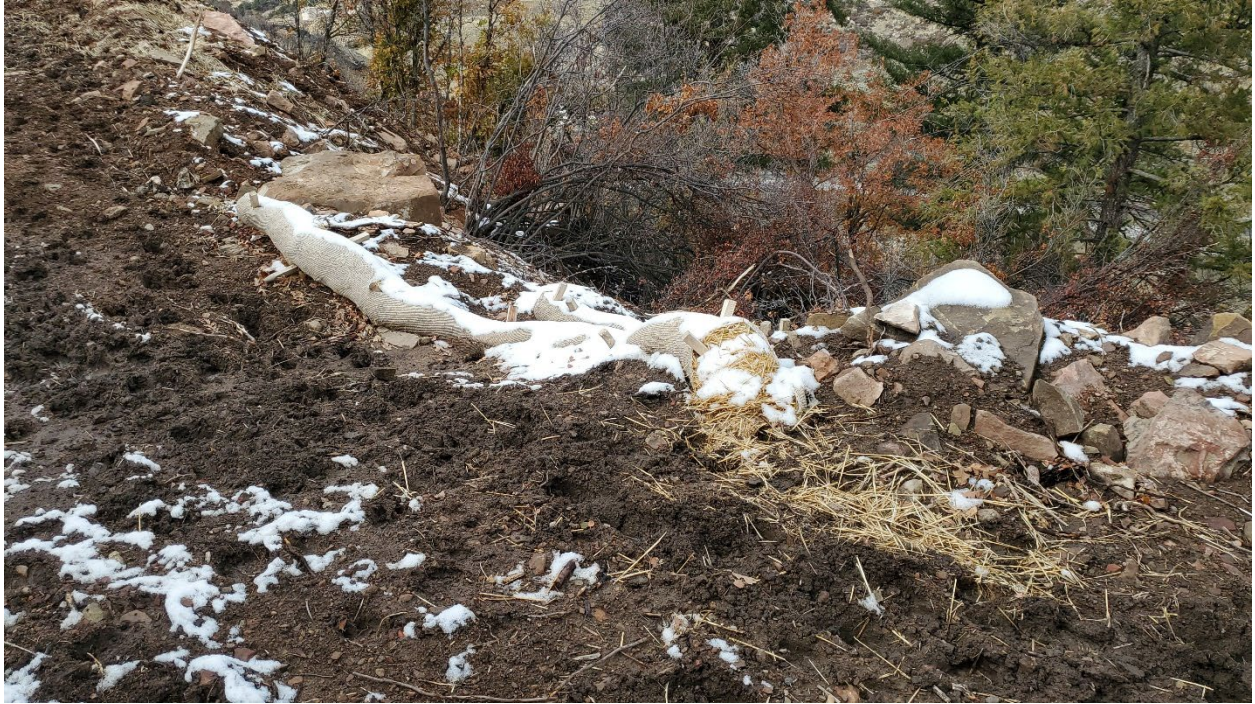
Figure 5: Straw wattle damage
