MINERALS PROGRAM INSPECTION REPORT
PHONE: (303) 866-3567

MINE NAME: Fountain Colony Pit	MINE/PROSPECTING ID#: M-1987-171	MINERAL: Sand and gravel	COUNTY: El Paso
INSPECTION TYPE: Monitoring	WEATHER: Clear	INSP. DATE: October 12, 2022	INSP. TIME: 09:15
OPERATOR: Kiewit Western Company	OPERATOR REPRESENTATIVE: Paul White & Misty Gothard	TYPE OF OPERATION: 112c - Construction Regular Operation	
REASON FOR INSPECTION: Normal I&E Program	BOND CALCULATION TYPE: Partial Bond	BOND AMOUNT: \$200,000.00	
DATE OF COMPLAINT: NA	POST INSP. CONTACTS: None	JOINT INSP. AGENCY: None	
INSPECTOR(S): Timothy Cazier, P.E.	INSPECTOR'S SIGNATURE:

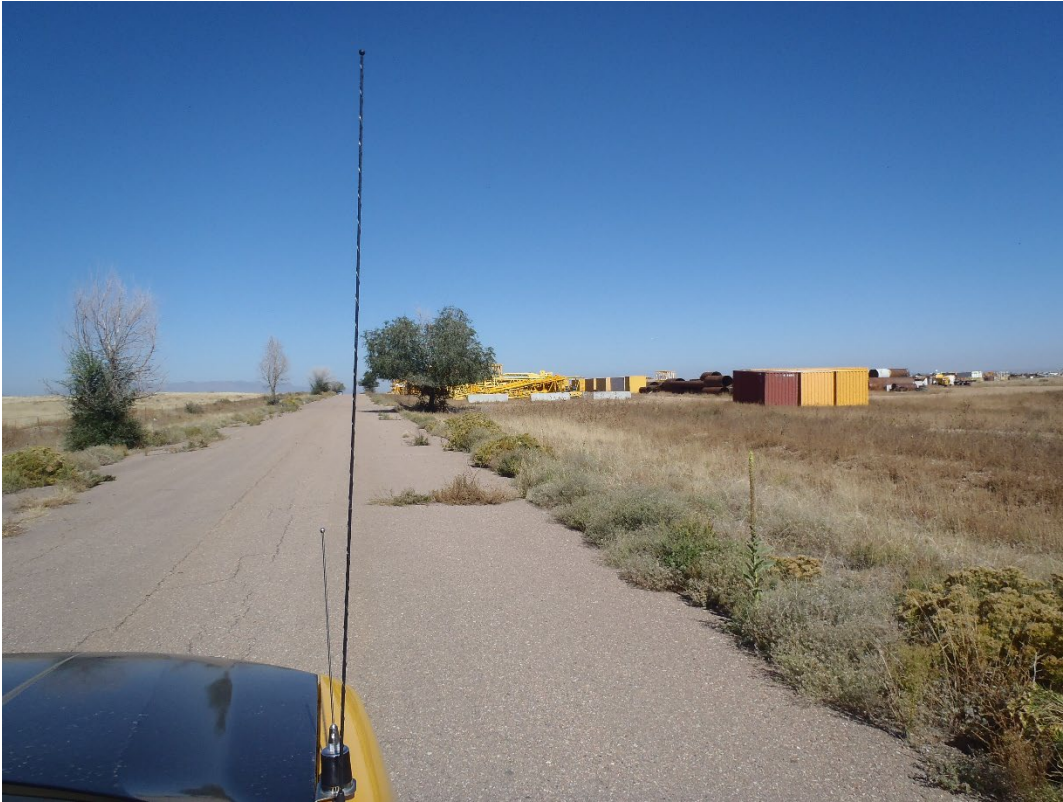
Roads: The main haul/access road is paved (see **Photo 1**) for about 1.2 miles and will remain post-reclamation. Other roads are two-track (see **Photo 2**) and consistent with either commercial/industrial or rangeland use

Photo 1. Paved access/haul road (looking NNW, note construction equipment on right).

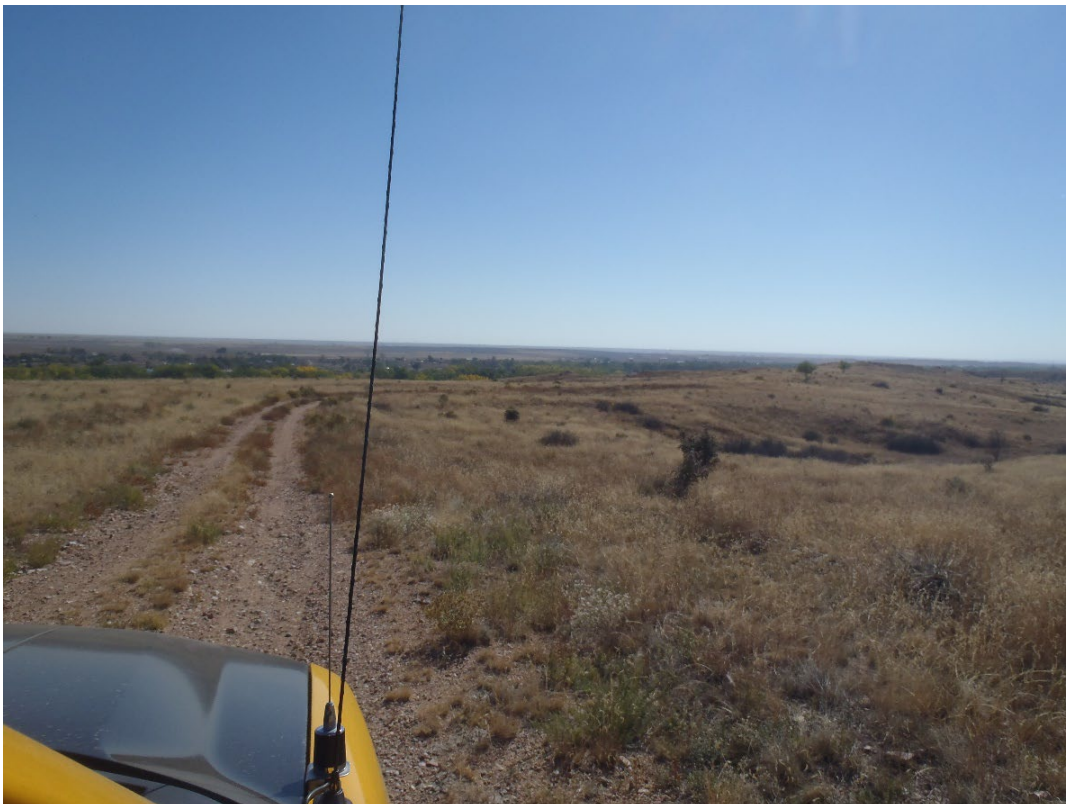
Photo 2. Two-track road in Phase III (looking SE).

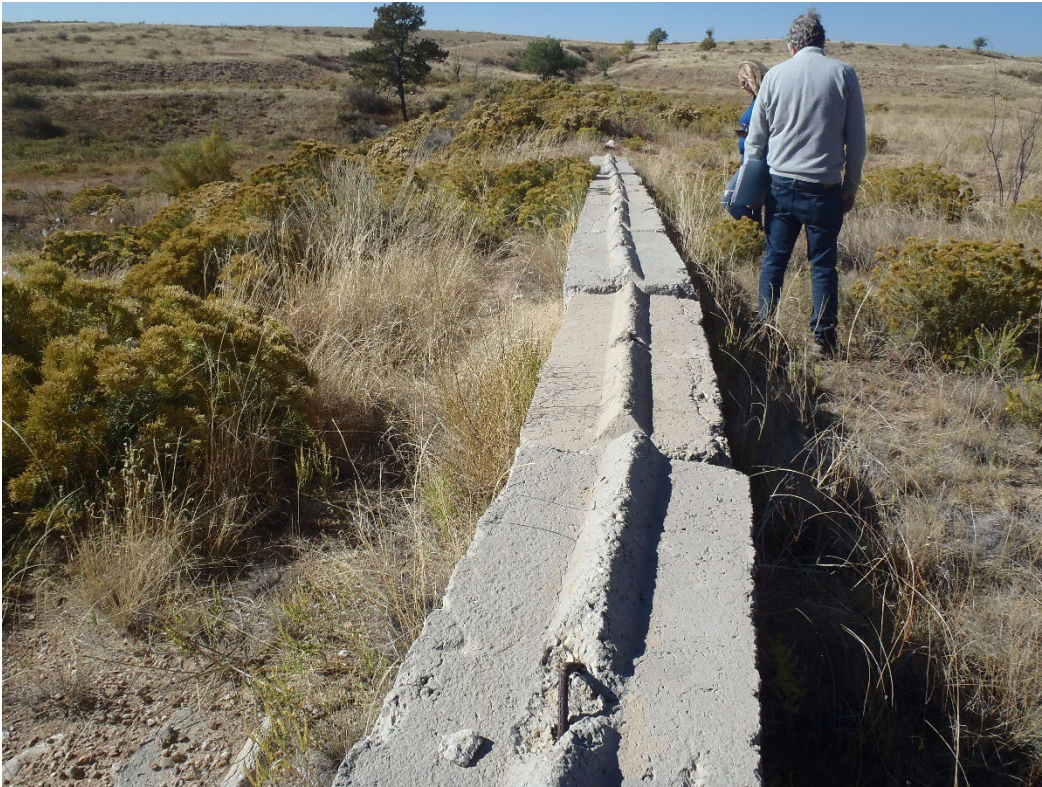
Reclamation Success: Grading, topsoiling and seeding appeared adequate. However, some stormwater controls, potentially temporary were observed including several grade control structures (see **Photos 3, 4 and 5**) and a 6-inch HDPE pipe (see **Photo 6**) daylighting near the northern-most sediment pond were observed. The mafic blocks will need to be removed prior to final release as they are not included in the approved reclamation plan. Mr. White and Ms. Gothard agreed to determine the use and disposition of the HDPE pipe.

Photo 3. Mafia blocks (looking SW, north side of northernmost sediment pond).

Post Inspection Meeting: Kiewit representatives were told with the exception of the mafia blocks, tamarisk in the third sediment pond, Russian thistle in phase V, and possibly the 6-inch HDPE pipe; the site appears to meet adequate reclamation criteria. Mr. White explained Kiewit is in the process of selling a portion of the site to a company wanting to use it for commercial/industrial use and that Kiewit desires to release this portion of the permit area. I explained that due to the unusual nature of an approved mixed post mine land use (commercial/industrial, with a rangeland backup), the DRMS will need a map delineating the commercial/industrial area from the rangeland area if the site is not released all at once. I further explained that this clarification to the permit would need to be submitted to the DRMS as a technical revision for review and approval. Ms. Gothard indicated Kiewit was considering changing the reclamation seed mix for the phase V reclamation. This should be included in the same technical revision.

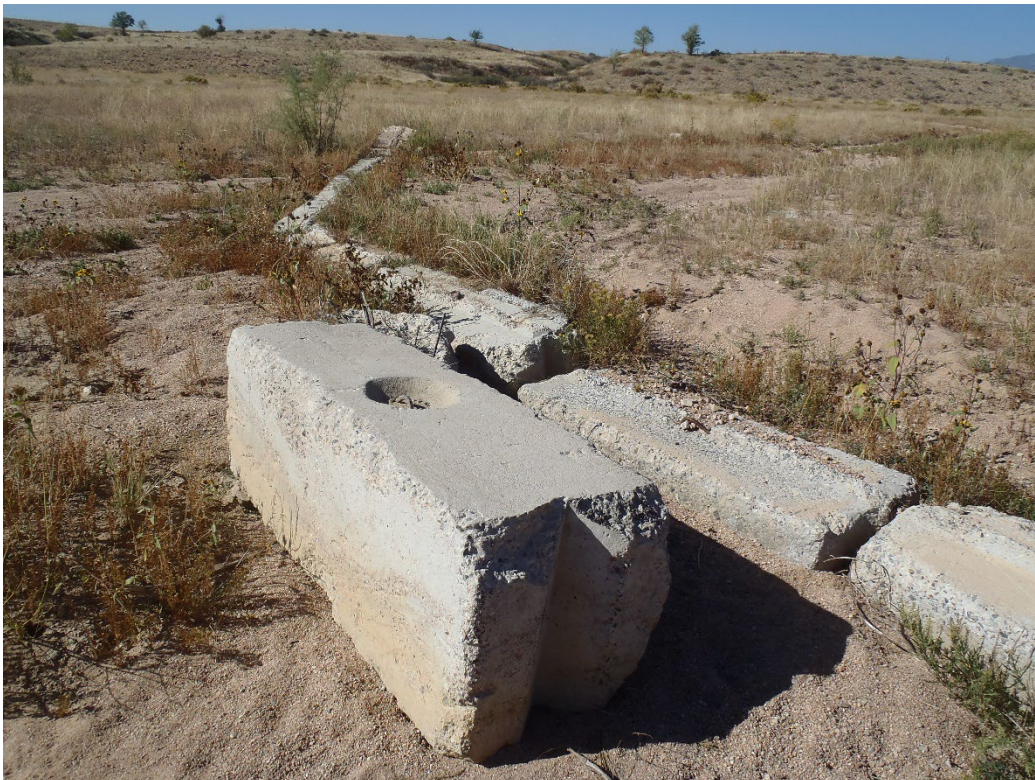
Photo 4. Mafia blocks (looking SW, ~230 feet north of blocks in Photo 3).

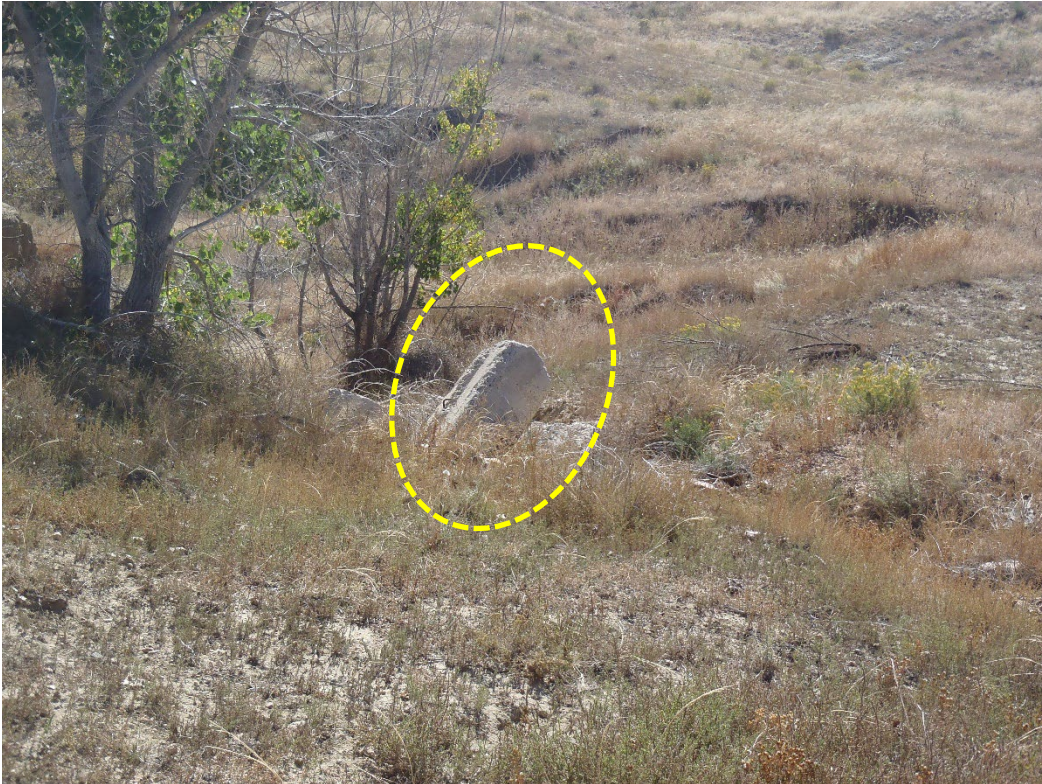
Photo 5. Mafia block (38° 39.105'N, 104° 42.317'W; looking east).

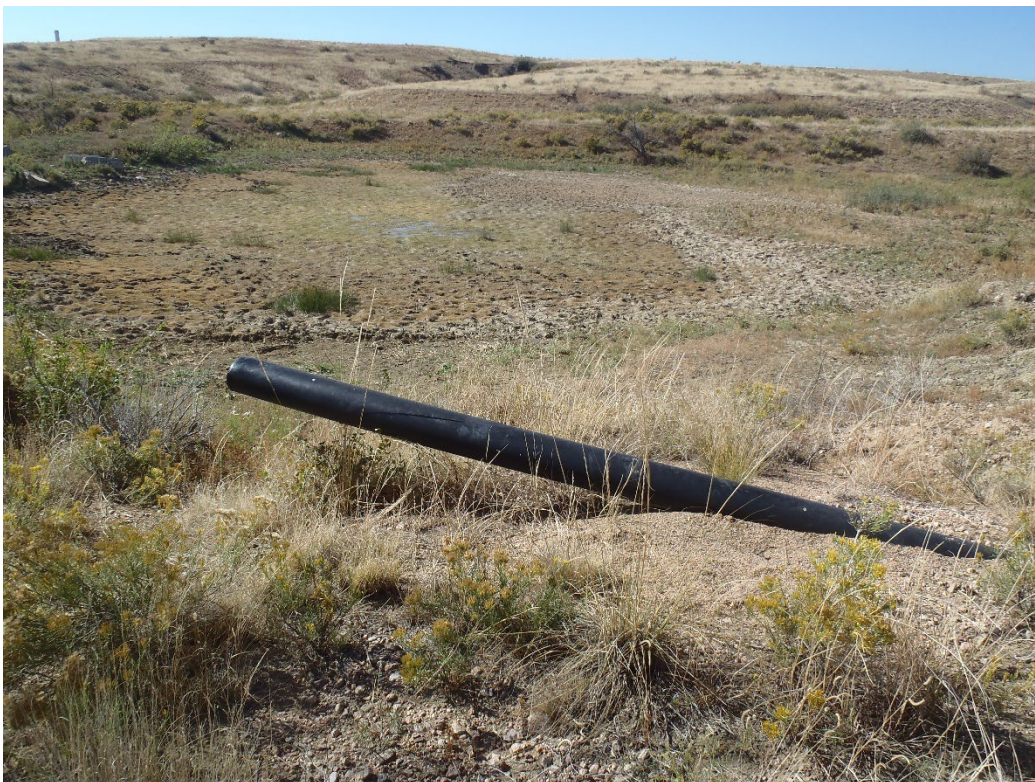
Photo 6. 6-inch HDPE pipe (looking SW, east side of northernmost sediment pond).

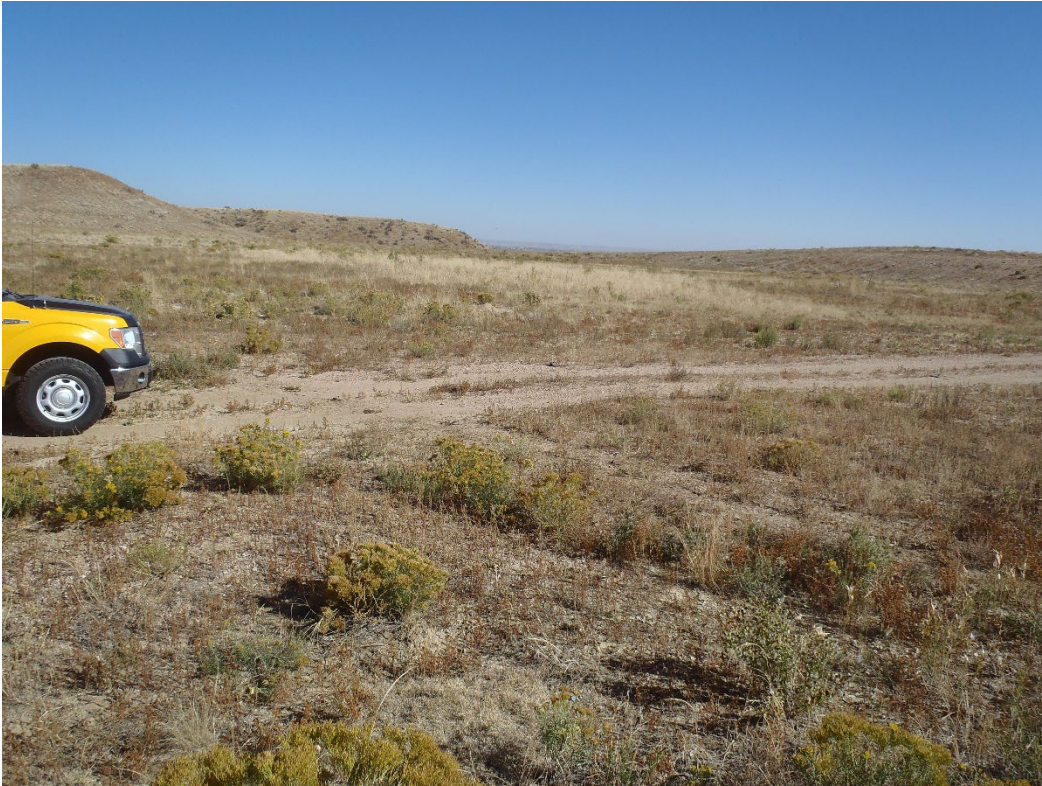
Revegetation: The vast majority of the site appeared to have well established diverse vegetation (see **Photos 7, 8 and 9**). However, a significant amount of tamarisk were observed third downstream sediment pond (see **Photo 10**). The DRMS approved a weed control plan for tamarisk as TR-3 in 2018, which Kiewit continues to implement. As the tamarisk were still being treated, the presence of the Colorado Noxious Weed List B species was not cited as a problem, but they will need to be treated prior to final reclamation release. In addition,

Photo 7. Typical established vegetation (looking NE, north side of northernmost sediment pond).

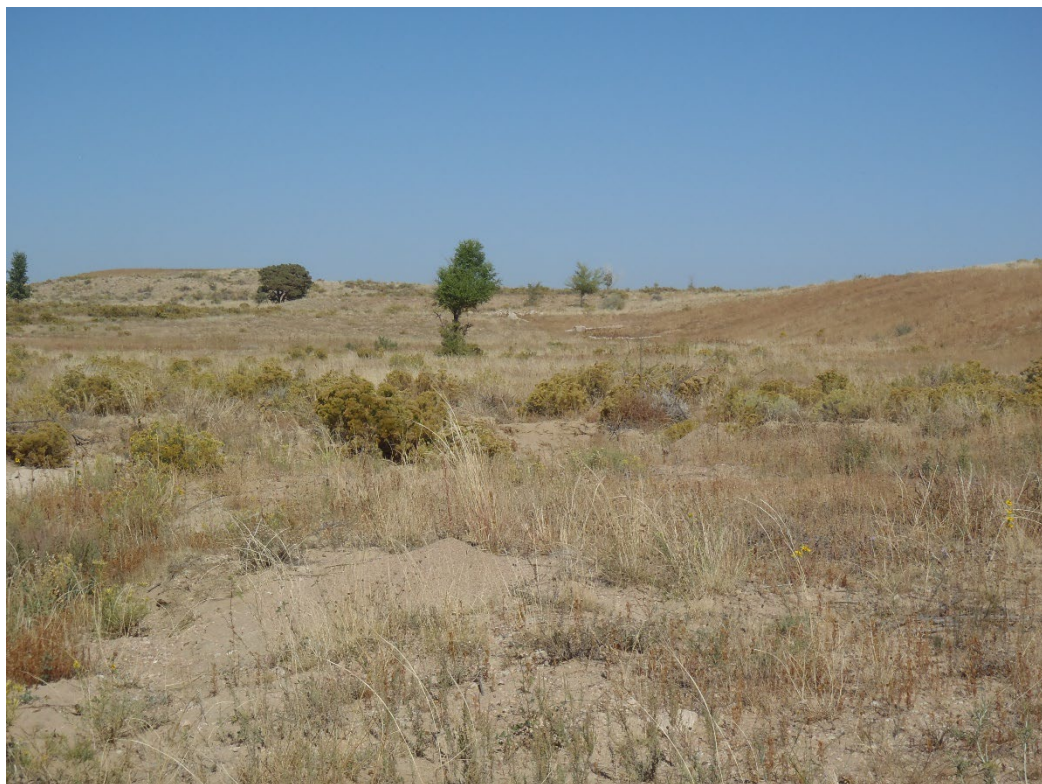
Photo 8. Typical established vegetation (looking NW, pit floor north of northernmost sediment pond).

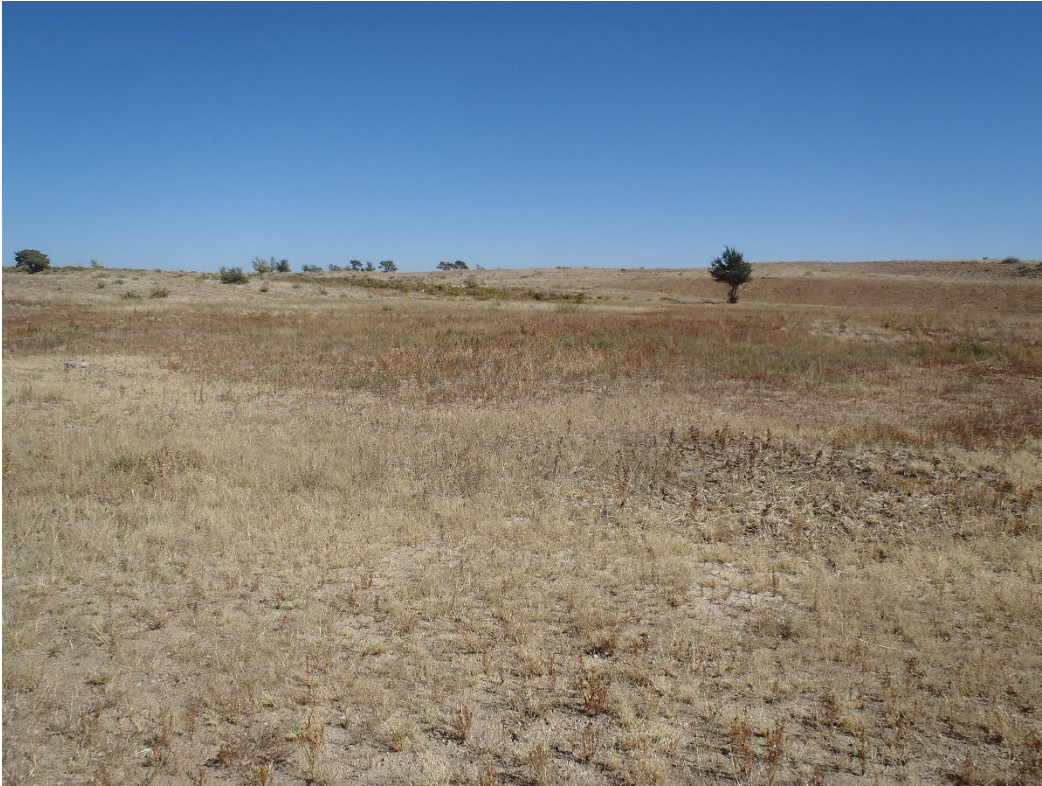
Photo 9. Typical established vegetation (looking NE, Phase III).

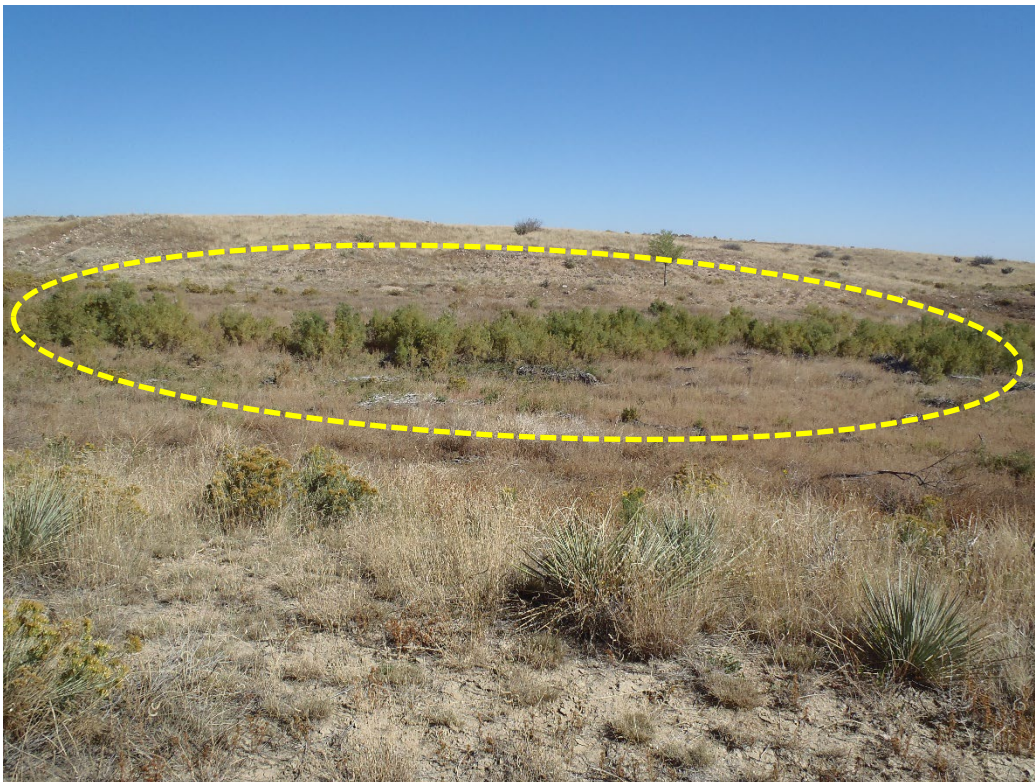
Photo 10. Tamarisk (looking east, third downstream pond: 38° 39.201'N, 104° 42.238'W).

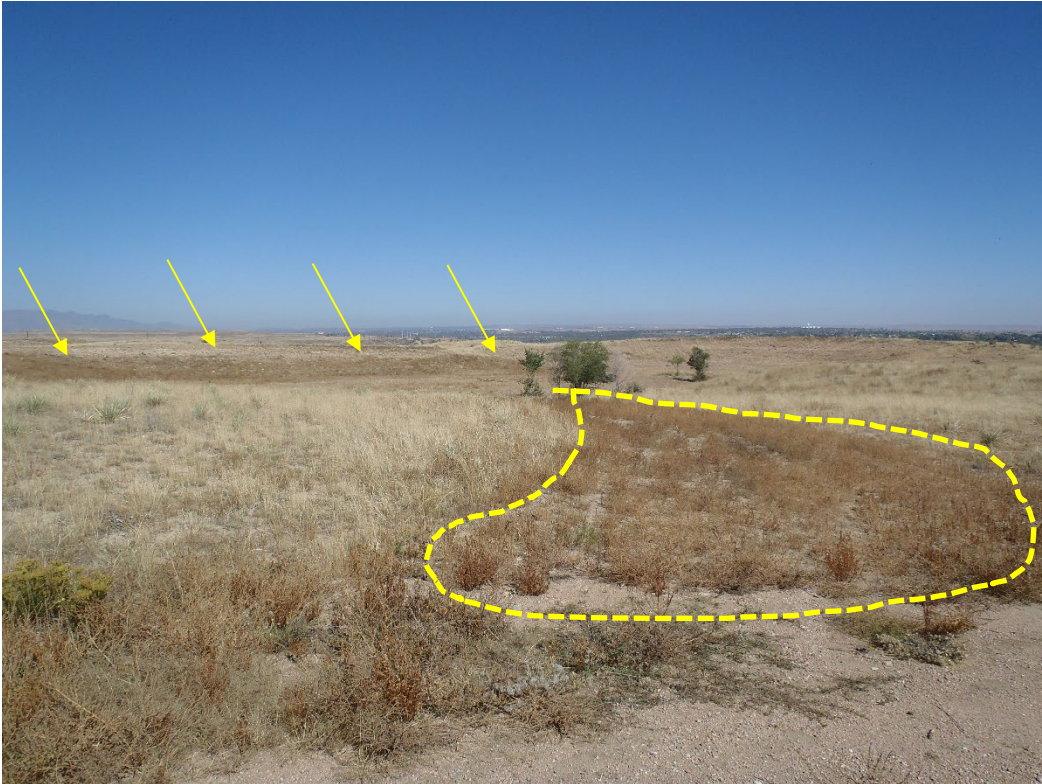
Russian thistle appeared to be the dominant species on the phase V reclaimed side slopes and access road (see **Photo 11**). Russian thistle is not a noxious weed species in Colorado, but it does not meet the criteria for diverse, long lasting cover (Rule 3.1.10(1)). As such, phase V is not releasable at this time.

Photo 11. Russian thistle on Phase V pit slope (arrows) and access road (looking north).

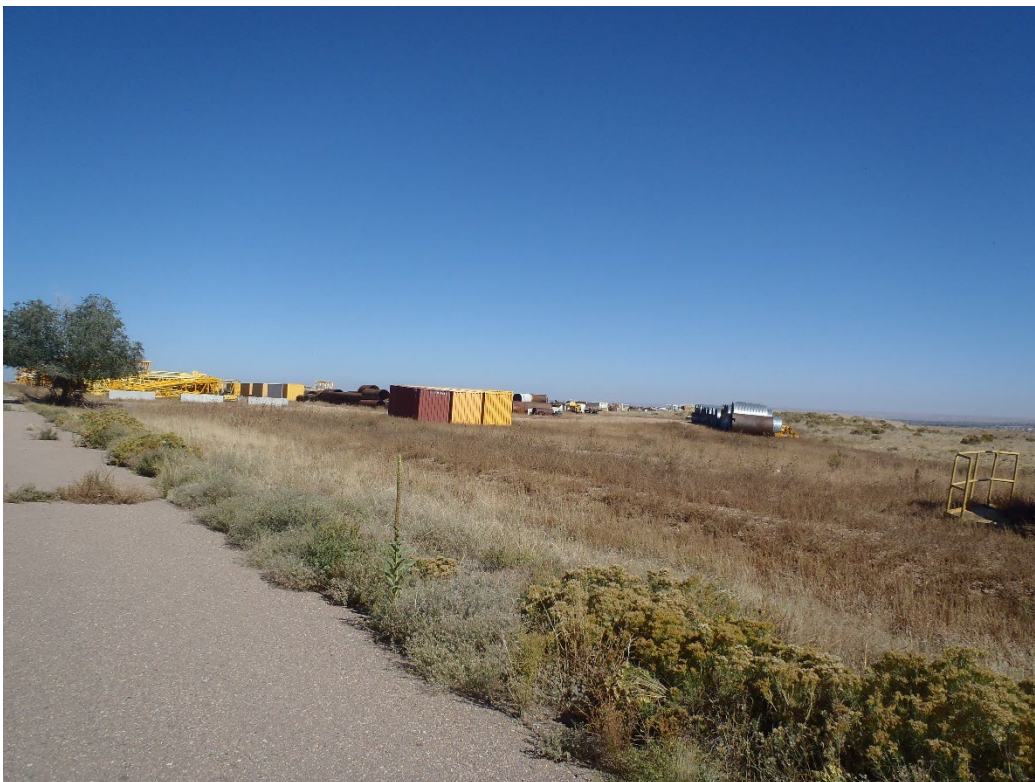
Support Facilities On-site: No processing equipment was observed on site. Kiewit was storing a considerable amount of non-mining construction equipment (see **Photo 12**). The storage of this type of equipment is allowed under the approved post mine commercial/industrial land use.

Photo 12. Equipment storage (looking north, east side of paved road).

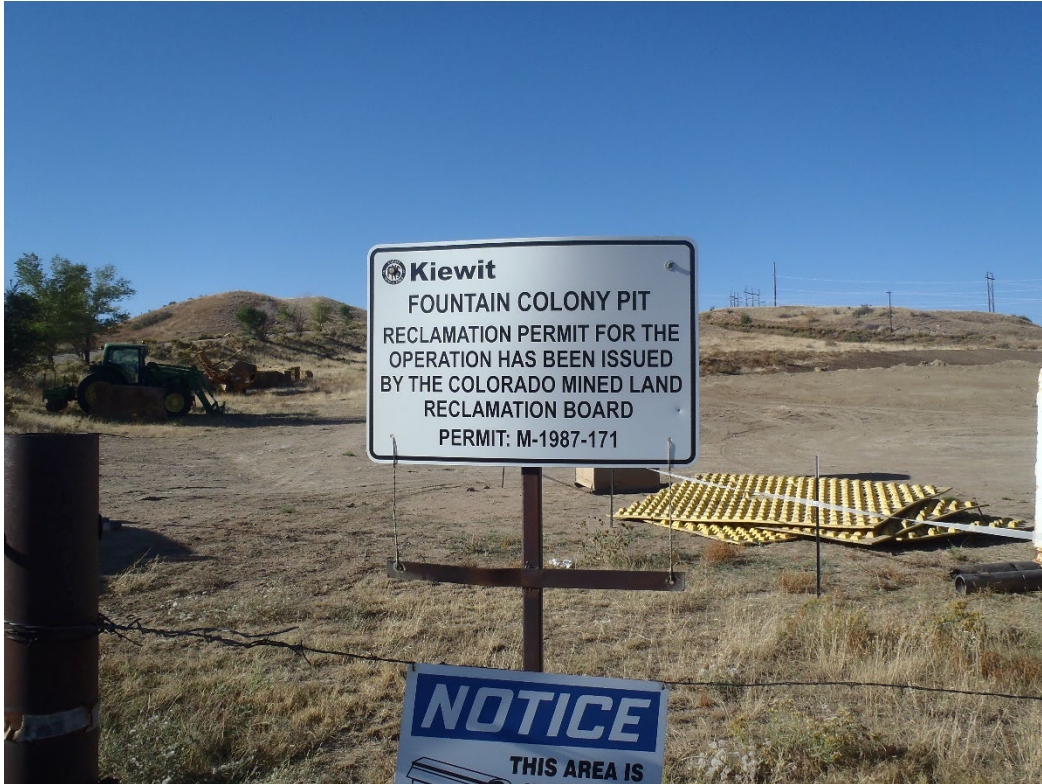
Signs and Markers: The permit sign was properly posted (see **Photo 13**) and the affected land boundary is constrained by topography within the permit area. A four strand barbed wire fence (see **Photo 14**) delineates the boundary on the west side

Photo 13. Permit sign (at entrance off Charter Oak Ranch Road).

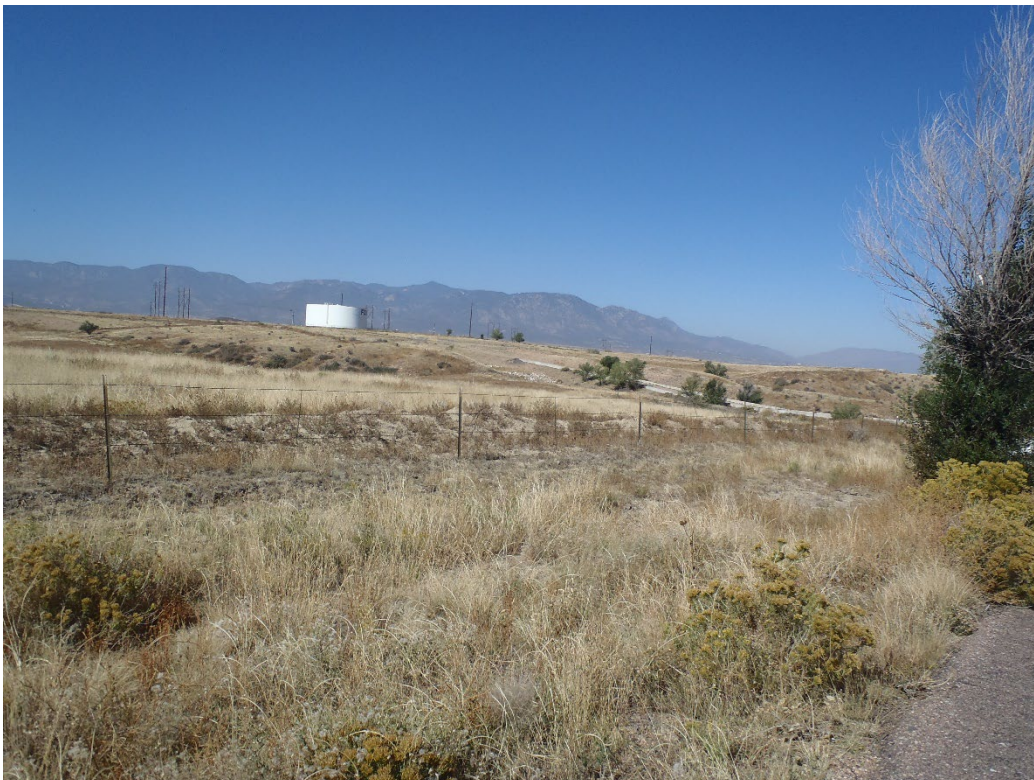
Structures: The four strand barbed wire fence on the west side of the site was the only observed structure observed within 200 feet of the affected area. Kiewit provided documentation of ownership to the DRMS subsequent to this inspection.

Photo 14. Four strand barbed wire fence (looking NW, from paved road).
