**MINERALS PROGRAM INSPECTION REPORT**  
**PHONE: (303) 866-3567**

| <b>MINE NAME:</b><br>Cresson Project | <b>MINE/PROSPECTING ID#:</b><br>M-1980-244 | <b>MINERAL:</b><br>Gold and silver | <b>COUNTY:</b><br>Teller |
| <b>INSPECTION TYPE:</b><br>Monitoring | <b>WEATHER:</b><br>Clear | <b>INSP. DATE:</b><br>May 26, 2022 | <b>INSP. TIME:</b><br>09:00 |

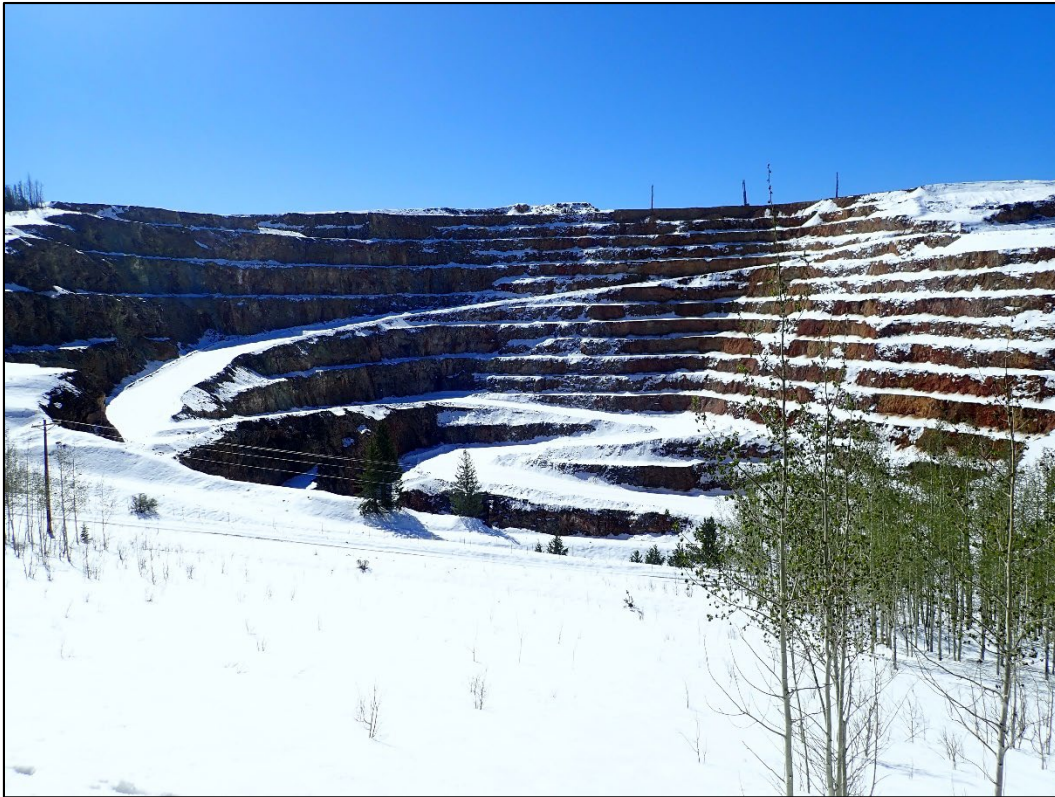
**Photo 1.** Globe Hill Pit as viewed from the CR82; looking southeast.

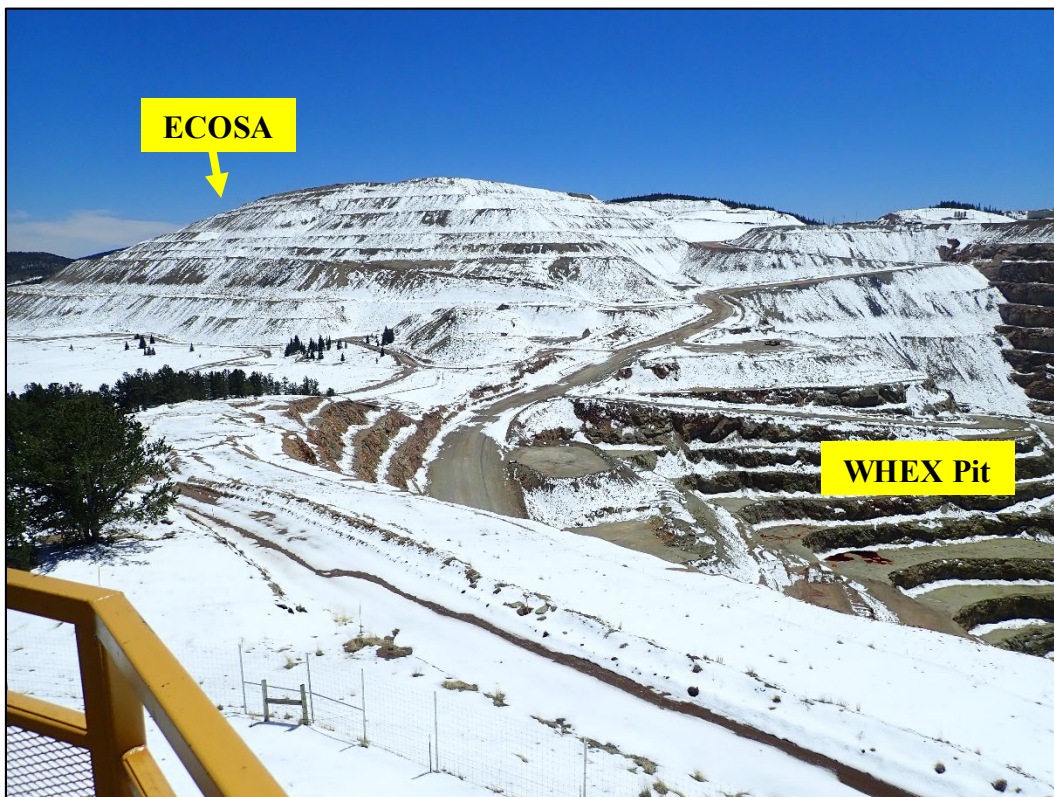
The ECOSA (see **Photo 2**) is one of two large waste rock piles that the Operator places overburden on that is not economically feasible to process for gold extraction. The ECOSA is located in the northeastern portion of the permit. The Operator accompanied the Division to the two seep areas located along the eastern and northern toe of the ECOSA. The first seep's sump area, which collects water from the oldest seep identified in 2017 and is located furthest to the south, was holding water during the inspection (see **Photo 3**). Based on the Operator's staff gauge, the water level appeared to be a little more than 2 feet below the highest marker. Due to heavy and wet overnight snow accumulation and a rapid morning melt event, water was observed flowing into the sump from the south. The second seep's sump area, which collects water from the newest seep identified in 2021 is located approximately 2,500 feet northwest of the older seep, was also holding water during the inspection. No staff gauge was present in either of the two sumps at the second seep area. The sump located outside of the ECOSA toe berm was nearly full (see **Photo 4**) while the smaller sump, located inside of the toe berm, didn't

**Photo 2.** Western portion of the ECOSA as viewed from the Grassy Valley Overlook along CR82; looking southeast.

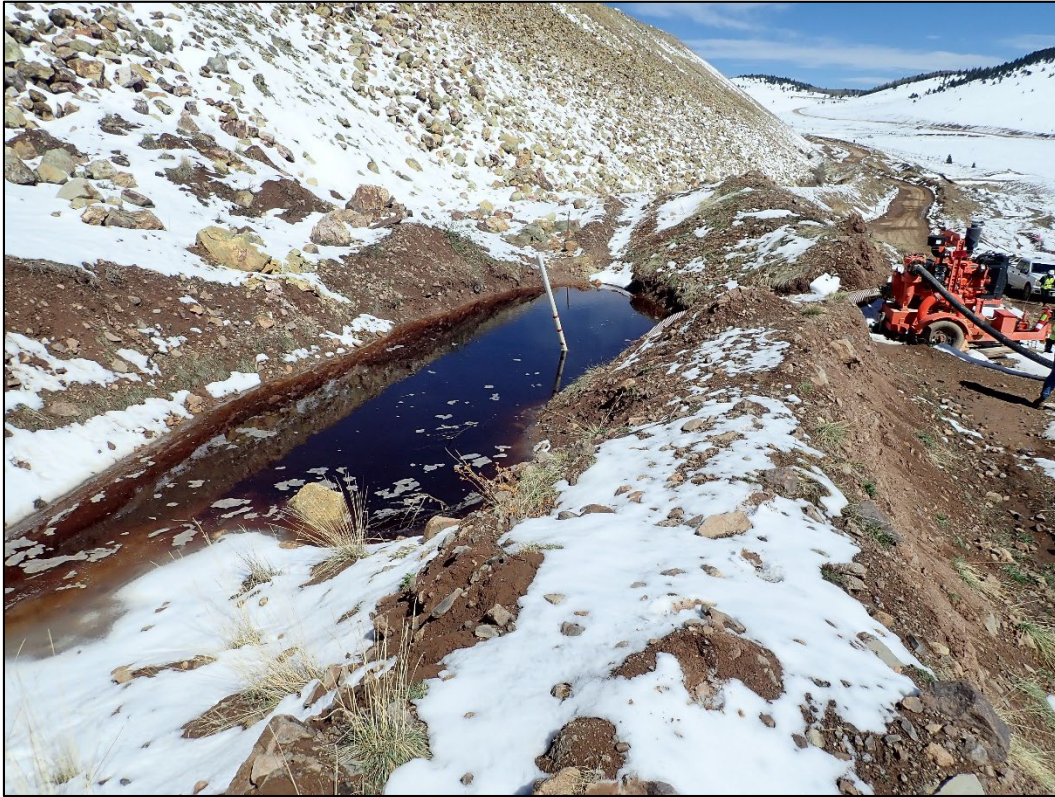
**Photo 3.** Southern seep collection sump; looking northwest.

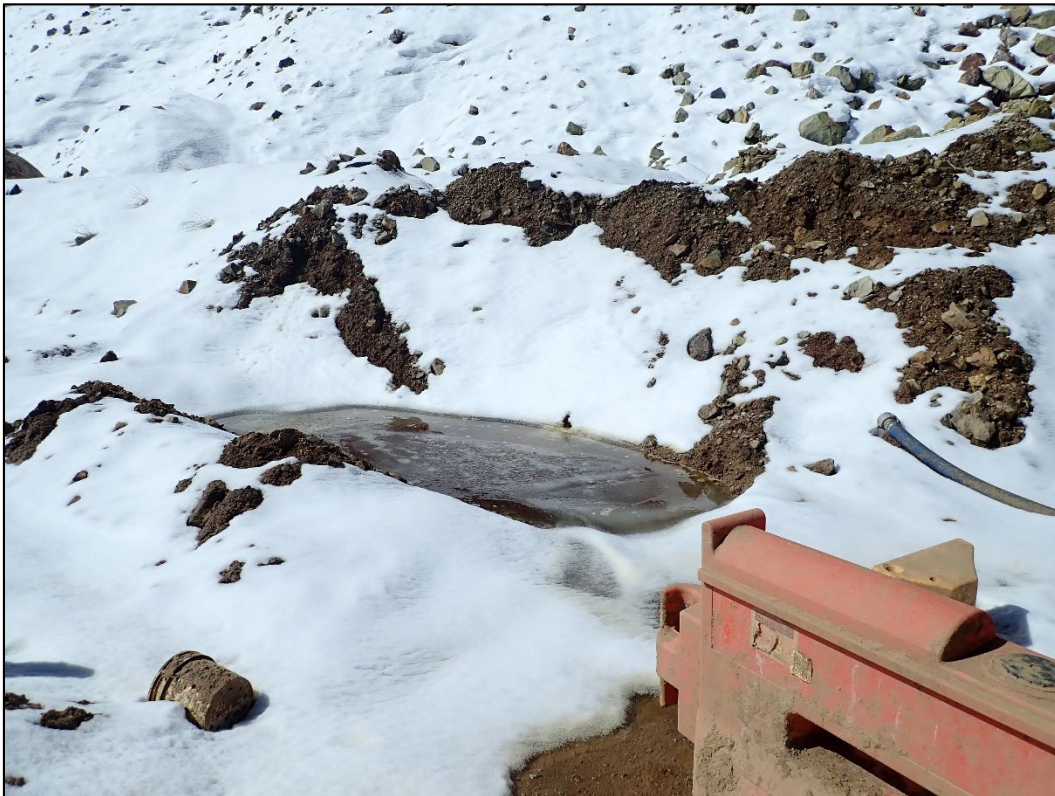
**Photo 4.** Northern seep collection area, sump outside of toe berm; looking southeast.

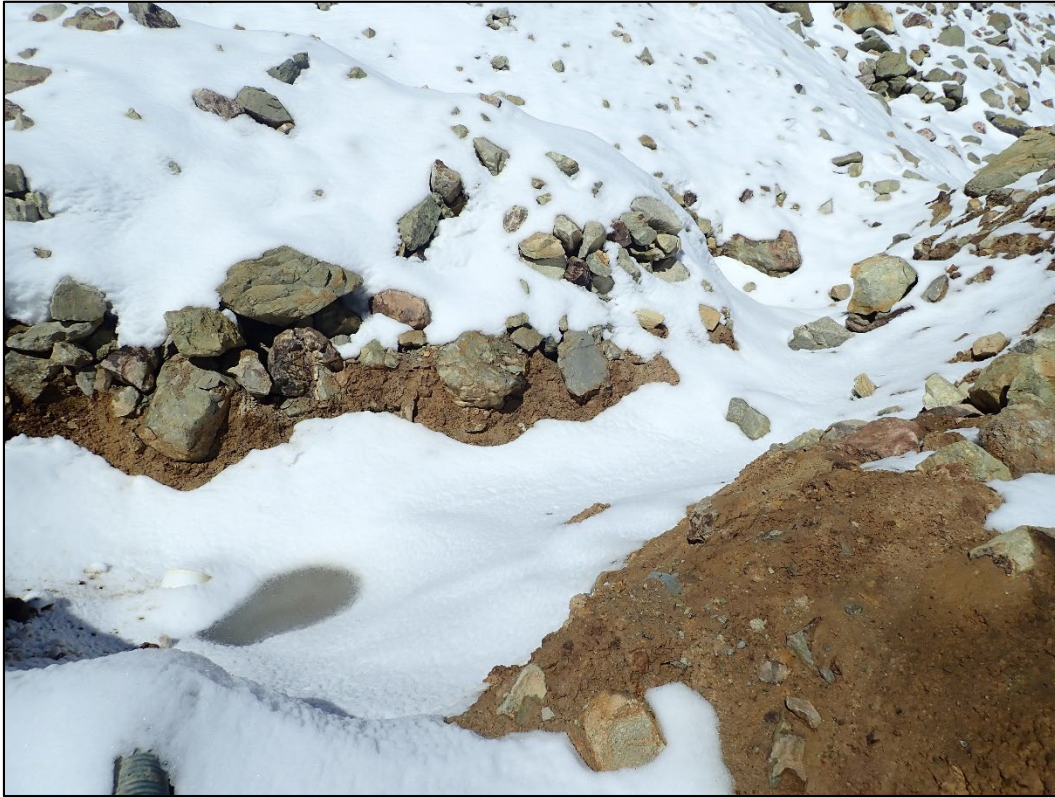
appear to holding water, however the snow accumulation made it difficult to determine (see **Photo 5**). The Operator checks the level of all of the seep sumps each shift and when needed, pumps the collected water and then transports it onto one of the lined valley leach facilities.

**Photo 5.** Northern seep collection area, sump inside of toe berm; looking southwest.

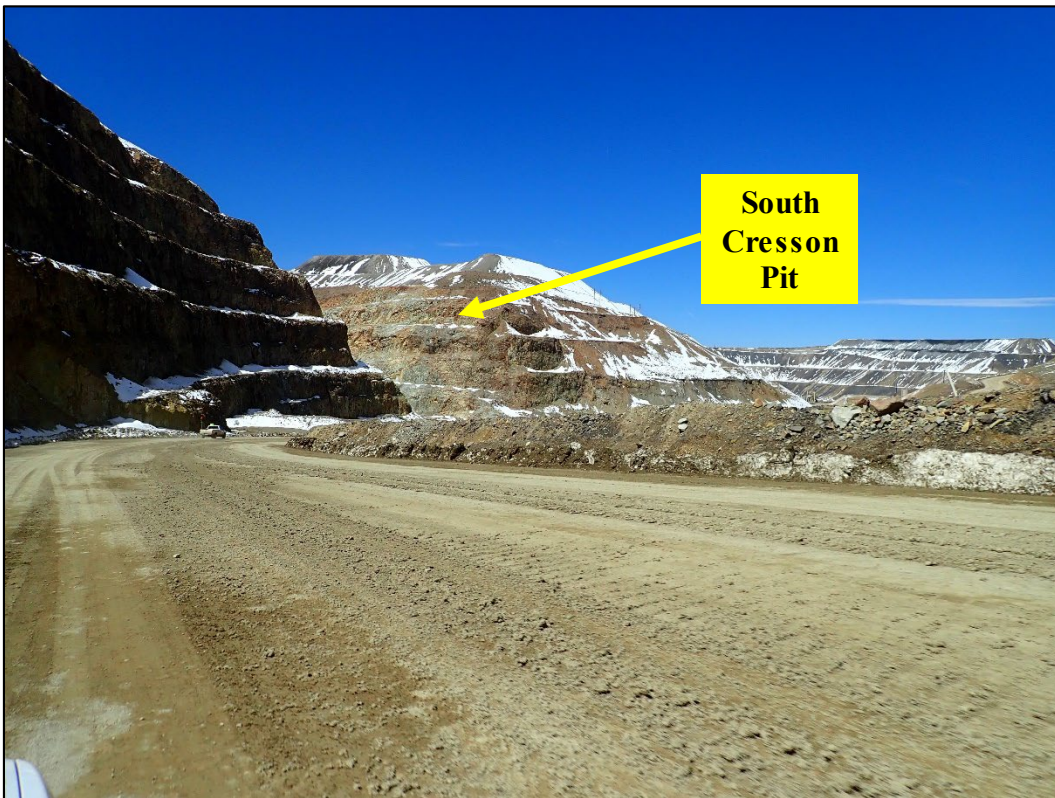
The South Cresson Pit is located in the southern portion of the permit and is connected to the Main Cresson Pit by a notch on the south side of the Main Cresson Pit (see **Photo 6**). The Operator accompanied the Division to an area above the southeast corner of the South Cresson Pit which was actively being mined at the time of the inspection (see **Photo 7**). The Operator stated the current pit floor is split between two benches with elevations of 9,775' and 9,815'. The Division observed the area of the highwall where a small bench failure had occurred and where the Operator was utilizing a truck tire berm to prevent sloughed rock from continuing down the highwall into the work area (see **Photo 8**). This area has previously been inspected by the Division and is no longer a concern as the Operator plans to mine through this area in Phase 2 of the South Cresson Pit mine plan.

**Photo 6.** South Cresson Pit's notch from the Main Cresson Pit; looking southwest.

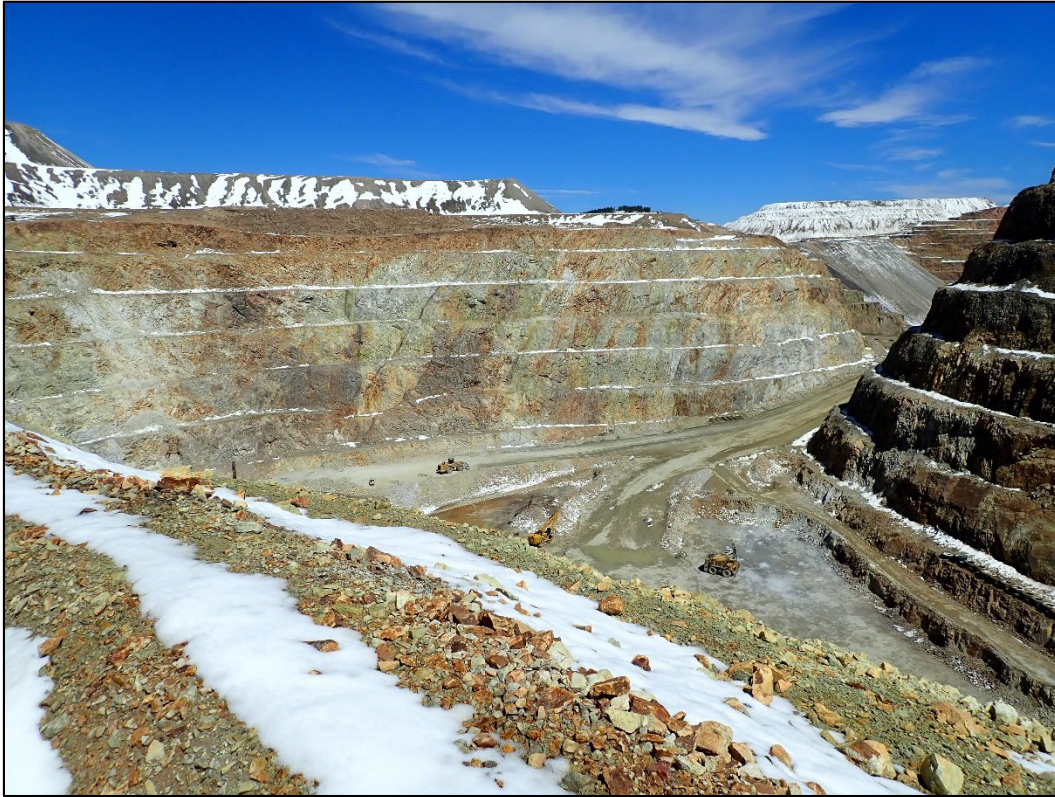
**Photo 7.** South Cresson Pit overview; looking northwest.

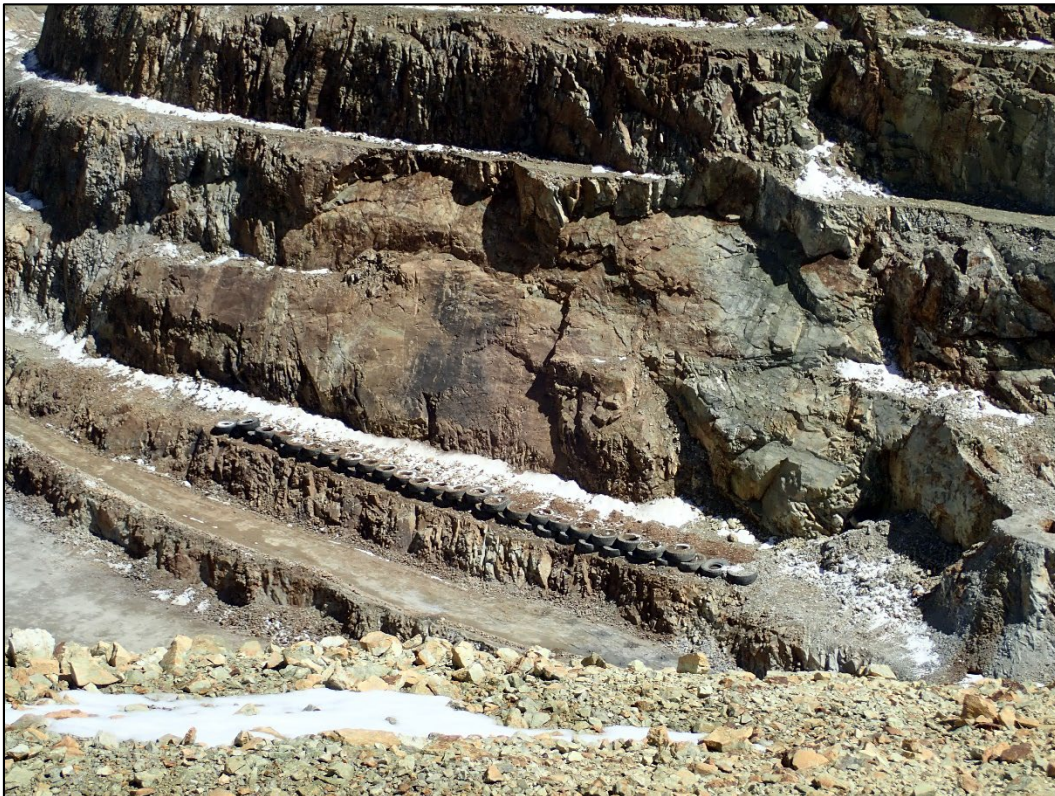
**Photo 8.** Truck tire berm below South Cresson bench failure; looking north.

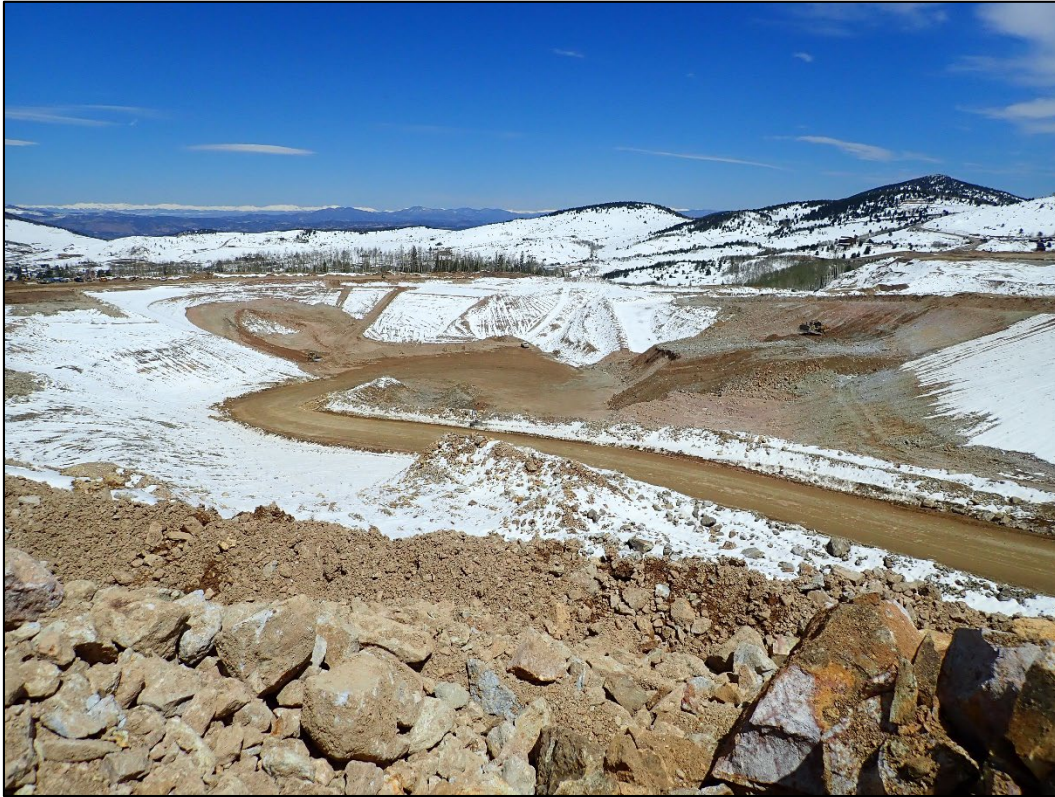
**Photo 9.** Schist Island Pit backfill area, Phase 3 VLF2 PSSA subgrade work occurring; looking northwest.

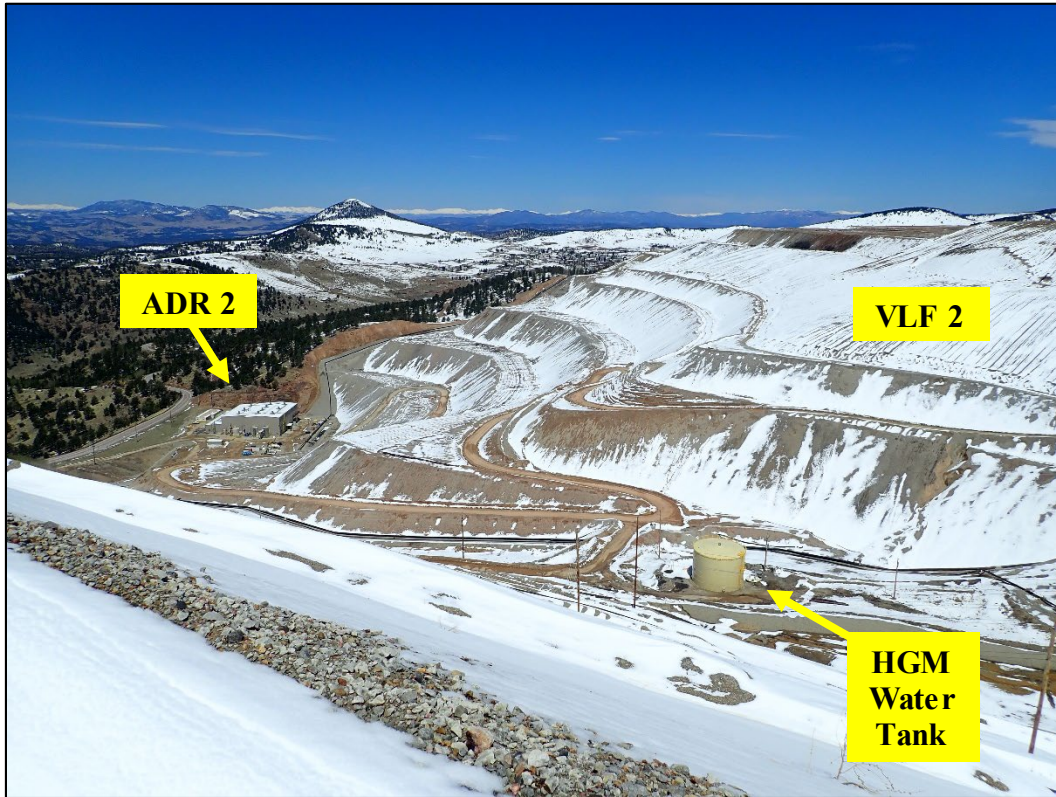
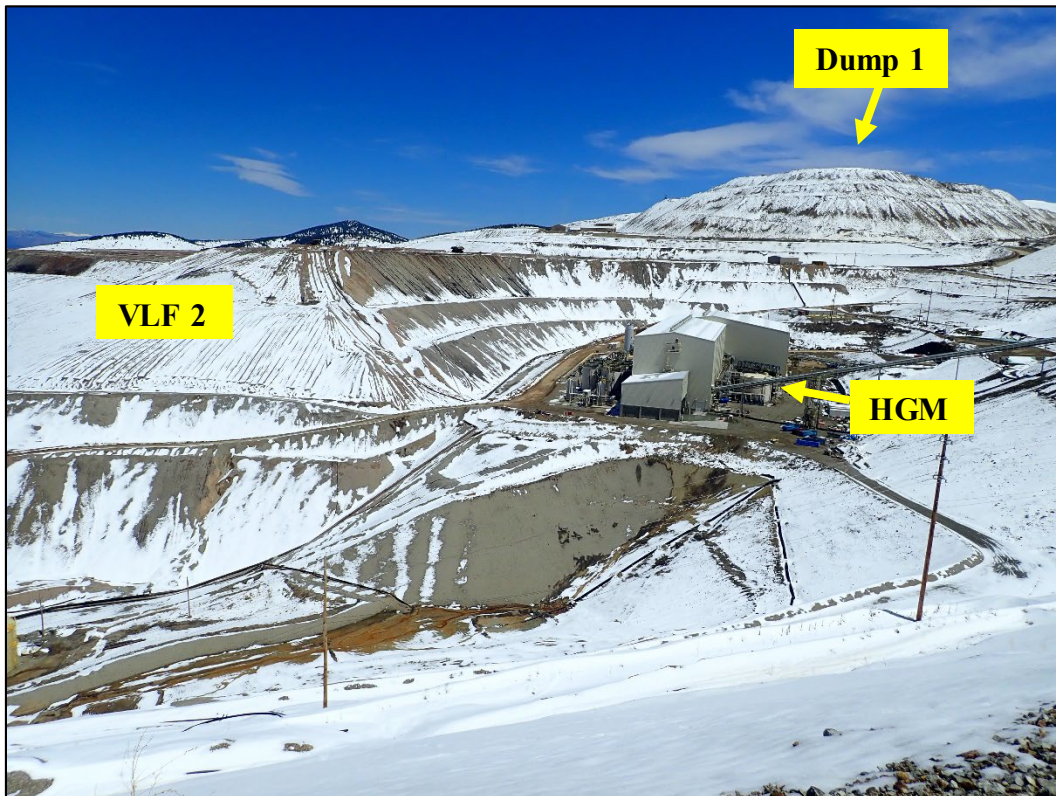
The Operator accompanied the Division to an area on the north side of VLF1 which allows an overview of VLF2 (see **Photos 11 & 12**). The Operator was actively placing ore on VLF2 at the time of the inspection. The Operator stated the current VLF2 stacking elevation was 10,100'.

**Photo 11.** VLF 2 overview; looking northwest.

**Photo 12.** VLF 2 overview; looking north.

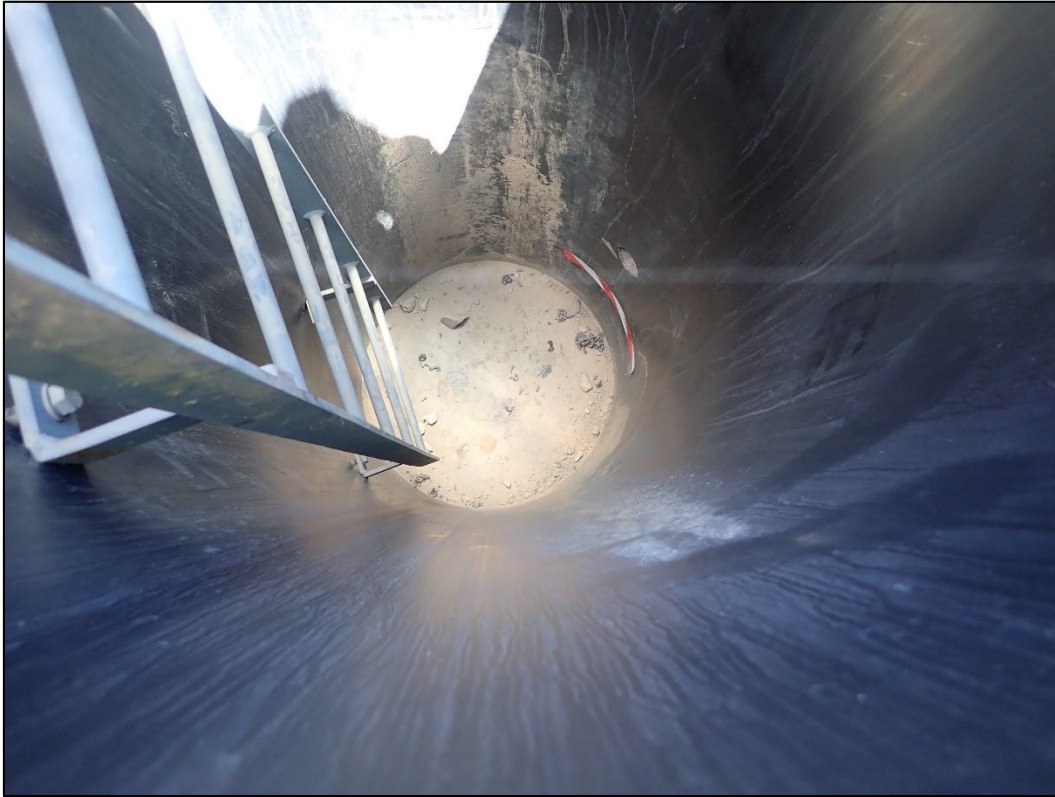
The Division then inspected the VLF2 Leak Detection Sump (LDS) 3, located just northeast of the High Grade Mill water tank between VLF1 and VLF2. LDS 3 was dry at the time of the inspection (see **Photo 13**). In accordance with TR127, the Operator has installed a piece of red reflective tape at the 1-foot level in the sump which is the level that triggers the Operator to pump and sample the fluid that the leak detection trench collects and reports to the sump. The Operator showed the Division a copy of a field data sheet which demonstrated compliance with the weekly monitoring program as the Operator had last inspected LDS 3, including the remaining 3 VLF2 LDSs and 15 VLF1 LDSs, on May 19, 2022; LDS 3 was marked as No Water Observed during that monitoring inspection.

**Photo 13.** VLF2 LDS 3; looking down.
