MINERALS PROGRAM INSPECTION REPORT
PHONE: (303) 866-3567

MINE NAME: Moonscape Pit	MINE/PROSPECTING ID#: M-1997-027	MINERAL: Sand and gravel	COUNTY: Delta
INSPECTION TYPE: Monitoring	WEATHER: Cloudy	INSP. DATE: October 25, 2022	INSP. TIME: 13:40
OPERATOR: Gray Rock Aggregate Company, LLC	OPERATOR REPRESENTATIVE: Chauncey Luttrell	TYPE OF OPERATION: 112c - Construction Regular Operation	
REASON FOR INSPECTION: Normal I&E Program	BOND CALCULATION TYPE: None	BOND AMOUNT: \$32,183.00	
DATE OF COMPLAINT: NA	POST INSP. CONTACTS: None	JOINT INSP. AGENCY: None	
INSPECTOR(S): Robert Zuber, P.E.	INSPECTOR'S SIGNATURE:

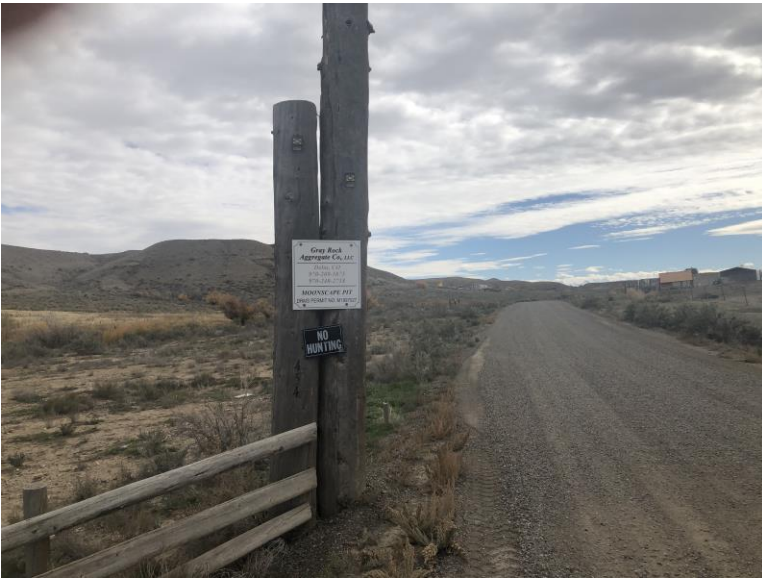
A sign at the entrance off of Sundown Road is in accordance with Rule 3. 1.12(1).

Entrance sign

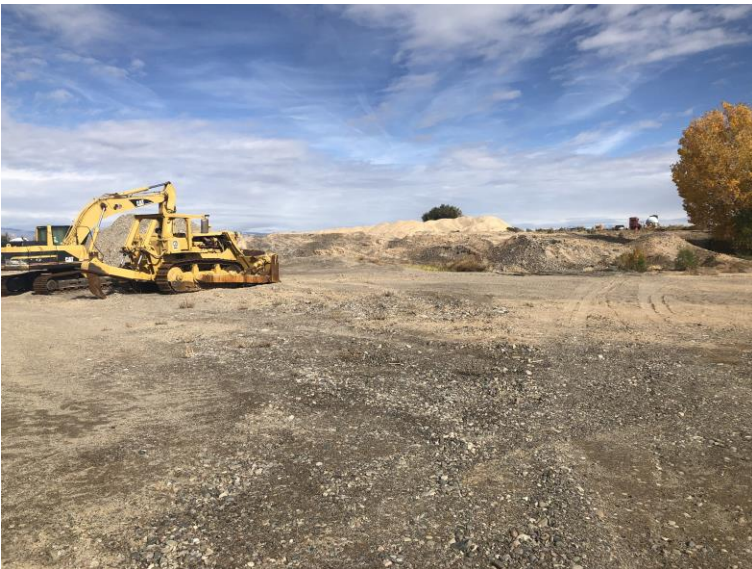
The stockpiles of material appear to be stable. Small amounts of crushed glass are stored onsite, per the permit. This material is to be used in road base.

Caterpillar equipment onsite (excavator and dozer) was not operating during the inspection. Mr. Luttrell indicated that little excavation has been done in recent months. He said that average production is 25,000 cubic tons per year.

Material piles and equipment

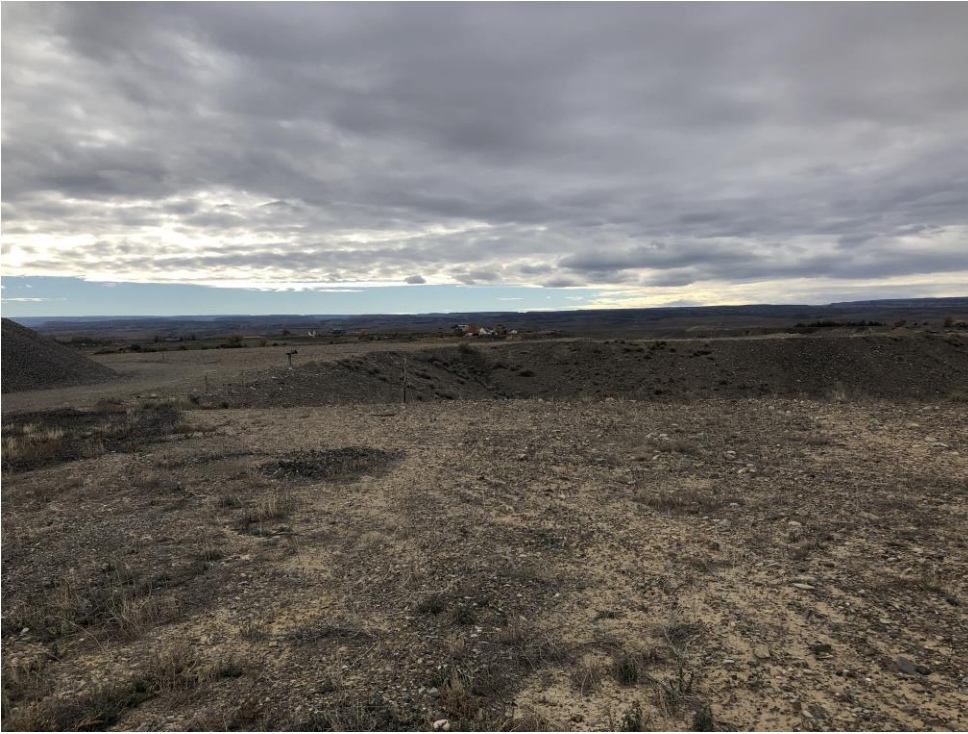
This site is permitted for 21.65 acres. The approved post-mining land use is cropland and pastureland. Approximately five acres are currently disturbed by mining activity and require reclamation. Some of the site (western portion) has been reclaimed, although vegetation is sparse in these areas.

Reclaimed area
