MINERALS PROGRAM INSPECTION REPORT

MINE NAME: Warren Gravel Pit	MINE/PROSPECTING ID#: M-2012-024	MINERAL: Gravel and sand	COUNTY: Delta
INSPECTION TYPE: Monitoring	WEATHER: Raining	INSP. DATE: October 26, 2022	INSP. TIME: 08:05
OPERATOR: Whitewater Building Materials Corporation	OPERATOR REPRESENTATIVE: Mark Gardner	TYPE OF OPERATION: 112c - Construction Regular Operation

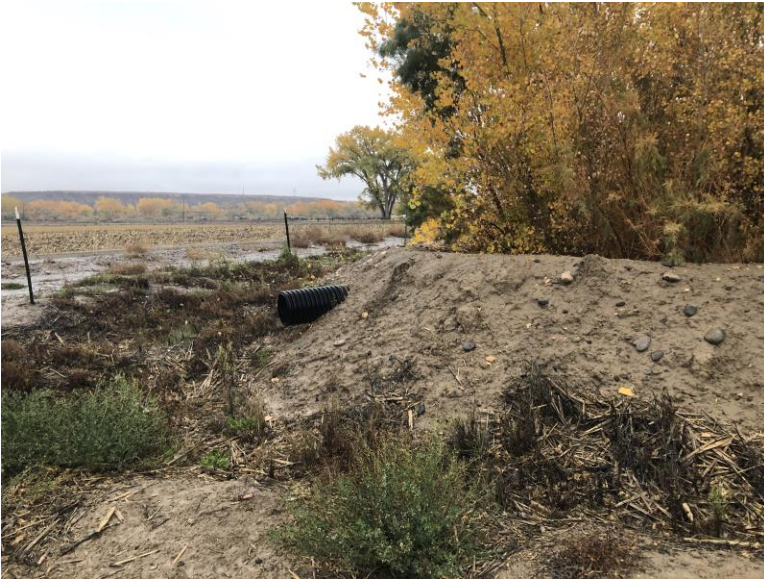
There was no sign of sediment or other pollutant loading to adjacent lands. Runoff from the site did not appear to be causing erosion. The discharge point (CDPS outfall) was not flowing, and there was no sign of recent discharge.

Discharge point from disturbed area

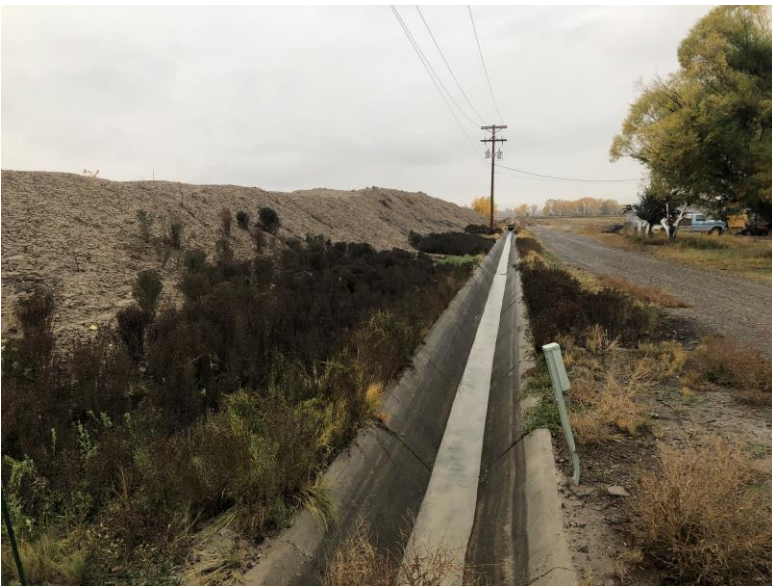
Looking west from northeast corner

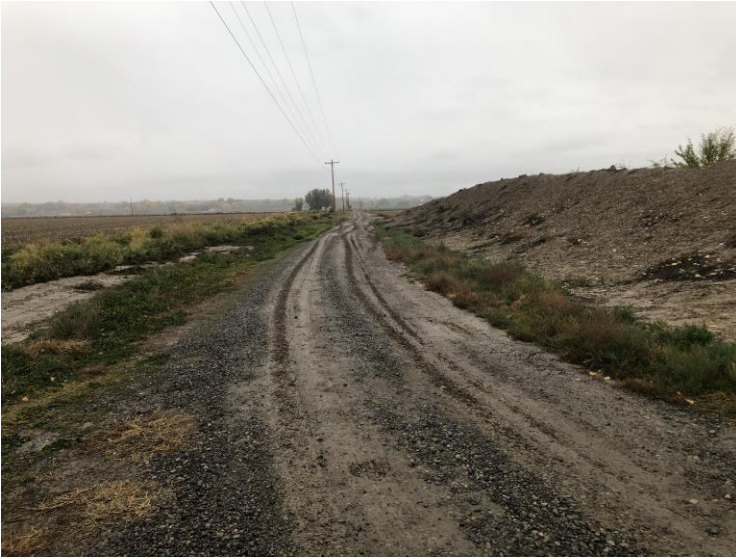
Looking south from northeast corner
