MINERALS PROGRAM INSPECTION REPORT

MINE NAME: Graff Pit	MINE/PROSPECTING ID#: M-2017-027	MINERAL: Aggregate	COUNTY: Delta
INSPECTION TYPE: Monitoring	WEATHER: Raining	INSP. DATE: October 26, 2022	INSP. TIME: 07:20
OPERATOR: Whitewater Building Materials Corporation	OPERATOR REPRESENTATIVE: Mark Gardner	TYPE OF OPERATION: 112c - Construction Regular Operation

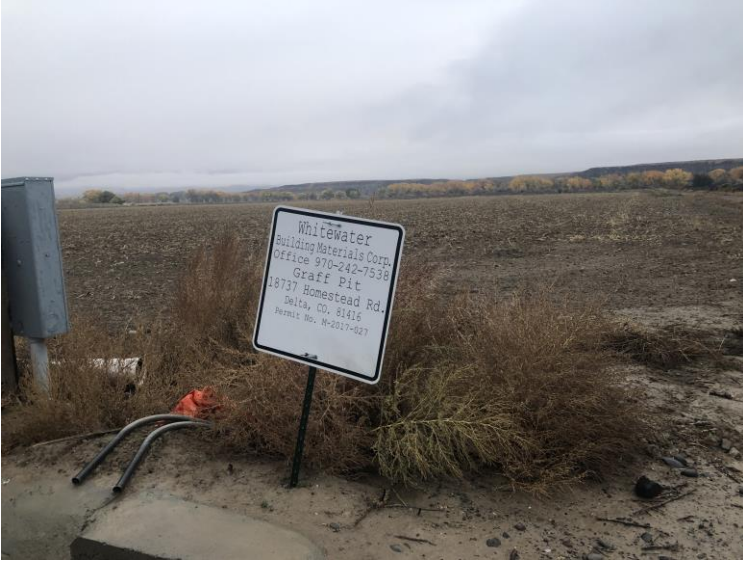
PROBLEM/POSSIBLE VIOLATION: Problem: The mine identification sign and affected area boundary markers were not in compliance with the requirements of Rule 3.1.12. The Operator shall, at the entrance of the mine site post a sign, which shall be clearly visible from the access road, with a minimum size equaling one hundred and eighty-seven (187) square inches, such as eleven (11) inches in height and seventeen (17) inches in width, with appropriate font size, with the following: the name of the Operator, a statement that a reclamation permit for the operation has been issued by the Colorado Mined Land Reclamation Board; and the permit number. Also, markers were not in place at the north end of the site.

A sign at the entrance off of Homestead Road does not include a reference to the Colorado Mined Land Reclamation Board. This is required per Rule 3. 1.12(1), and the sign needs to be updated. Also, markers of the boundary were missing at the north end.

Entrance sign

CORRECTIVE ACTIONS: The operator must post a sign at the entrance to the mine site which shall be clearly visible from the access road and specify the following; the name of the operator, indicate that a reclamation permit for the operation has been issued by the Colorado Mined Land Reclamation Board, and the permit number. The boundaries of the affected area must be marked by monuments or other markers that are clearly visible and adequate to delineate such boundaries. Proof of signs and markers must be submitted to the Division by the corrective action date.

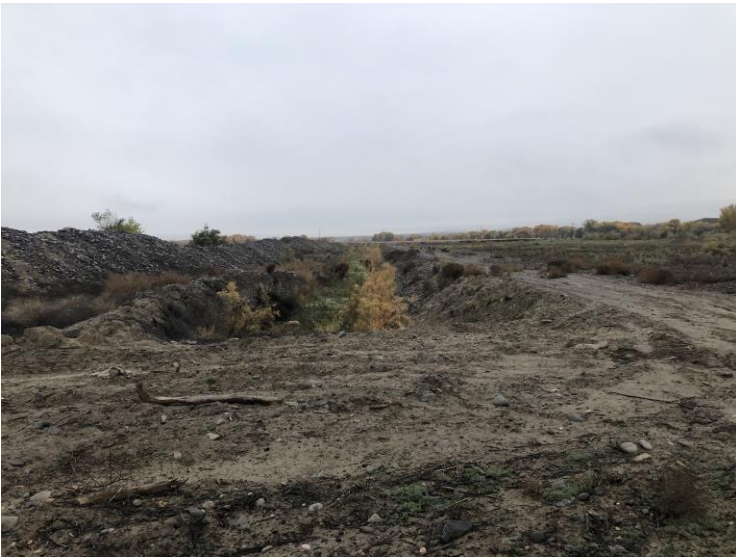
A small amount of disturbance was seen at the northeast corner of the site. This includes a berm and excavation. Future Annual Reports should show and describe all disturbance.

Excavation and berm at northeast corner

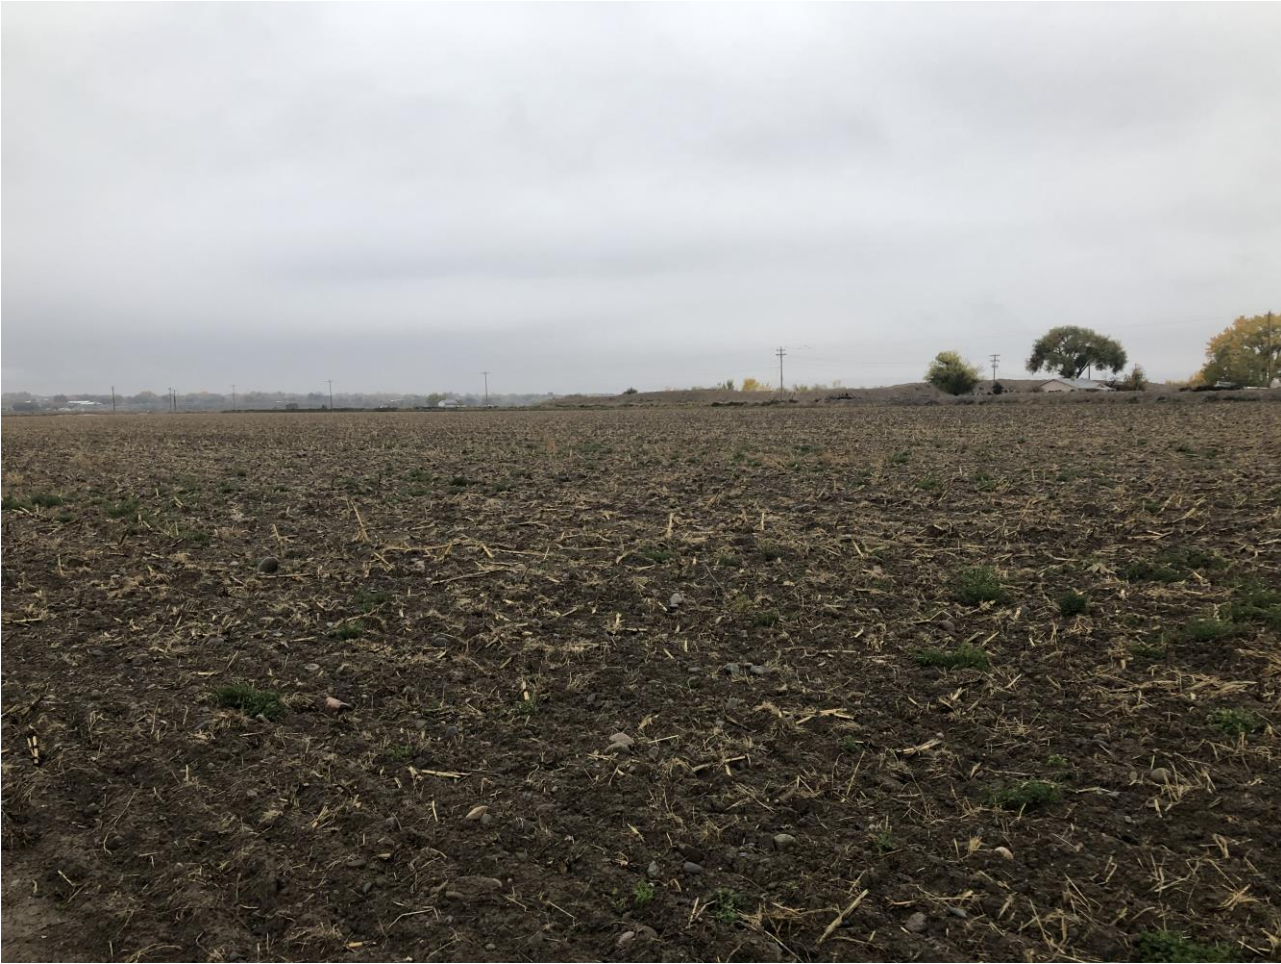
Looking southwest from north side
