PERMIT INFORMATION

Permit Number: C-1981-028 Mine Name: Keenesburg Strip Mine Operator: Coors Energy Company Operator Address: Mr. Ben Moline	County: Weld Operation Type: Surface Permit Status: Permanent Cessation Ownership: Private
PO Box 4030 Golden, CO 80402	Operator Representative Present: None
Operator Representative Signature: (Field Issua	nnce Only)

INSPECTION INFORMATION

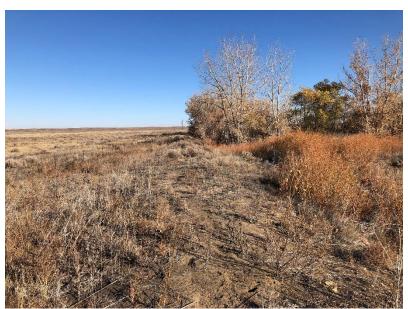
Sediment Pond 2 and the Dugout Pond contained little to no water (thick vegetation obscures the bottoms). They were not discharging during the inspection. There were no signs that either pond had discharged recently. No problems were observed.

Sediment Pond 2 (inlet channel on right)
