MINERALS PROGRAM INSPECTION REPORT

MINE NAME: South 40 Quarry No. 2	MINE/PROSPECTING ID#: M-2020-051	MINERAL: Unknown commodity	COUNTY: Fremont
INSPECTION TYPE: Monitoring	INSPECTOR(S): Timothy Cazier, P.E.	INSP. DATE: August 18, 2022	INSP. TIME: 09:15
OPERATOR: High Plains Stone Company	OPERATOR REPRESENTATIVE: Debbie Wagner	TYPE OF OPERATION: 110c - Construction Limited Impact	
REASON FOR INSPECTION: Normal I&E Program	BOND CALCULATION TYPE: Partial Bond	BOND AMOUNT: \$3,428.00	
DATE OF COMPLAINT: NA	POST INSP. CONTACTS: Colo. Land Board	JOINT INSP. AGENCY: None	
WEATHER: Clear	INSPECTOR'S SIGNATURE:

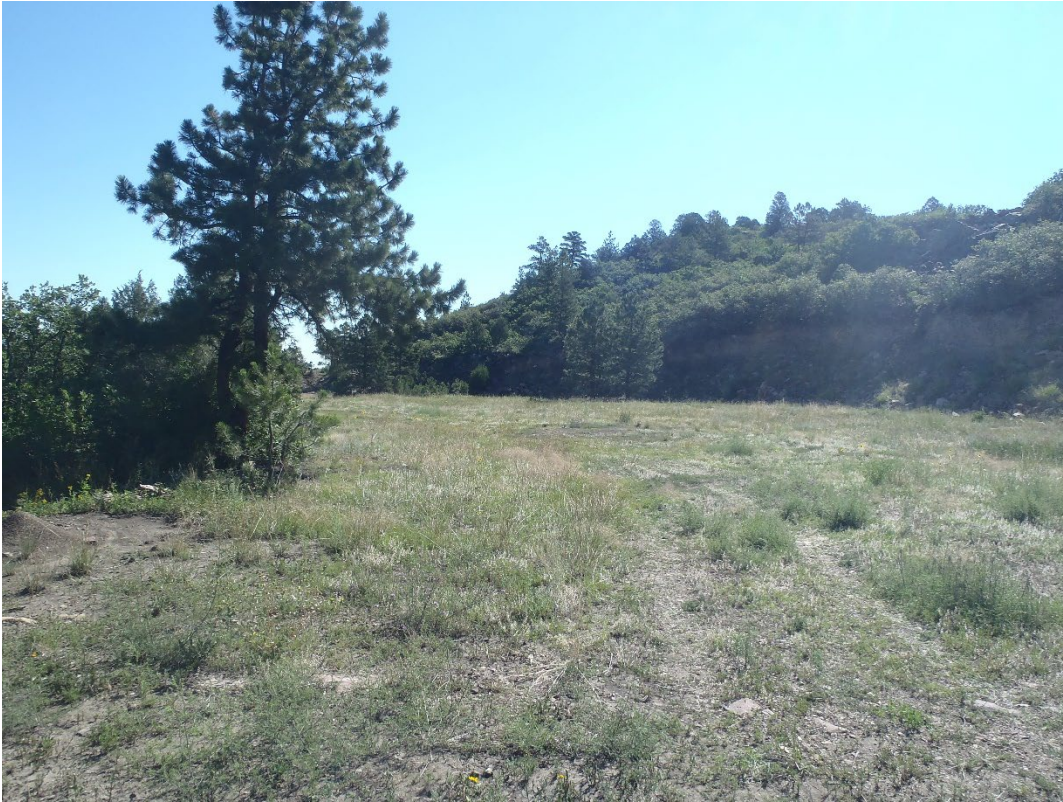
Roads: The staging area was observed to be well vegetated (see **Photo 1**) as was some of the access road (see **Photo 2**). The western segment of the access road was not vegetated (see **Photo 3**).

Photo 1. Revegetated staging area (looking east).

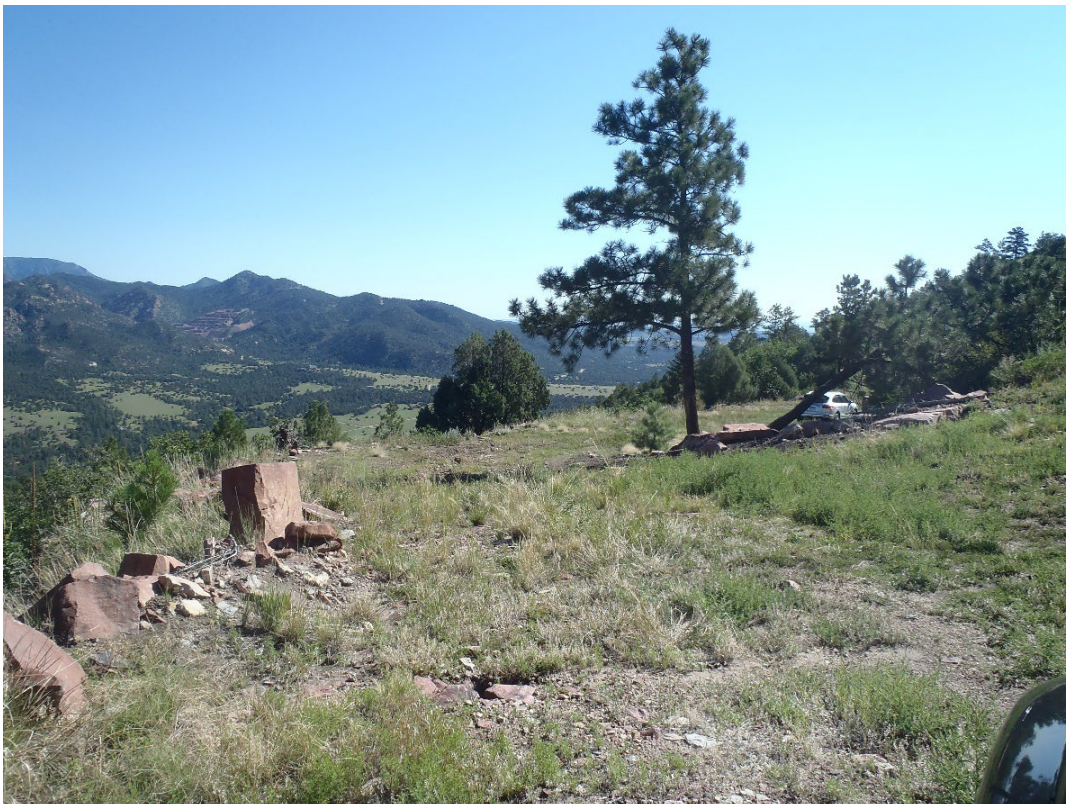
Photo 2. Revegetated access road, west of staging area (looking east).

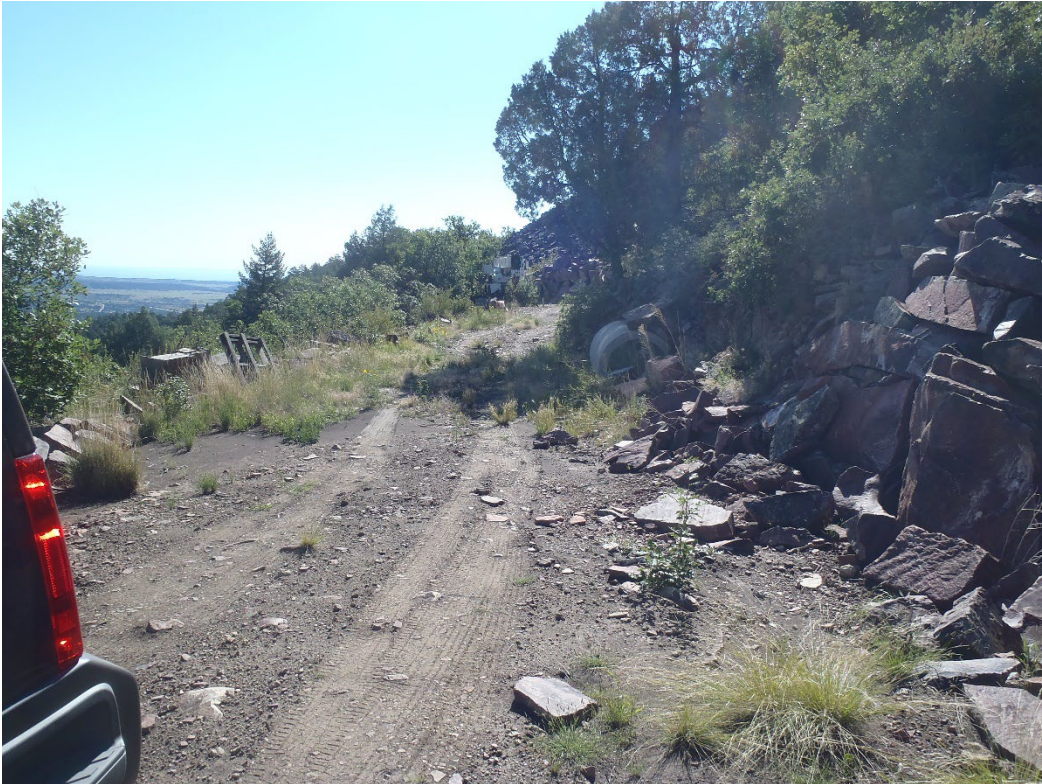
Reclamation Success: Grading and topsoiling are not necessary at this time. Ms. Wagner indicated all the observed revegetation is a result of natural volunteers, as they have not performed any seeding. Most of the west end of the access road still requires revegetation, as well as segments of the east end of the access road. The reclamation also requires the removal of refuse such as pallets (see **Photo 4**), culverts (see **Photo 5**), cables (see **Photo 6**); as well as two loaders (see **Photos 7 and 8**) and a crane (see **Photo 9**).

Photo 3. Typical western segment of access road needing revegetation work (looking east).

Post Inspection Meeting: The DRMS encouraged the Permittee to complete reclamation as soon as possible, with the first priority being removal the equipment and refuse; followed by seeding at an appropriate time in consultation with the Soil Conservation District. It was also recommended the small amount of knapweed observed in the staging area be treated at the same time the knapweed observed in the South 40 Quarry area (M-1990-016) is treated.

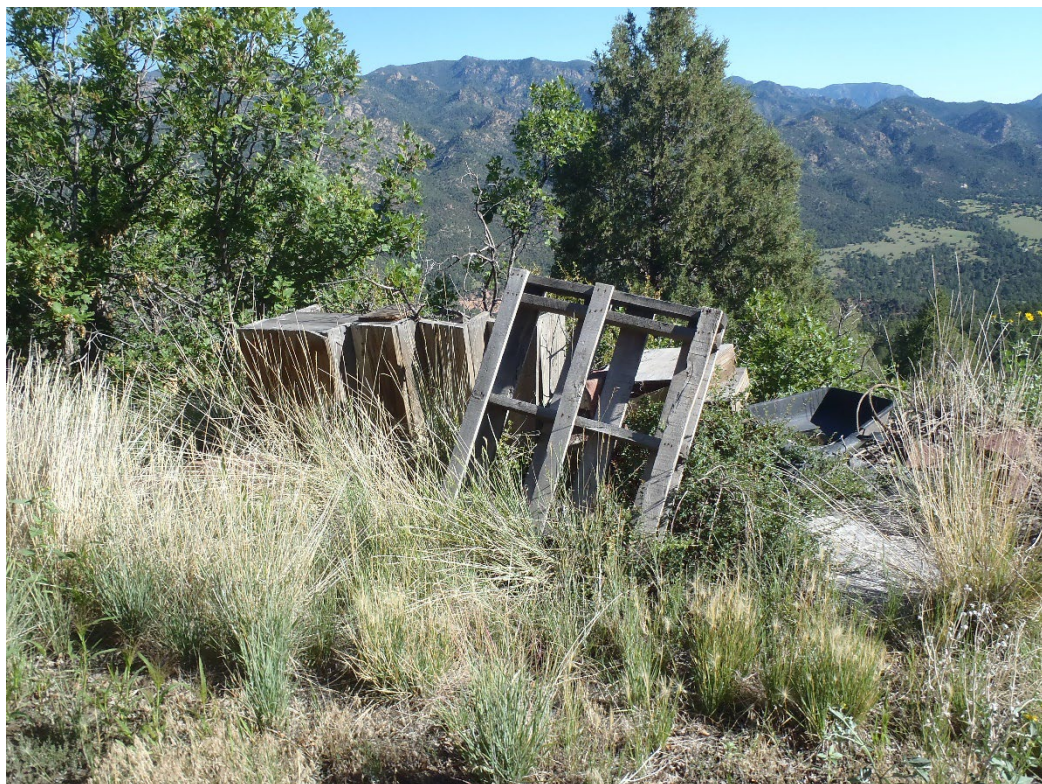
Photo 4. Refuse - pallets (looking north along access road).

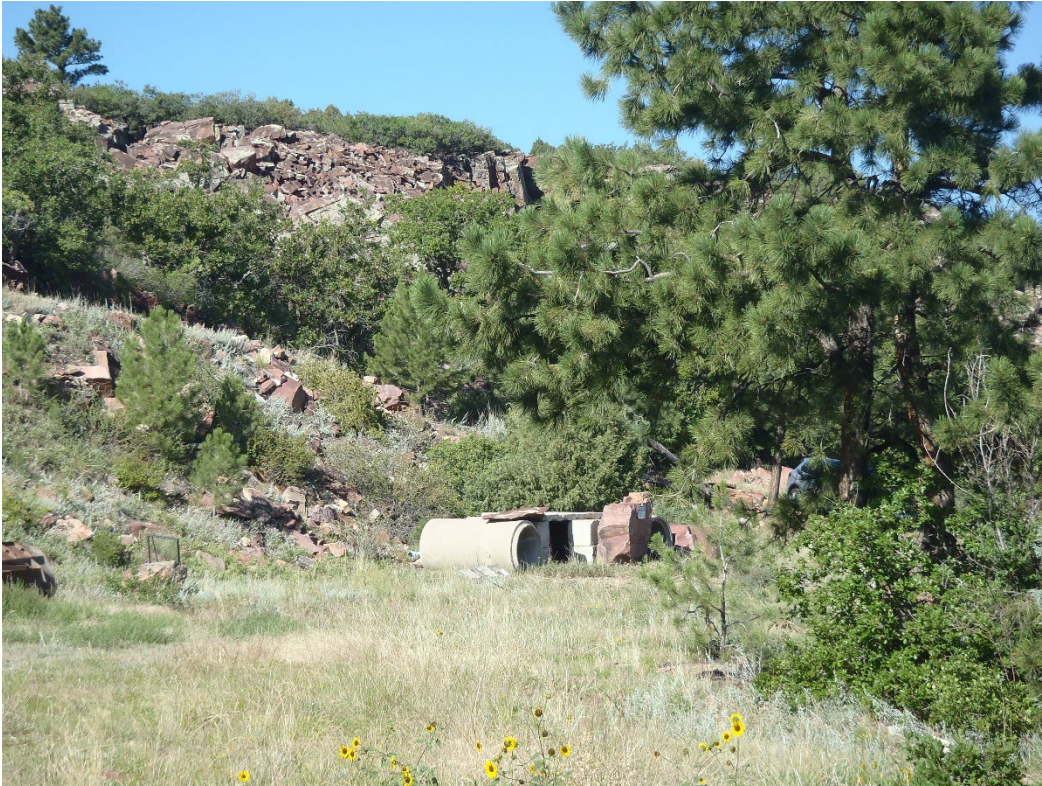
Photo 5. Refuse – RCP culverts (looking west from staging area).

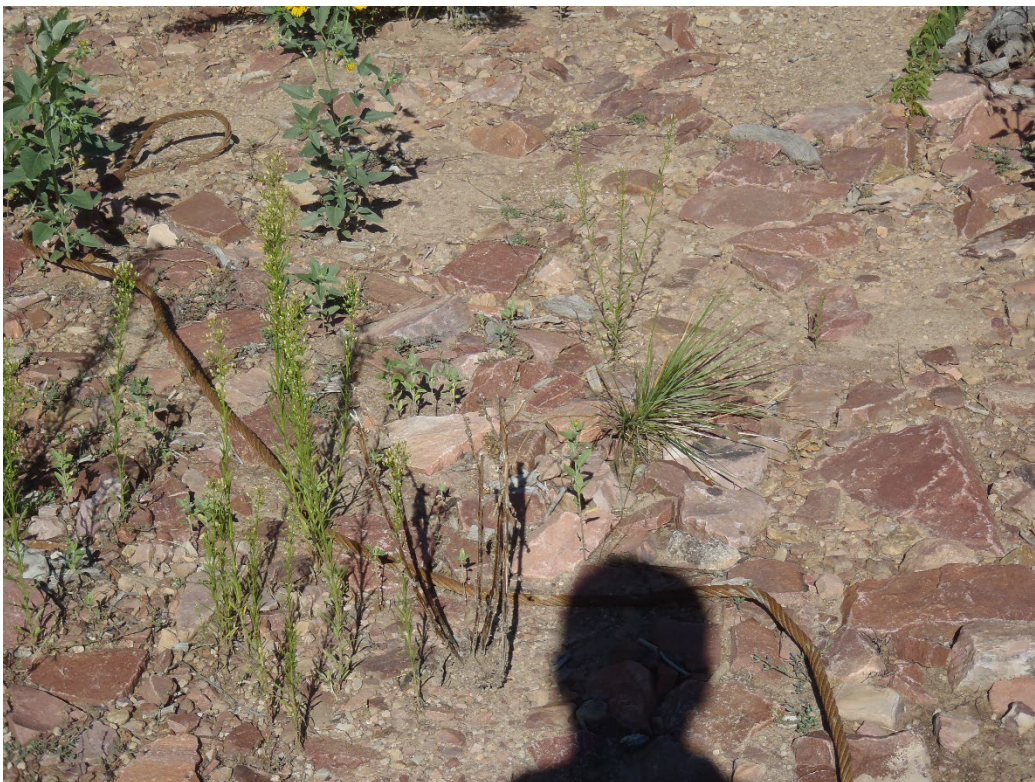
Photo 6. Refuse – rusty cables.

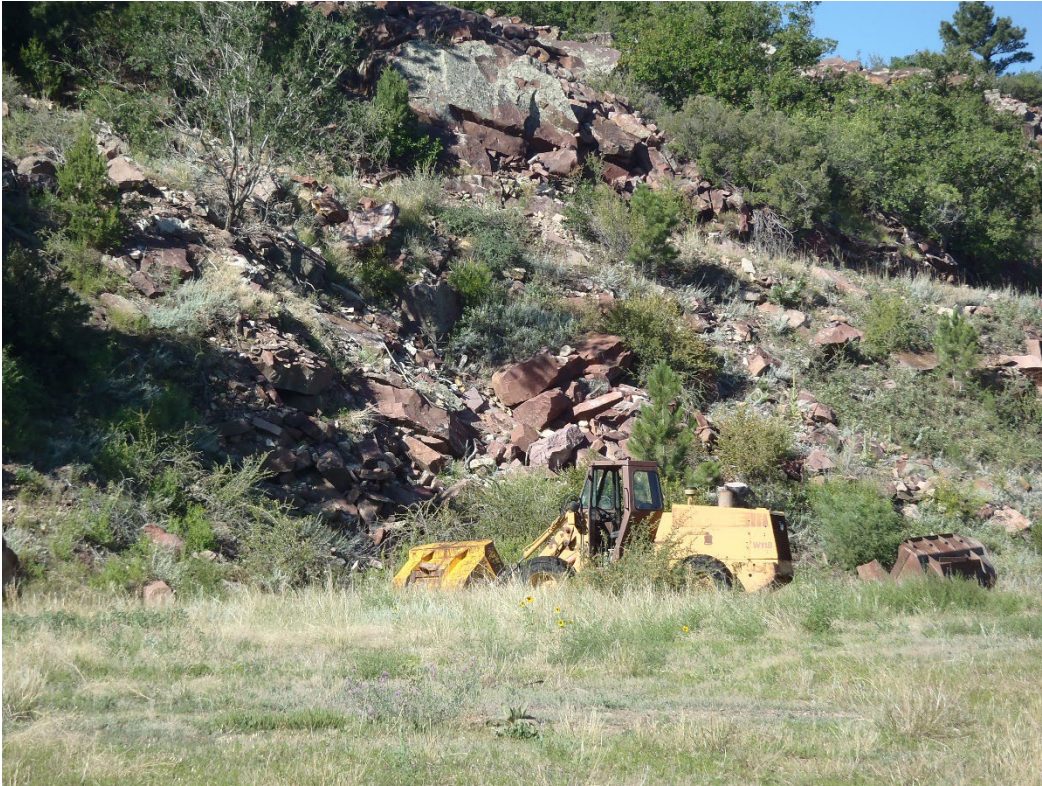
Photo 7. Loader on west end of staging area (looking west).

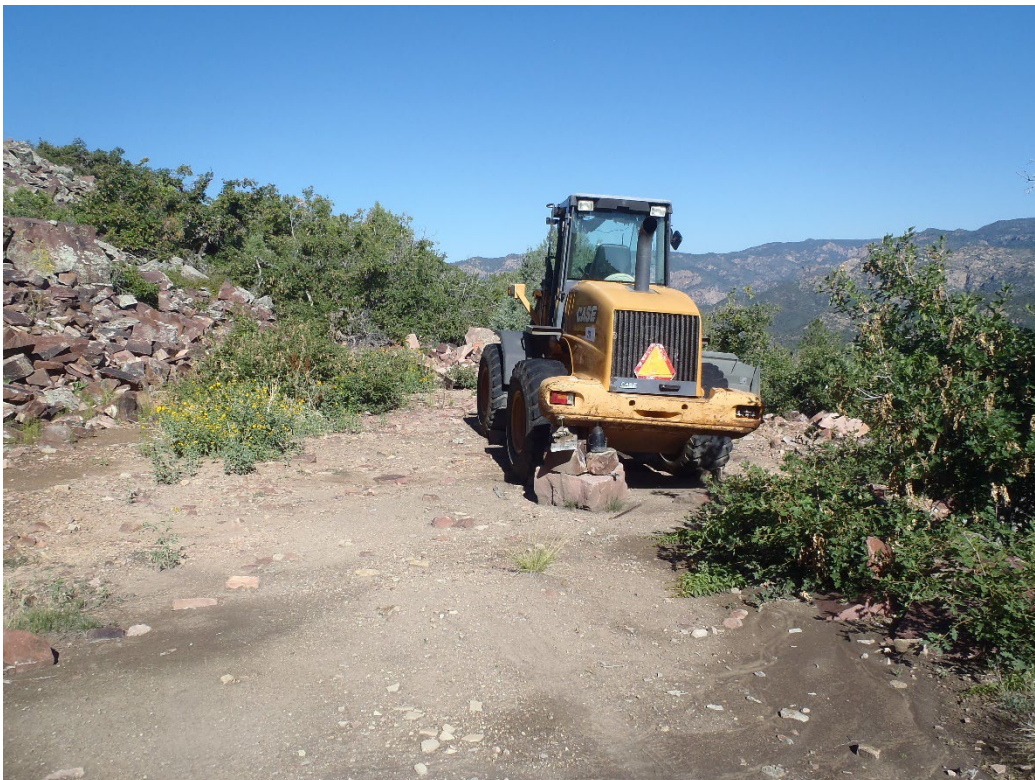
Photo 8. Loader at west limit of access road (looking west).

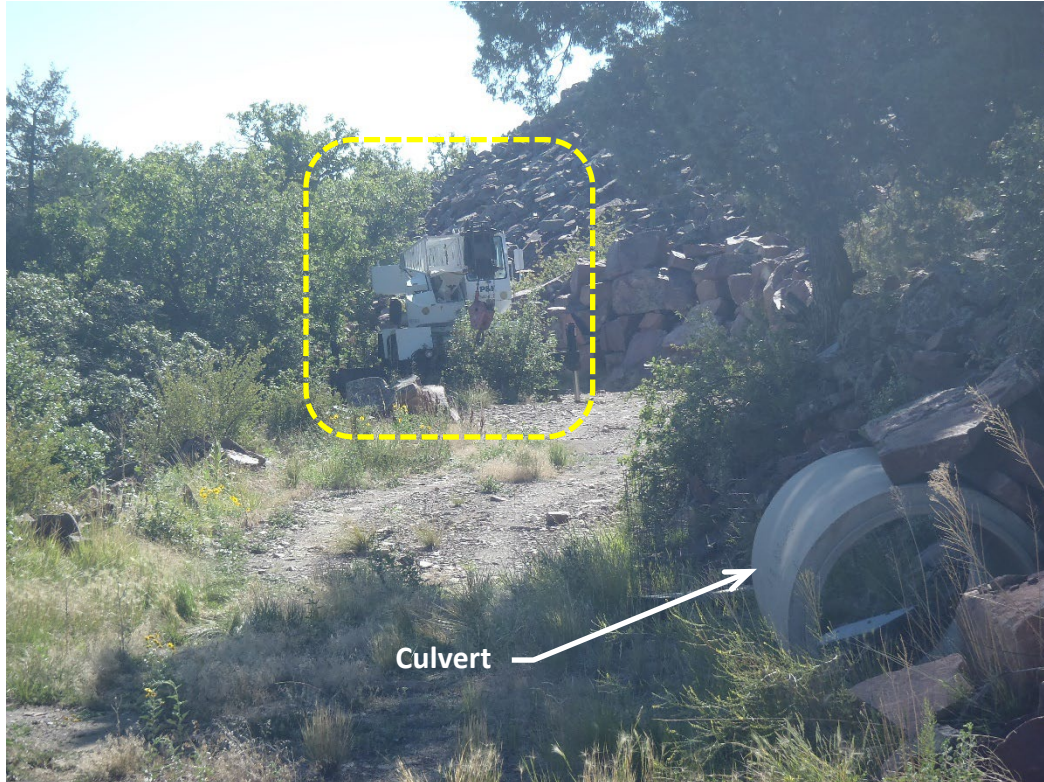
Photo 9. Crane and refuse culver near west end of access road (looking east).
