MINERALS PROGRAM INSPECTION REPORT

MINE NAME: South 40 Quarry	MINE/PROSPECTING ID#: M-1990-016	MINERAL: Stone	COUNTY: Fremont
INSPECTION TYPE: Monitoring	INSPECTOR(S): Timothy Cazier, P.E.	INSP. DATE: August 18, 2022	INSP. TIME: 09:50
OPERATOR: High Plains Stone Company	OPERATOR REPRESENTATIVE: Debbie Wagner	TYPE OF OPERATION: 110c - Construction Limited Impact	
REASON FOR INSPECTION: Normal I&E Program	BOND CALCULATION TYPE: Partial Bond	BOND AMOUNT: \$2,000.00	
DATE OF COMPLAINT: NA	POST INSP. CONTACTS: Colo. Land Board	JOINT INSP. AGENCY: None	
WEATHER: Clear	INSPECTOR'S SIGNATURE:

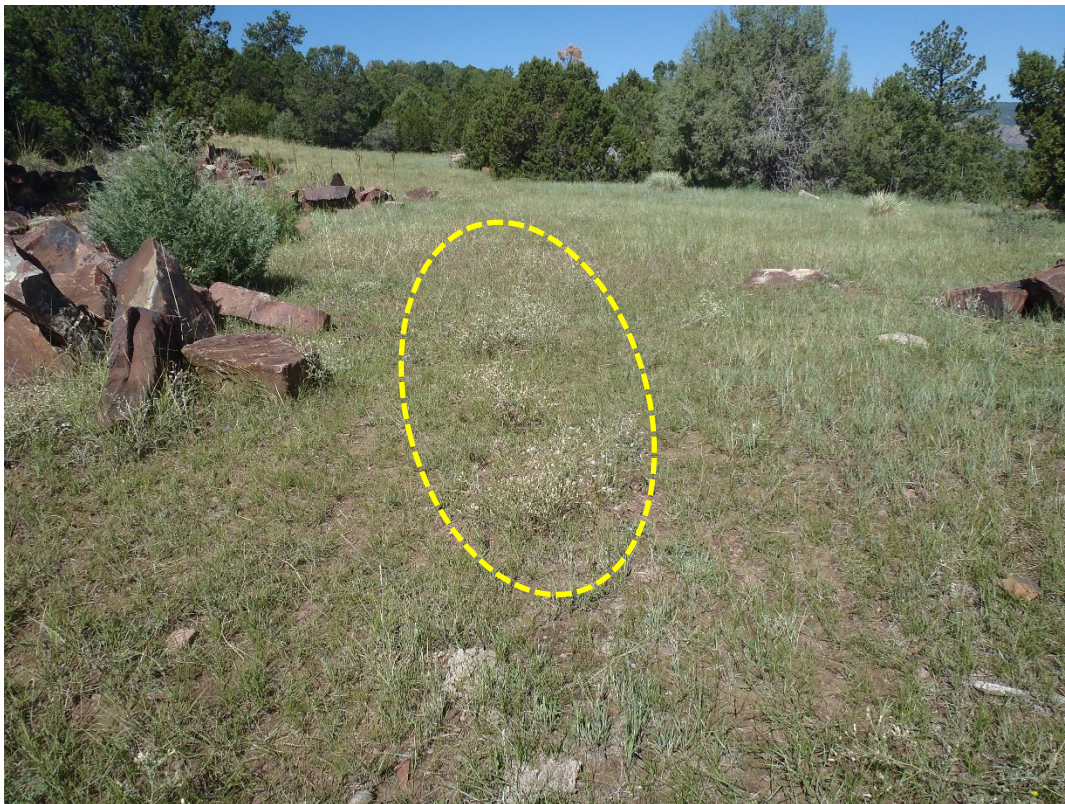
Roads: An access road of approximately 500 feet was advanced from the BLM access road in Parcel 1. It was observed to be self-reclaimed (see **Photo 1**).

Reclamation Success: No active reclamation has been initiated. However, the disturbed portions of Parcel 1 (see **Photos 1** and **2**) and Parcel 2 (see **Photo 3**) were observed to be self-reclaimed. Refuse was observed that must be removed prior to final release. This includes concrete slabs (see **Photo 4**), concrete blocks (see **Photo 5**), and wooden pallets (see **Photo 6**).

Photo 1. Reclaimed Parcel 1 access road (looking SW, knapweed circled).

Revegetation: Site representatives stated they had not seeded any disturbed areas. All the revegetation was a result of volunteer succession. Knapweed was observed during the previous inspection in the BLM access road (not included in this permit's affected area). The knapweed (see **Photo 7**) has since moved into both Parcels 1 (see **Photo 1**) and 2 (see **Photo 3**) and must be treated prior to a release of reclamation liability. Because the knapweed is prevalent outside the affected area, it was not cited as a problem. [The Operator should implement a weed control program to control the spread of knapweed on site.](#)

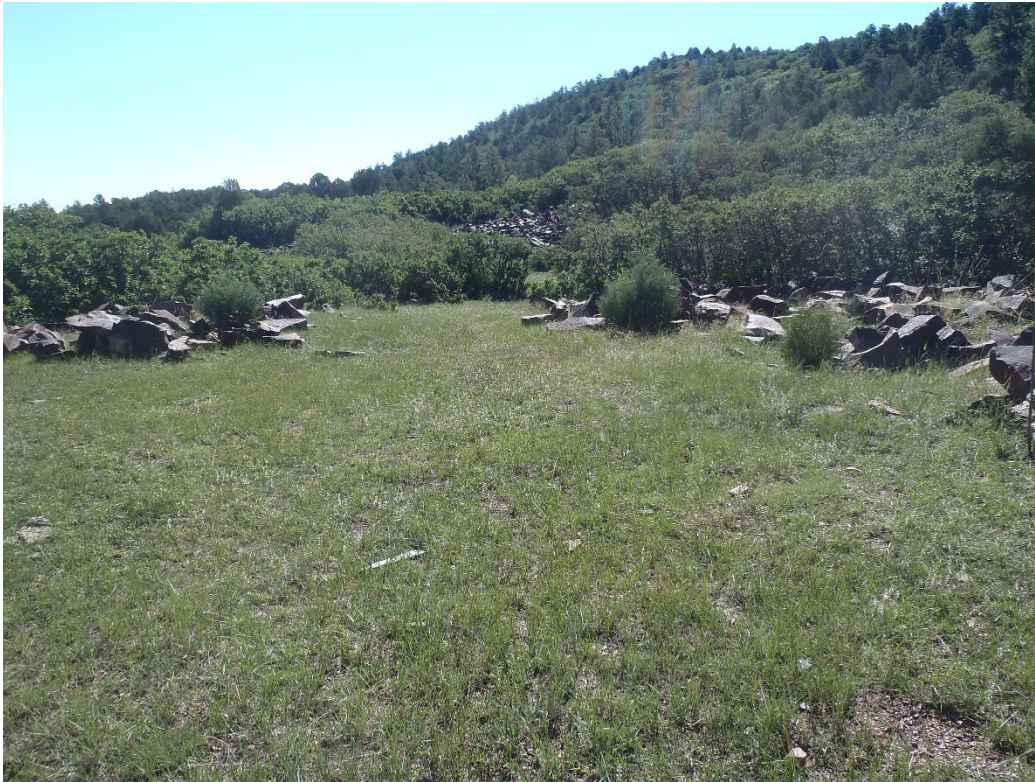
Photo 2. Reclaimed Parcel 1 access road (looking east).

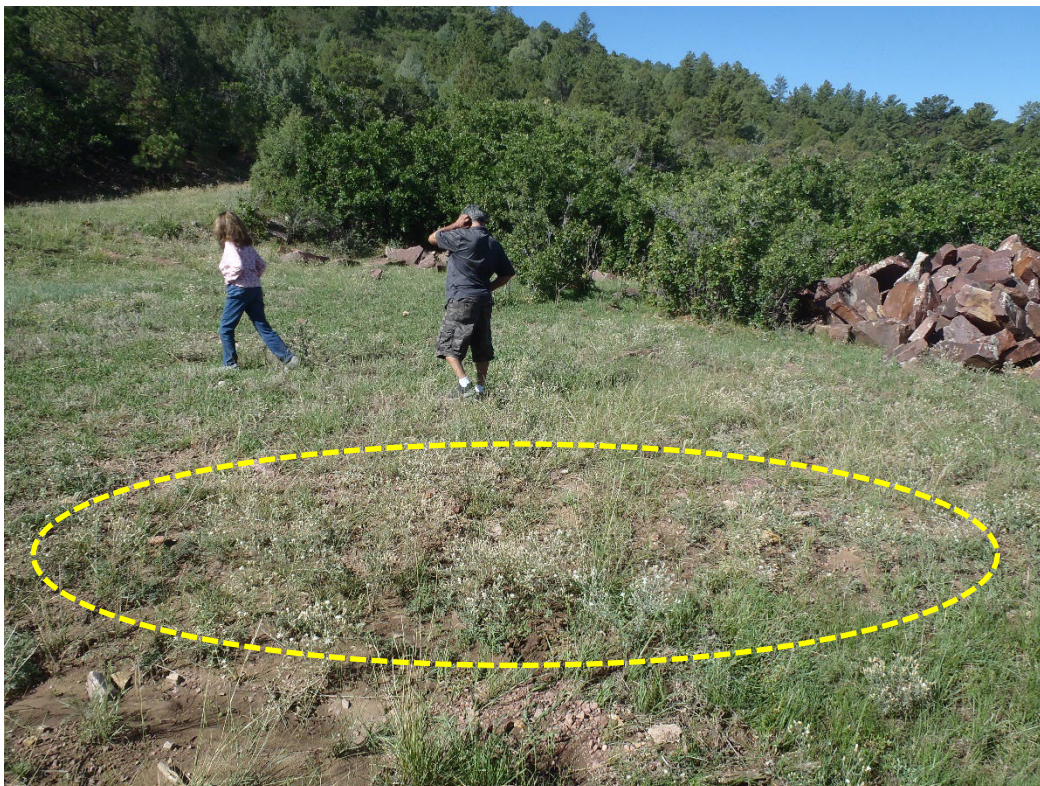
Photo 3. Reclaimed Parcel 2 (looking west, knapweed circled).

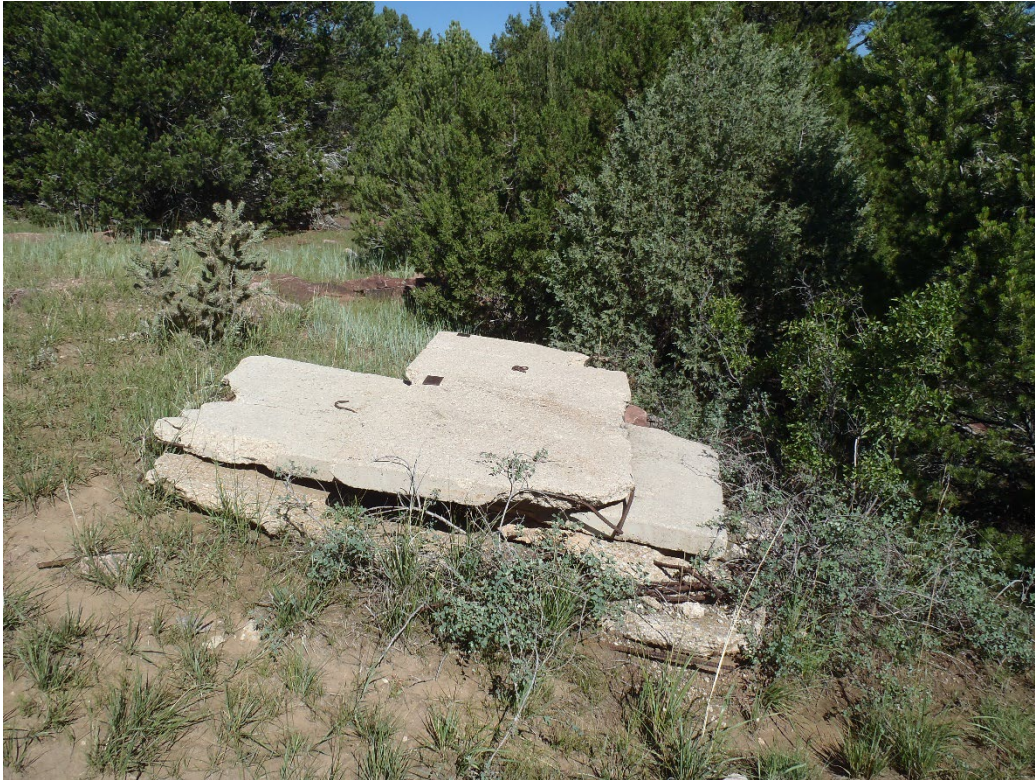
Photo 4. Concrete slabs in Parcel 1 (looking west).

Post Inspection Meeting: The site representatives were informed at the close of the inspection that based on observations, the only issues preventing final release are: 1) the treatment of the knapweed, and 2) the removal of the refuse. The DRMS recommended addressing both these issues as soon as possible, and requesting final release of the permit as soon those tasks are completed.

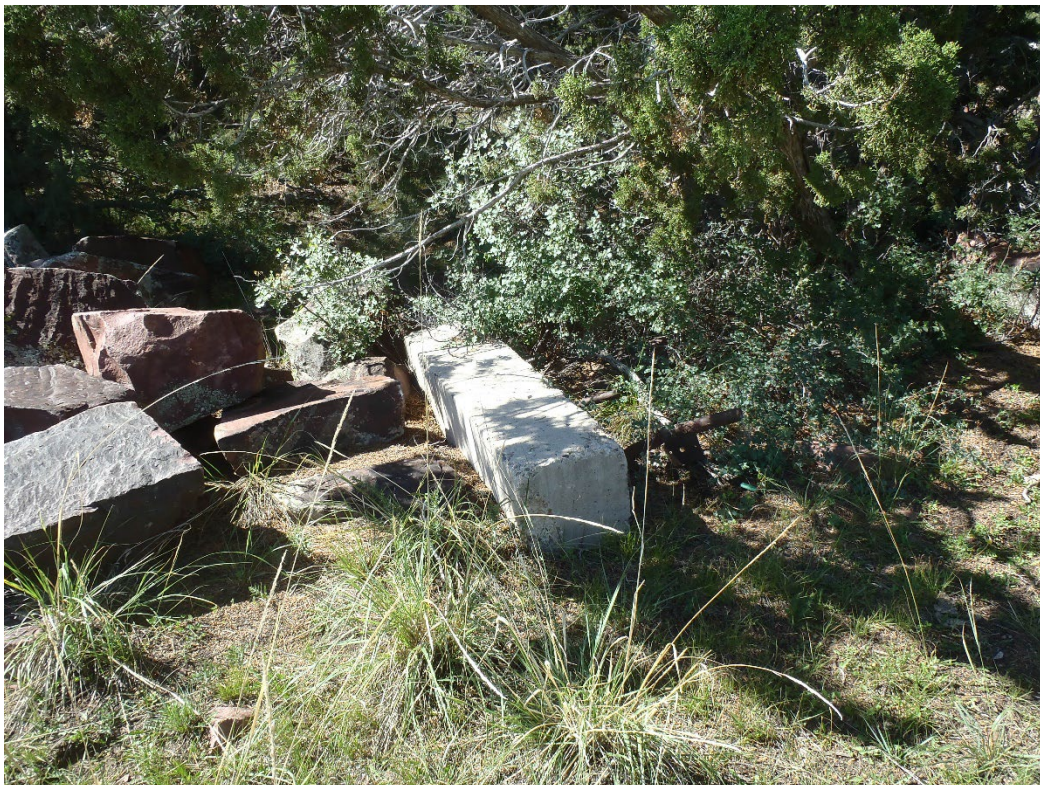
Photo 5. Concrete block in Parcel 1 (south side of access road).

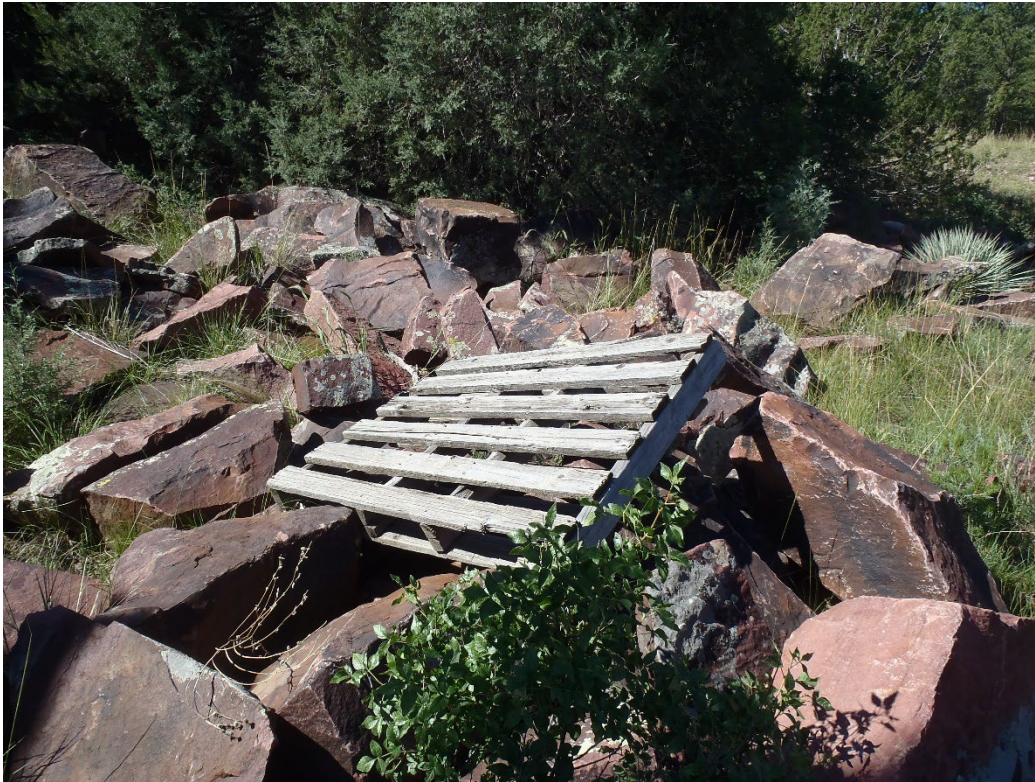
Photo 6. Wooden pallet in Parcel 1.

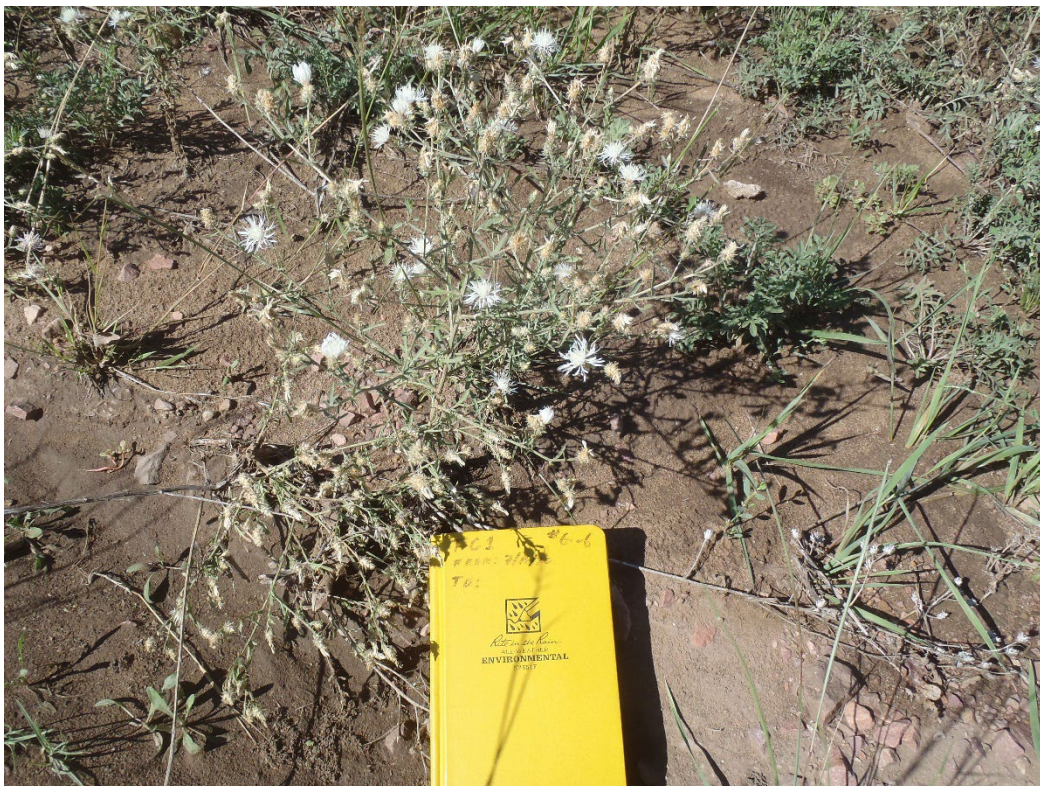
Photo 7. Knapweed (typical of that observed in Parcels 1 and 2).

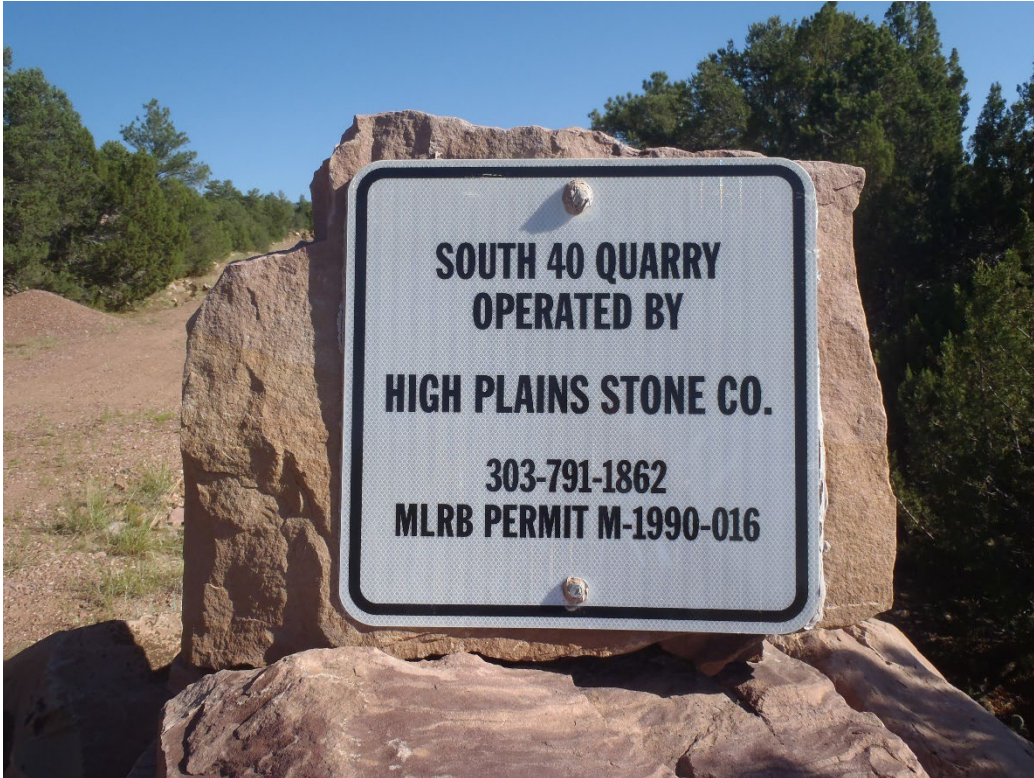
Signs and Markers: The permit sign was properly posted (see **Photo 8**). Boundary markers were never placed, but no new disturbance has occurred for several years.

Photo 8. Permit sign (~ a half mile from where the access road bifurcates between the South 40 Quarry and the South 40 Quarry No. 2).
