MINERALS PROGRAM INSPECTION REPORT
PHONE: (303) 866-3567

MINE NAME: Penn Mine	MINE/PROSPECTING ID#: M-2021-032	MINERAL: Silver and gold	COUNTY: Lake
INSPECTION TYPE: Monitoring	WEATHER: Clear	INSP. DATE: October 18, 2022	INSP. TIME: 12:10
OPERATOR: CJK Milling Company, LLC	OPERATOR REPRESENTATIVE: Steve Craig	TYPE OF OPERATION: 110(2) - Hard Rock Limited Impact	
REASON FOR INSPECTION: Normal I&E Program	BOND CALCULATION TYPE:	BOND AMOUNT: \$47,365.00	
DATE OF COMPLAINT: NA	POST INSP. CONTACTS: None	JOINT INSP. AGENCY: Other Agency	
INSPECTOR(S): Lucas West	INSPECTOR'S SIGNATURE:

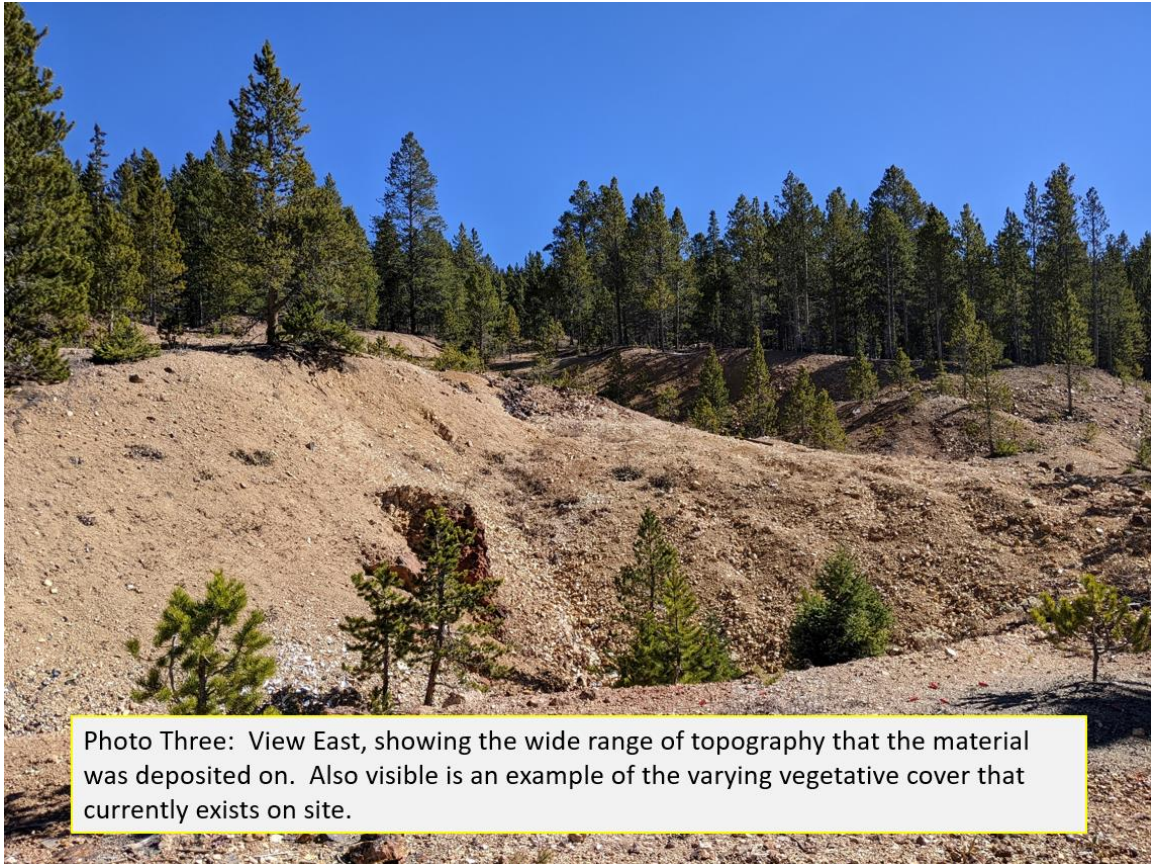
Photo Three: View East, showing the wide range of topography that the material was deposited on. Also visible is an example of the varying vegetative cover that currently exists on site.
