MINERALS PROGRAM INSPECTION REPORT
PHONE: (303) 866-3567

MINE NAME: Henderson Mine	MINE/PROSPECTING ID#: M-1977-342	MINERAL: Molybdenum	COUNTY: Clear Creek, Grand
INSPECTION TYPE: Monitoring	INSPECTOR(S): Peter Hays	INSP. DATE: June 21, 2022	INSP. TIME: 10:00
OPERATOR: Climax Molybdenum Company	OPERATOR REPRESENTATIVE: Geoff Niggeler	TYPE OF OPERATION: 112d-3 - Designated Mining Operation	
REASON FOR INSPECTION: Normal I&E Program	BOND CALCULATION TYPE: None	BOND AMOUNT: \$135,204,778.00	
DATE OF COMPLAINT: NA	POST INSP. CONTACTS: None	JOINT INSP. AGENCY: None	
WEATHER: Clear	INSPECTOR'S SIGNATURE:

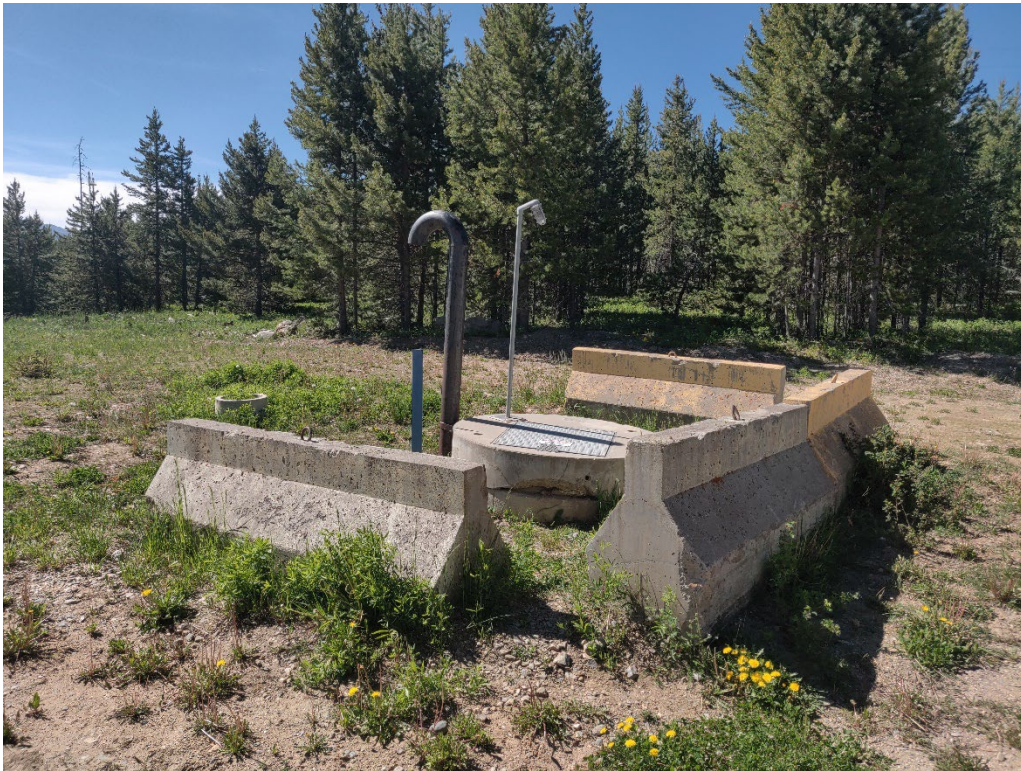
On May 24, 2022, the Operator reported water was surfacing along the west access road, south of the TSF. The water was tested and determined to be a combination of spring runoff and Mill Process Water. A leaky vent valve was determined to be the source of the water. A temporary valve was installed by the Operator since the previous inspection. A permanent replacement valve was ordered by the Operator and was expected to be installed in the fall. The standing water observed on the west access road had reduced in quantity since the last inspection.

View of the return line valve vault

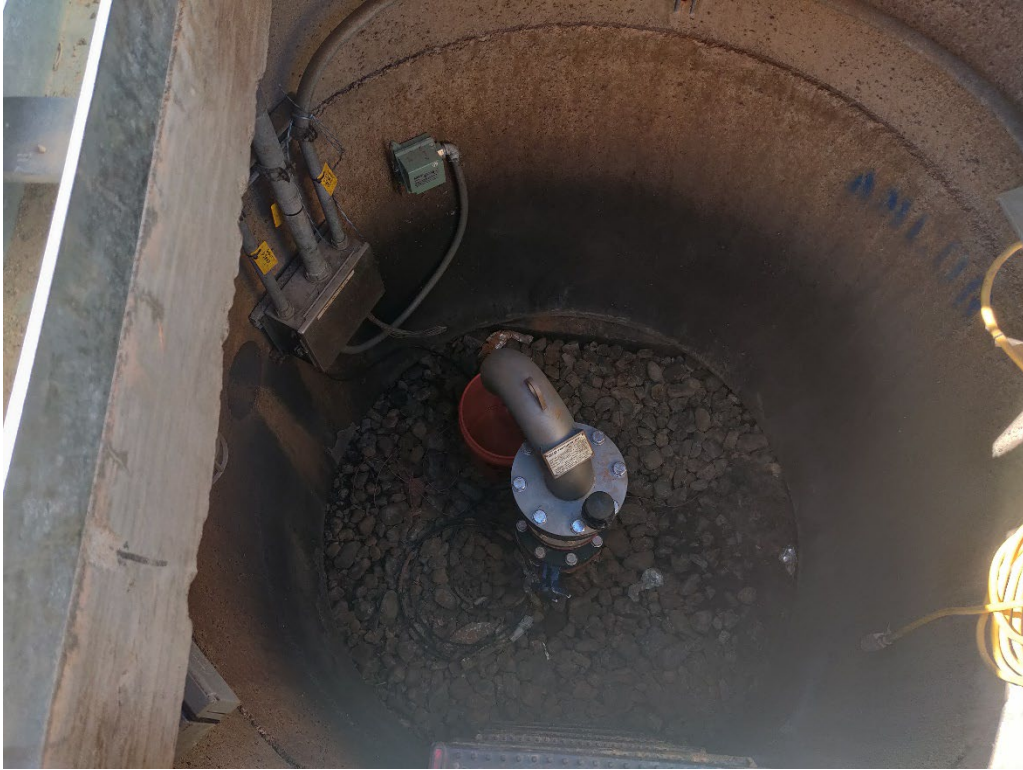
View of the temporary return line valve

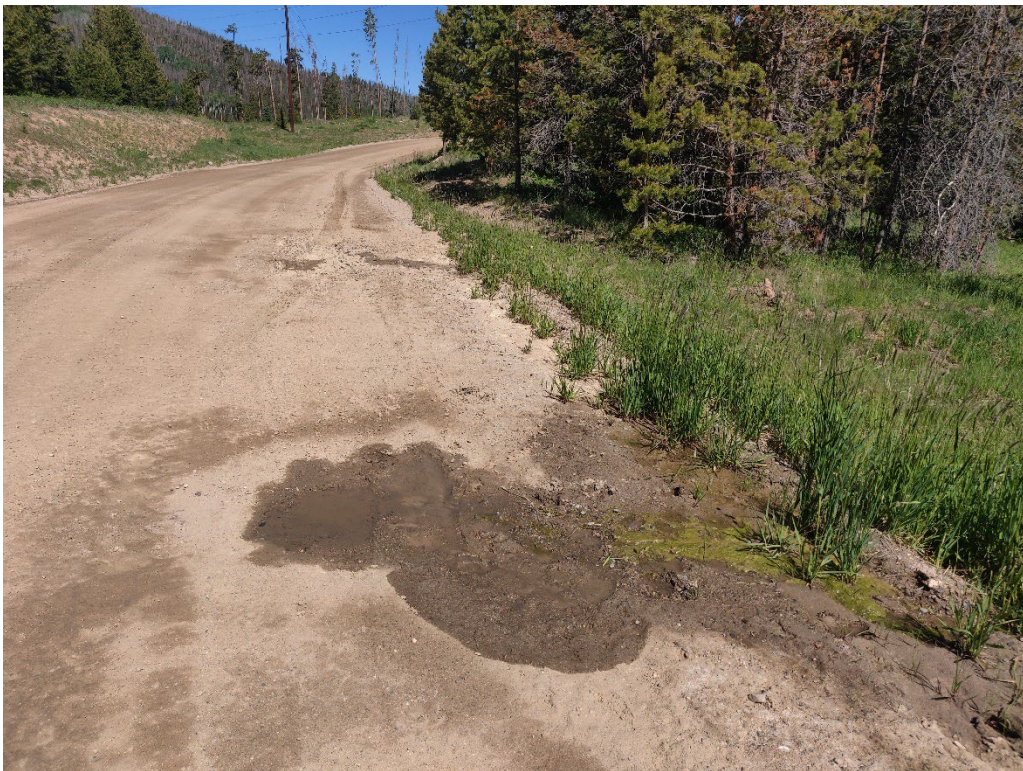
View of the reduced surface water area on the west access road

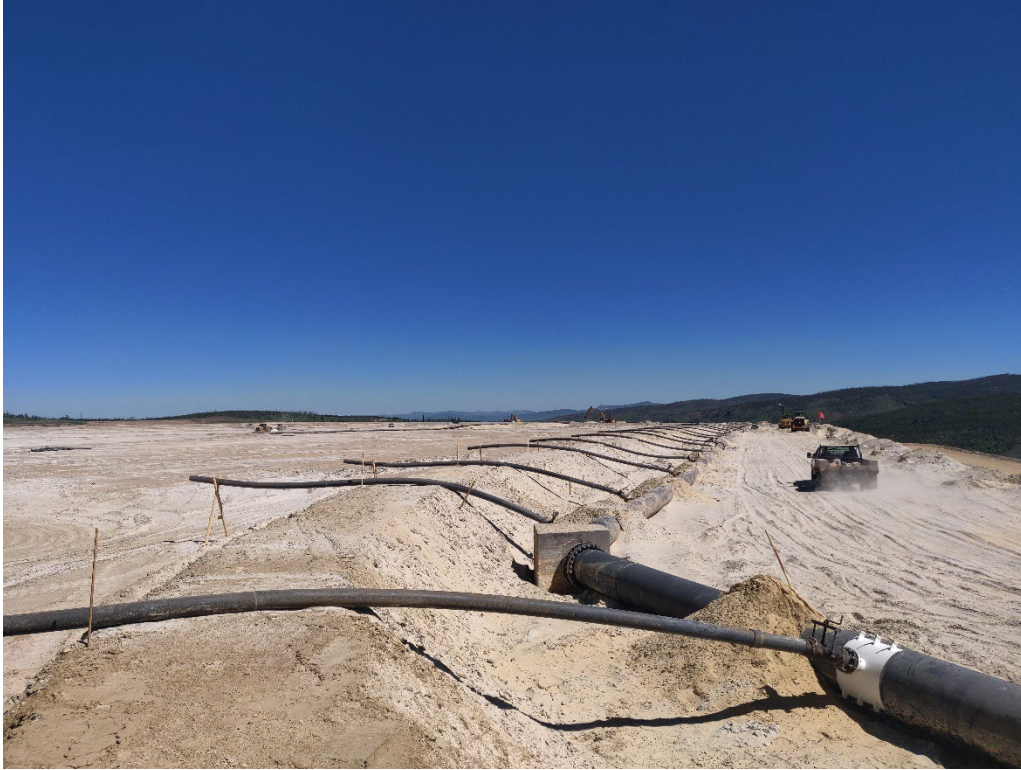
The 1-Dam crest raise construction was observed during the inspection. The raise was complete in Cell 1 and construction of the raise will continue to the north for the remainder of 1-Dam this year.

View of the completed 1-Dam crest raise in Cell 1

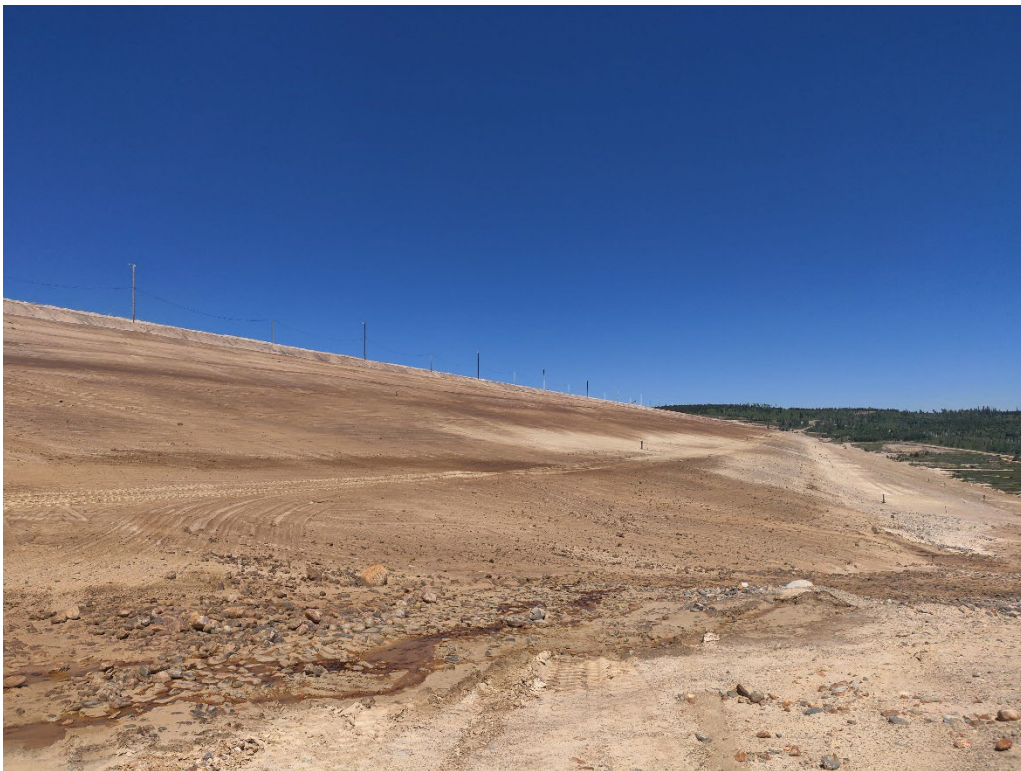
The application of coherex on the TSF was complete at the time of the inspection. Coherex will continue to be applied as part of the on-going maintenance of the TSF. No release of dust from the TSF outside of the permit boundary was observed during the inspection.

View of the coherex application on the face of 1-Dam

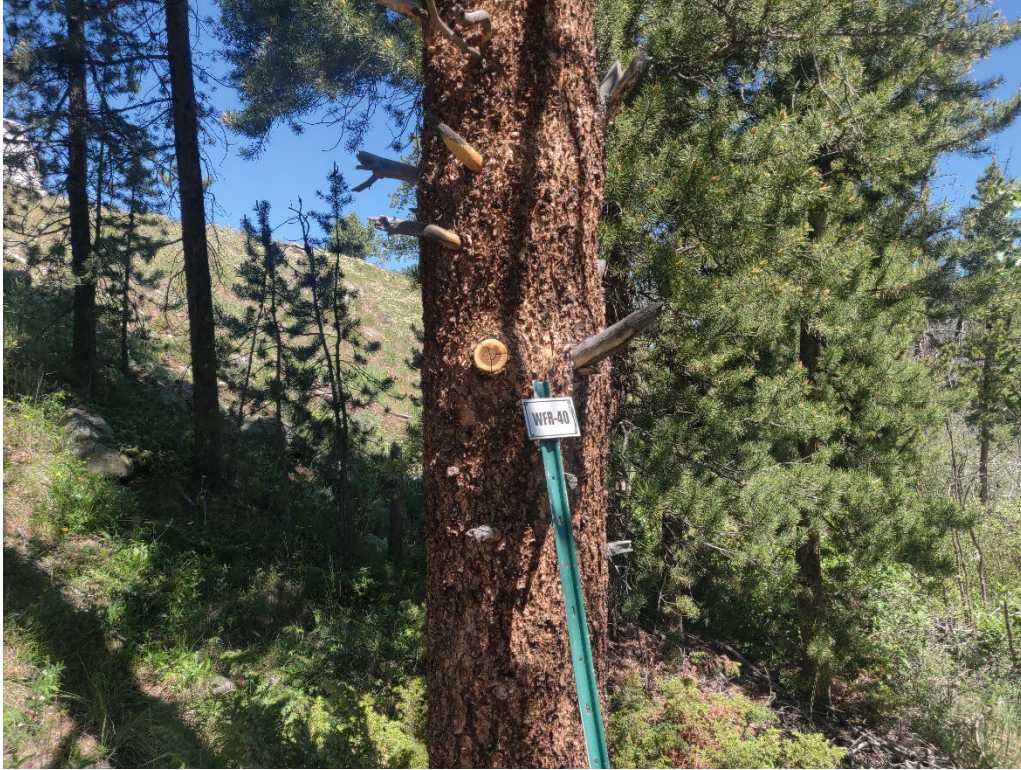
View of WFR-40 surface water sampling location sign

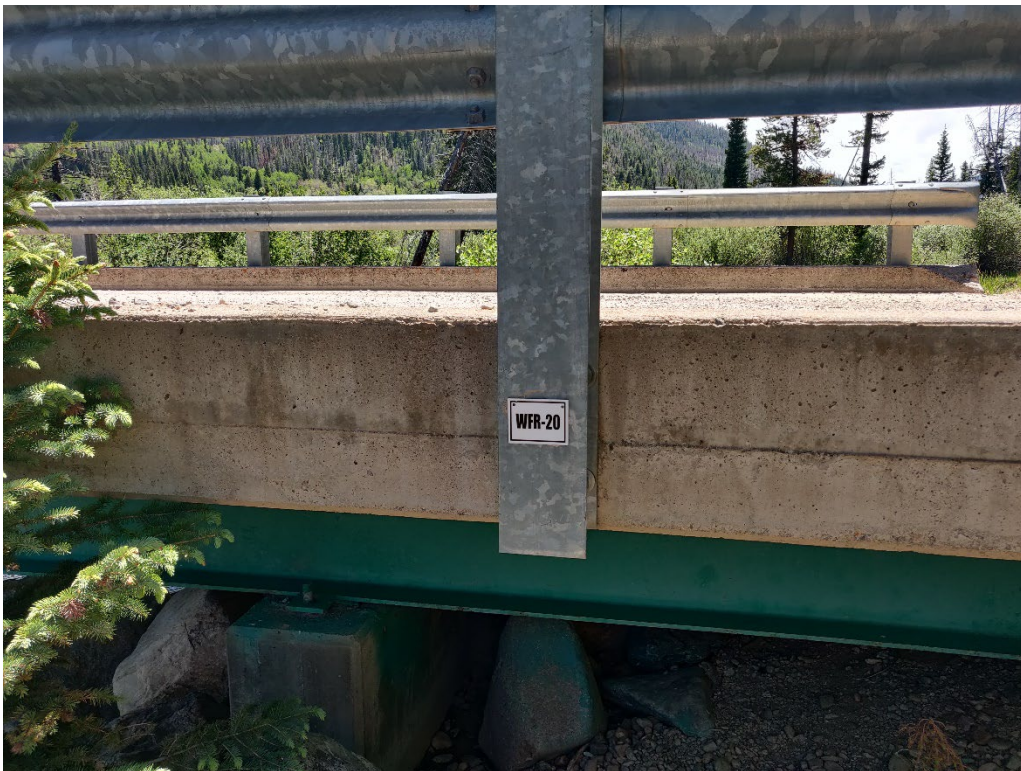
View of WFR-20 surface water sampling location sign

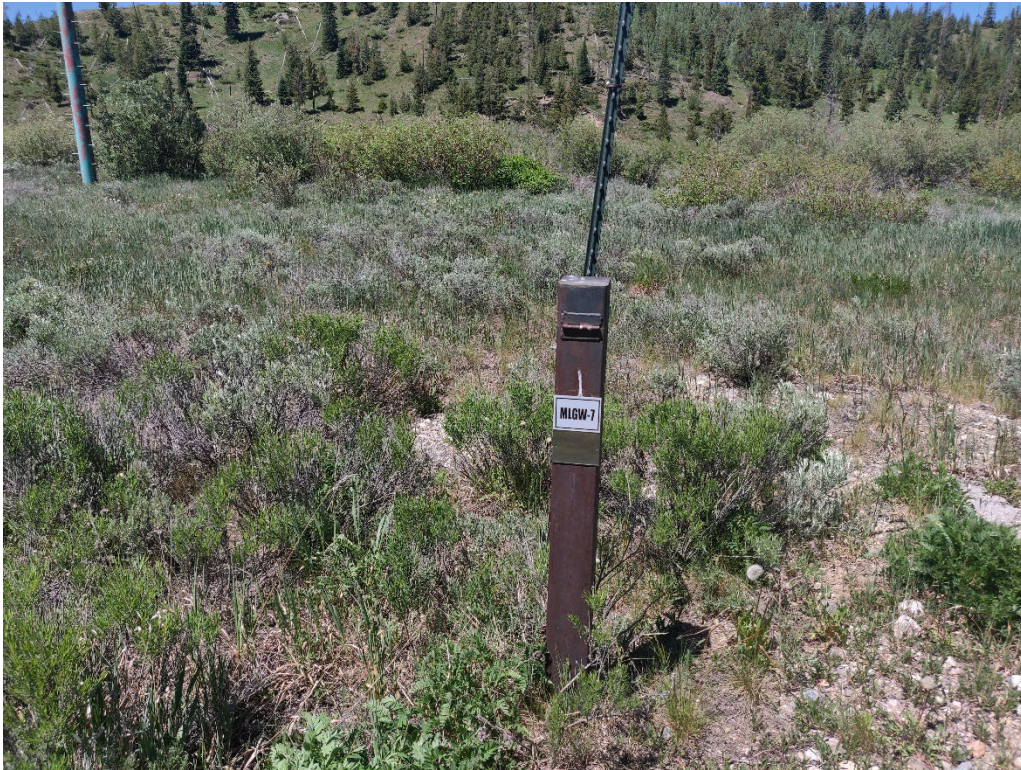
View of MLGW-7 POC well casing and sign

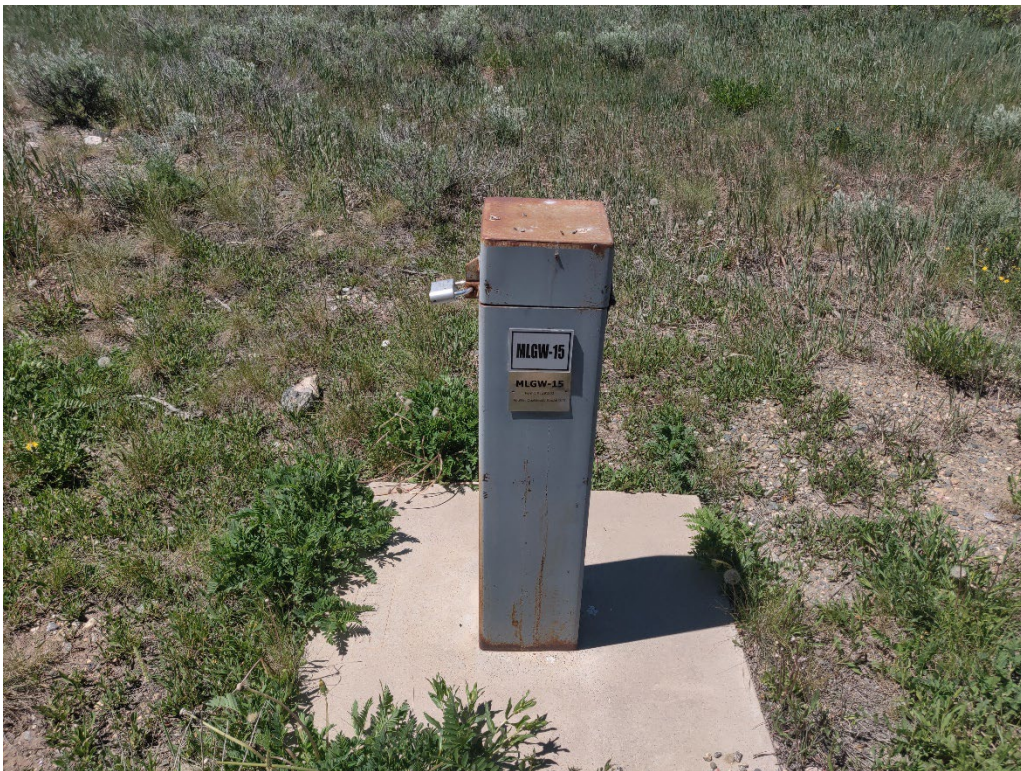
View of MLGW-15 POC well casing and sign

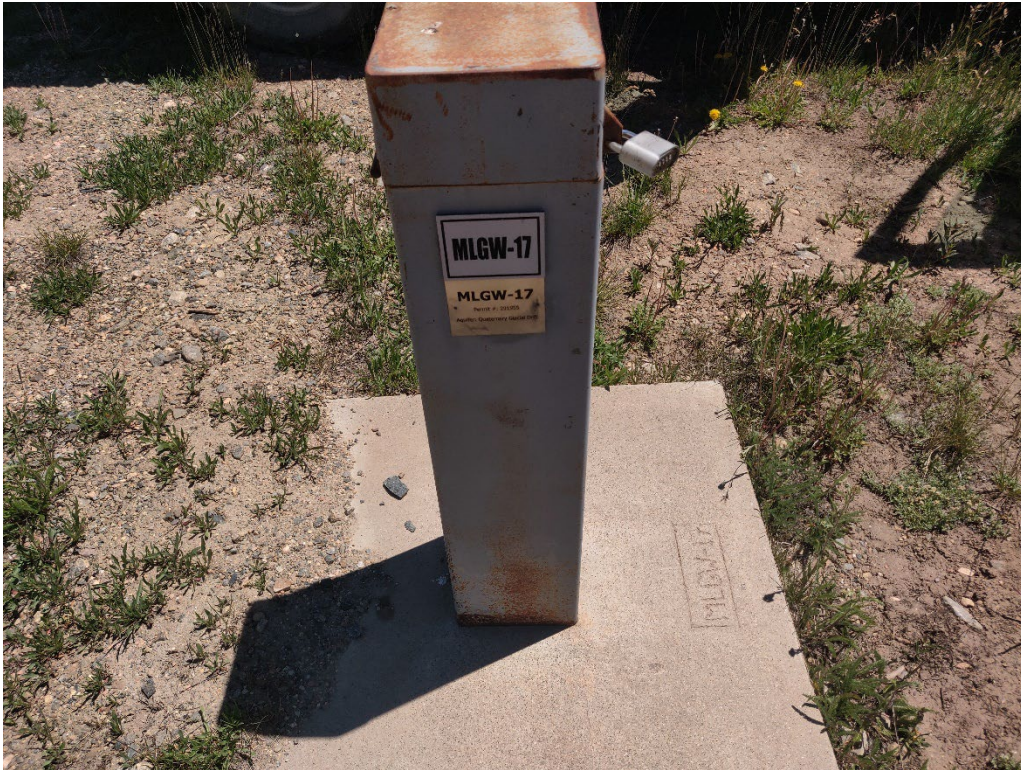
View of MLGW-17 well casing and sign

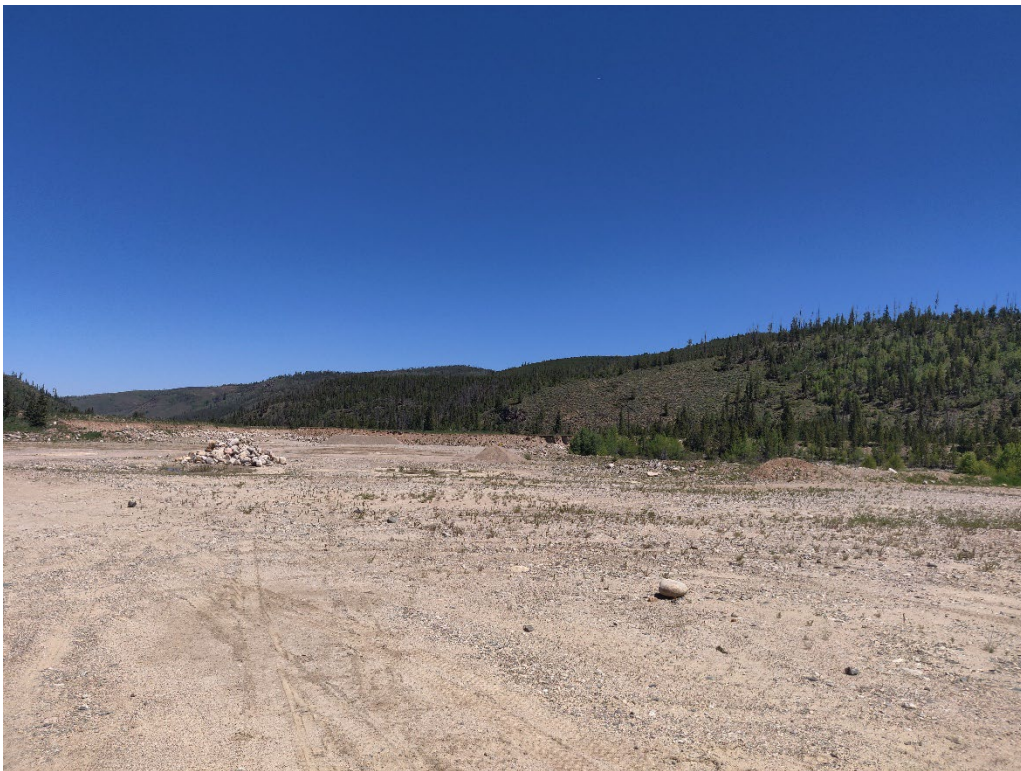
The gravel pit was inactive at the time of the inspection. Stockpiles of material were observed on the pit floor. The Operator stated no additional mining would occur in the north end of the pit. Mining is expected to occur to the south and southeast of the current pit floor when mining operations continue in the future. Groundwater will not be exposed during the future mining operations.

View of the gravel pit floor from the south end looking north
