**MINERALS PROGRAM INSPECTION REPORT**  
**PHONE: (303) 866-3567**

<b>MINE NAME:</b> Henderson Mine	<b>MINE/PROSPECTING ID#:</b> M-1977-342	<b>MINERAL:</b> Molybdenum	<b>COUNTY:</b> Clear Creek, Grand
<b>INSPECTION TYPE:</b> Monitoring	<b>WEATHER:</b> Clear	<b>INSP. DATE:</b> October 25, 2022	<b>INSP. TIME:</b> 10:30
<b>OPERATOR:</b> Climax Molybdenum Company	<b>OPERATOR REPRESENTATIVE:</b> Ben Bates	<b>TYPE OF OPERATION:</b> 112d-3 - Designated Mining Operation	
<b>REASON FOR INSPECTION:</b> Normal I&E Program	<b>BOND CALCULATION TYPE:</b>	<b>BOND AMOUNT:</b> \$135,204,778.00	
<b>DATE OF COMPLAINT:</b> NA	<b>POST INSP. CONTACTS:</b> None	<b>JOINT INSP. AGENCY:</b> None	
<b>INSPECTOR(S):</b> Peter Hays	<b>INSPECTOR'S SIGNATURE:</b>

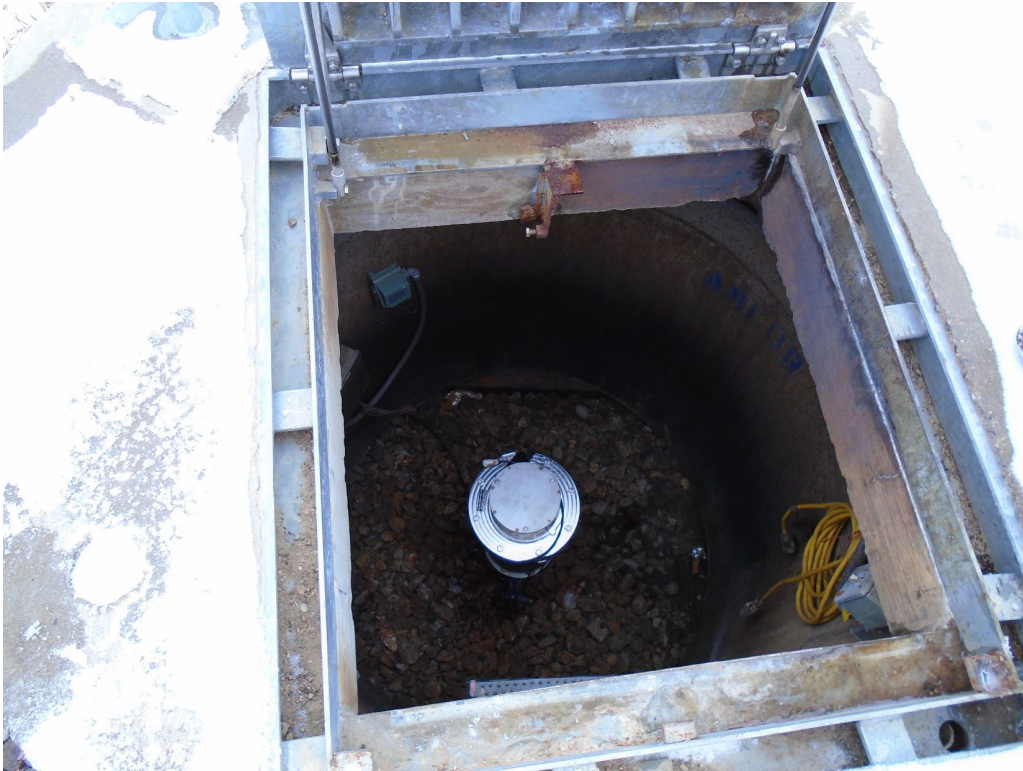
The permanent replacement valve for the mill water return line was installed by the Operator in mid-September. The Operator reported the maintenance for the valve was updated to prevent leaks in the future. The previously observed standing water on the west access road was not present during the inspection. The Operator reported the area was dry by mid-August.

View of the permanent mill water return line valve

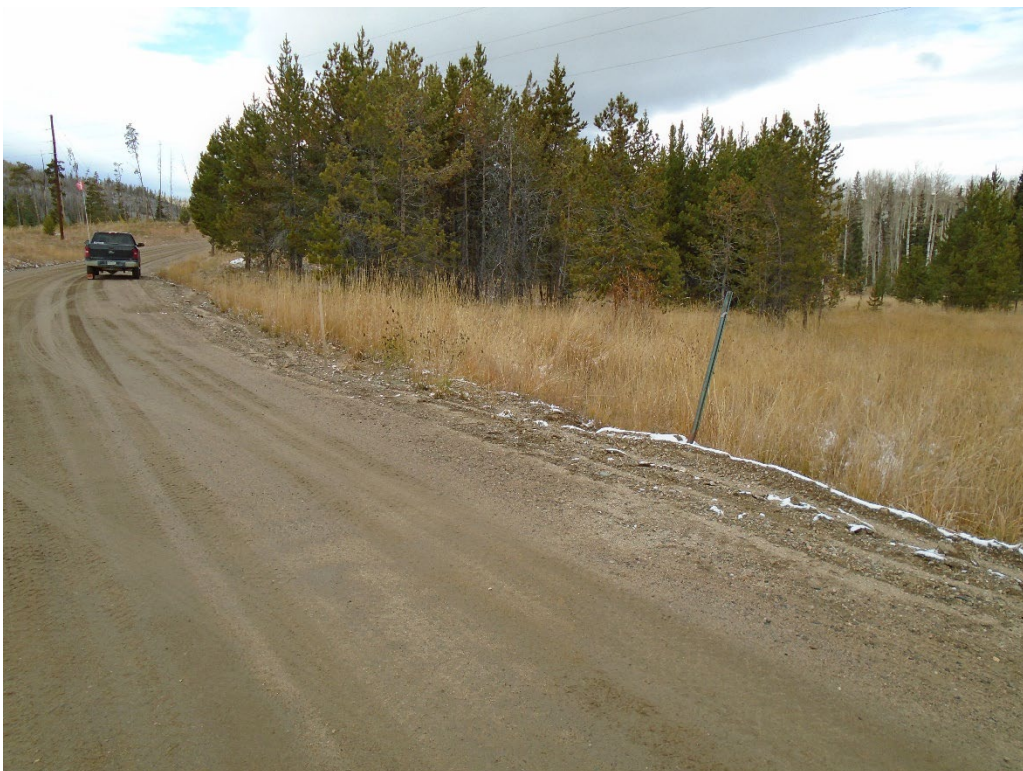
View of the location of the previous mil water return line surface water exposure

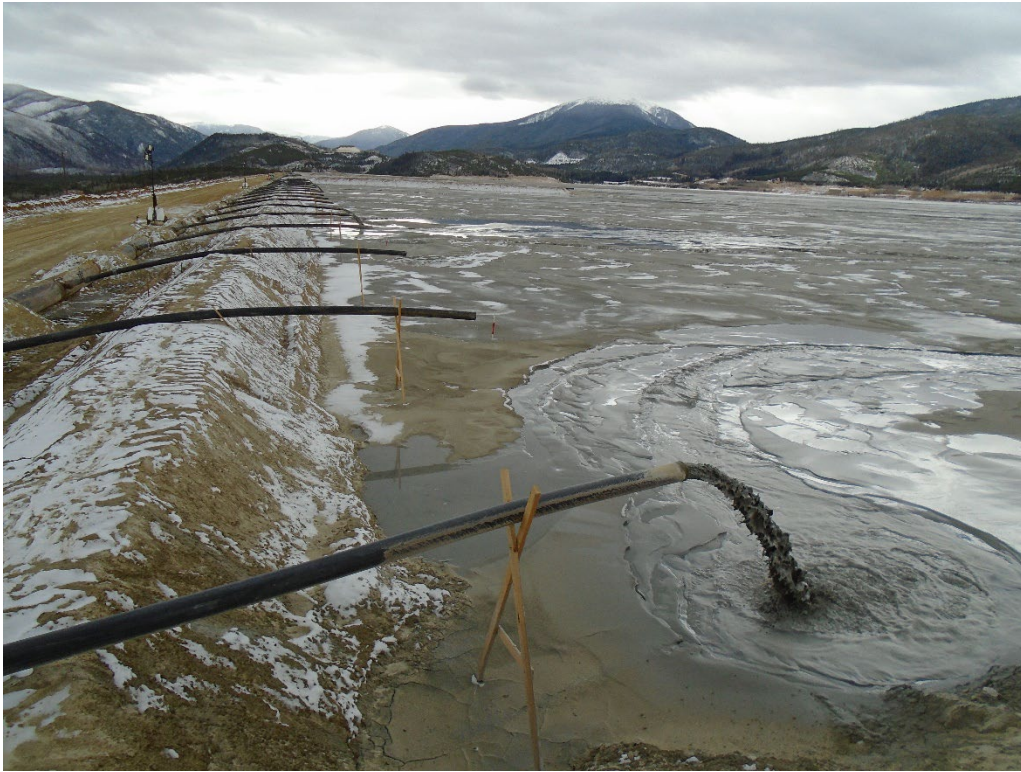
The 1-Dam crest raise construction is complete for the entire length of the dam. The Operator reported the raise was completed in late September to early October. Spigot deposition was observed in Cell 7 during the inspection. Cells 8 and 9 were prepared for spigot deposition prior to the Operator switching to leadoff deposition through the winter.

View of spigot deposition in Cell 7 on 1-Dam

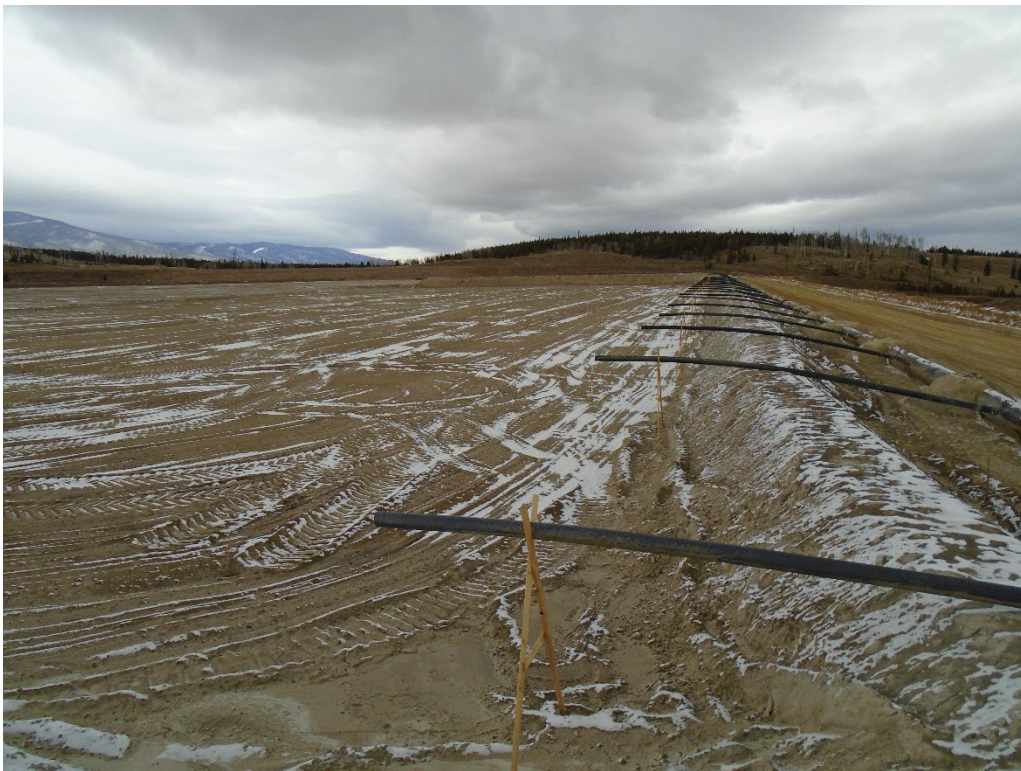
View of Cell 8 on 1-Dam

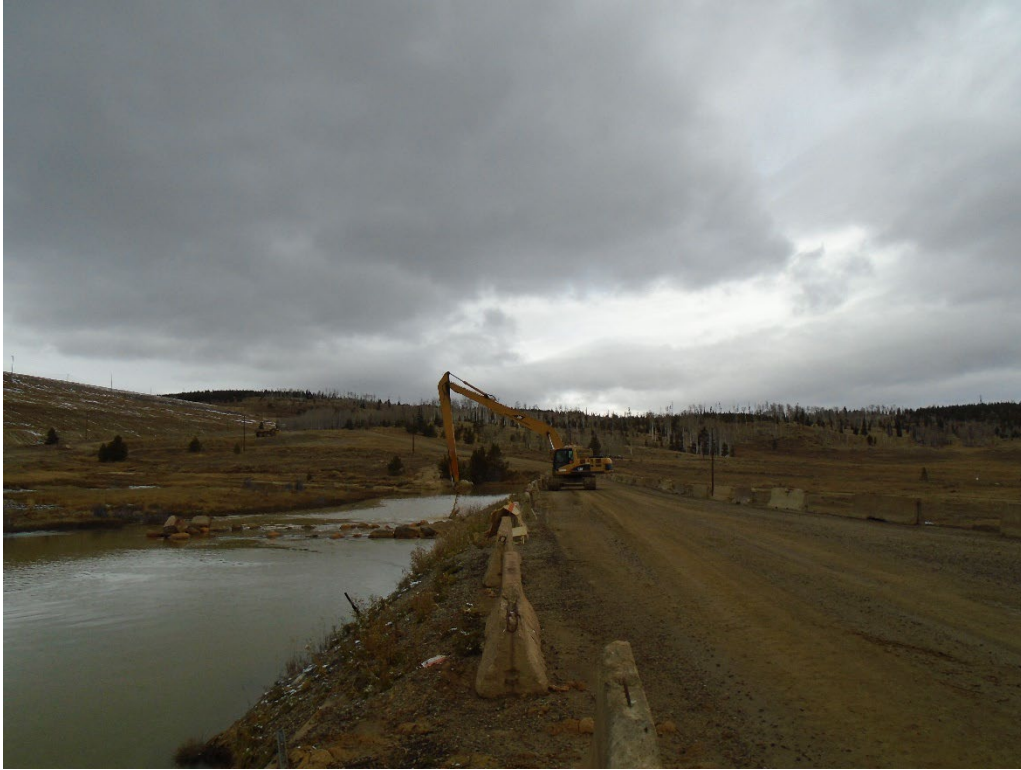
The dredging of the north seep water canal was observed during the inspection. The tailings were being transported by haul truck to the seep water collection and return system approved by the Division under TR33.

View of the north seep canal dredging operation
