MINERALS PROGRAM INSPECTION REPORT

MINE NAME: Slab Canyon Quarry	MINE/PROSPECTING ID#: M-1977-347	MINERAL: Limestone (general)	COUNTY: Larimer
INSPECTION TYPE: Monitoring	INSPECTOR(S): Amy Eschberger	INSP. DATE: August 31, 2022	INSP. TIME: 12:15
OPERATOR: Holcim (US) Inc.	OPERATOR REPRESENTATIVE: Mike Toelle, Tom Newman	TYPE OF OPERATION: 112c - Construction Regular Operation	
REASON FOR INSPECTION: Normal I&E Program	BOND CALCULATION TYPE: None	BOND AMOUNT: \$184,819.00	
DATE OF COMPLAINT: NA	POST INSP. CONTACTS: None	JOINT INSP. AGENCY: None	
WEATHER: Clear	INSPECTOR'S SIGNATURE:

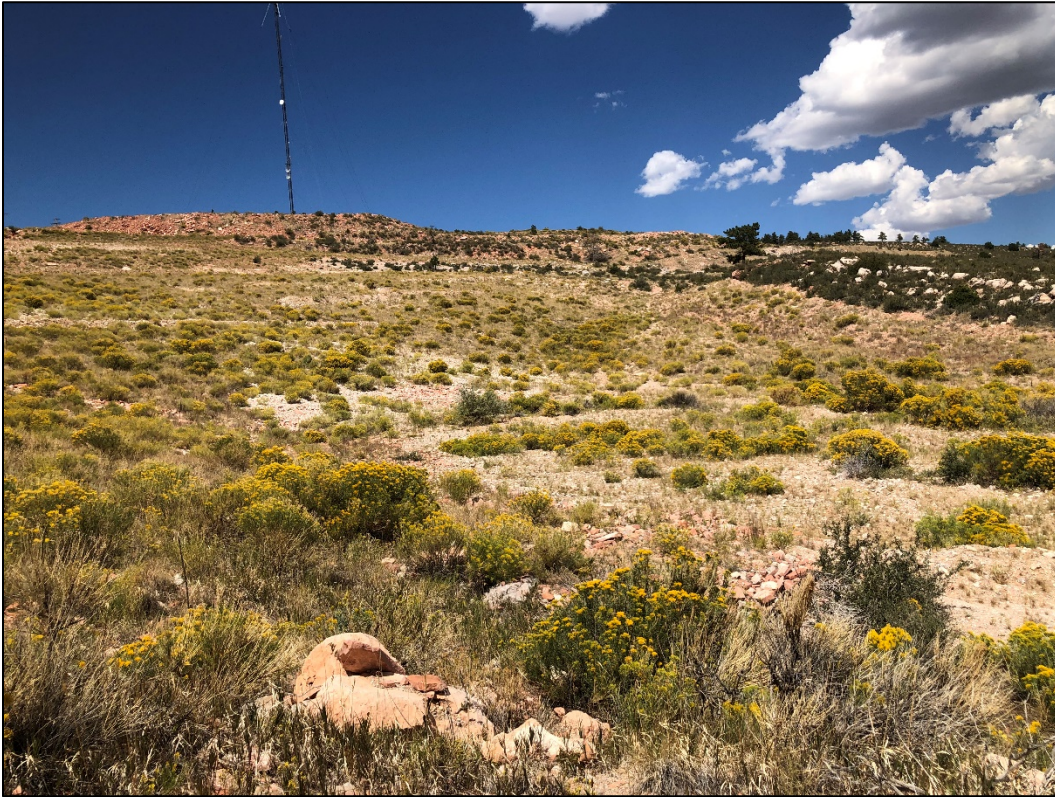
Photo 1. View looking west across reclaimed area at base of ridge (adjacent to access road).

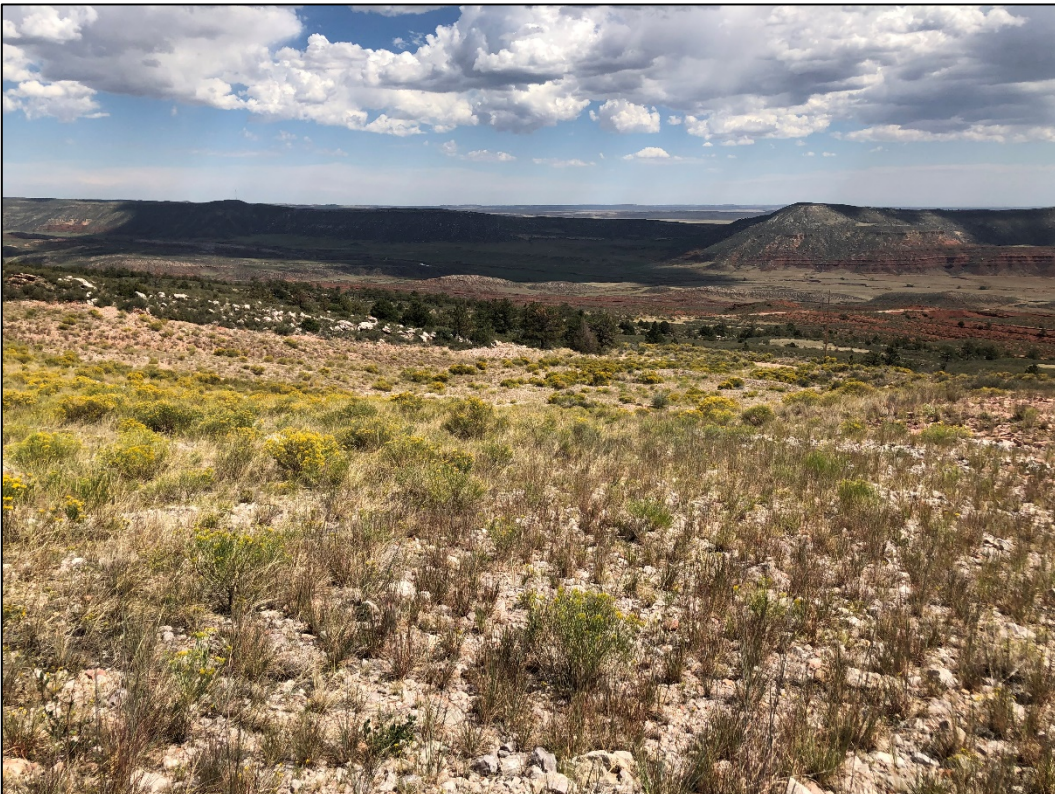
Photo 2. View looking east across reclaimed area at base of ridge (adjacent to access road).

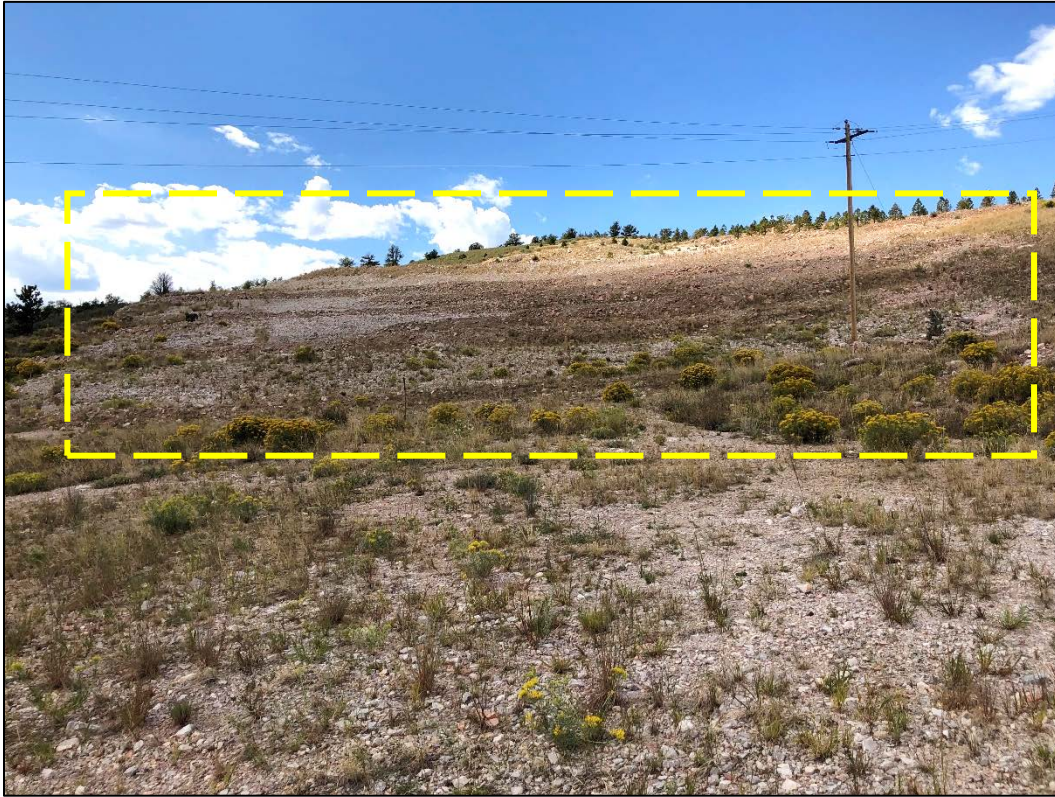
During the current inspection, the Division observed the berms that had been constructed across the east-facing slope in accordance with TR-2. This modified configuration of the slope appeared to be more stable and no erosion issues were observed. However, none of the trees planted in 2019 had survived. There were some grasses observed growing in the depressions between the berms, and the last few downgradient berms had more grass and shrub cover. However, the majority of this slope was still void of vegetation. During the inspection, there was discussion about submitting an additional Technical Revision to further modify the revegetation plan for this slope, which has proven very difficult to revegetate. One of the possibilities discussed was removing trees from the revegetation plan since their success rate on this slope has been 0%, even with the modifications made per TR-2.

Photo 3. View looking west at portion of east-facing slope undergoing reclamation (indicated).

It is clear the operator has put forth significant efforts over the years to complete reclamation of the east-facing slope. Nonetheless, the operator should be reminded of Rule 3.1.3, which requires that all reclamation be carried to completion with all reasonable diligence, and that each phase of reclamation be completed within 5 years from the date that reclamation of such phase commenced. Given the amount of time that has passed since mining ceased and final reclamation of the site was initiated, the Division recommends the operator either reseed/replant the bare slope or submit a Technical Revision to revise the revegetation plan for this slope as soon as feasible.

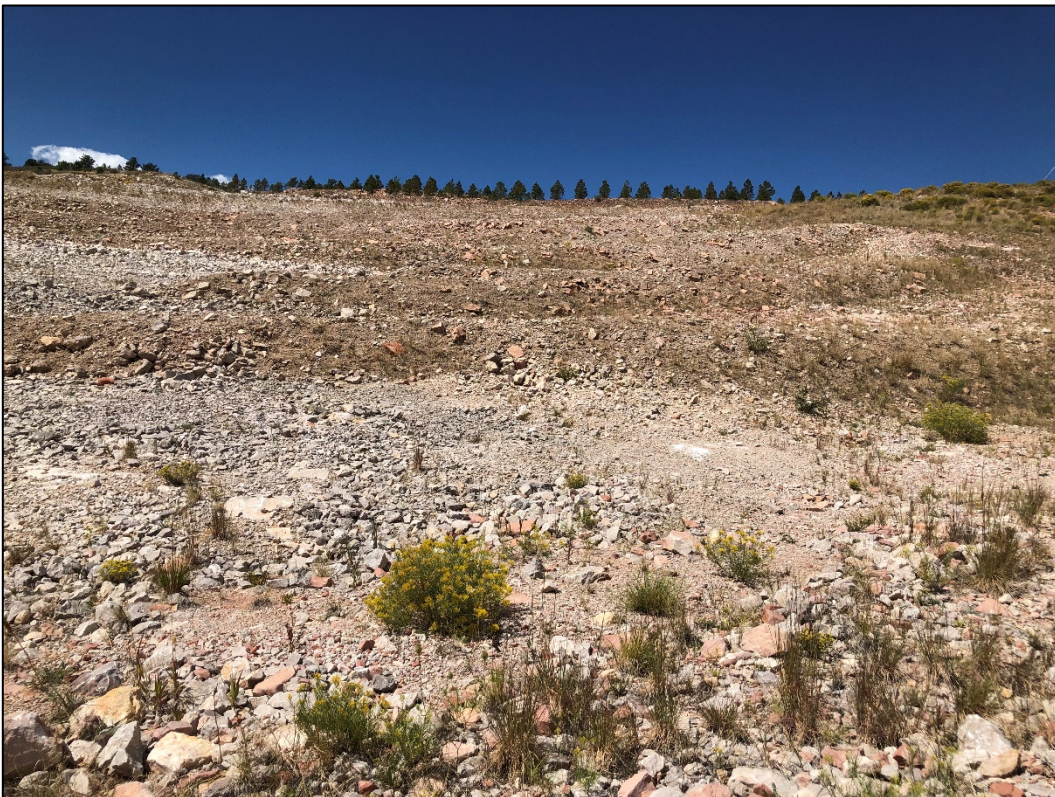
Photo 4. View looking west showing closer view of east-facing slope undergoing reclamation.

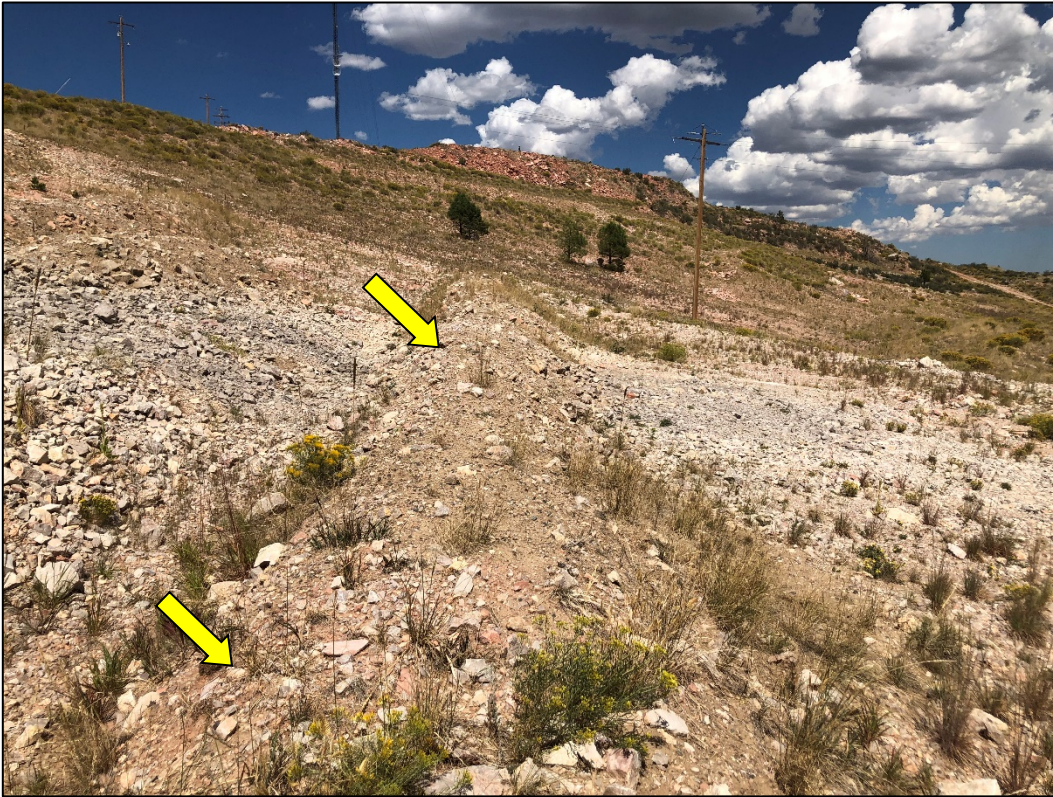
Photo 5. View looking north at berm (indicated) constructed across east-facing slope undergoing reclamation. Note some grasses and shrubs growing along edges of berm, but no trees per approved plan.

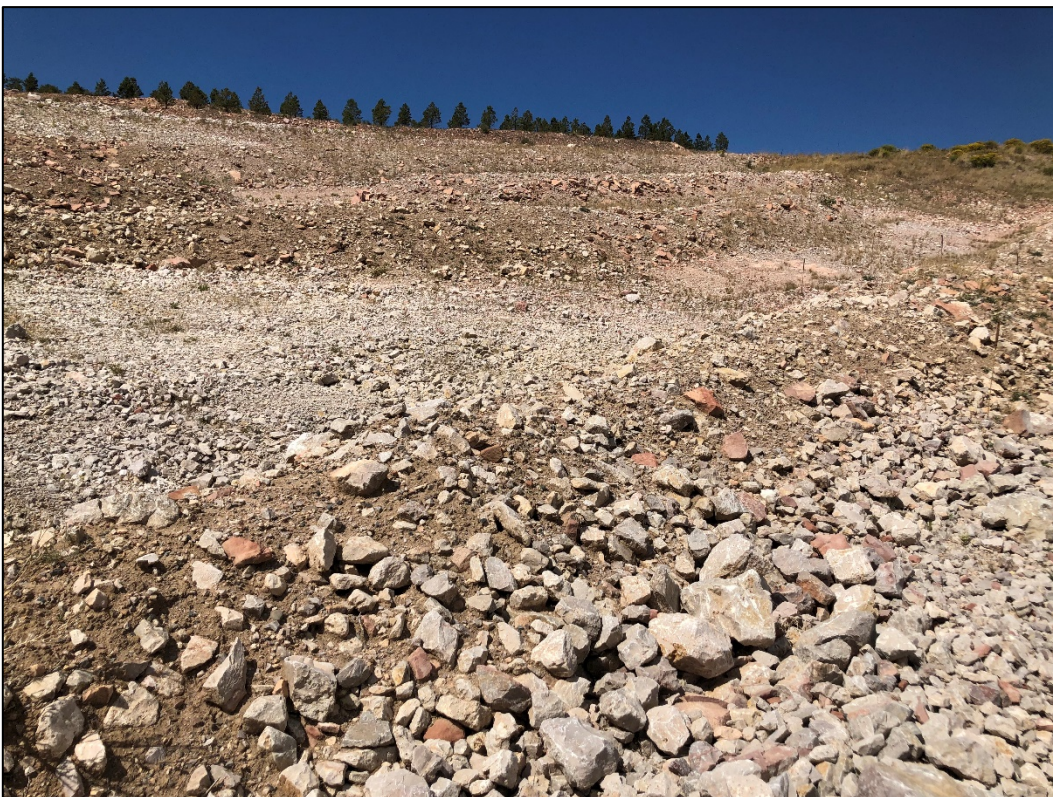
Photo 6. View looking northwest across top half of east-facing slope undergoing reclamation. Note berms constructed across slope in accordance with TR-2, but no vegetation growing in this area.

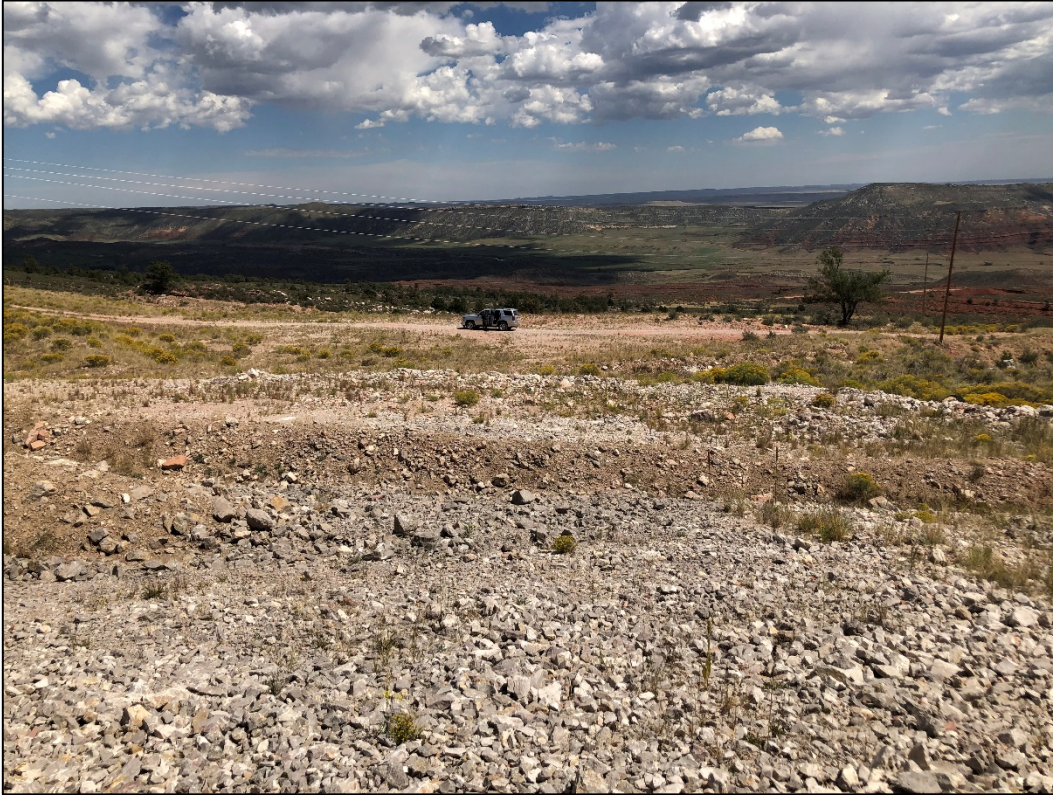
Photo 7. View looking east across bottom half of east-facing slope undergoing reclamation. Note berms constructed across slope in accordance with TR-2, but very little to no vegetation growing in this area.

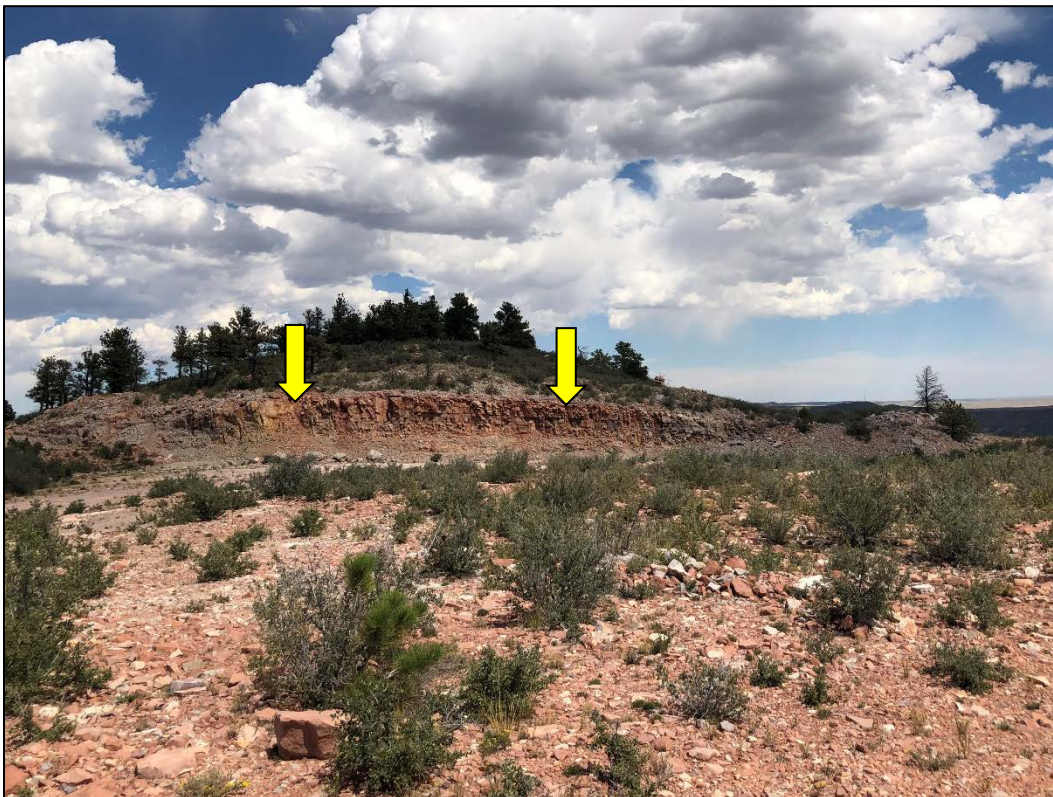
Photo 8. View looking north at small section of steep rock wall (indicated) left along northern edge of ridge top disturbance, which will remain as-is for final reclamation. Backfilling this portion of the wall was complicated by its location adjacent to the access road.

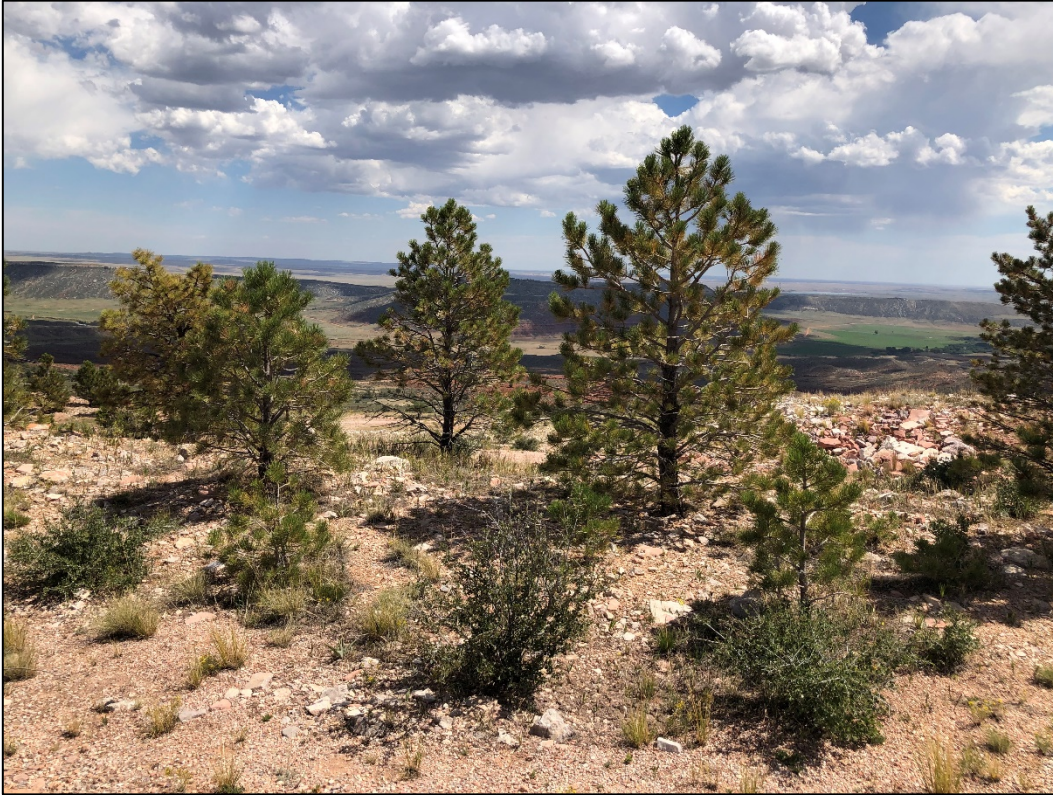
Photo 9. View looking east at tree pad constructed on top of ridge, showing vegetation on pad comprised of grasses, shrubs, and pine trees.

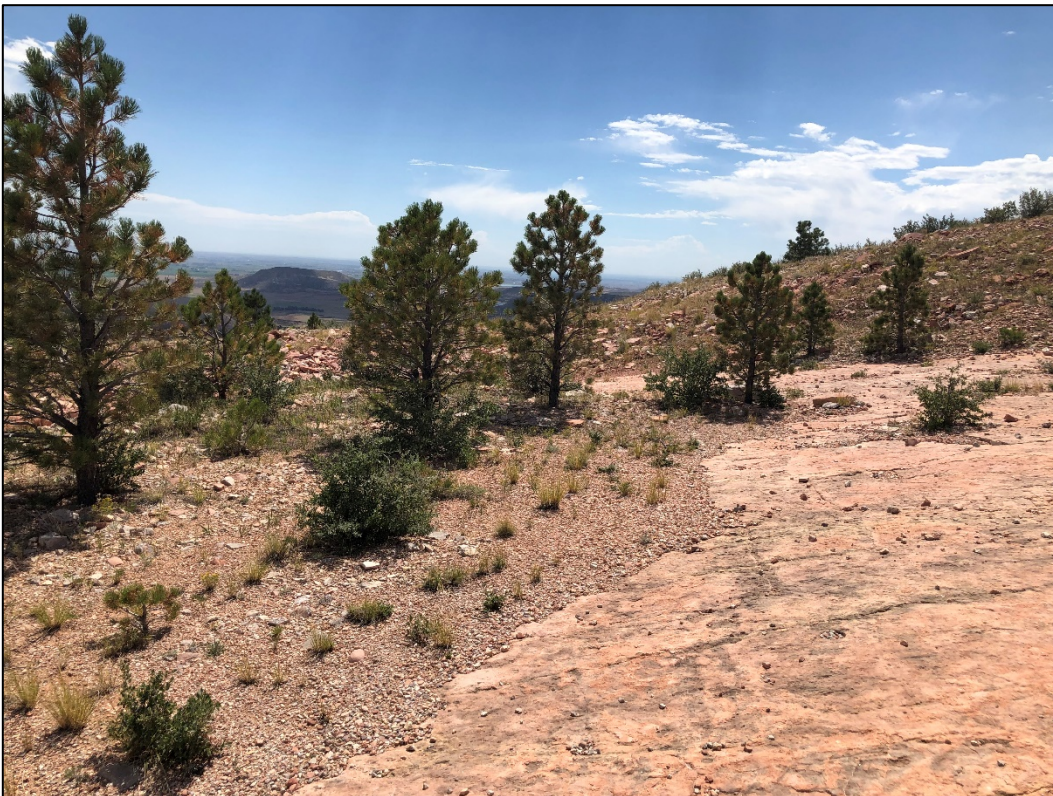
Photo 10. View looking south across top of ridge, showing tree pad (at left) with vegetation comprised of grasses, shrubs, and pine trees. Note trees volunteering into bare rock areas between pads (at right).

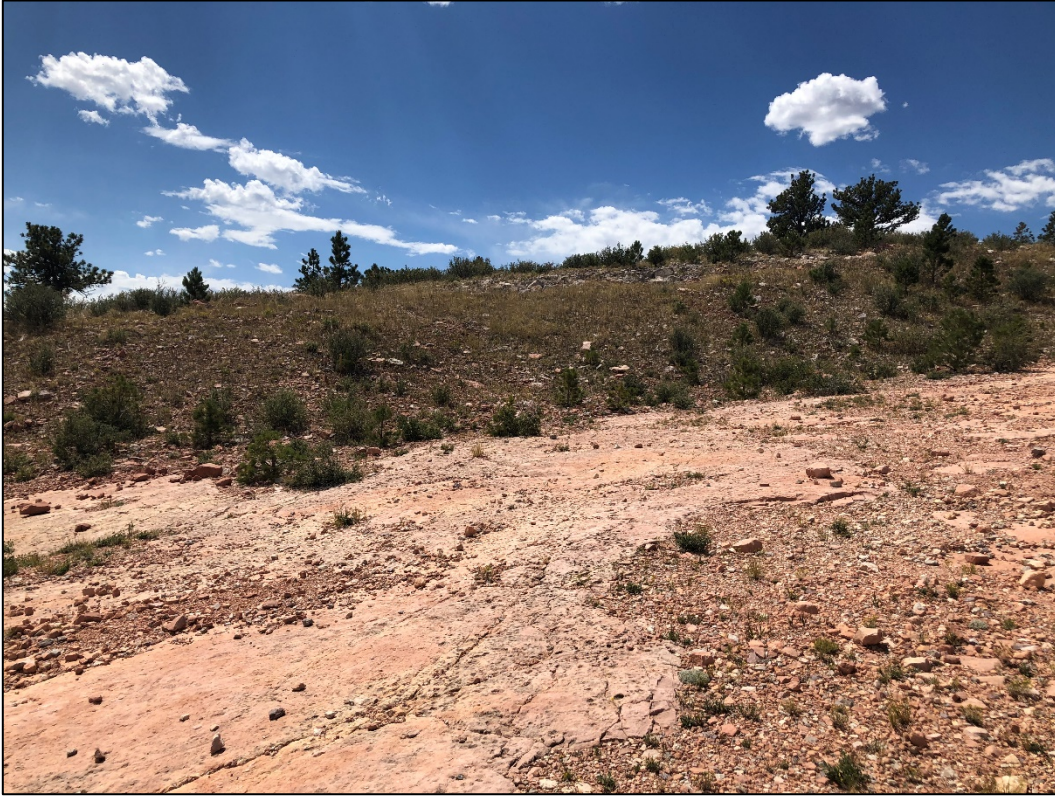
Photo 11. View looking south at reclaimed southern wall of ridge top disturbance.

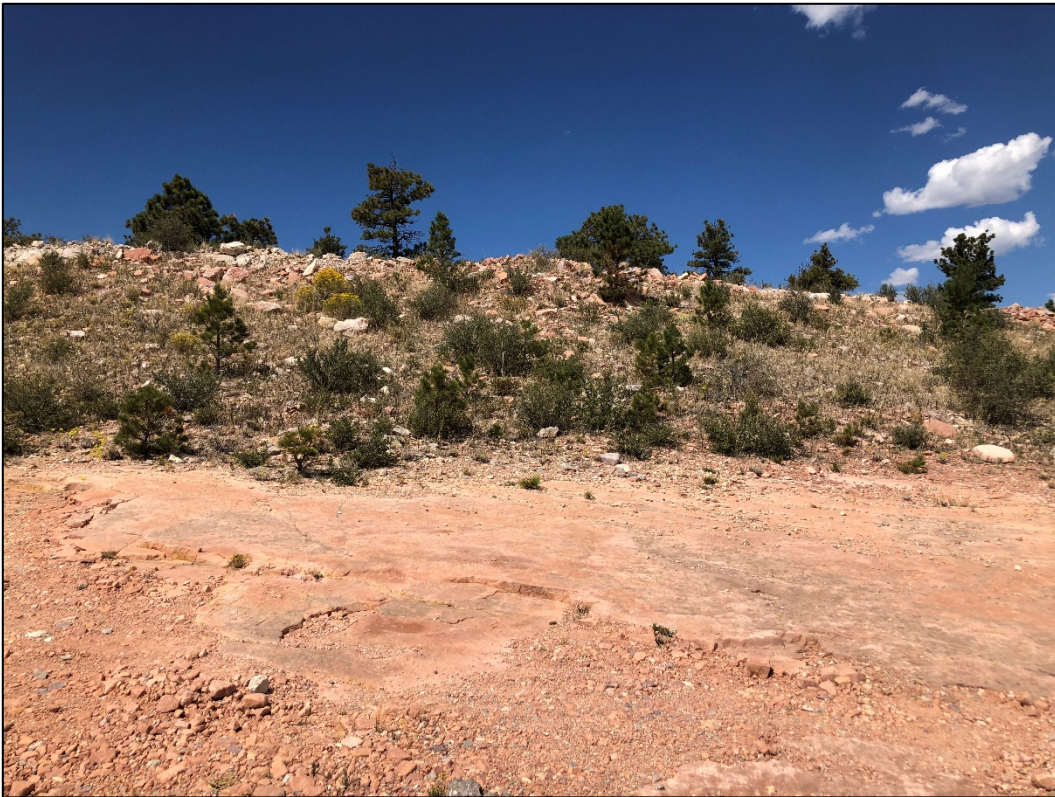
Photo 12. View looking west at reclaimed western wall of ridge top disturbance.

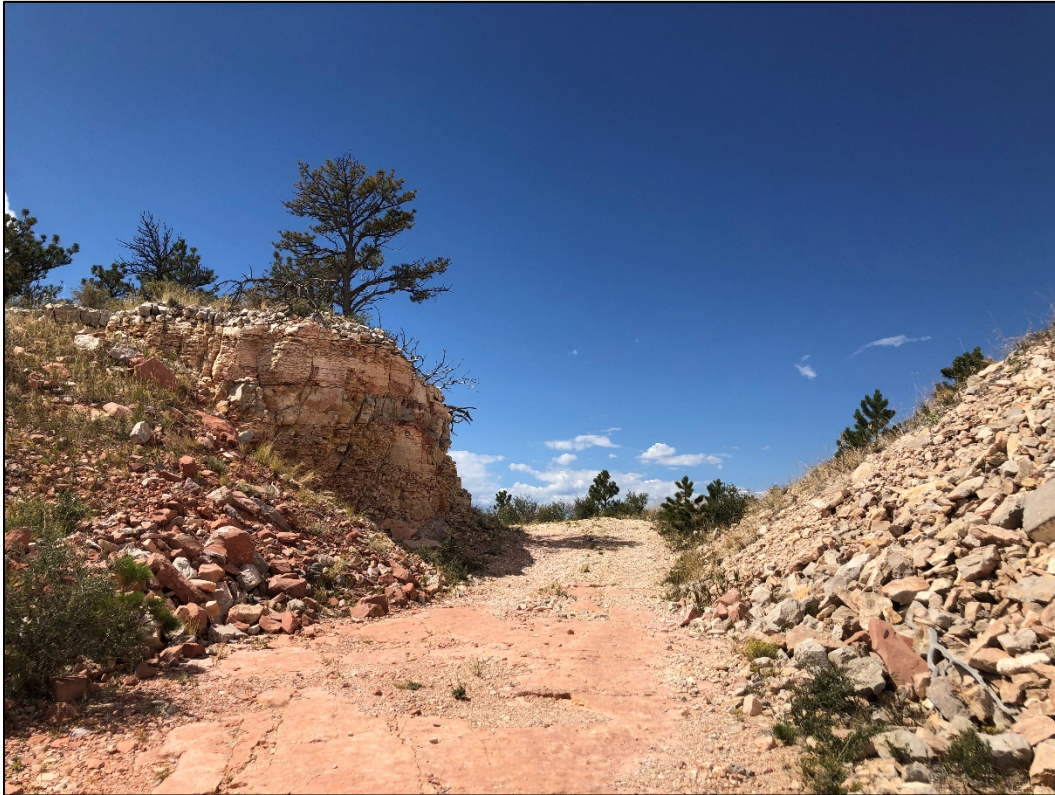
Photo 13. View looking west at small section of steep rock wall that will remain at southwestern corner of ridge top disturbance, where road exits this area to the west/southwest.

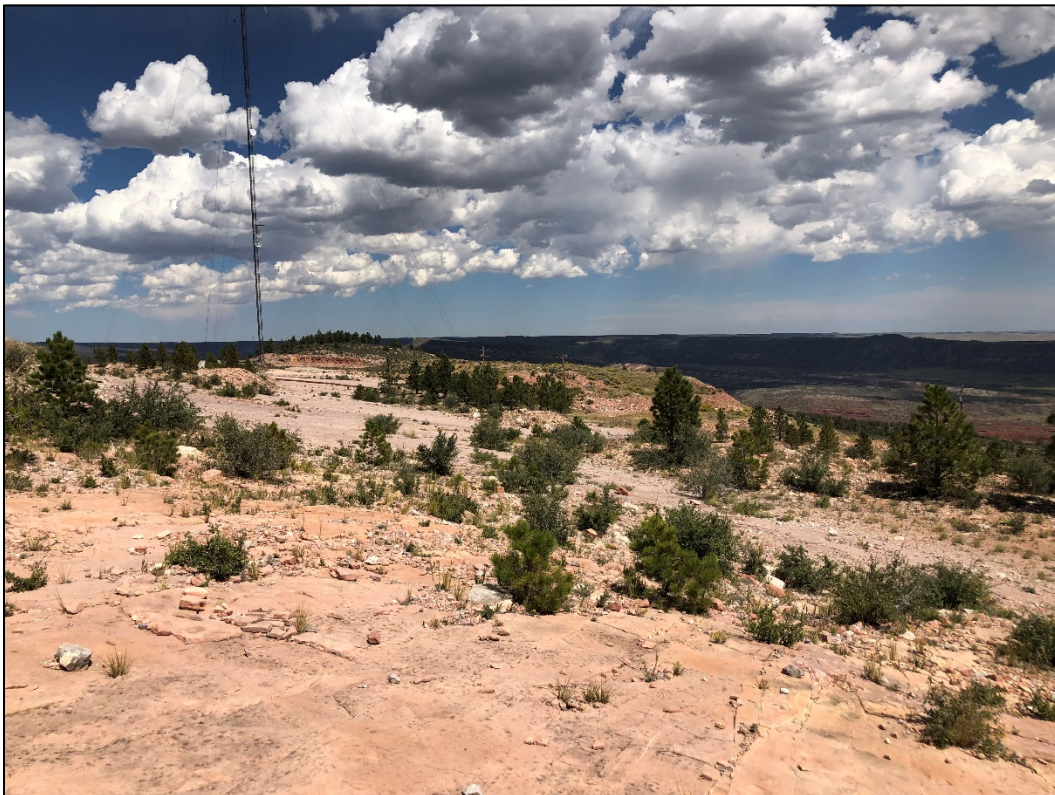
Photo 14. View looking north across ridge top disturbance, showing grasses, shrubs, and trees volunteering into bare rock areas between tree pads. Note radio tower at top of ridge (in background, at left) which will remain for final reclamation.

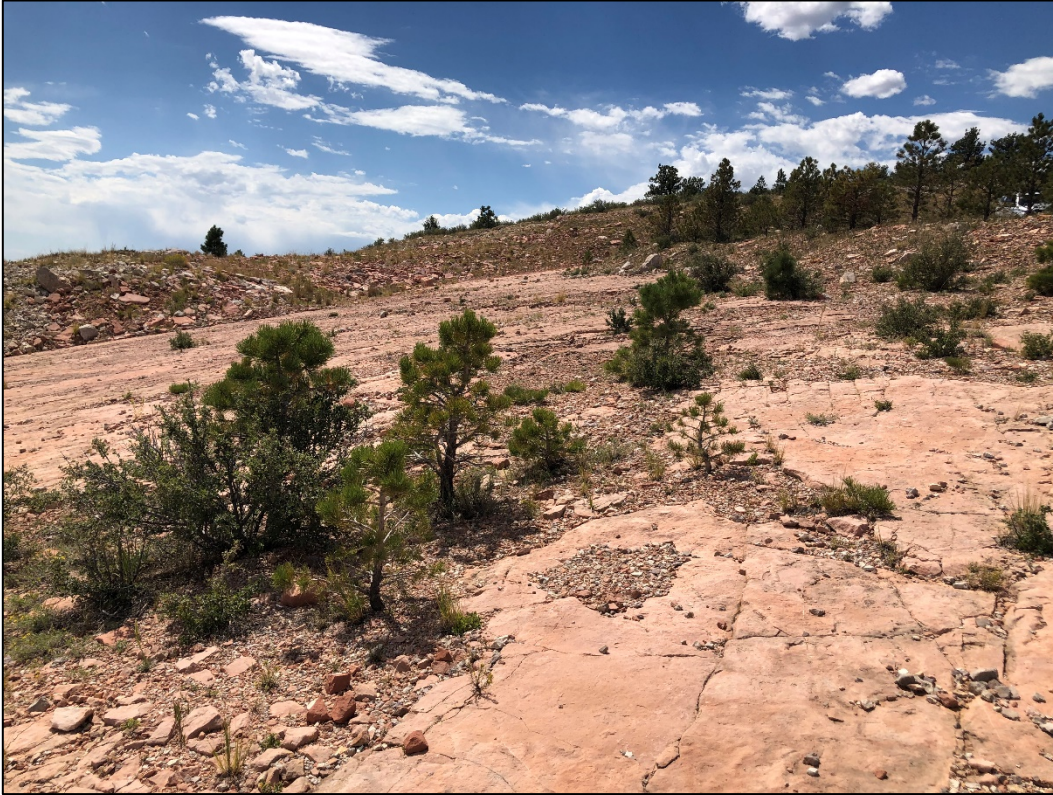
Photo 15. View looking south across ridge top disturbance, showing grasses, shrubs, and trees volunteering into bare rock areas between tree pads

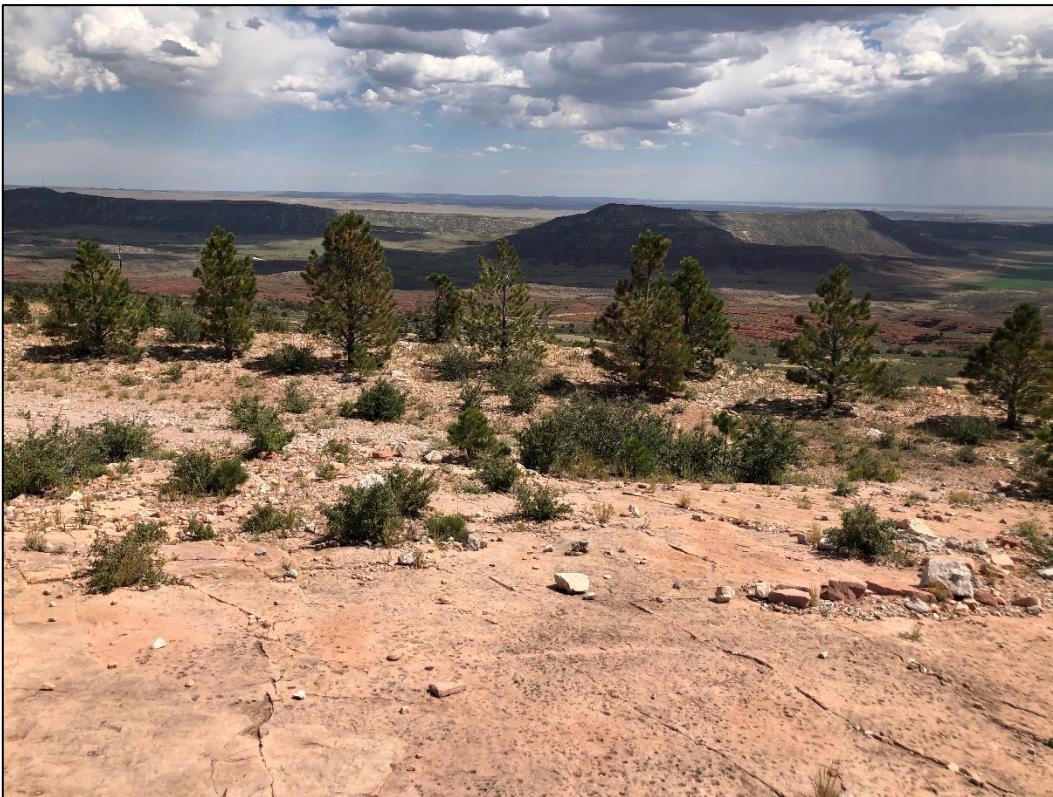
Photo 16. View looking east across ridge top disturbance, showing tree pad with vegetation comprised of grasses, shrubs, and pine trees. Note vegetation volunteering into bare rock areas between pads.

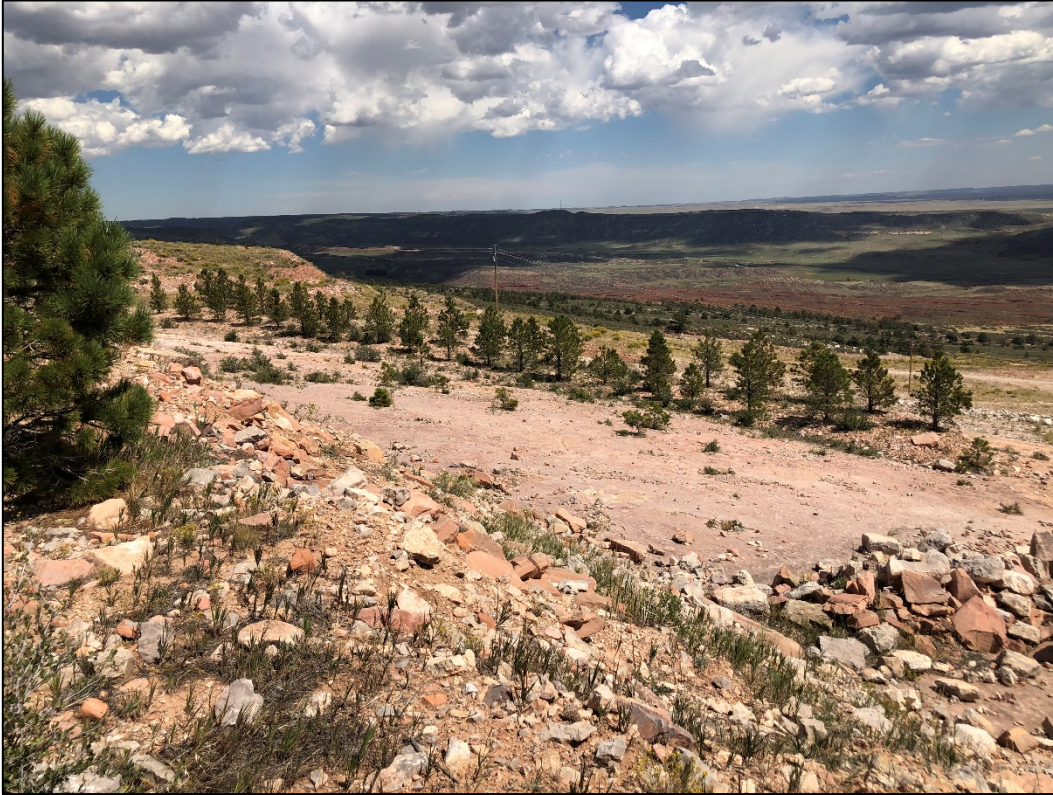
Photo 17. View looking east/northeast from top of tree pad constructed on ridge top, looking toward another tree pad constructed downslope.

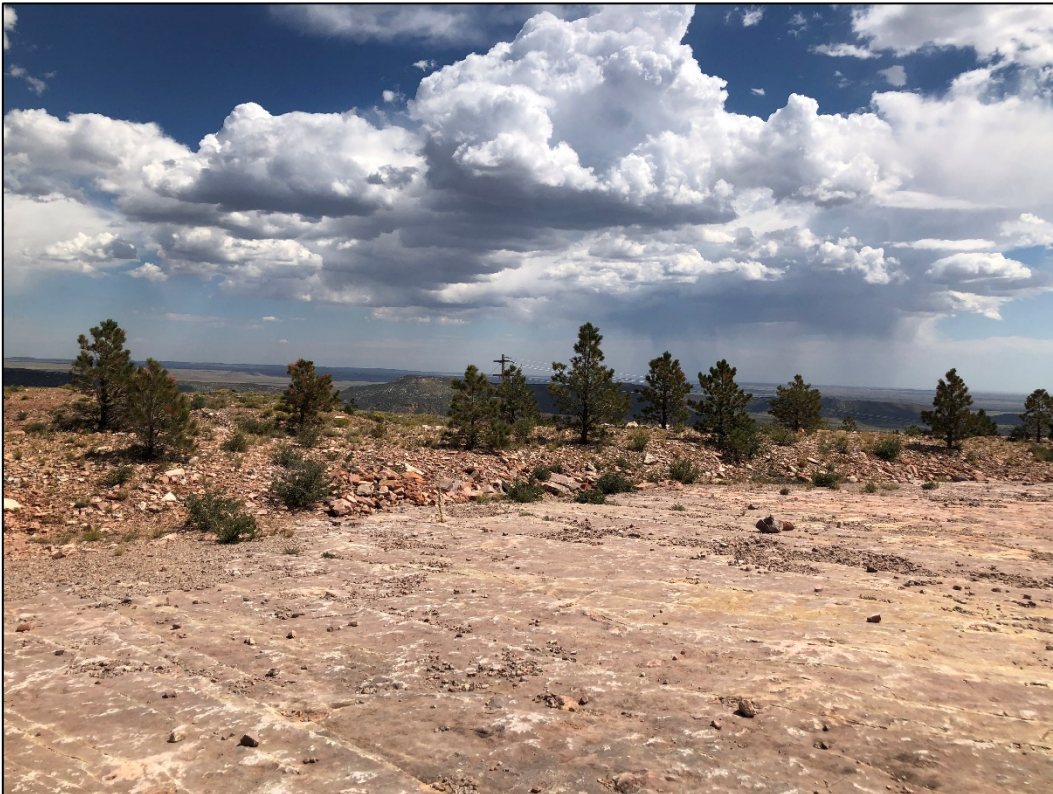
Photo 18. View looking east/southeast across ridge top, showing tree pad (in background) with bare rock exposed in between pads (in foreground).

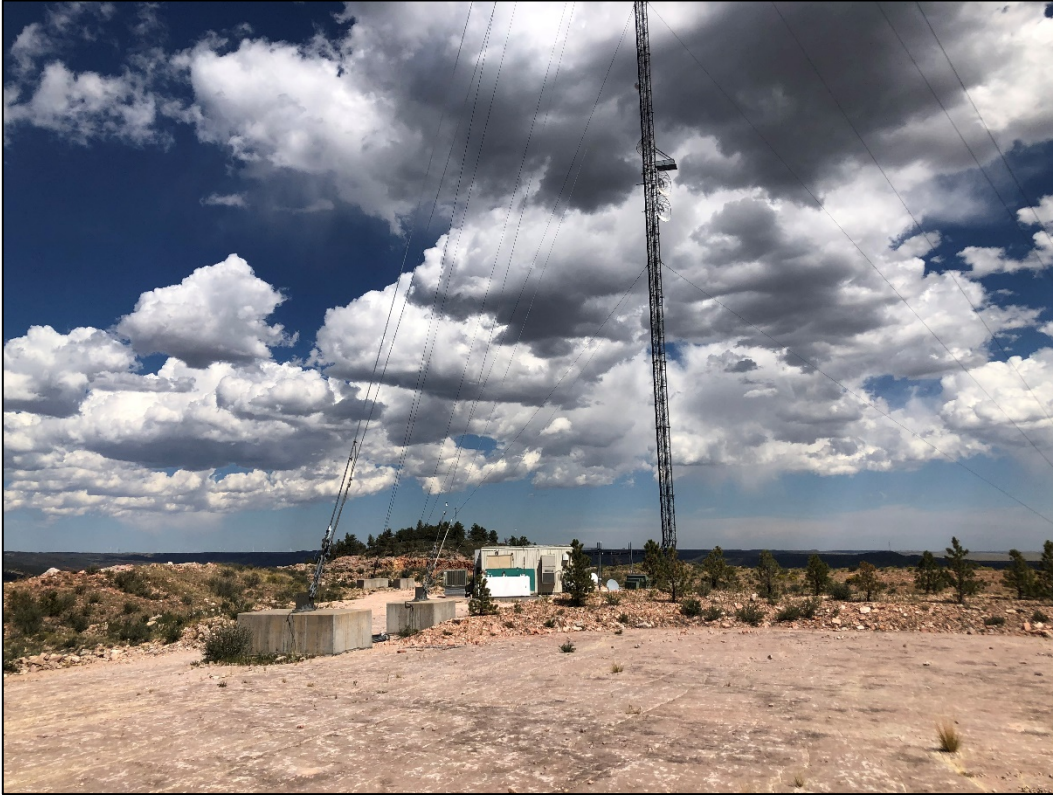
Photo 19. View looking north at radio tower on top of ridge, which will remain for final reclamation.

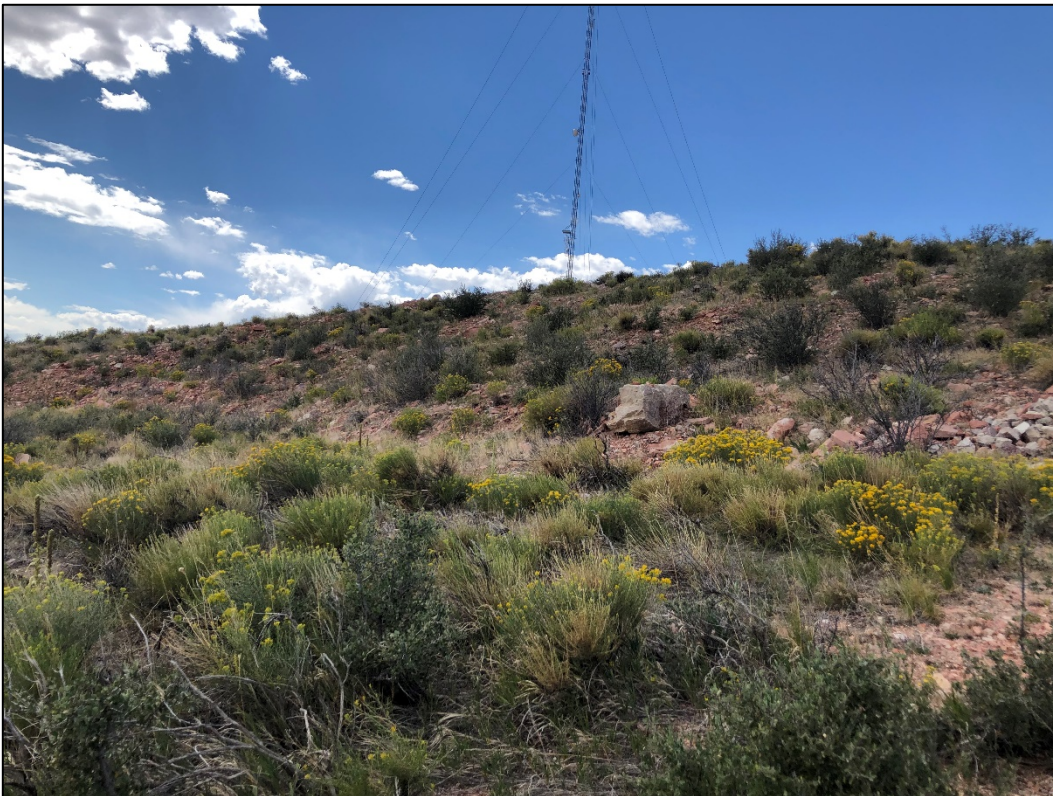
Photo 20. View looking west across reclaimed northern portion of east-facing slope.

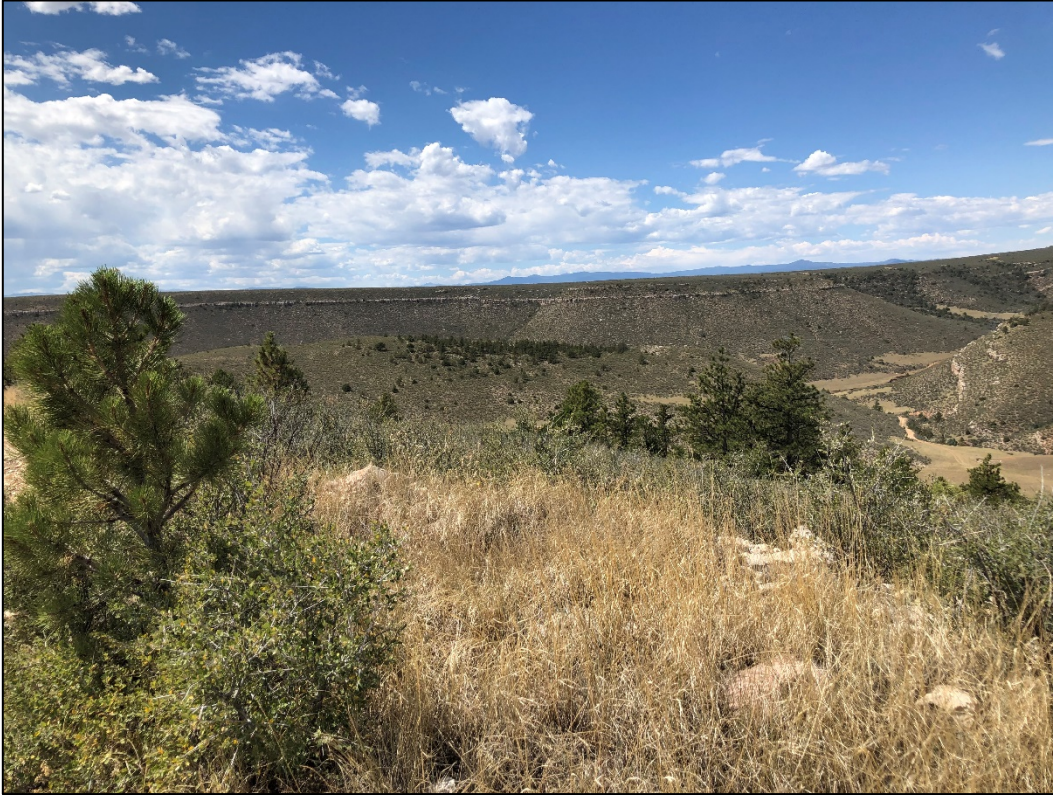
Photo 21. View looking southwest across undisturbed portion of permit area located south/southwest of phase 1 disturbance.
