MINERALS PROGRAM INSPECTION REPORT
PHONE: (303) 866-3567

MINE NAME: Thornburg Pit	MINE/PROSPECTING ID#: M-1983-060	MINERAL: Sand and gravel	COUNTY: Adams
INSPECTION TYPE: Monitoring	WEATHER: Clear	INSP. DATE: October 26, 2022	INSP. TIME: 10:00
OPERATOR: Thornburg Family Limited Partnership	OPERATOR REPRESENTATIVE: John Wakeham and Stanley Thornburg	TYPE OF OPERATION: 112c - Construction Regular Operation	
REASON FOR INSPECTION: Normal I&E Program	BOND CALCULATION TYPE:	BOND AMOUNT: No Bond Held	
DATE OF COMPLAINT: NA	POST INSP. CONTACTS: None	JOINT INSP. AGENCY: None	
INSPECTOR(S): Nikie Gagnon	INSPECTOR'S SIGNATURE:

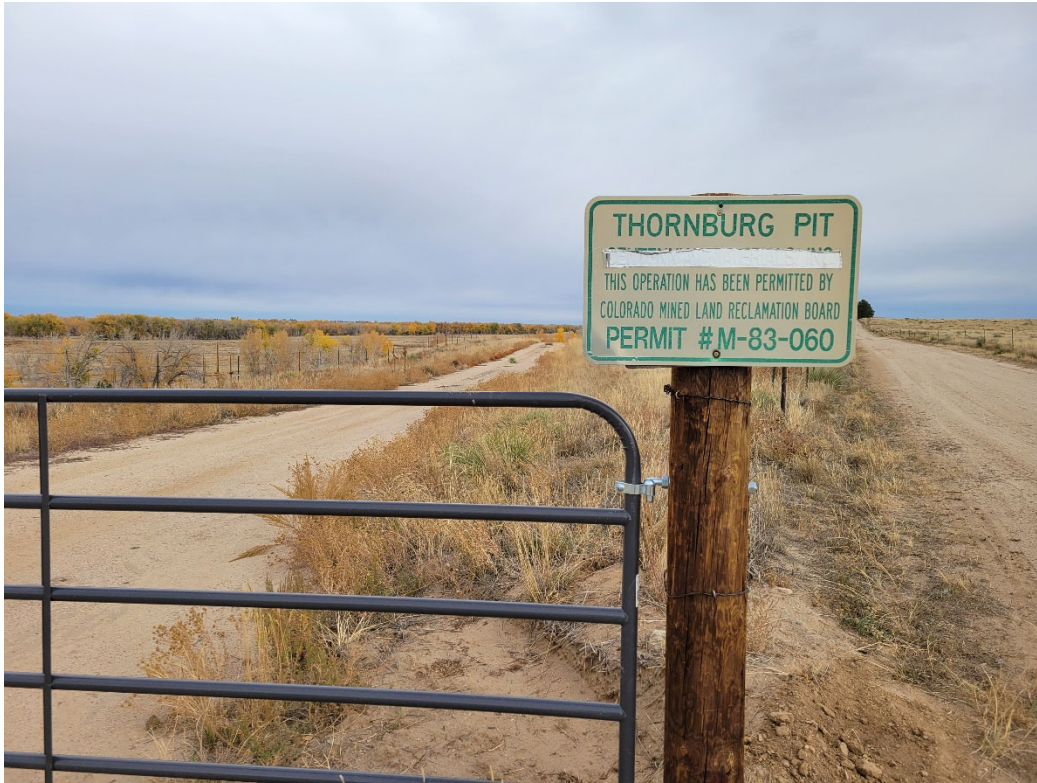
The permit identification sign was in place at the entrance to the site. The permit boundary markers were observed in place around the perimeter.

Mine sign at the entrance to site. Gravel access road leads to active mining area.

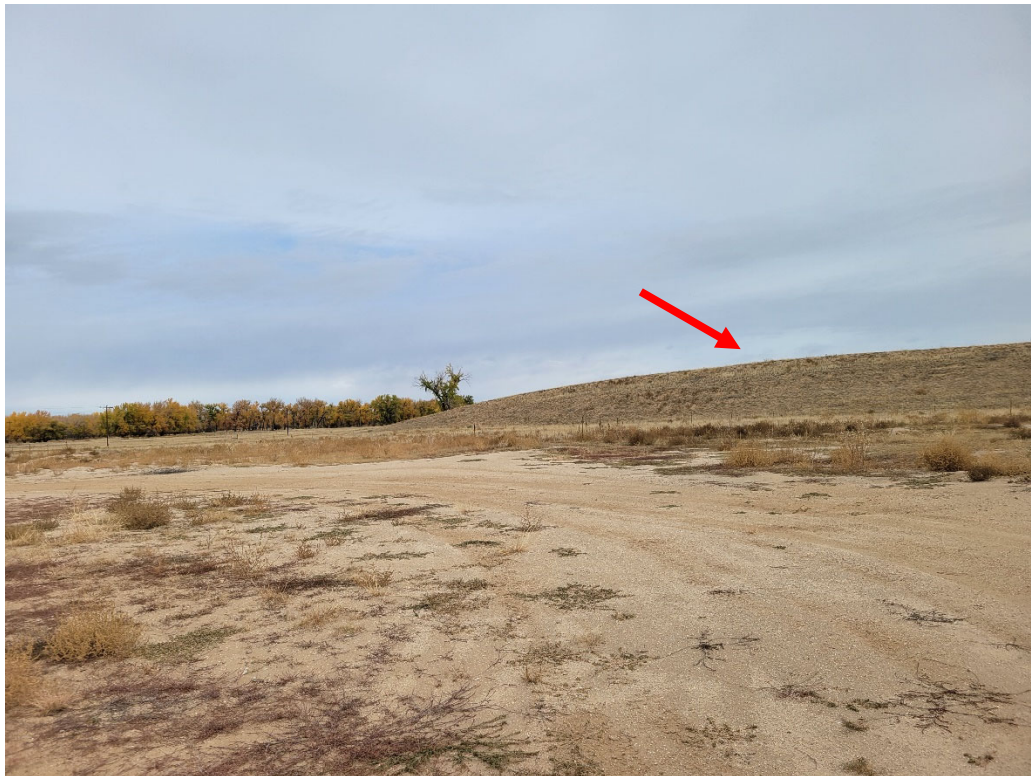
The topsoil stockpile is located on the north side of the affected land. This pile is stable and vegetated and appears to have been in place for a while.

Looking north at the topsoil pile (red arrow). Trees along Kiowa Creek in the background.

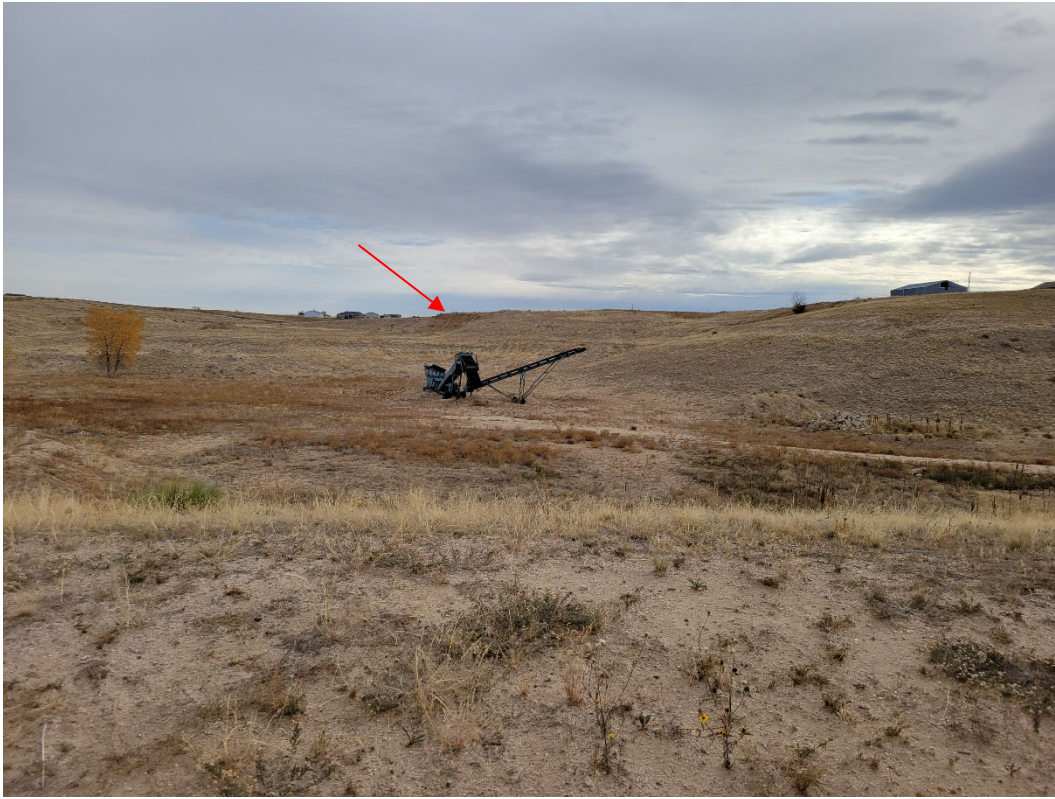
The affected area of the mine is estimated to be about six acres in size. Mining has been conducted in the M1, M2 and M3 phased areas and the operator appears to be conducting concurrent reclamation. Two un-reclaimed excavated areas exist at the site. One is a small pit within the M2/M3 area with a highwall that is 18 feet high and approximately 300 feet in length. This area appears to be inactive. The second pit is located in the M1/M2 area and daylight to the north. The highwall in this area is nearly vertical, approximately 20 feet in height and about 350 feet in length. John Wakeham indicated this M2 pit will be the area of mining after the transfer. The reclaimed areas within M1, M2, and M3 have gentle slopes that are at a 3H:1V angle or less.

Looking northeast across reclamation area 2. Red arrow points to small pit excavation in M2/M3 area.

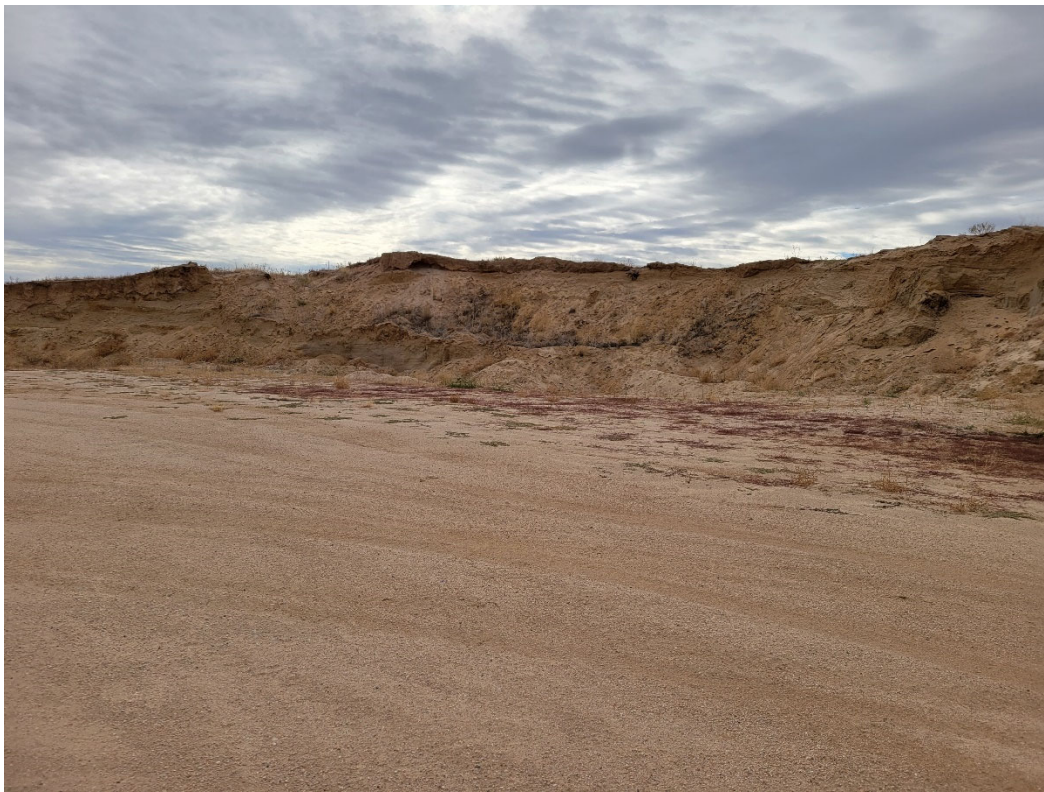
Looking southeast at the highwall in the M2 area. Successor indicates this will be the area of active mining.

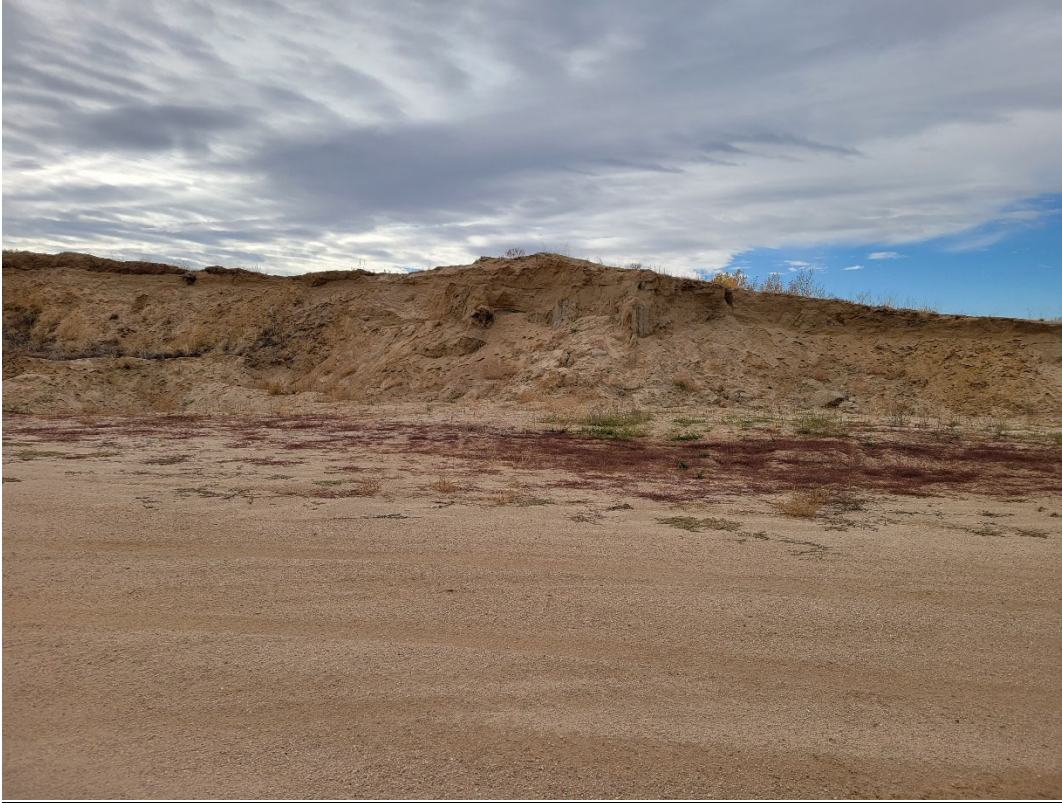
Looking south at highwall in the M2 area. Successor indicates this will be the area of active mining.

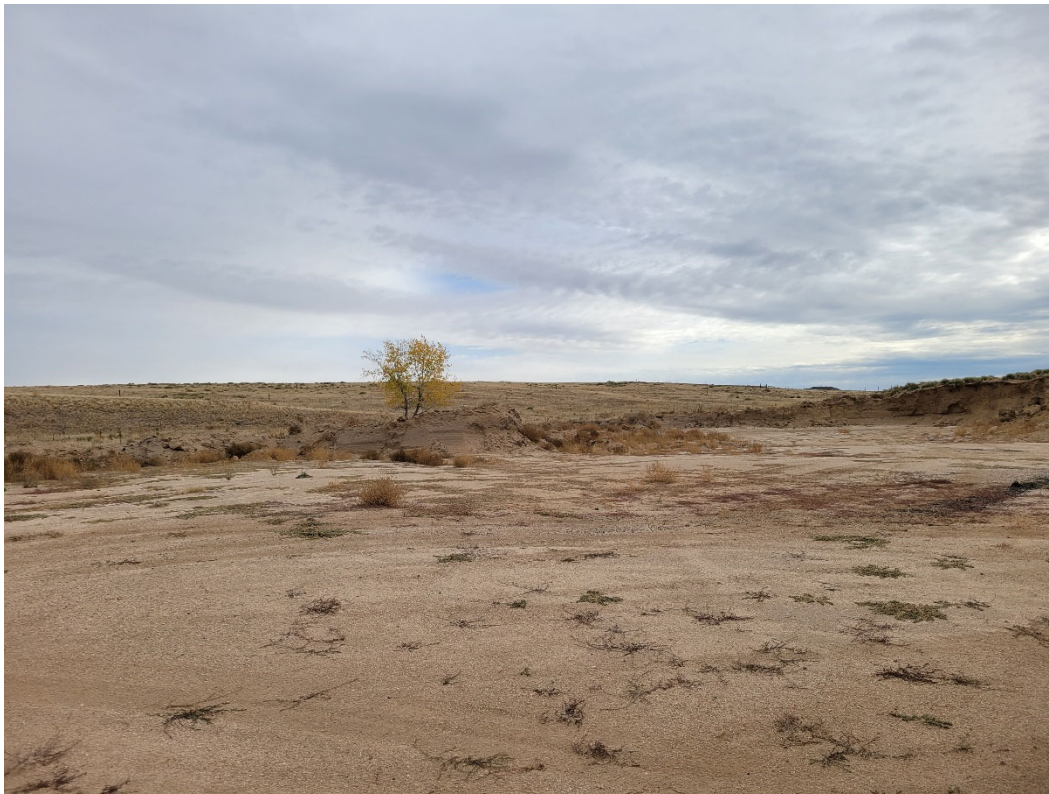
Looking east from M2 pit floor. Reclaimed M3 area in the distance.
