MINERALS PROGRAM INSPECTION REPORT
PHONE: (303) 866-3567

MINE NAME: Richardson Pit	MINE/PROSPECTING ID#: M-2021-014	MINERAL: Borrow material for	COUNTY: Cheyenne
INSPECTION TYPE: Monitoring	WEATHER: Clear	INSP. DATE: October 25, 2022	INSP. TIME: 10:00
OPERATOR: Castle Rock Construction Company of Colorado	OPERATOR REPRESENTATIVE: Travis Bell	TYPE OF OPERATION: 111 - Construction by Government Agency	
REASON FOR INSPECTION: Normal I&E Program	BOND CALCULATION TYPE: Complete Bond	BOND AMOUNT: \$12,500.00	
DATE OF COMPLAINT: NA	POST INSP. CONTACTS: None	JOINT INSP. AGENCY: None	
INSPECTOR(S): Nikie Gagnon	INSPECTOR'S SIGNATURE:

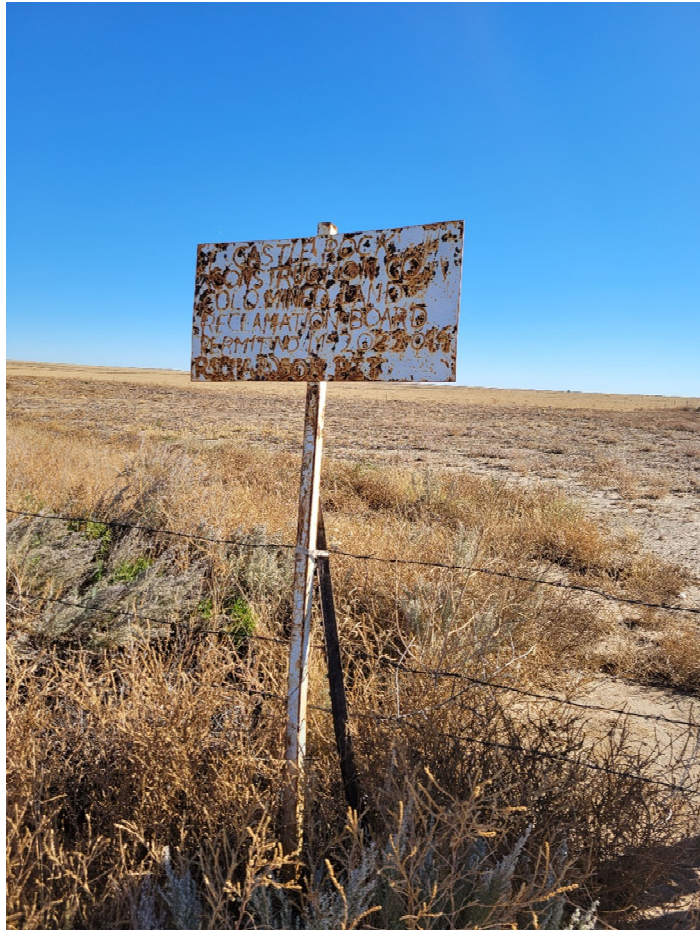
The mine entrance sign was in place facing US 287. The sign is rusted and faded, however, the permit number and permittee name is still legible. The Division recommends replacing the sign. The permit boundary markers were in place. A barbed wire fence surrounds the permit area.

Sign at the entrance to the site.

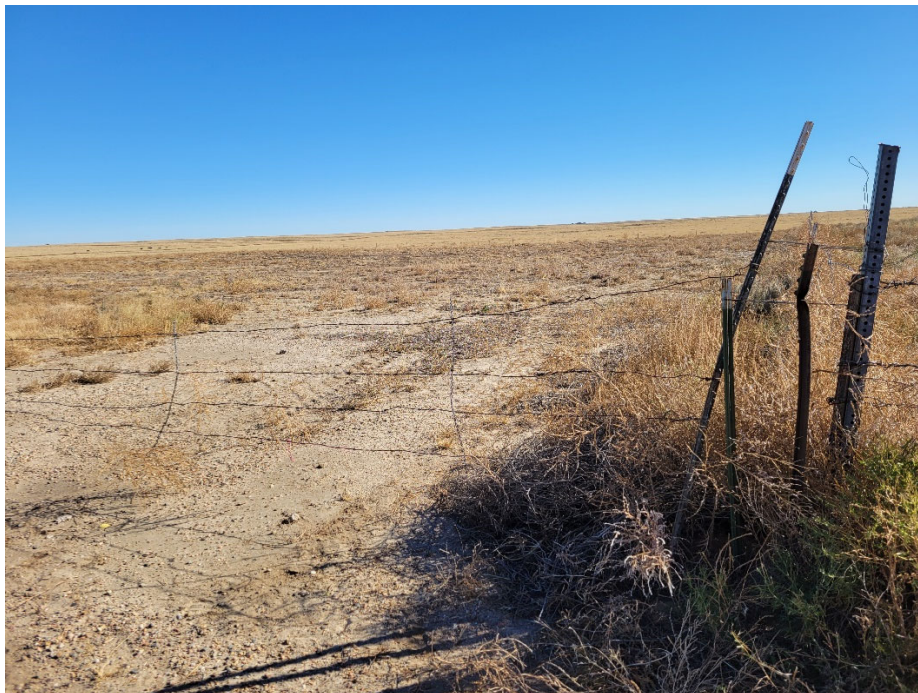
The site is accessed via U.S. 287. A barbed wire fence and gate secures the site. The entrance to the site is bare and compacted. This section should be reworked to encourage vegetation growth.

Entrance to the site. Soil is compacted and bare here.

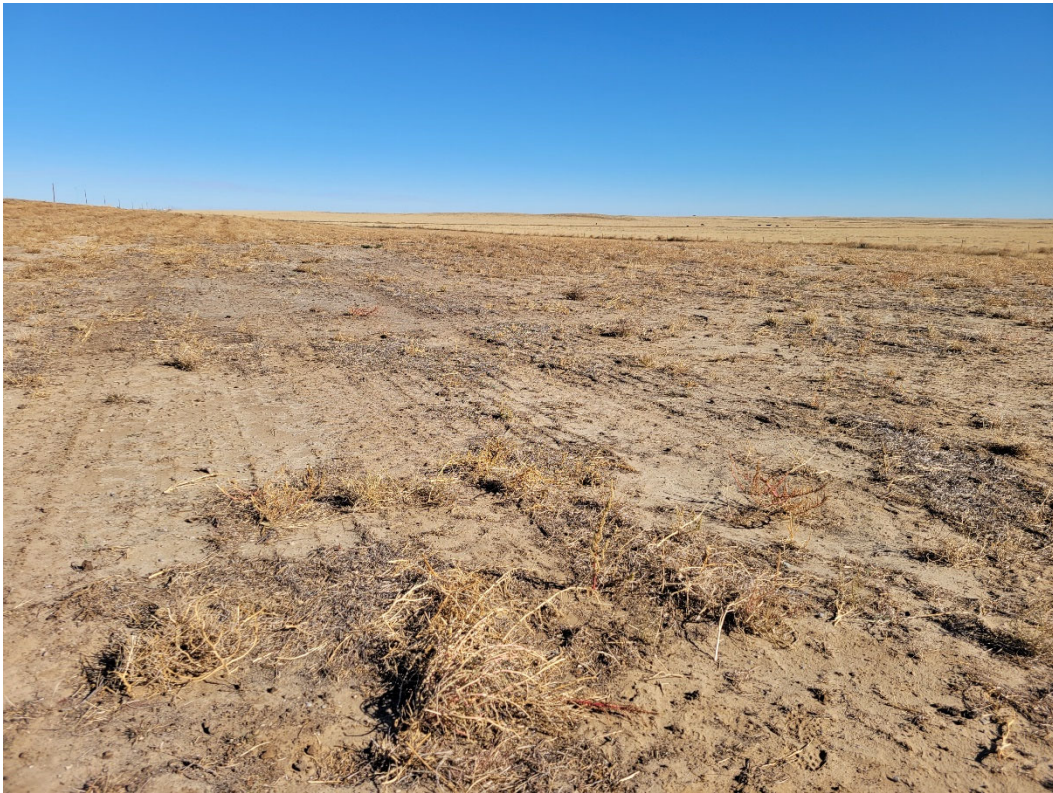
The site is graded to a 4:1 or shallower slope and drains to the east. This site was seeded in the fall of 2021. The area is bare in spots and dominated by last year's annual weeds. Some desirable species are starting to sprout, however perennials are slow growing and may take a few years to get established. No erosion issues were noted during the inspection. The site looks as expected for a clay pit recently graded and seeded.

Looking north across the graded area. Annual weed stalks.

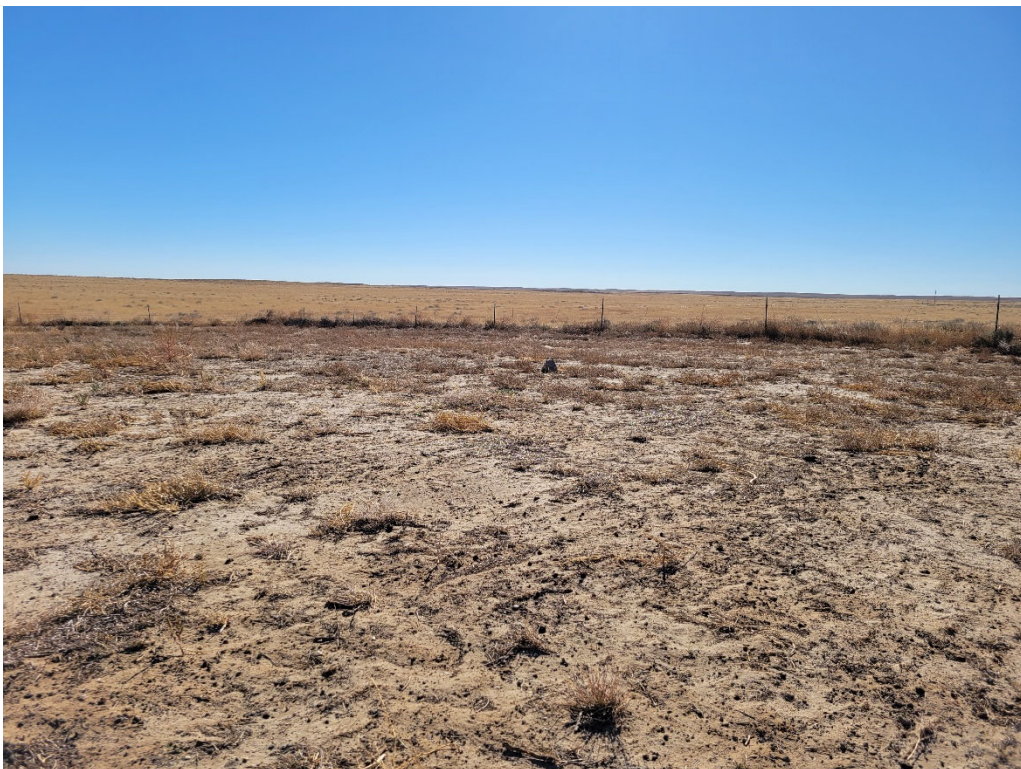
Looking east at permit boundary. Mostly bare ground. Barbed wire fence surrounds the site.
