**MINERALS PROGRAM INSPECTION REPORT**  
**PHONE: (303) 866-3567**

<b>MINE NAME:</b> Pikeview Quarry	<b>MINE/PROSPECTING ID#:</b> M-1977-211	<b>MINERAL:</b> Limestone (general), granite gneiss and do	<b>COUNTY:</b> El Paso
<b>INSPECTION TYPE:</b> Monitoring	<b>WEATHER:</b> Clear	<b>INSP. DATE:</b> November 9, 2022	<b>INSP. TIME:</b> 10:00
<b>OPERATOR:</b> Continental Materials Corporation	<b>OPERATOR REPRESENTATIVE:</b> Jerry Schnabel	<b>TYPE OF OPERATION:</b> 112c - Construction Regular Operation	
<b>REASON FOR INSPECTION:</b> Normal I&E Program	<b>BOND CALCULATION TYPE:</b> None	<b>BOND AMOUNT:</b> \$13,389,784.00	
<b>DATE OF COMPLAINT:</b> NA	<b>POST INSP. CONTACTS:</b> None	<b>JOINT INSP. AGENCY:</b> None	
<b>INSPECTOR(S):</b> Zach Trujillo	<b>INSPECTOR'S SIGNATURE:</b>

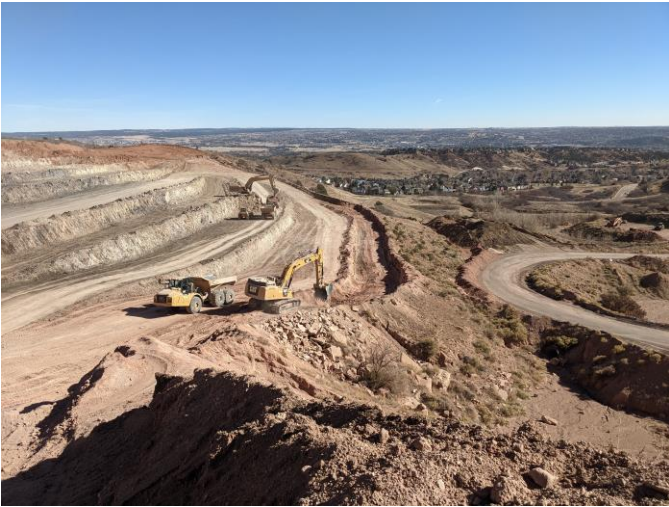
Backfill material was being excavated from the northeast end of the permit in the area of the previous maintenance shop. Numerous benches in the excavation area were observed as fill material is being pulled. A total of two excavators were operating along the benches at the time of the inspection loading haul trucks with backfill material. Backfill was being dumped along the south end of the buttress area along the slope. Dozers were pushing and grading the dumped material. At the date of this inspection, over half of the backfill has been placed along the slope. Excavated benches will eventually be graded to a continuous slope for final reclamation after all borrow material has been removed.

Backfill excavation.

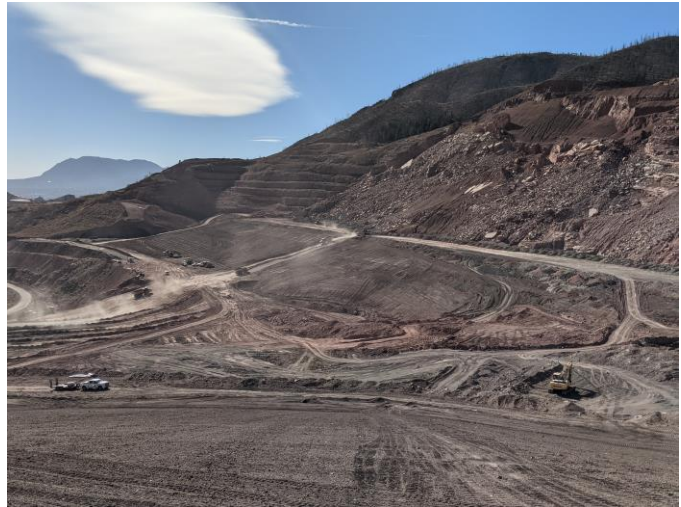
Fill placement at buttress.

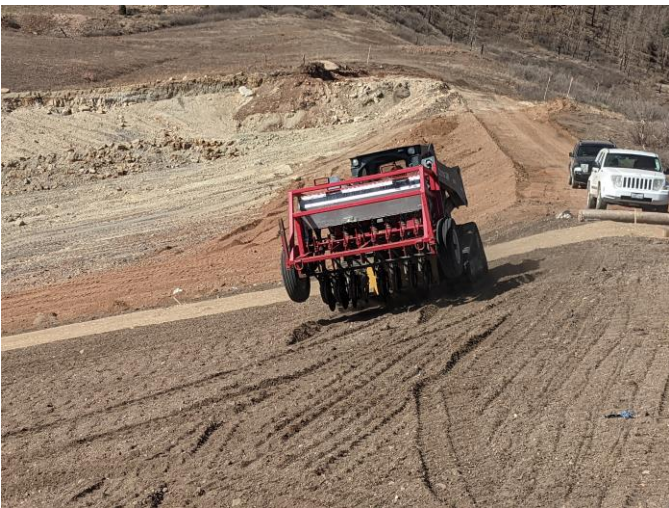
Topsoil placement had occurred prior to this inspection along the northern slope within the Colorado Springs city boundary at a depth of approximately 6 inches. The area was currently being seeded and mulched. This topsoiled area is being split into two test plots to assess reclamation success. Both areas are being drill seeded however the eastern section will be hydromulched while the western section will receive coconut-hay mats. One of the mats was being installed at the time of this inspection.

Drill seeding.

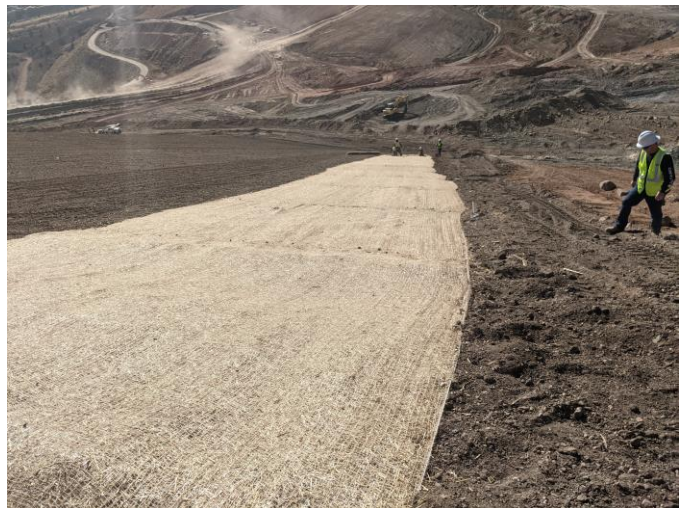
Coconut-hay mat placement.

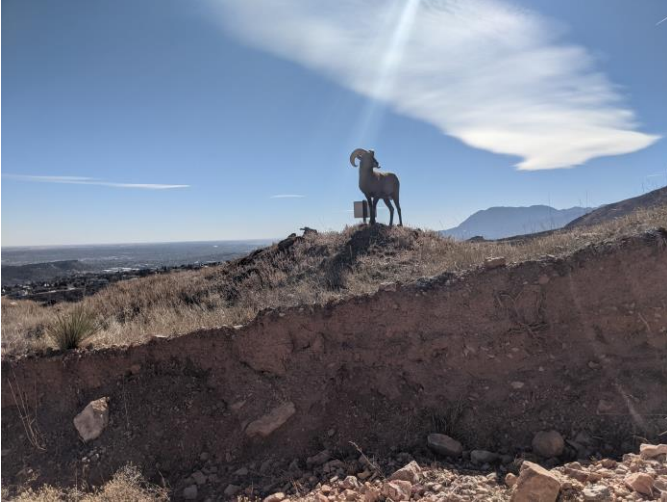
A bighorn sheep was observed along the southern end of the perimeter access road. Bighorn sheep frequent the area based on documentation by the Division and CMC.

Bighorn sheep.
