**MINERALS PROGRAM INSPECTION REPORT**  
**PHONE: (303) 866-3567**

<b>MINE NAME:</b> Seifert Pit	<b>MINE/PROSPECTING ID#:</b> M-1985-040	<b>MINERAL:</b> Sand and gravel	<b>COUNTY:</b> Custer
<b>INSPECTION TYPE:</b> Monitoring	<b>WEATHER:</b> Windy	<b>INSP. DATE:</b> November 9, 2022	<b>INSP. TIME:</b> 12:05
<b>OPERATOR:</b> Seifert Construction dba Seifert Enterprises, L	<b>OPERATOR REPRESENTATIVE:</b> Eric Seifert	<b>TYPE OF OPERATION:</b> 112c - Construction Regular Operation	
<b>REASON FOR INSPECTION:</b> Normal I&E Program	<b>BOND CALCULATION TYPE:</b> Partial Bond	<b>BOND AMOUNT:</b> \$40,000.00	
<b>DATE OF COMPLAINT:</b> NA	<b>POST INSP. CONTACTS:</b> None	<b>JOINT INSP. AGENCY:</b> None	
<b>INSPECTOR(S):</b> Eric Scott	<b>INSPECTOR'S SIGNATURE:</b>

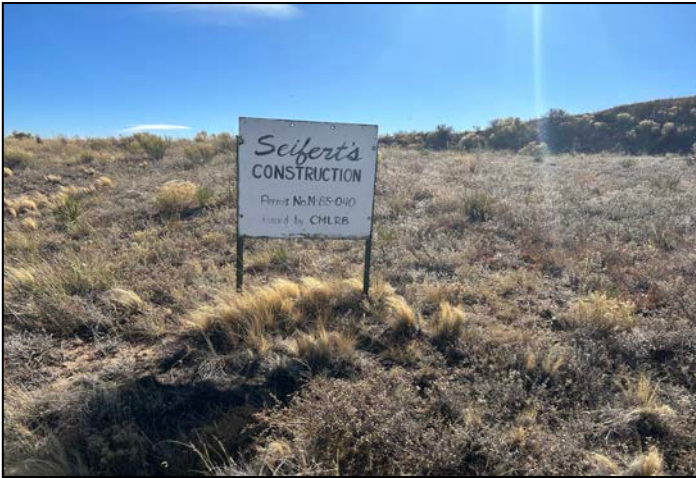
The site identification sign was present and the permit boundary is defined by fencing (photo 1). No problems or issues were noted. The attached photos 2-4 show the general condition of the affected area at the time of this inspection.

**Photo 1 – Site identification sign present at entrance to pit.**

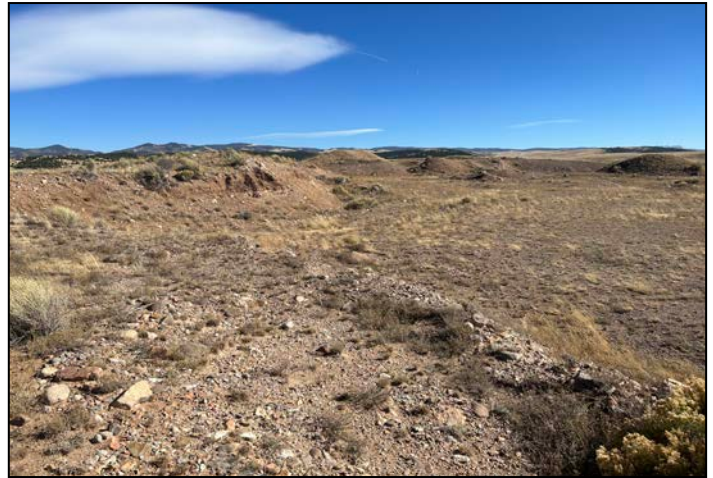
**Photo 2 – Photo taken from pit entrance looking SE at affected area.**

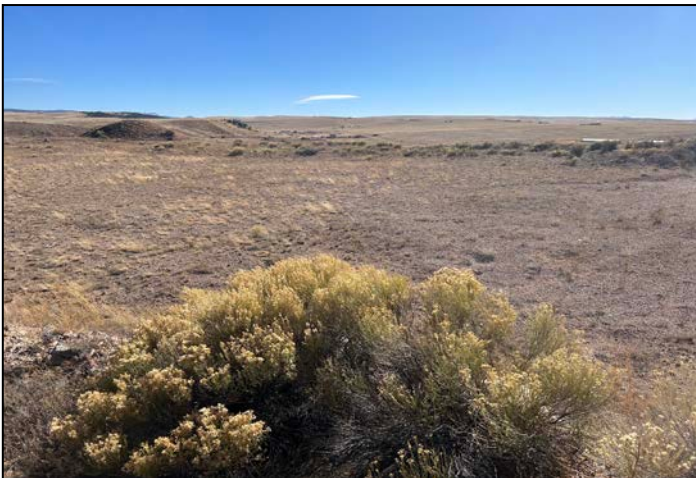
**Photo 3 – Photo taken from pit entrance looking S at affected area.**

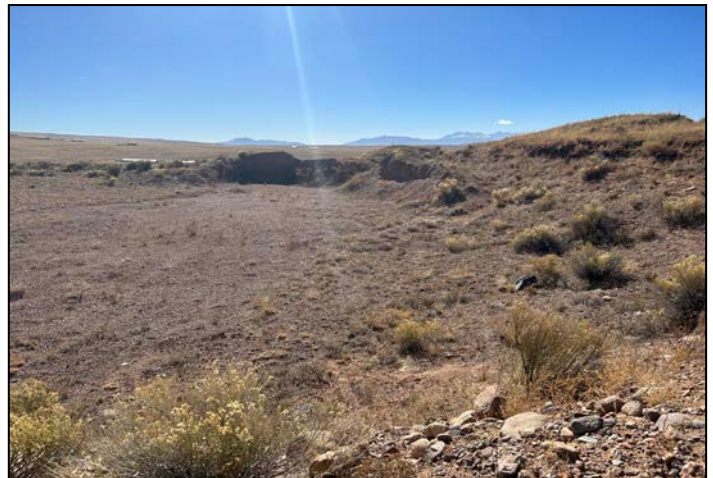
**Photo 4 – Photo taken from pit entrance looking SW at affected area.**
