MINERALS PROGRAM INSPECTION REPORT
PHONE: (303) 866-3567

MINE NAME: Ula Pit	MINE/PROSPECTING ID#: M-1991-083	MINERAL: Gravel	COUNTY: Custer
INSPECTION TYPE: Monitoring	WEATHER: Windy	INSP. DATE: November 9, 2022	INSP. TIME: 13:00
OPERATOR: Seifert Construction dba Seifert Enterprises, I	OPERATOR REPRESENTATIVE: Eric Seifert	TYPE OF OPERATION: 112c - Construction Regular Operation

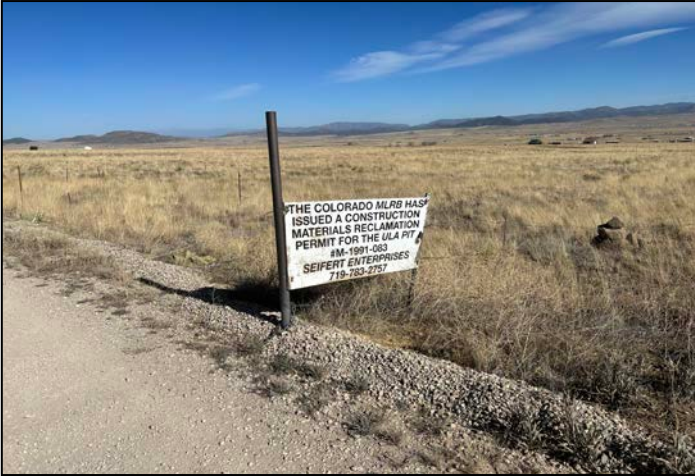
The site identification sign was present (photo 1), and the permit boundary is defined by existing fencing. The site is currently permitted for a maximum allowable disturbed area of 15 acres. Based on this inspection and a review of available aerial photography only about 11 acres of the 40 acre permit have been affected.

Photo 1 – Site Identification Sign at access road on N side of CR 160

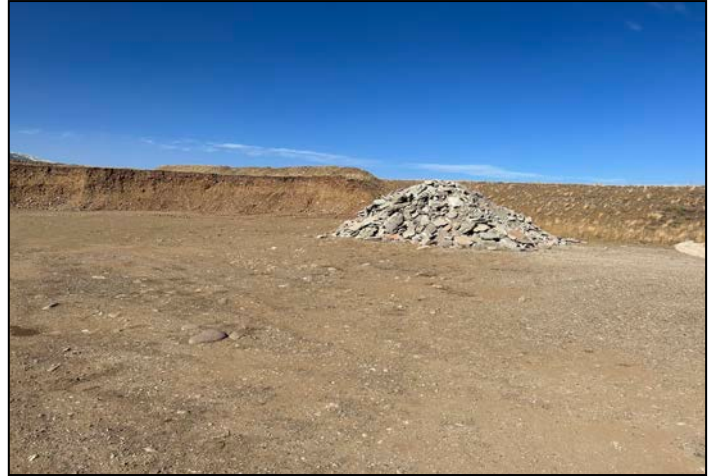
Photo 2– Concrete pile to be recycled as approved in TR1 in north center of site.

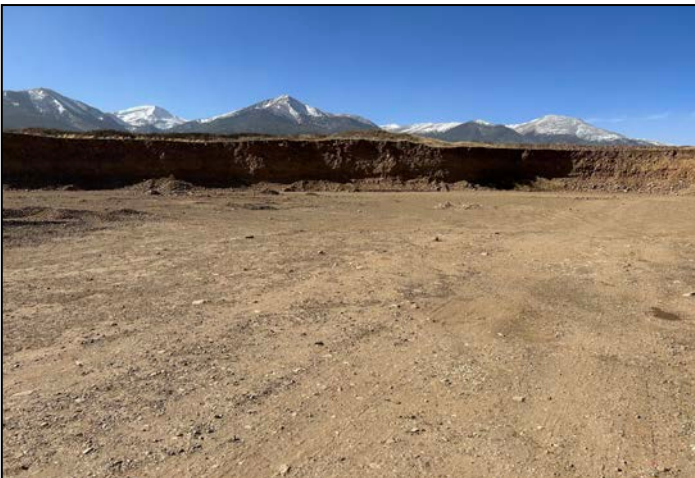
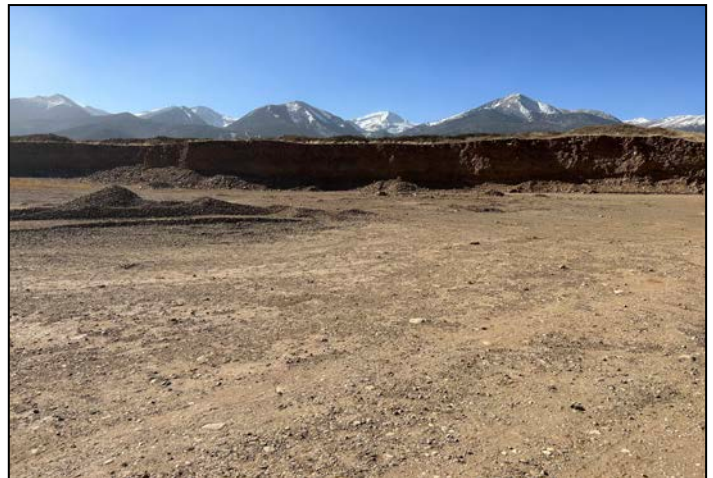
Photo 4

PROBLEM/POSSIBLE VIOLATION: Problem: The current mine plan needs to be updated and clarified pursuant to C.R.S. 34-32.5-112 (1)(c)(VI). The operator must provide sufficient information to describe or identify how the operator intends to conduct the operation. TR1 Approved in February of 2020 amended the mining plan to include a working high wall 400' long and 10' high, however the working high wall observed during this inspection was both higher (approx. 20-25') and longer (approx. 700') than is currently approved.

As stated on the first page of this report, the currently approved mining plan and reclamation bond allows for a working highwall of 400' long by 10' high. However, based on this inspection, the existing highwall exceeds both of these dimensions (approx. 700' long and 20-25' high). (photos 2-4)

Photos 3 and 4 - Working face high wall on west end of affected area is larger than the currently approved 400' long by 10' high.

CORRECTIVE ACTIONS: The operator shall submit a Technical Revision, with the required \$216 revision fee, to update and clarify the current approved mine plan to reflect the increased height and length of the working high wall present on-site. The operator may also provide evidence that the high wall observed during this inspection has been reduced to the 400' long and 10' high condition currently approved by the corrective action date.

This will require the submittal of a Technical Revision to the mining plan to reflect the increased height and length of the working high wall present on-site. The operator may also provide evidence that the high wall observed during this inspection has been reduced to the 400' long and 10' high dimensions currently approved by the corrective action date.

This Technical Revision, or proof that the highwall has been reduced to the approved dimensions, should be submitted to DRMS no later than the corrective action due date specified of 1/31/23.
