MINERALS PROGRAM INSPECTION REPORT
PHONE: (303) 866-3567

MINE NAME: Boyer Pit	MINE/PROSPECTING ID#: M-2002-122	MINERAL: Sand and gravel	COUNTY: Custer
INSPECTION TYPE: Monitoring	WEATHER: Windy	INSP. DATE: November 9, 2022	INSP. TIME: 11:30
OPERATOR: Seifert Construction dba Seifert Enterprises, I	OPERATOR REPRESENTATIVE: Eric Seifert	TYPE OF OPERATION: 112c - Construction Regular Operation

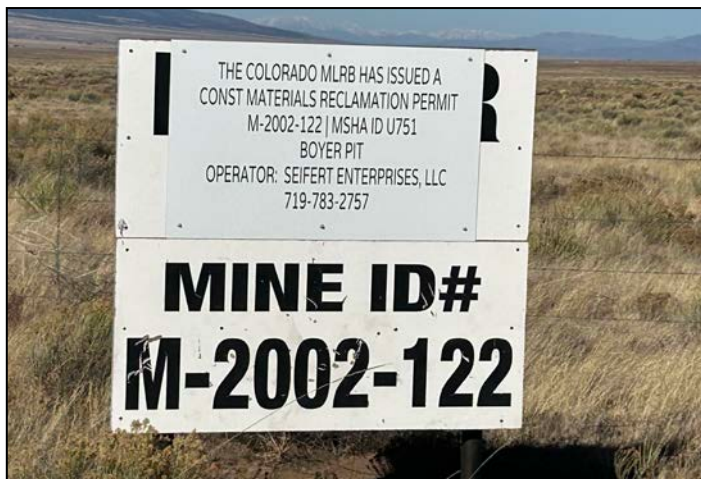
Although the site identification sign was present (photo 1), no permit boundary markers were observed in the field at the time of this inspection. As specified on the first page of this report, operator will need to conduct a survey and replace the boundary markers in the correct location(s), and provide proof to the Division (photos, and GPS coordinates of corner marker locations) that this has been done by the corrective action date specified of 1/31/23.

Photo 1 – Site identification sign located adjacent to CR 105

CORRECTIVE ACTIONS: The operator shall conduct a survey and replace the boundary markers in the correct location(s). The operator shall provide proof to the Division (photos, and GPS coordinates of corner marker locations) that this has been done by the corrective action date.

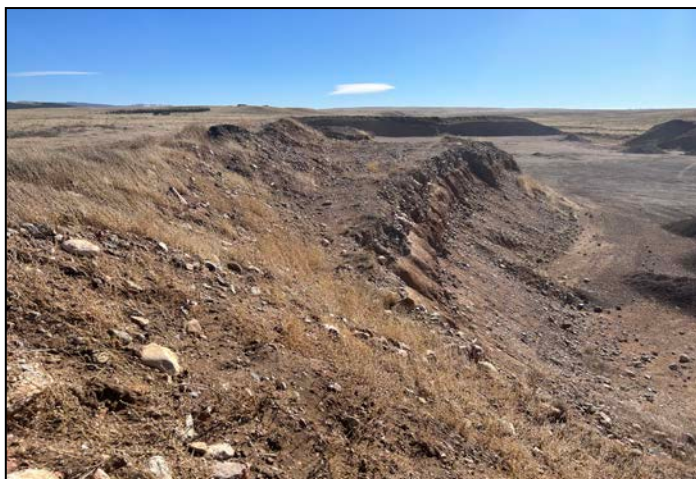
Weed control efforts (specifically Scotch Thistle control) will need to be maintained at the site, however, no problems or issues were noted. The attached photos 2-4 show the general condition of the affected area at the time of this inspection.

Photos 2 – 5 Currently active area of site - looking from north to south and scanning SE to SW
