MINERALS PROGRAM INSPECTION REPORT PHONE: (303) 866-3567

MINE NAME:		MINE/PROSPECTING ID#:	MINERAL:	COUNTY:
Schoolfield Pit		M-1993-027	Gravel	Custer
INSPECTION TYPE:		WEATHER: Windy	INSP. DATE:	INSP. TIME:
Monitoring		-	November 9, 2022	12:30
OPERATOR:		OPERATOR REPRESENTATIVE:	TYPE OF OPERATION:	
Seifert Construction dba Seifert Enterprises, I		Eric Seifert	110c - Construction Limited Impact	
REASON FOR INSPECTION:		BOND CALCULATION TYPE:	BOND AMOUNT:	
Normal I&E Program		Partial Bond	\$25,000.00	
DATE OF COMPLAINT:		POST INSP. CONTACTS:	JOINT INSP. AGENCY:	
NA		None	None	
INSPECTOR(S):	INSPECTOR'S SIGNATURE:		SIGNATURE DATE:	
Eric Scott		Ein Lut	November 10, 2022

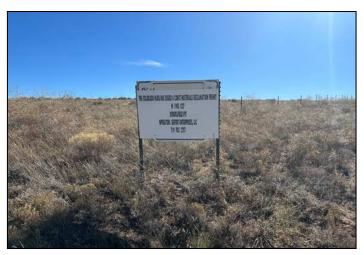
$\label{eq:continuous} Photo \ 1-Site\ identification\ sign\ located\ on\ south\ side\ of\ CR\ 328\ at\ site\ access\ road.$

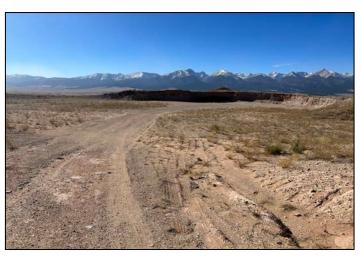
Photo 1 - NE corner of affected area looking WSW.

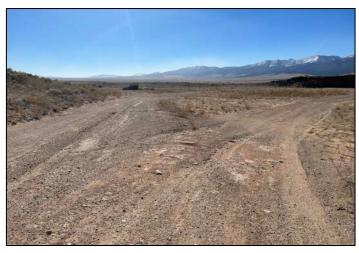
Photo 3 – NE corner of affected area looking South.
