November 8, 2022

Project No.: 19125

Regarding: Daniels Sand Pit 2, Permit No. M-1973-007-SG
Slope Stability Monthly Monitoring Report

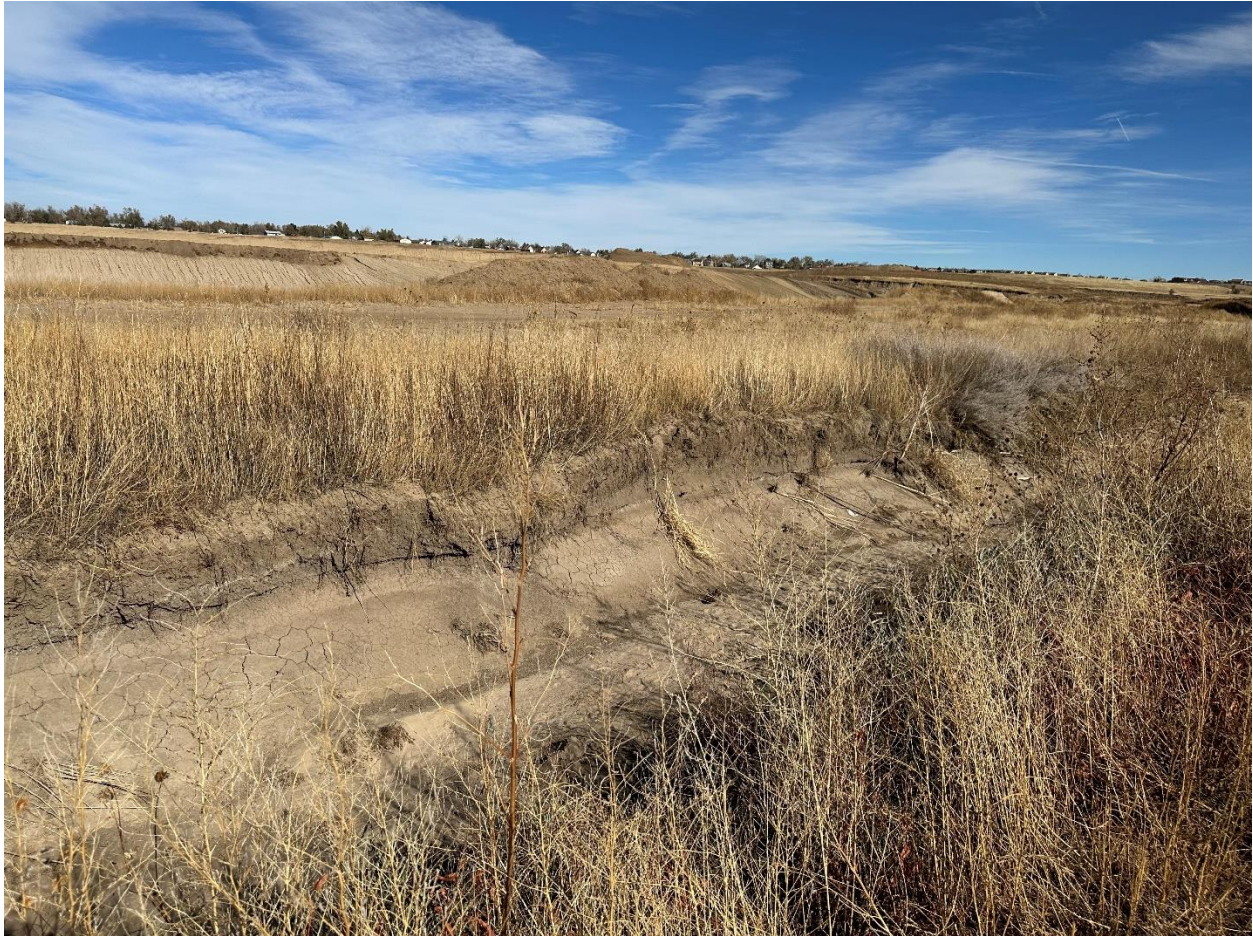
- Weather: 40-68°, sunny, winds 10-20 mph
- Visual observation of the Fountain Mutual Ditch:
 - No tension cracks
 - No toe erosion that was visible
 - Vegetation growing on banks and at invert of ditch
 - Tumbleweeds present in ditch
 - No water flowing/dry ditch
 - No sloughed slope surfaces
 - The condition of the ditch is stable

Photo 1. Fountain Mutual Ditch looking NE

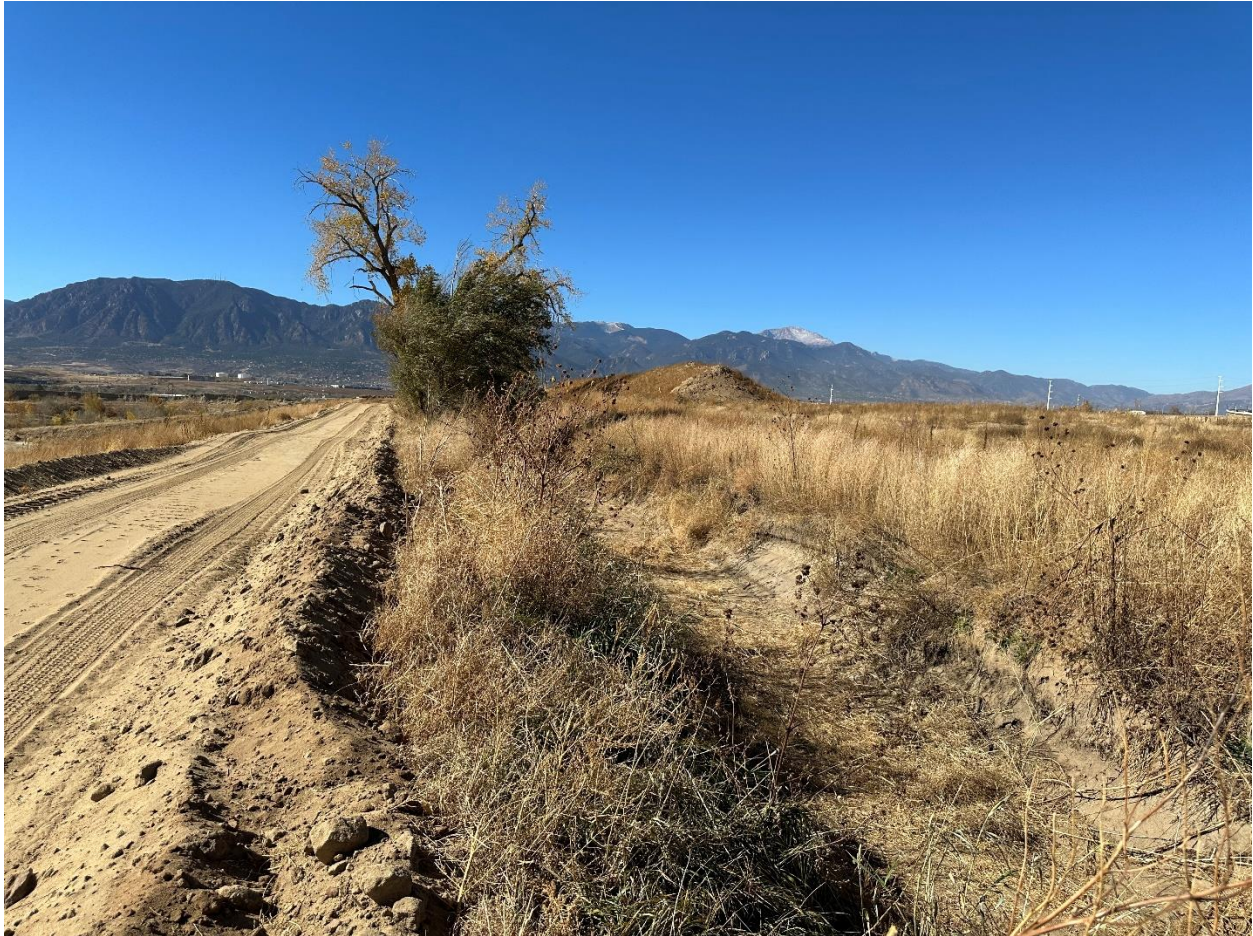
Photo 2. Fountain Mutual Ditch looking west

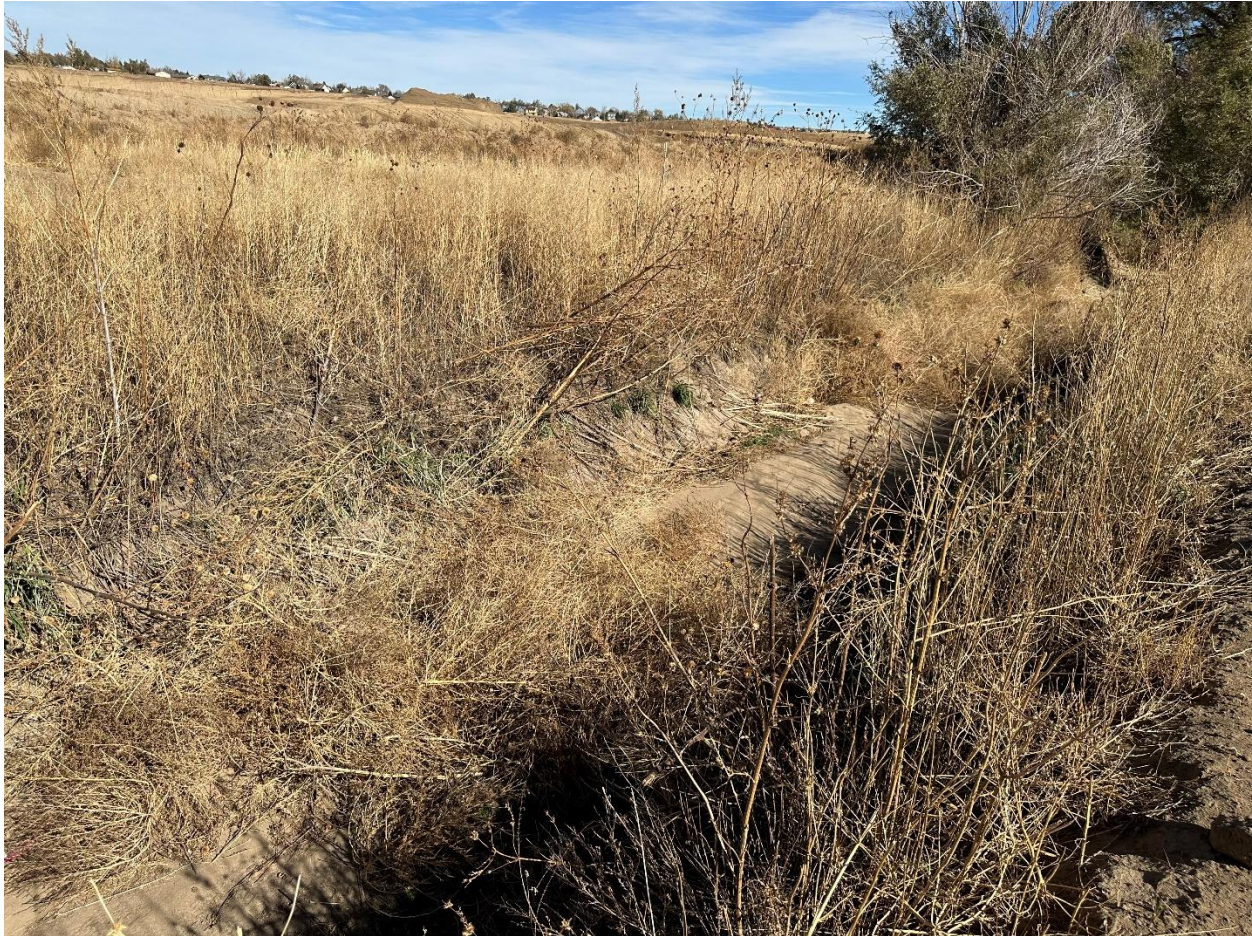
Photo 3. Fountain Mutual Ditch invert with tumbleweeds

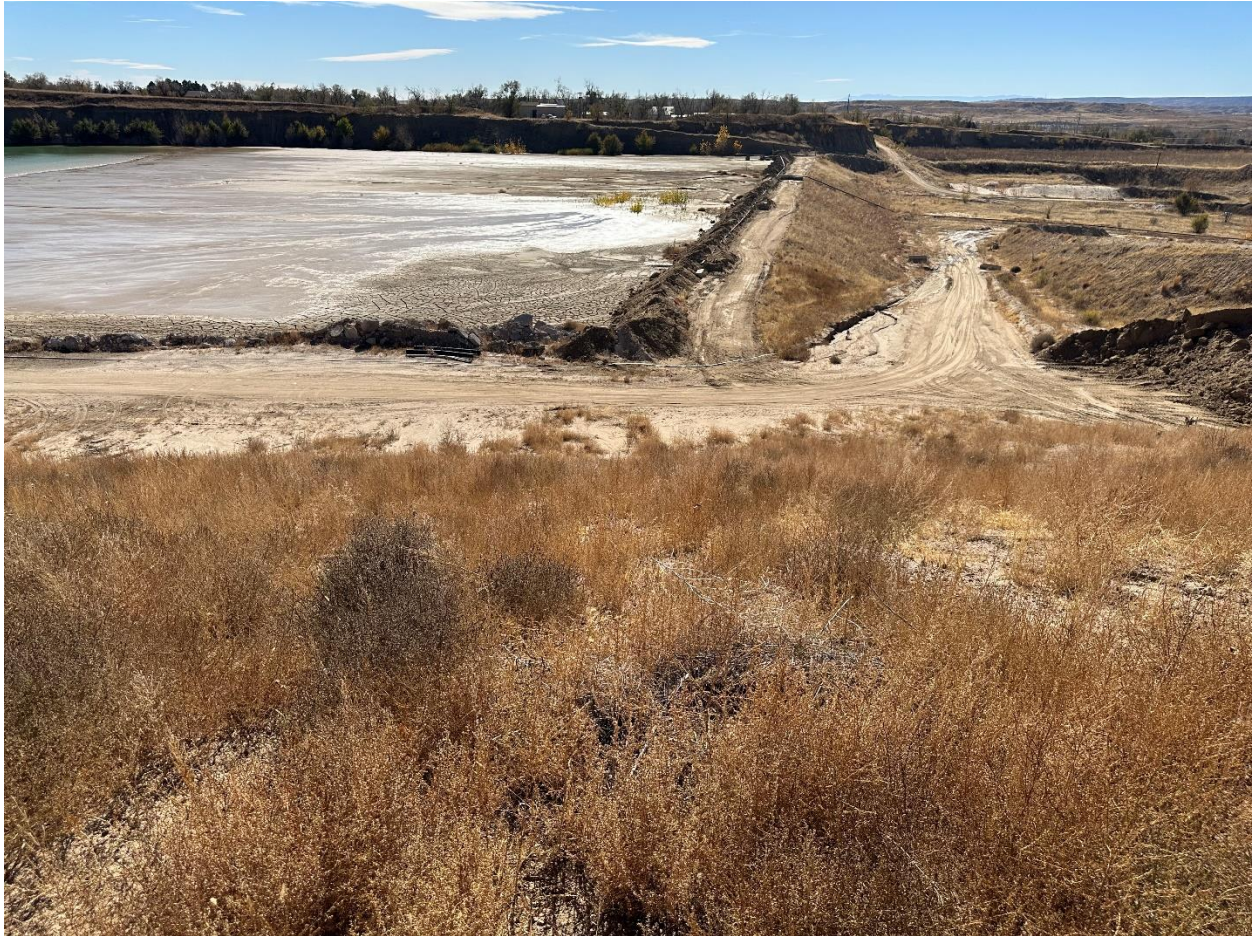
- Visual observations of the Butress Slope
 - The buttress slope varies from 3H:1V to 4H:1V
 - Vegetation (mainly weeds) are growing in some locations on the buttress
 - Several locations visible evidence of surface water runoff and erosion gullies throughout alignment

Photo 4. Buttress slope looking south with weeds (western slope)

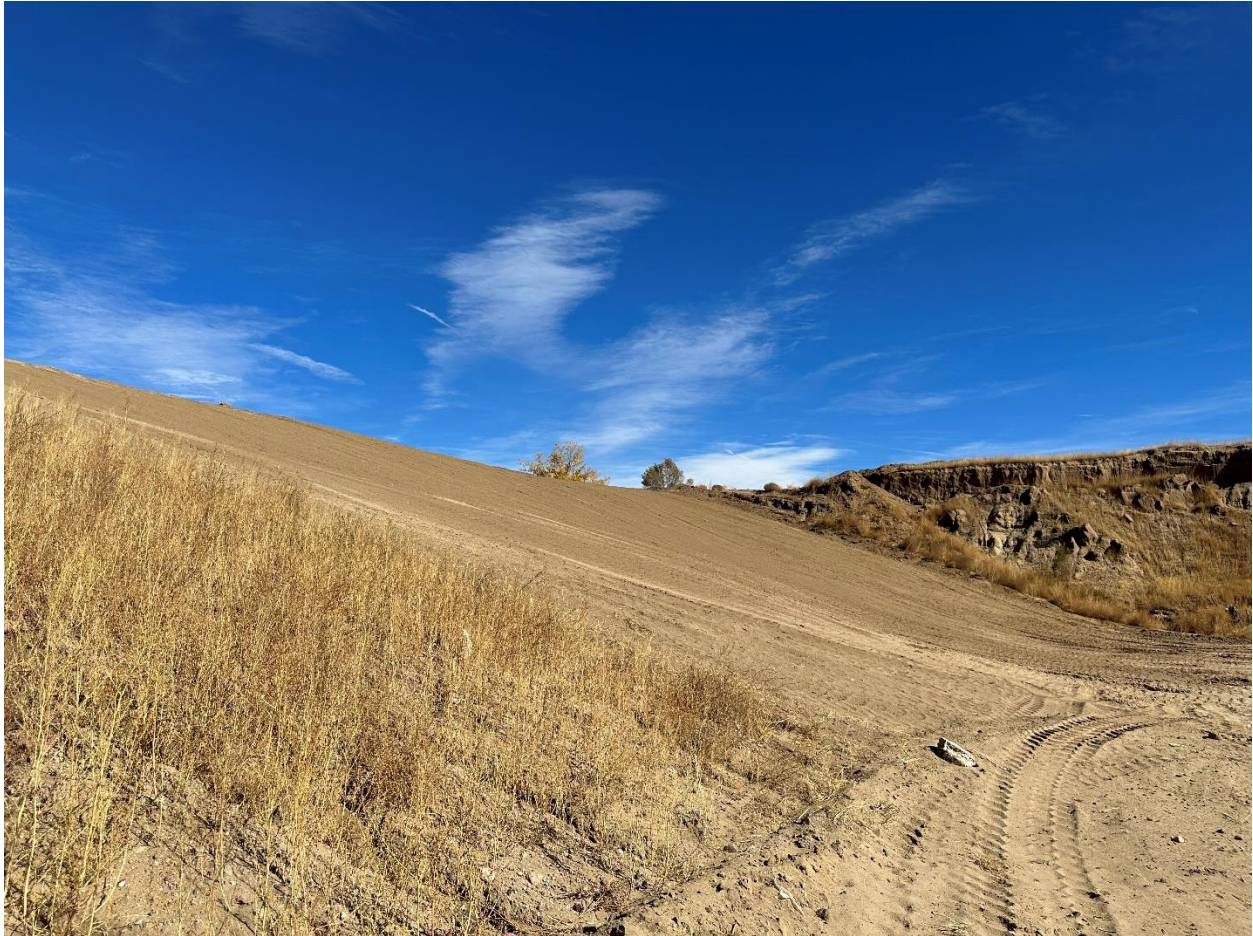
Photo 5. Buttress slope with repair looking east from toe

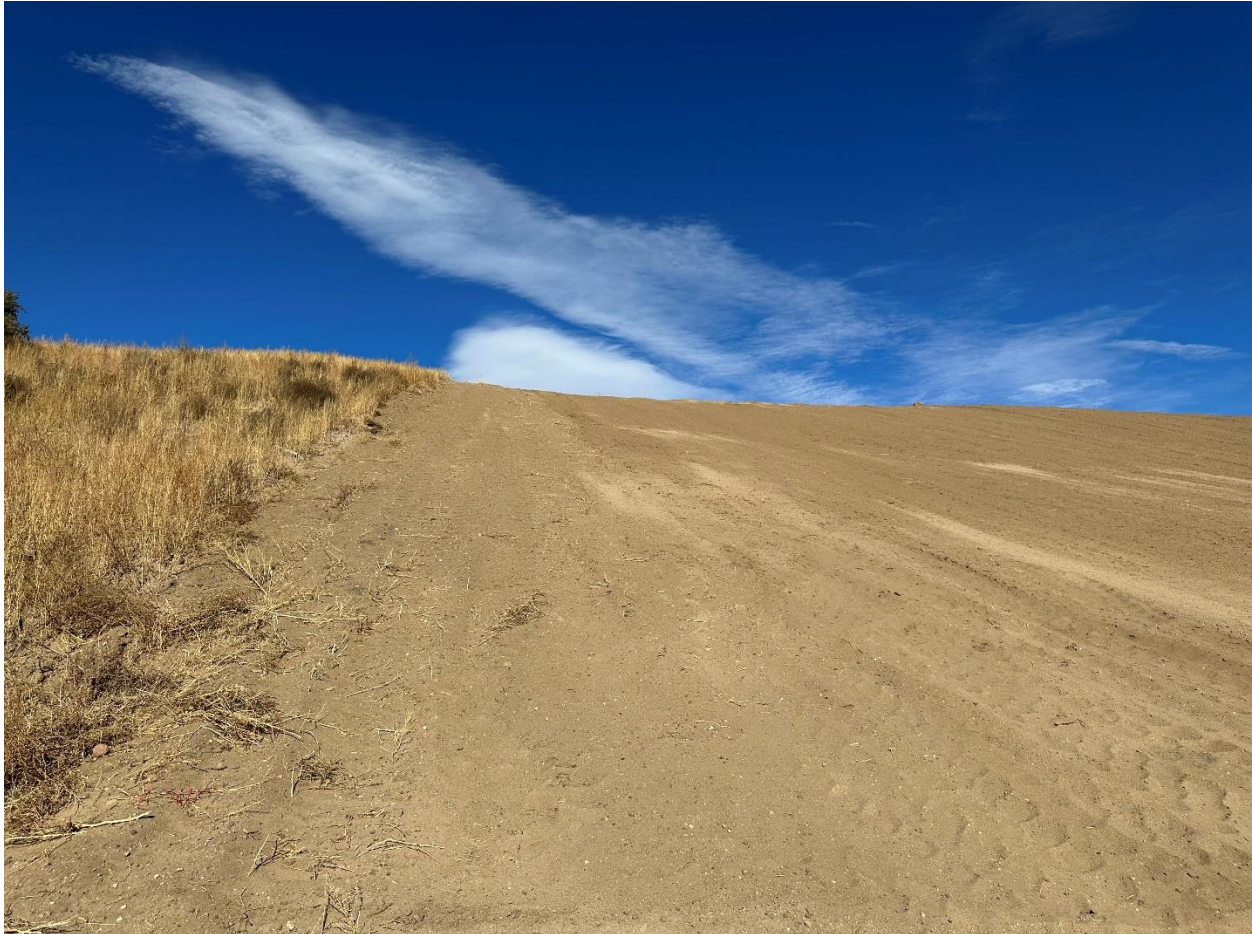
Photo 6. Buttress slope repair looking north from toe

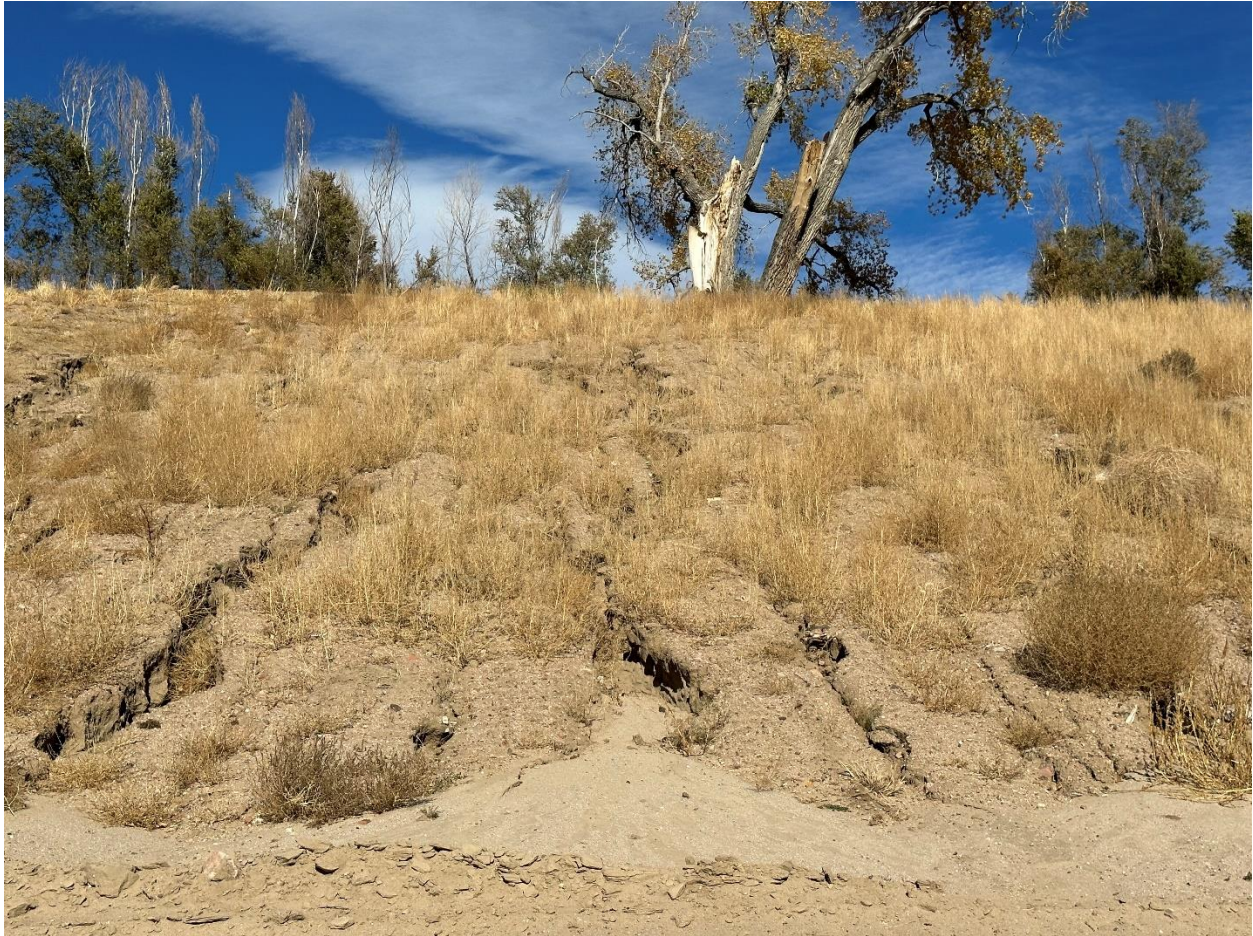
Photo 7. Buttress slope looking north, note evidence of drainage/erosion gullies forming. More sediment near toe

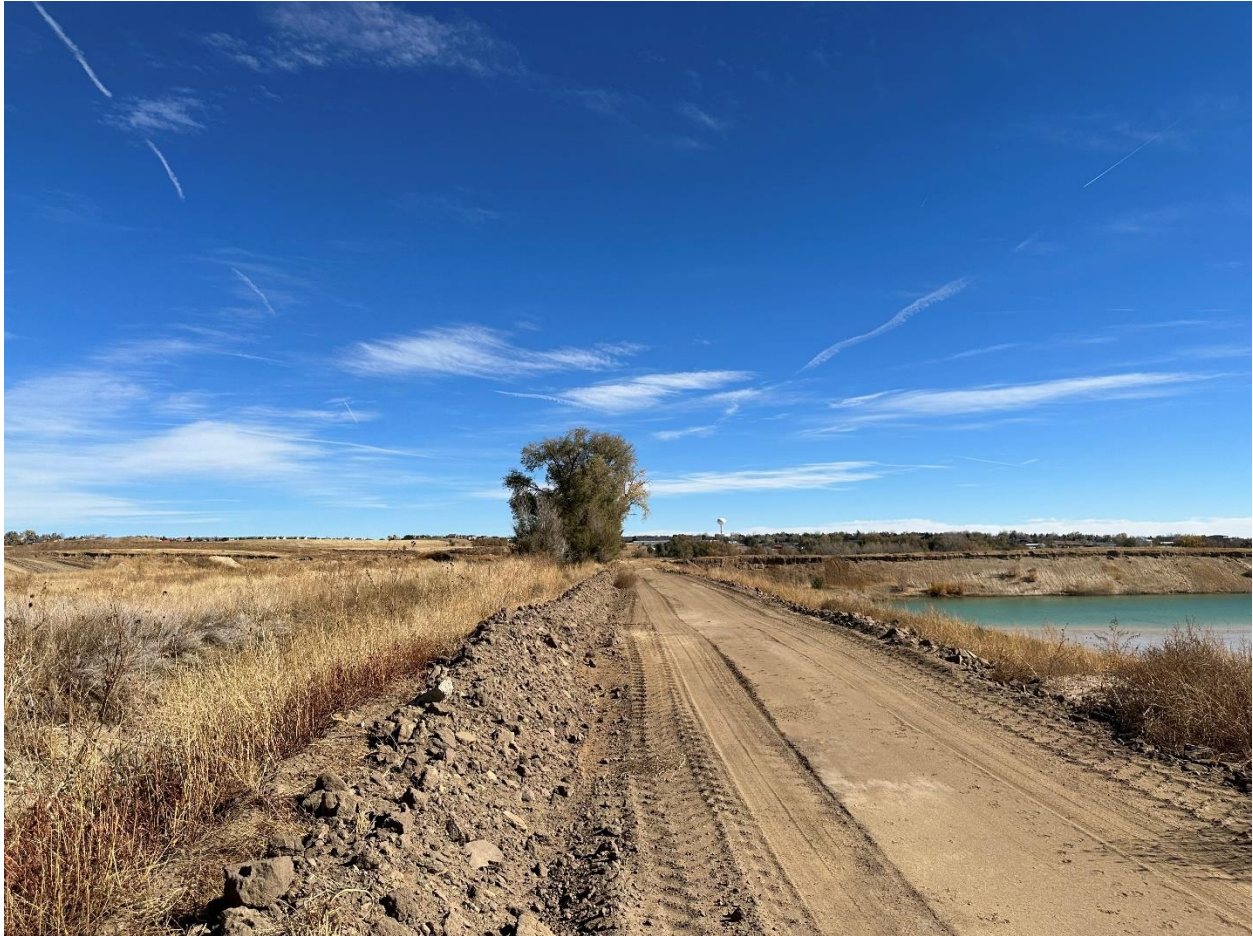
Photo 8. Berm between access road and ditch

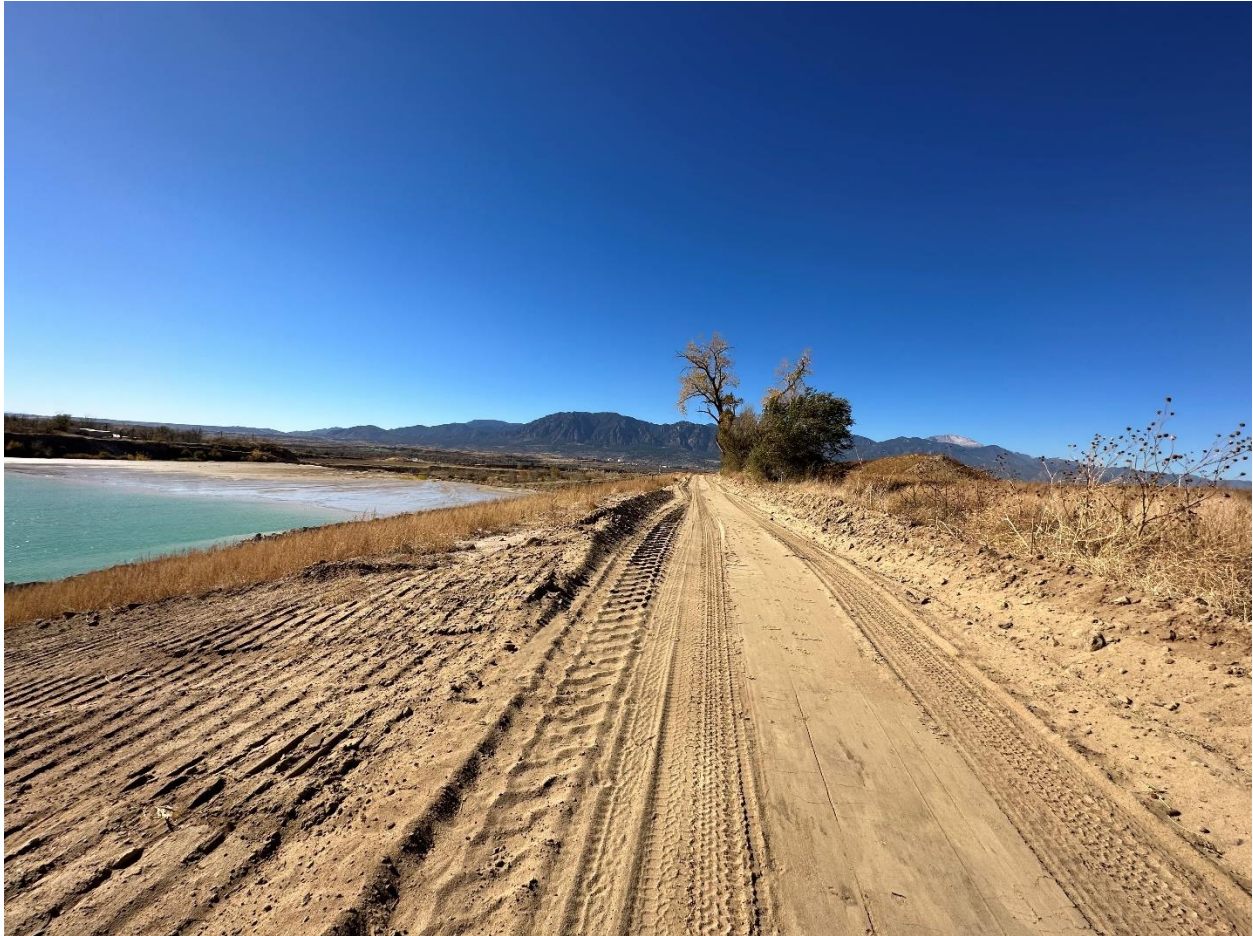
Photo 9. Repair of gullies near access road

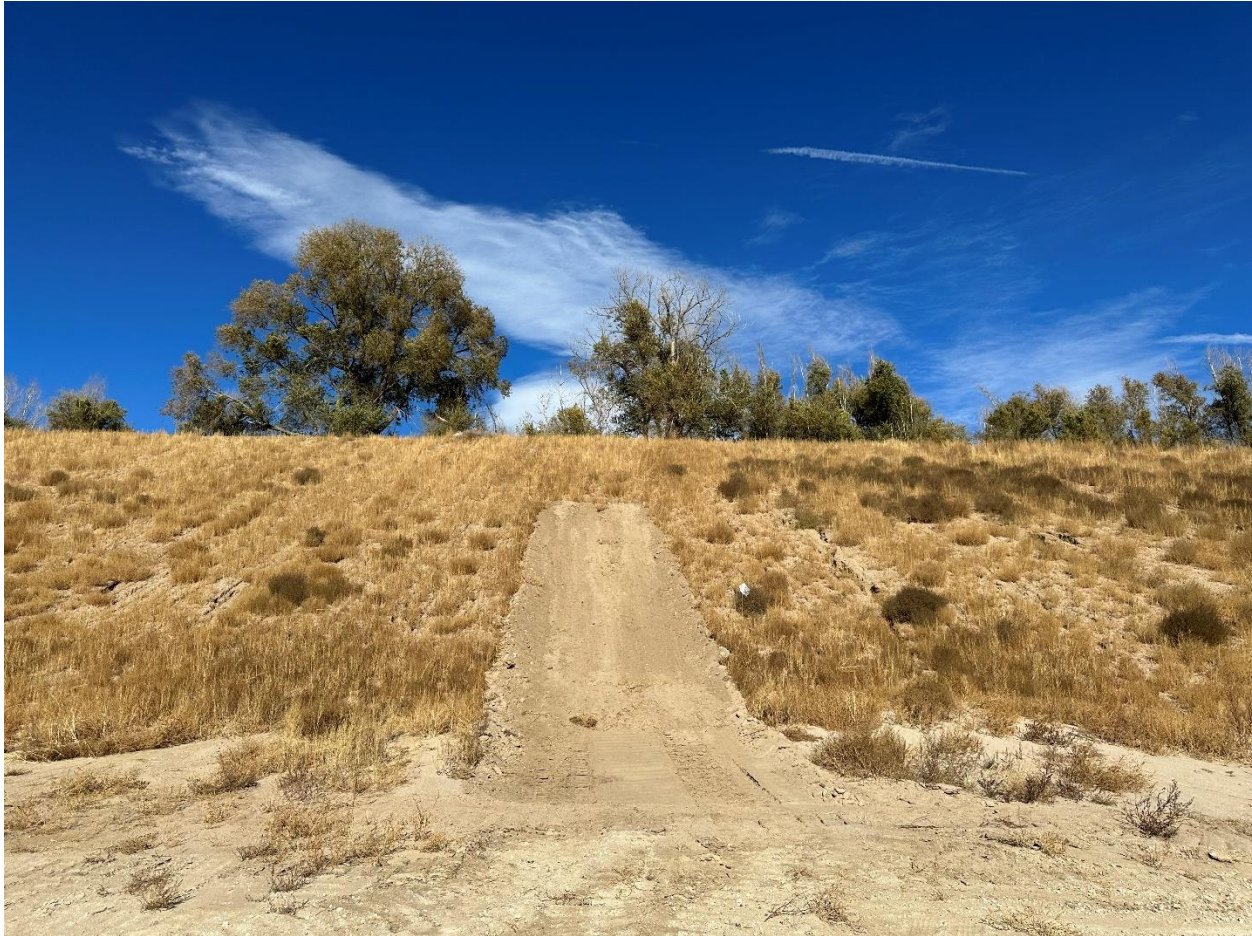
Photo 10. Repair along slope
