Re: Roadside Portals Mine, C-1981-041, Response to Letter of Concerns

Partial Phase III Bond Release No. 11

Proposed Decision
and
Findings of Compliance
for the

PERMIT NUMBER C-1981-041

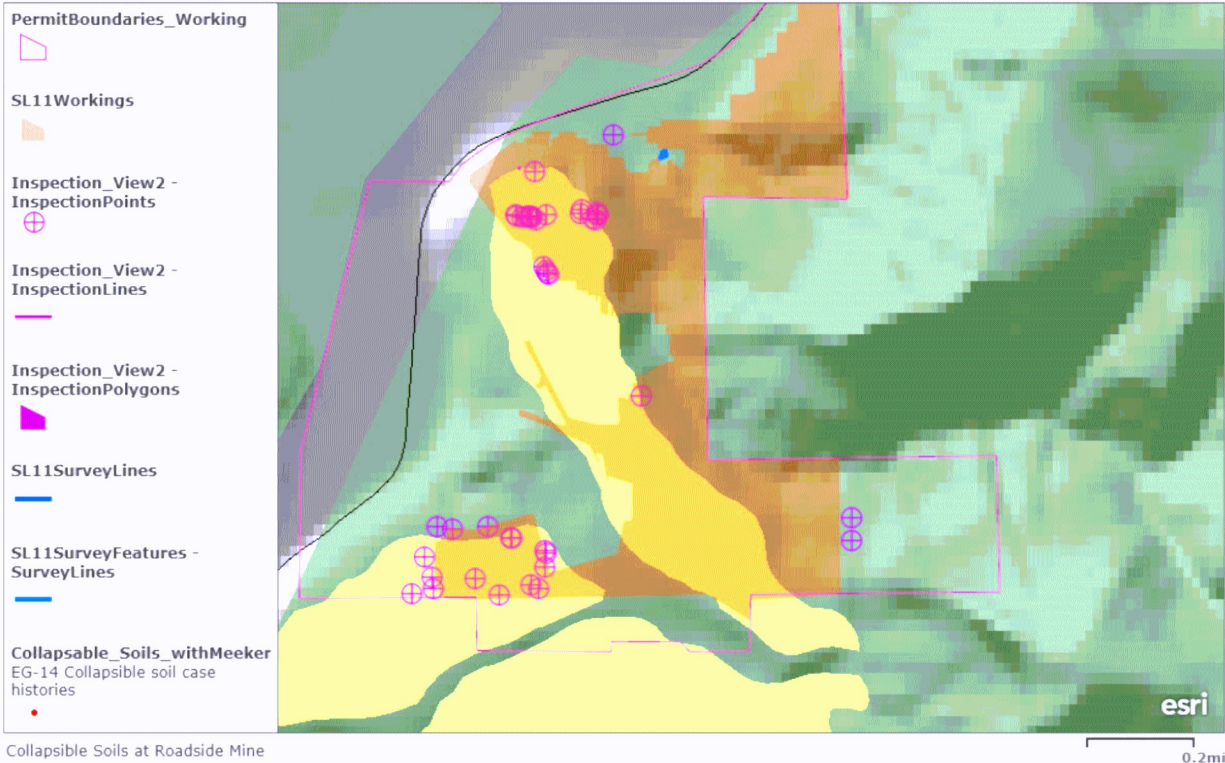
SL-11 Collapsible Soils

Exhibit 1 was created using GPS data collected during SL-11 bond release inspections and combining them with a Hydrocompactive soils layer from ARConline created by the Colorado Geological Survey. The yellow polygon is the mapped deposits of hydrocompactive soils. The Roadside Mine's permit boundary is a blue line. The GPS points collected during the Division's bond release inspections are the blue circles with crosshairs in them.

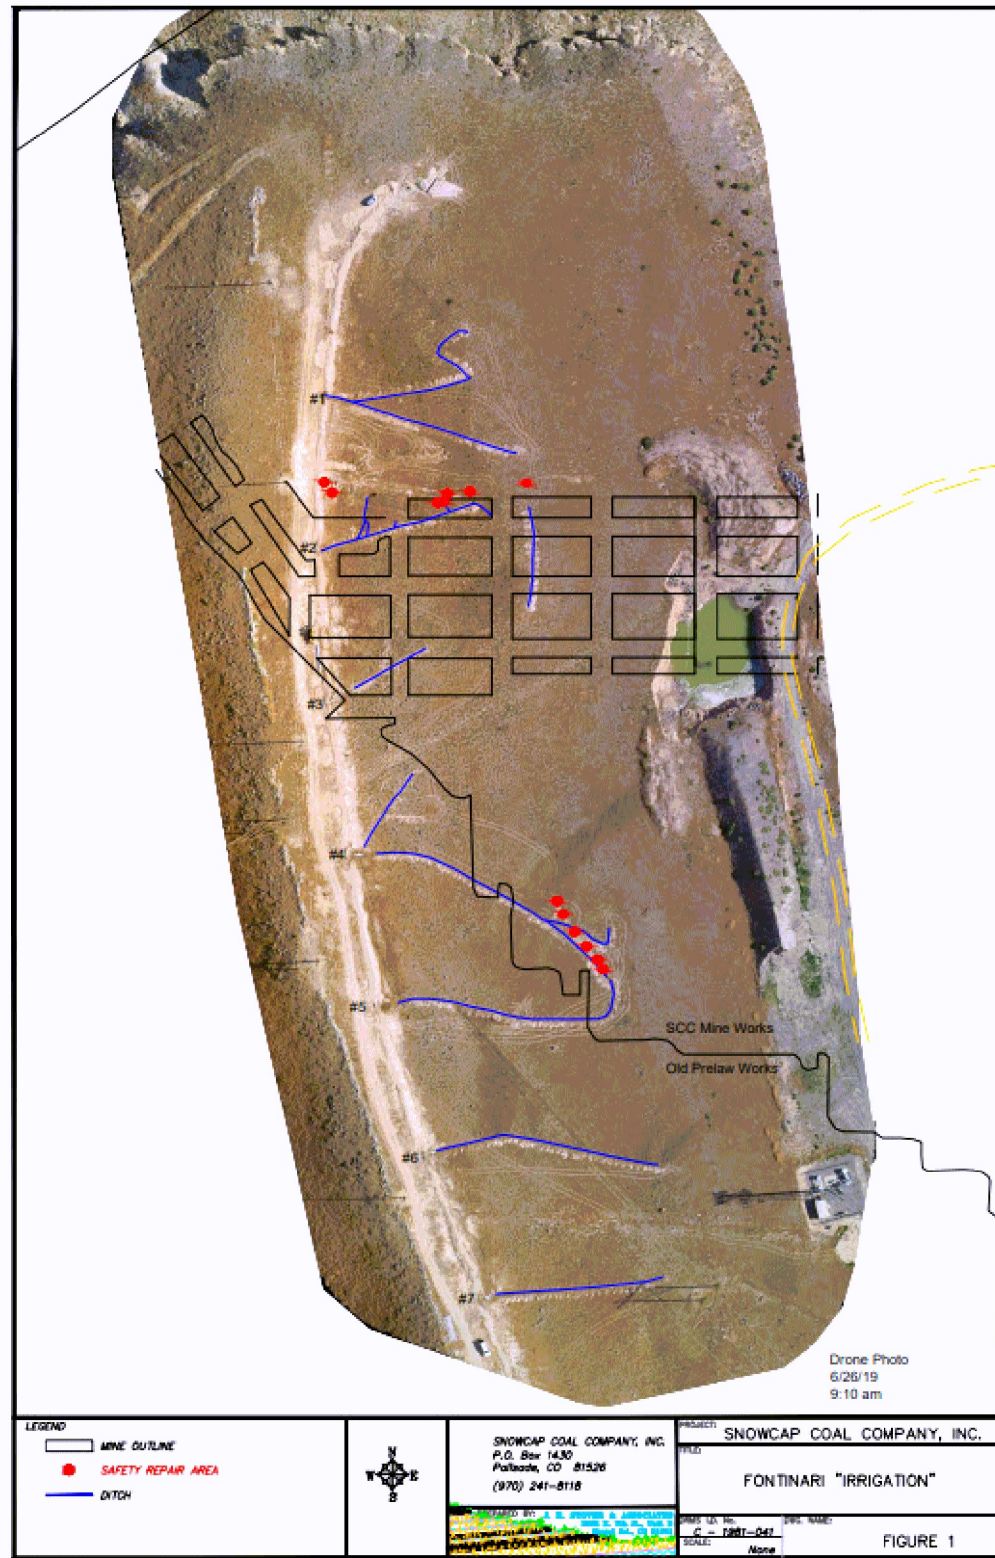
Exhibit 2 is a photograph taken by a drone of the Tract 70 Mesa. Mr. Fontanari's ditches can be observed to be in an irregular placement. SCC's repair locations can be seen as dots on the map. M. Fontanari's ditches can be seen adjacent to and in one case cutting through SCC's repairs.

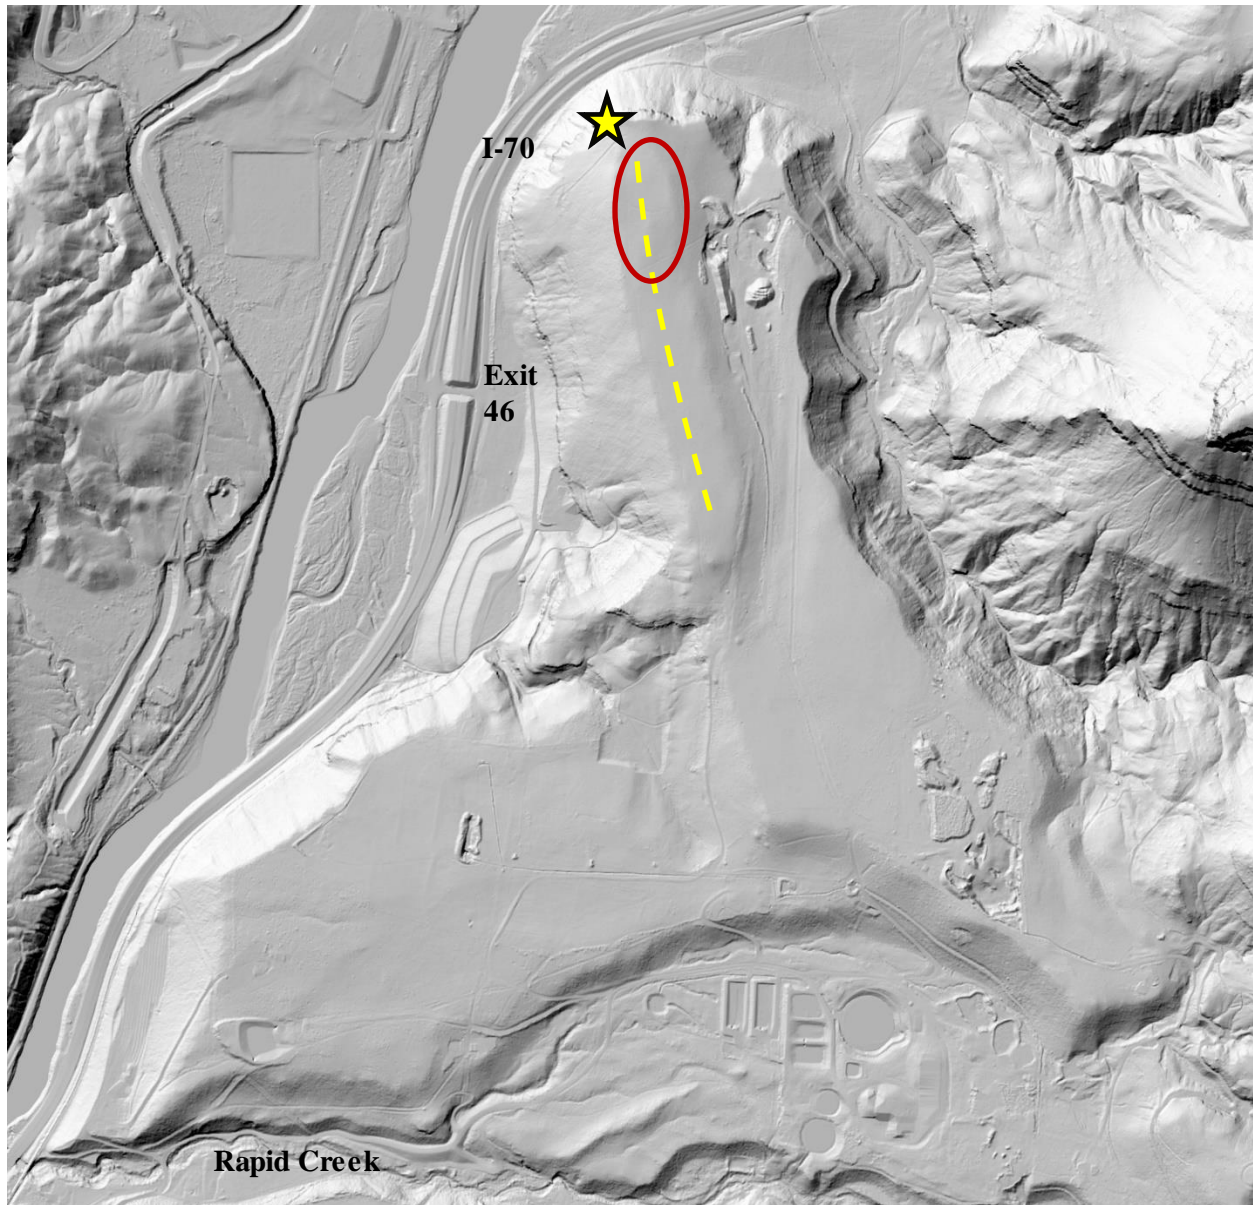
Figure 1. Lidar bare-earth hillshade image. Long linear gravel capped mesa is shown by yellow dashed line. Area of soil dissolution and piping voids approximated by red-lined oval. Location of star is where CDOT mitigated rockfall hazards related to water seepage and flow by scaling and construction of rockfall fence.

During the inspection, several small soil piping-type sinkholes and soil cracks were observed in clay and silt soil that contained dispersed angular to subrounded rocks up to boulder sizes. Most were clustered in the approximate oval area shown in the figures. DRMS and the mine representative stated that the mine workings were about 500' below the ground surface where the bulk of soil piping had occurred along the long linear mesa (shown as yellow-dashed line in Figure 1) with the lateral ditches running through it (seen in Figure 2 GE photo). This linear mesa remnant had the rockfall problems addressed by CDOT at its furthest point.

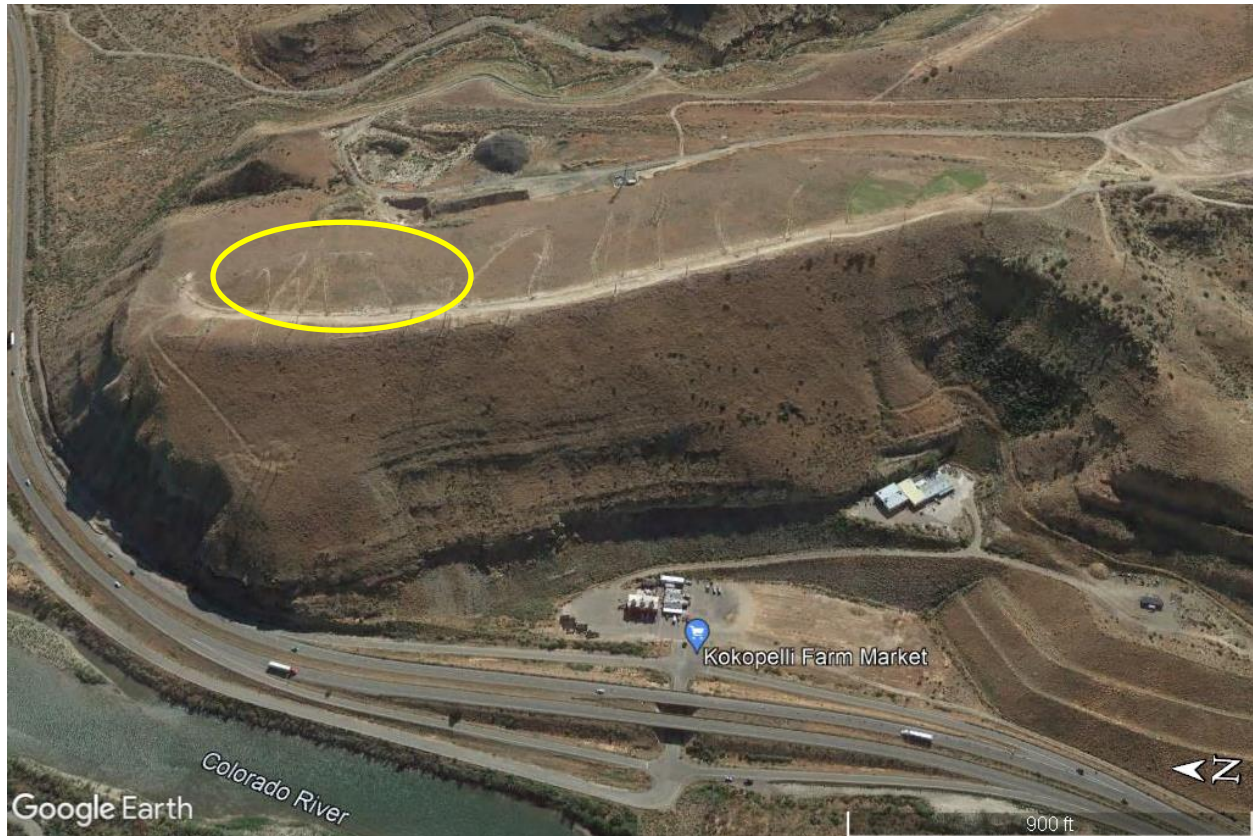
Figure 2. Oblique GE image of linear gravel-capped mesa remnant. Note lateral irrigation ditches on surface. Area of piping/soil dissolution approximated by yellow oval.

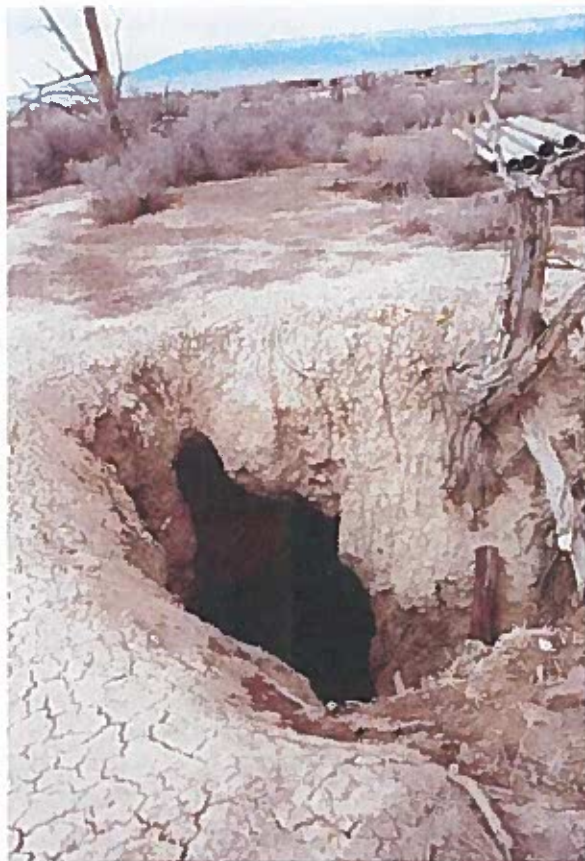
Piping-void surface collapse near Loutsenhizer Arroyo east of Olathe.

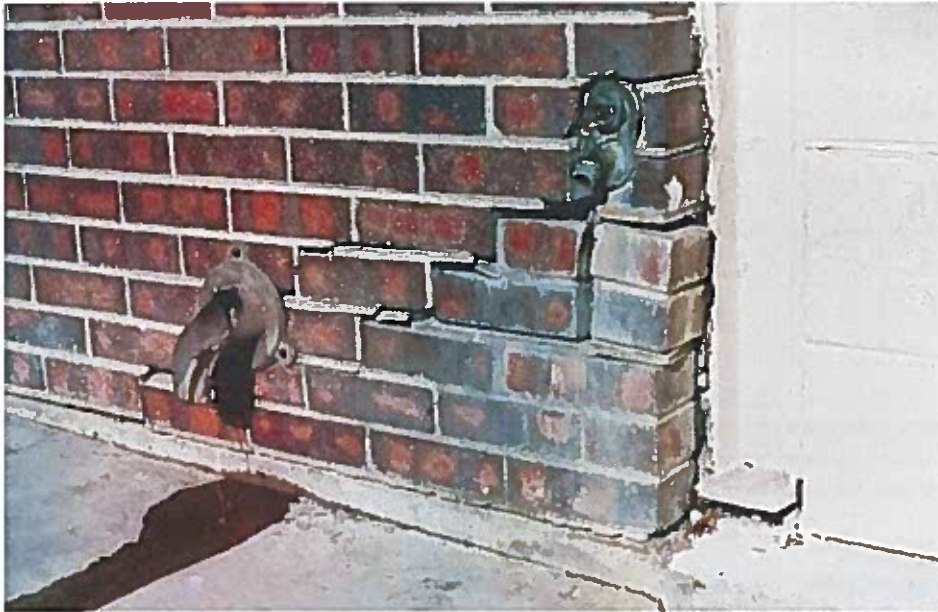
Damage to foundation and mortared brick walls from settlement of collapsible soils. Building in Montrose was demolished shortly after photo was taken. [Photo credit: Buckhorn Geotech]

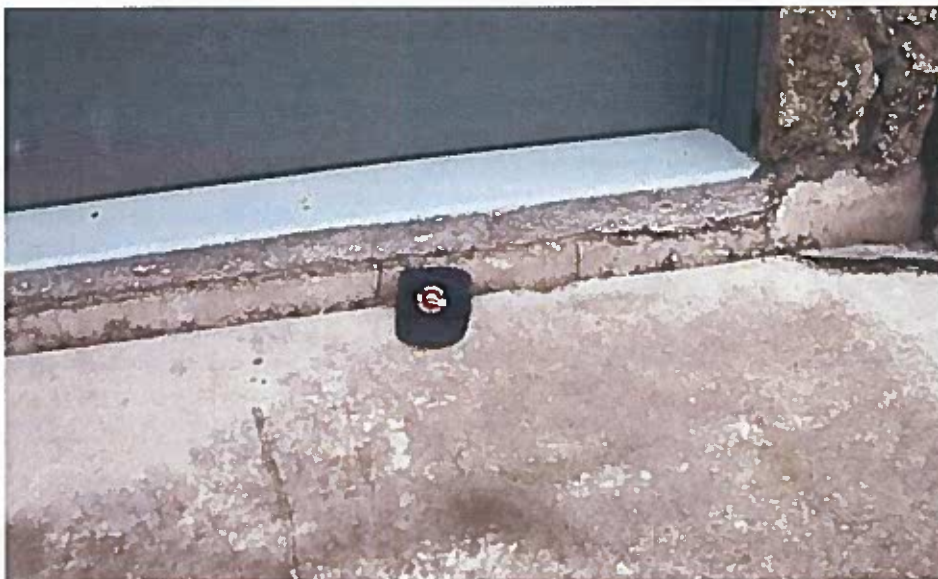
Continued settlement in collapsible soil dropped new town home driveway to a level where vehicles are unable to enter garage. Note leveling slab of concrete on garage floor from previous repair.

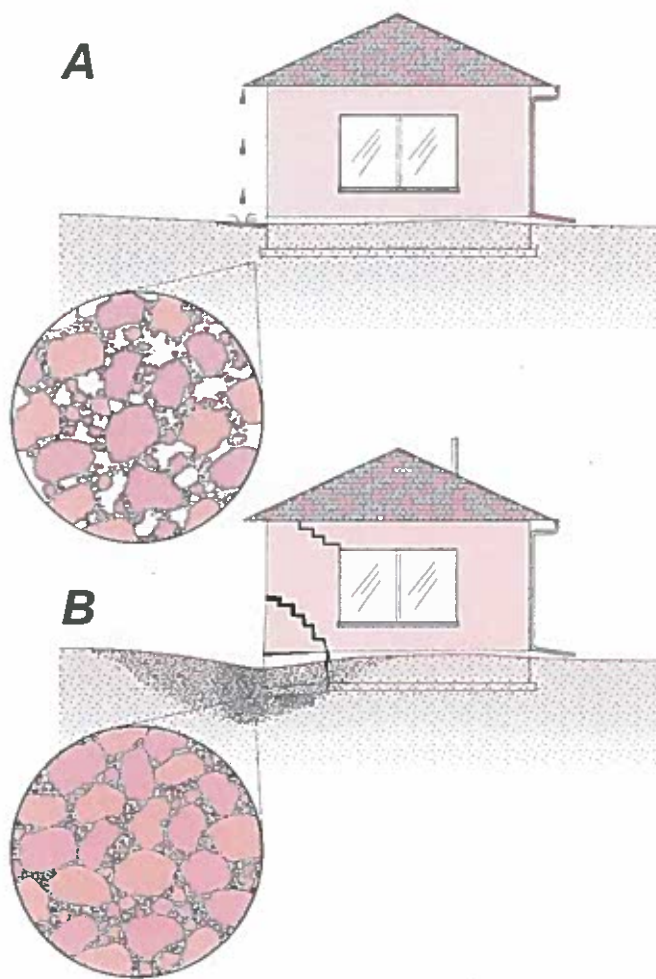
Figure 3-1 A, Wetting of high-void-space hydrocompactive soil has caused; B, collapse and densification of the soil fabric, ground settlement, and distress to the structure.

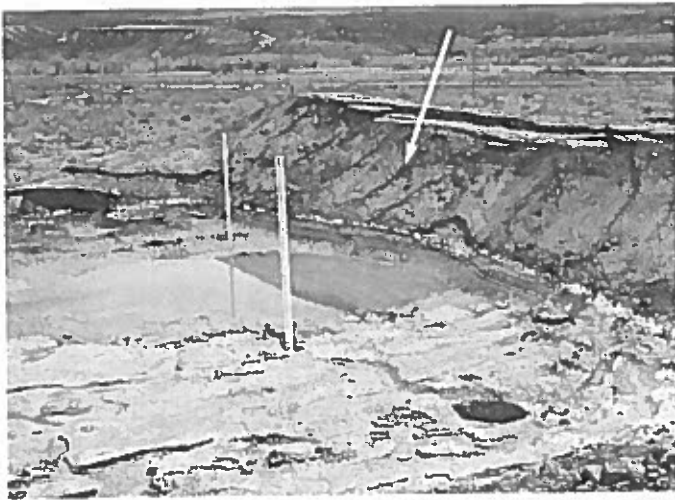
Figure 3-4. Ground settlement during a soil-flooding test near Rifle. Hydrocompaction has created arcuate, concentric ground cracks in the 10-ft-high test embankment adjacent to the pond (see arrow). Note collapse features in floor of pond due to piping erosion. Photo courtesy of R. Barrett and CDOT.

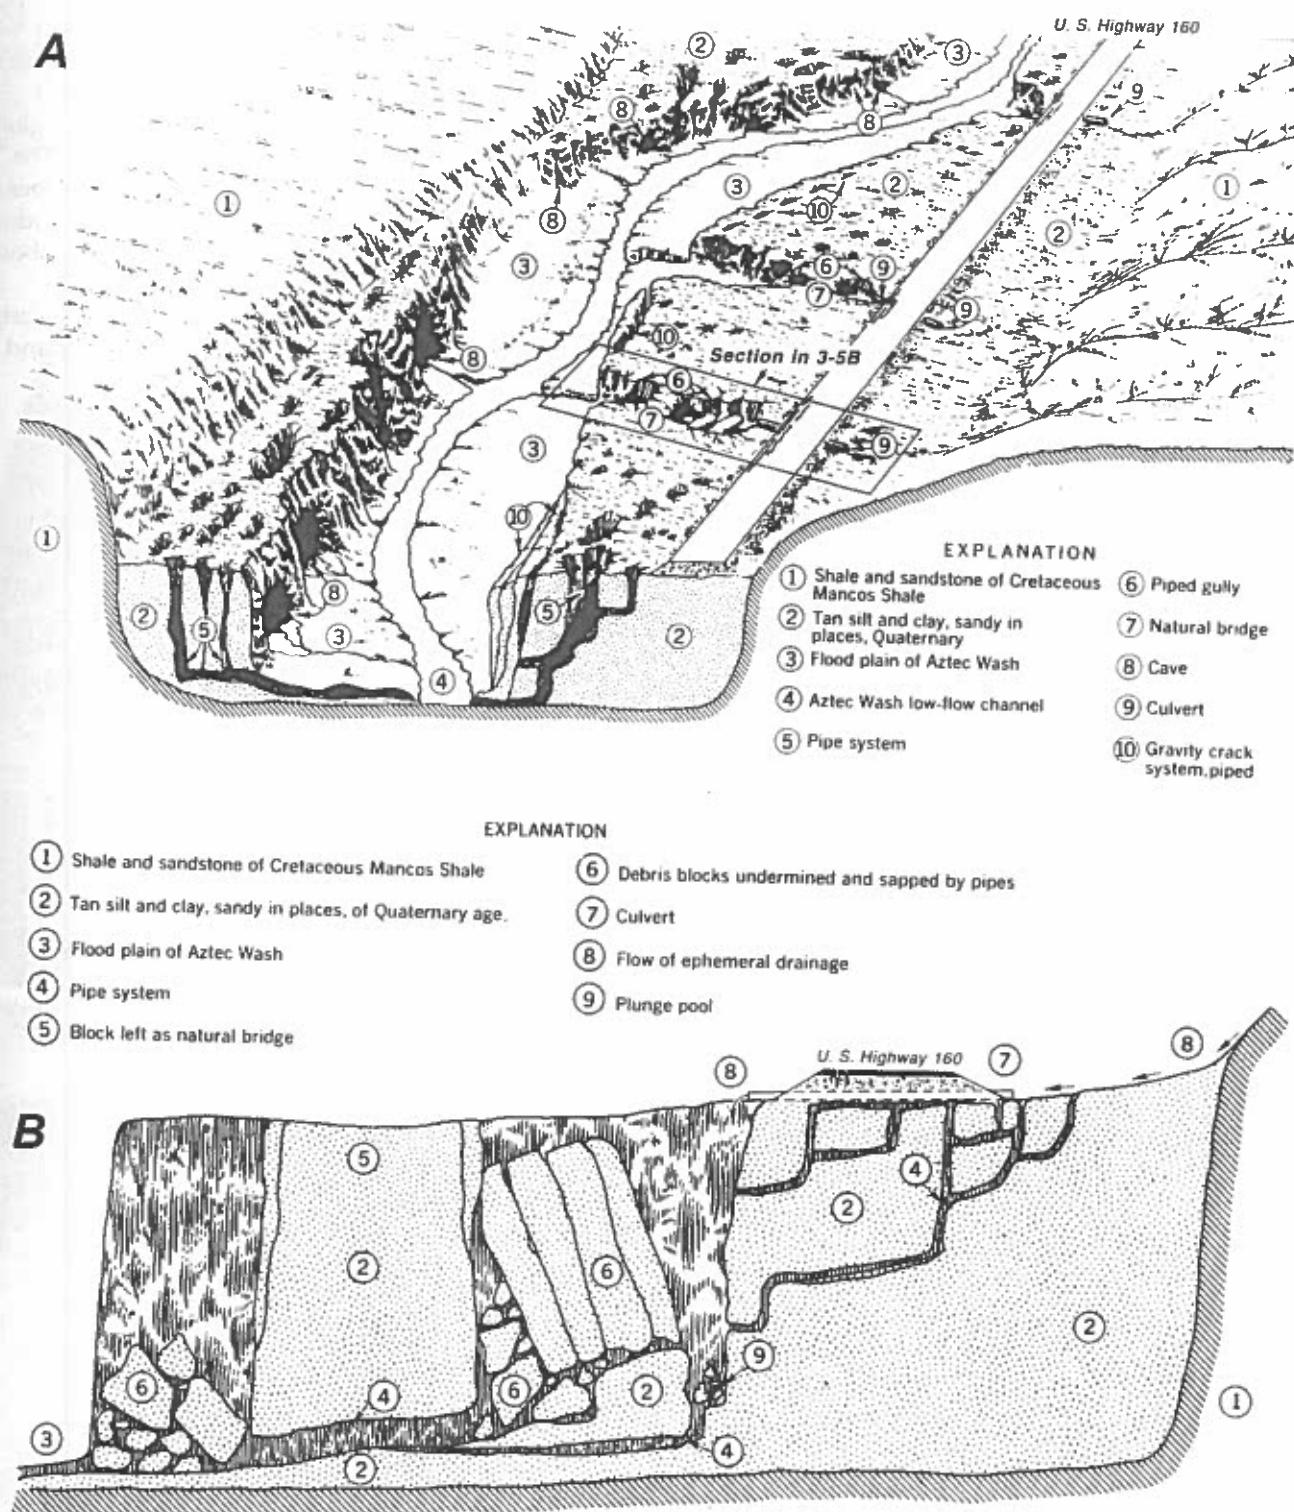
Figure 3-5. A, Terrain resulting from piping dissolution of geologically recent alluvial sediments and the creation of pseudokarst morphology in an example along U.S. Highway 160 at Aztec Wash in southwest Colorado. B, Cross section through the terrain. Illustration from Parker and Jenne (1967).

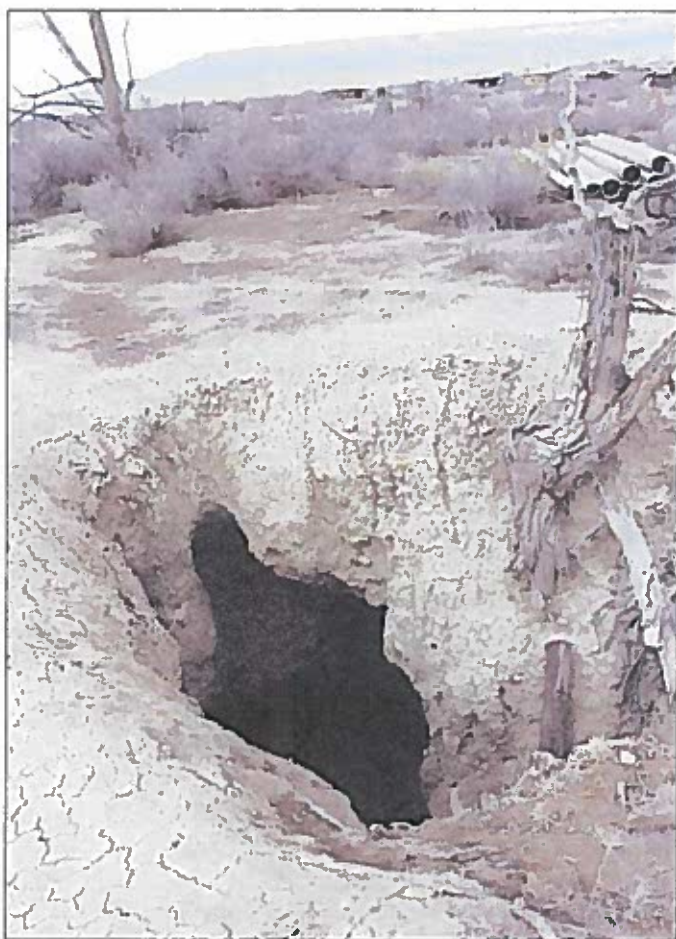
Figure 3-6. Sinkhole and cavern formation due to soil dispersion, piping, and void collapse along Loutsenhizer Arroyo, north of Montrose.

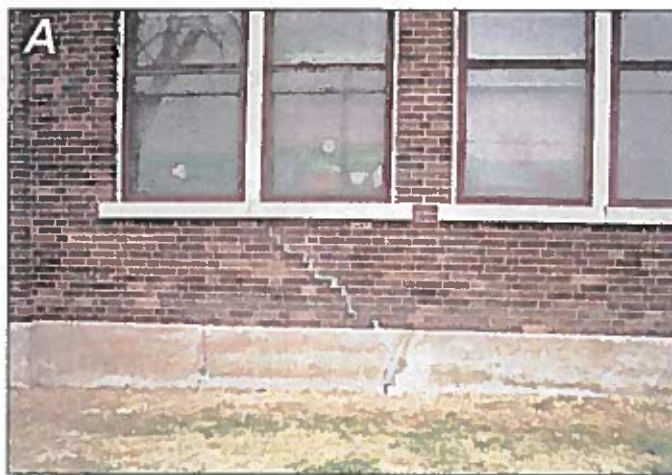
Figure 3-7. A, Typical damage to foundation walls and brickwork from settlement is visible on a school in Canon City.

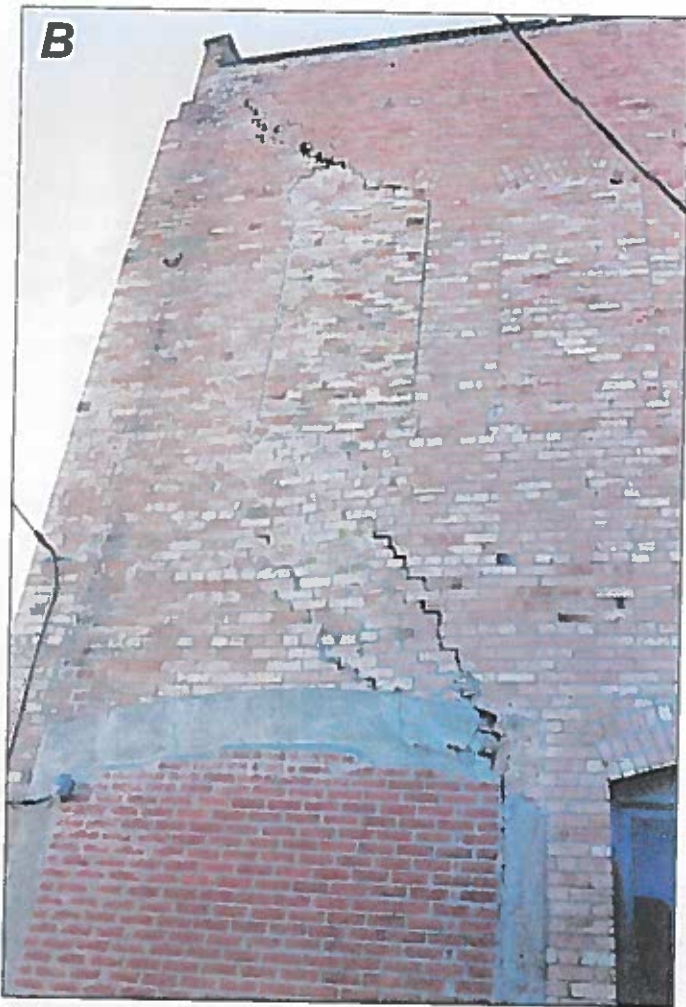
Figure 3-7. B, Extensive settlement-caused brickwork damage mars a downtown building in Montrose.

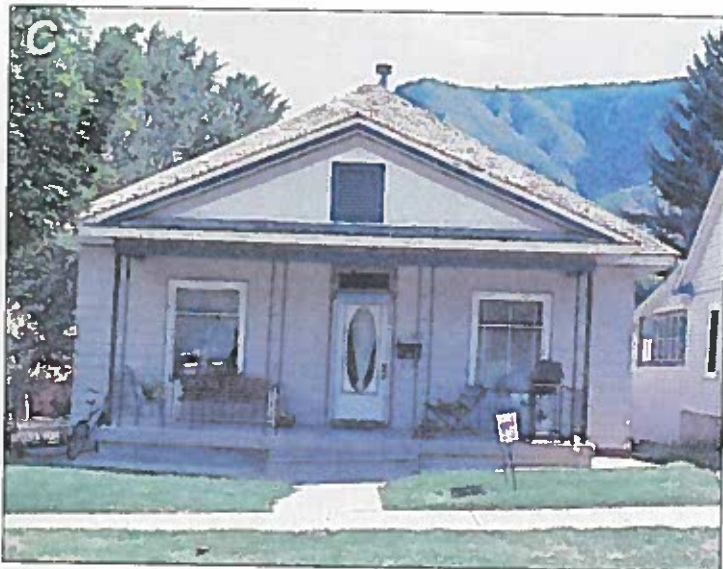
Figure 3-7. C, Settlement has damaged the porch and doorway of a home in Glenwood Springs.

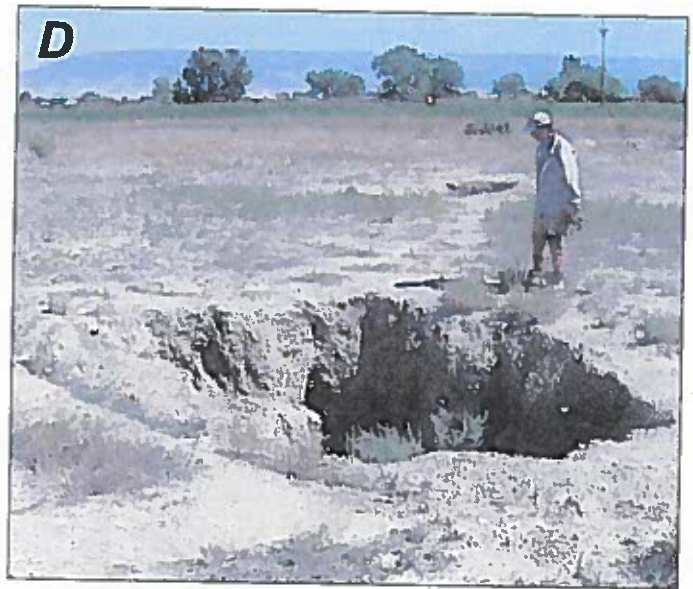
Figure 3-7. D, Pseudokarst collapse from dispersion and piping erosion has caused this agricultural field to be abandoned near Olathe. The plateau in the background is Grand Mesa.

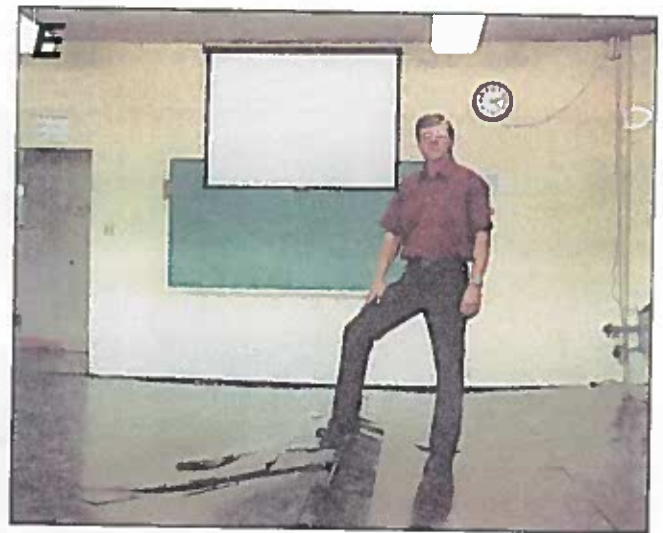
Figure 3-7. E, The wood flooring in a school in Montrose has buckled because of compression due to settlement of the underlying concrete slab-on-grade. Photo courtesy of Tom Griepentrog, Buckhorn Geotech.

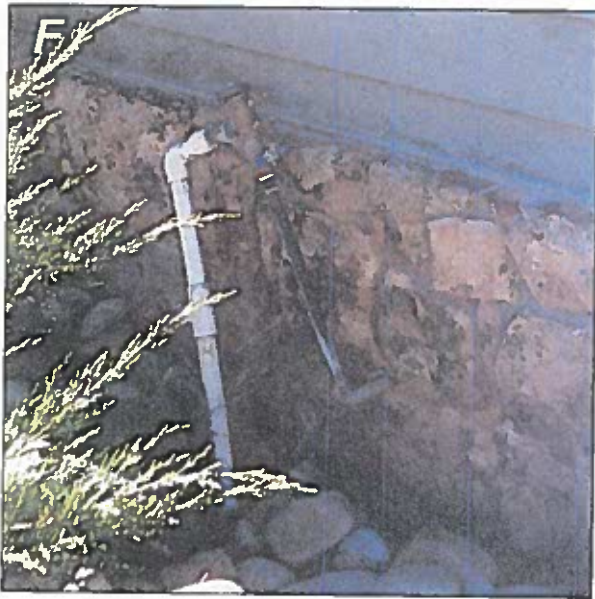
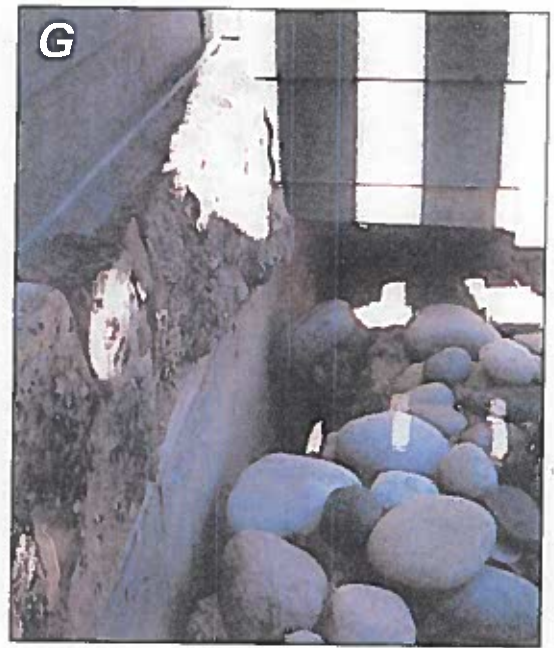
Figure 3-7. *F* and *G*, Large wetting events such as broken water mains will cause widespread settlements, ultimately putting the soil of the surrounding area into tension (which is why arcuate cracks form around wetting ponds). In these two photographs, soil is being pulled down and away from the foundation walls. Note the gap along the foundation wall and the distress of the water line into the home. Dangerous conditions occur if natural gas or buried power lines are pulled to the point of rupture.

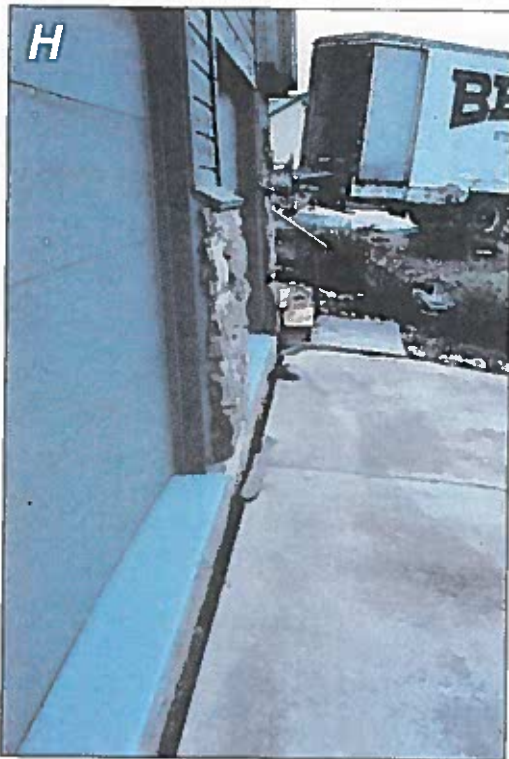
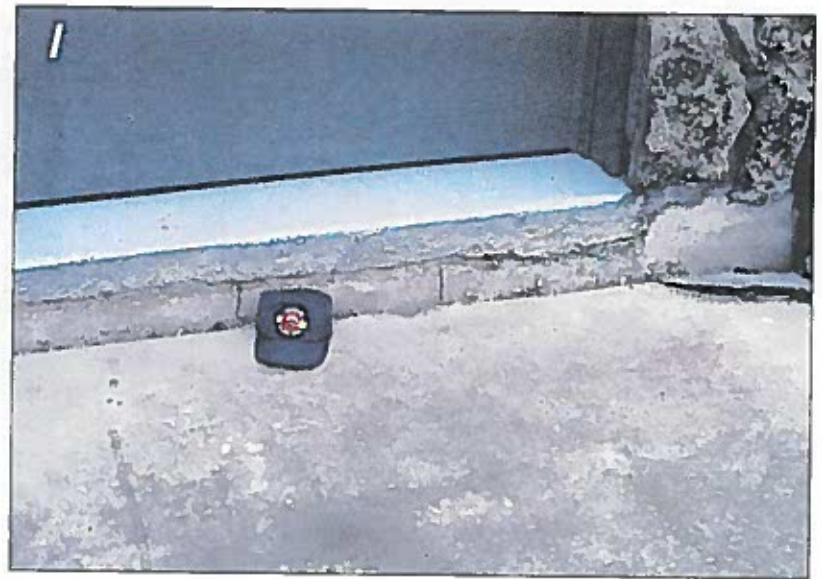
H and *I*, Large-scale settlement due to a water main break in road (off picture) has pulled this driveway down and away from the residence. This residence was previously underpinned, and a new leveling concrete pad was poured in the garage. The pipe piles were of inadequate depth, and deeper wetting of the collapsible soils caused further distress to the structure. (In *I*, a baseball hat shows the scale).
