MINERALS PROGRAM INSPECTION REPORT
PHONE: (303) 866-3567

MINE NAME: Whirlwind Mine	MINE/PROSPECTING ID#: M-2007-044	MINERAL: Uranium and vanadium	COUNTY: Mesa
INSPECTION TYPE: Monitoring	WEATHER: Clear	INSP. DATE: November 7, 2022	INSP. TIME: 11:00
OPERATOR: Energy Fuels Resources (USA) Inc.	OPERATOR REPRESENTATIVE: Todd Eldredge	TYPE OF OPERATION: 112d-1 - Designated Mining Operation	
REASON FOR INSPECTION: Normal I&E Program	BOND CALCULATION TYPE: None	BOND AMOUNT: \$375,078.00	
DATE OF COMPLAINT: NA	POST INSP. CONTACTS: DRMS	JOINT INSP. AGENCY: None	
INSPECTOR(S): Amy Yeldell	INSPECTOR'S SIGNATURE:

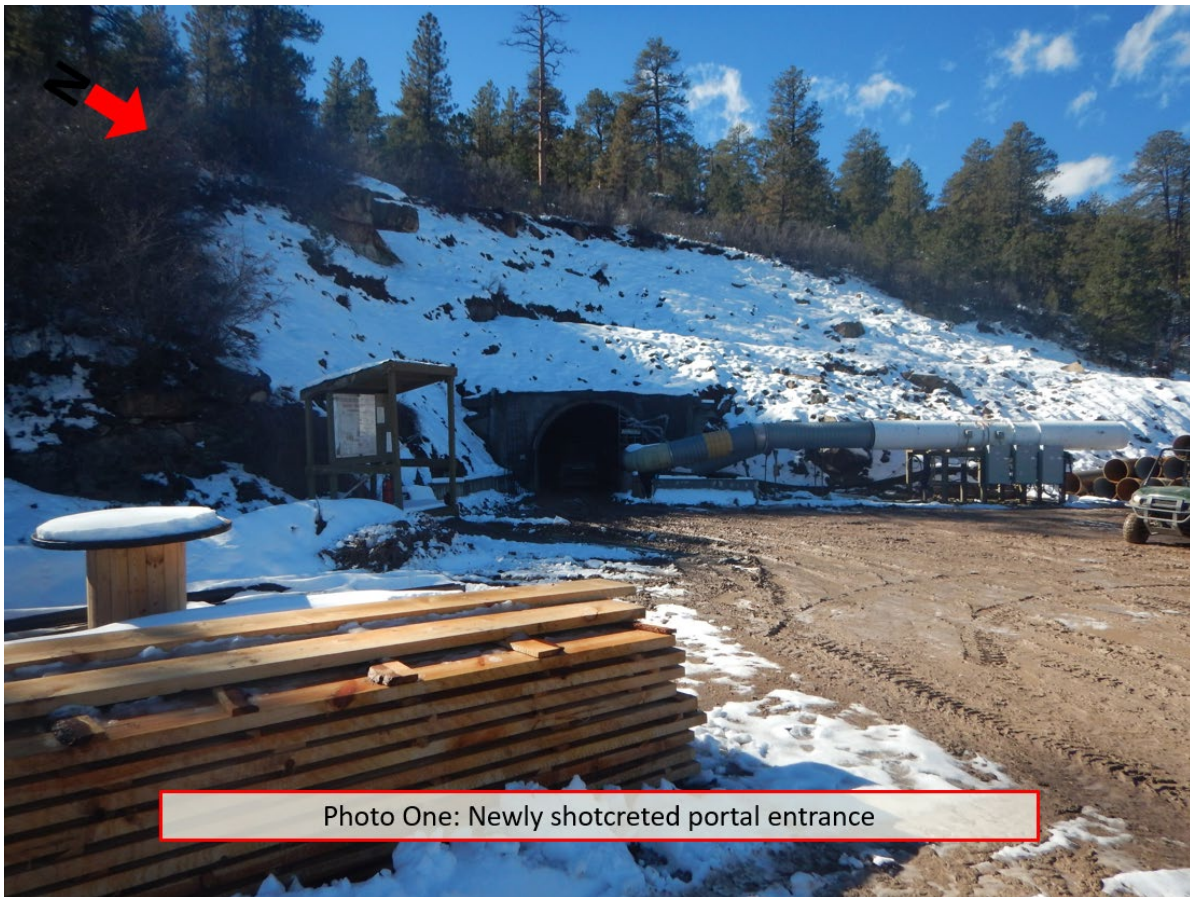
As of June 7, 2022 per CS-1 the site is in active status after having been in temporary cessation for an extended period of time. Crews were on site at the time of the inspection and will continue to work until weather shuts them down for the winter. The entrance to the portal has been re-enforced and shotcreted for safety. The primary focus on site is safety rehab work on the decline. Misc. ore and rock is being removed from the tunnel as needed and stored on the ore storage pad within the existing footprint of disturbance. Crews are estimated to be approximate 600 LF down the existing tunnel so far. The ventilation fan pipes have been removed. Damaged sections are being replaced and the pipe is being reinstalled as rehab work progresses down the decline. The refuge chamber and water tank are stored on the ore storage pad. Underground mining equipment is also being stored on the pad while rehab work is being conducted. Extra timbers and steel sets of varying sizes are on site and ready for use. Dry shotcrete was on site however due to the risk of freezing equipment has been winterized and additional shotcreteing will not occur until the spring. No fuel is stored on site, all fuel for equipment is brought up in slip tanks. All storage buildings/ containers appeared well organized.

Photo One: Newly shotcreted portal entrance

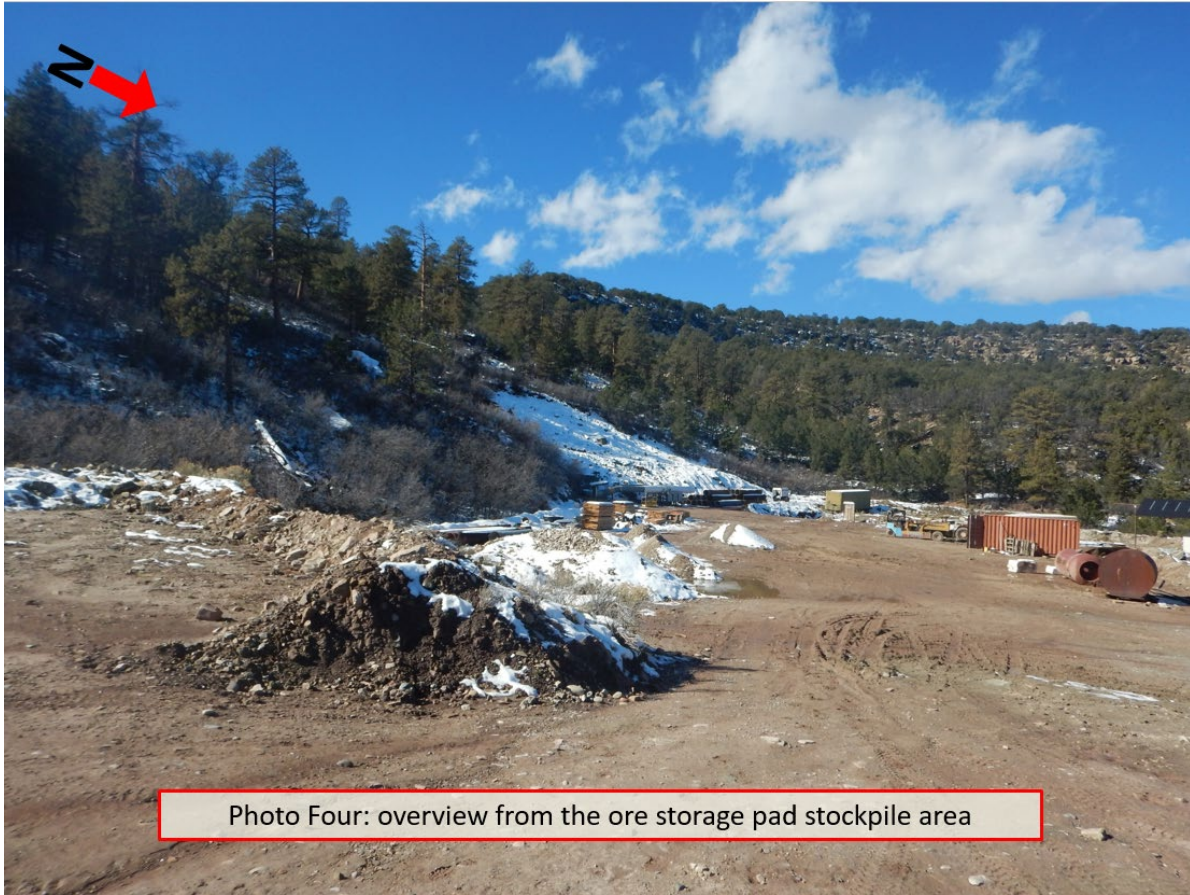
Photo Four: overview from the ore storage pad stockpile area

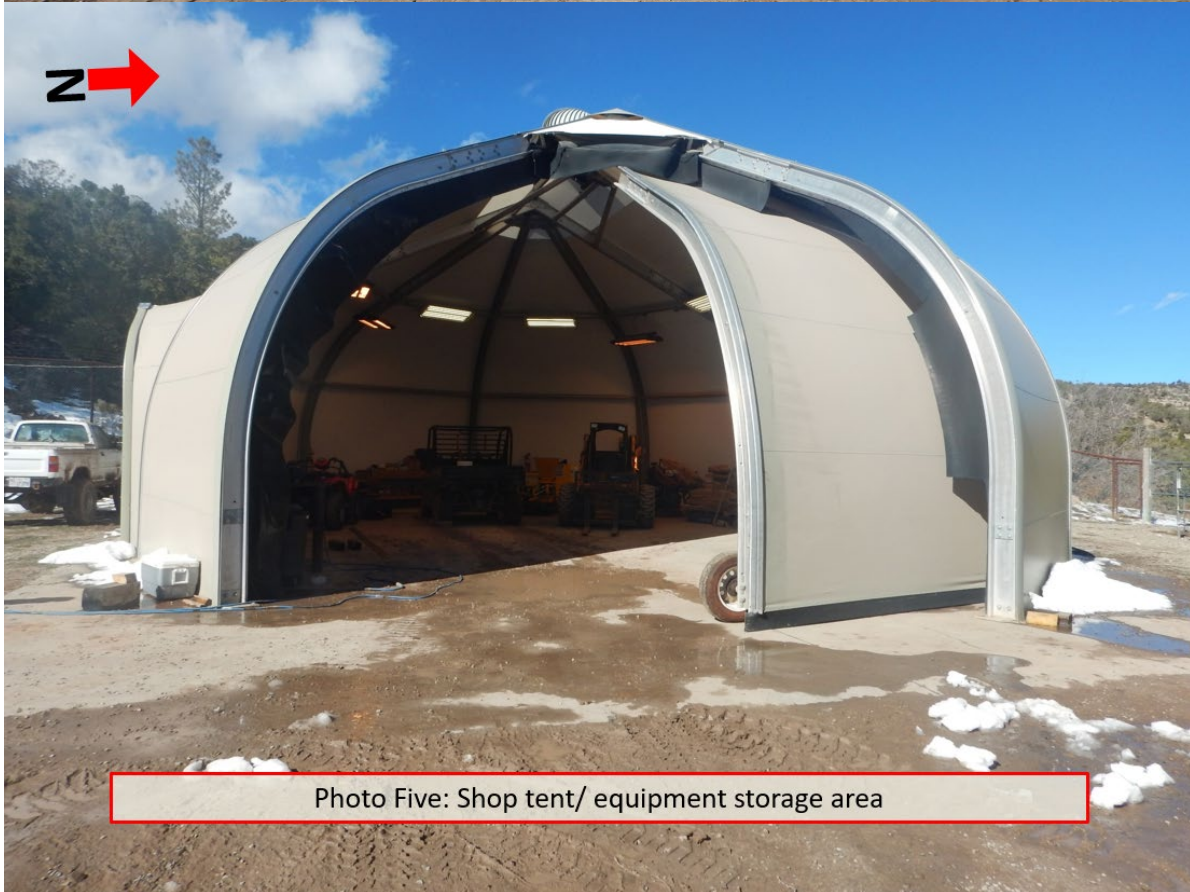
Photo Five: Shop tent/ equipment storage area

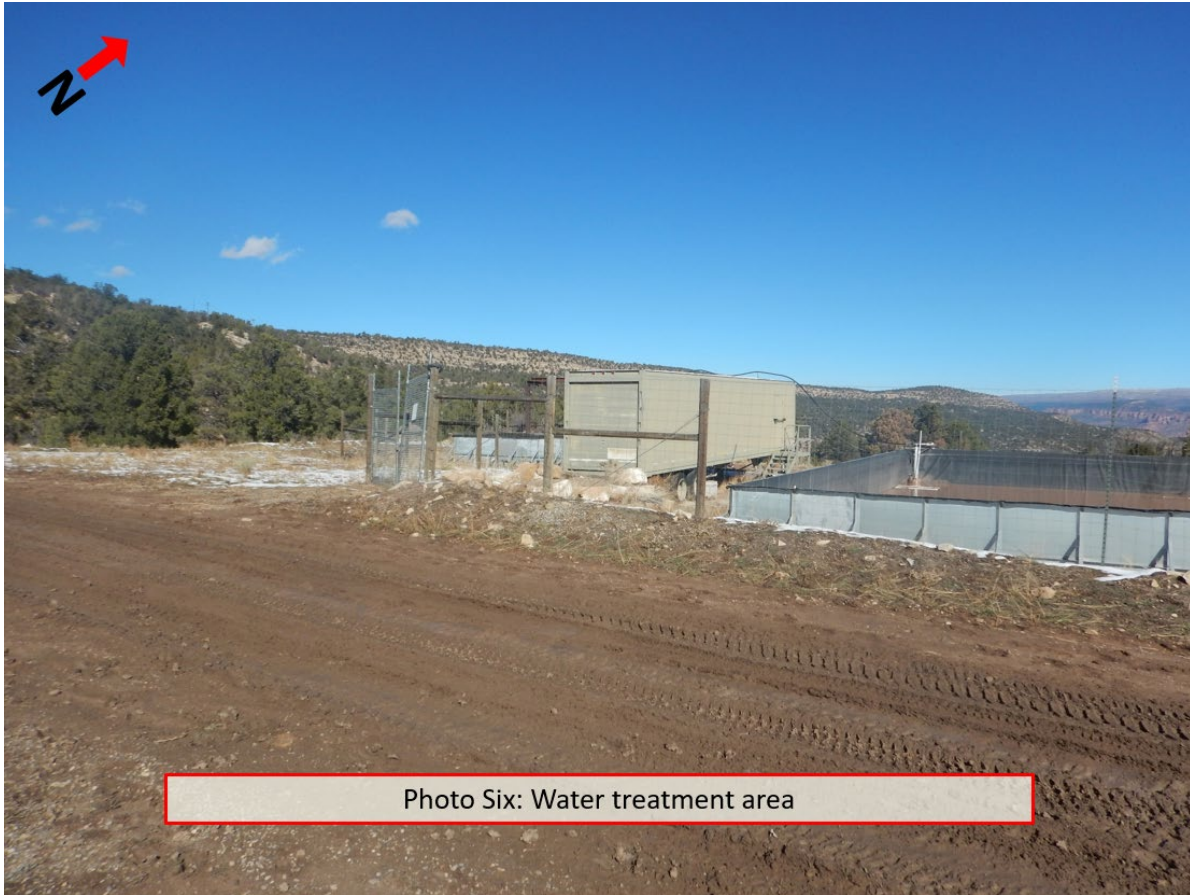
The site conditions around the water treatment system and stormwater ponds on the north side of the site remain unchanged. Over the winter the operator will be working on getting a new water treatment system fabricated with hopes of installing it in the spring/summer of 2023. Prior to the installation of a new system a technical revision will be required. In order for mining to progress the underground workings must be dewatered and that water must be treated. Additionally per the approval of CS-1, prior to any additional developments of mine workings, the underground portion of the reclamation cost estimate specifically, the bulkhead costs, will need to be re-evaluated. The Operator will need to provide the Division with three bids from independent contractors for the scope of work outlined under the Division's Memo: Cost Estimate for Water Impounding Concrete Bulkheads dated Nov. 14, 2007. Any additional financial warranty required to cover the underground closures will need to be posted prior to work commencing. For the time being the Division currently holds a financial warranty amount of \$375,078 for this site.

Photo Six: Water treatment area

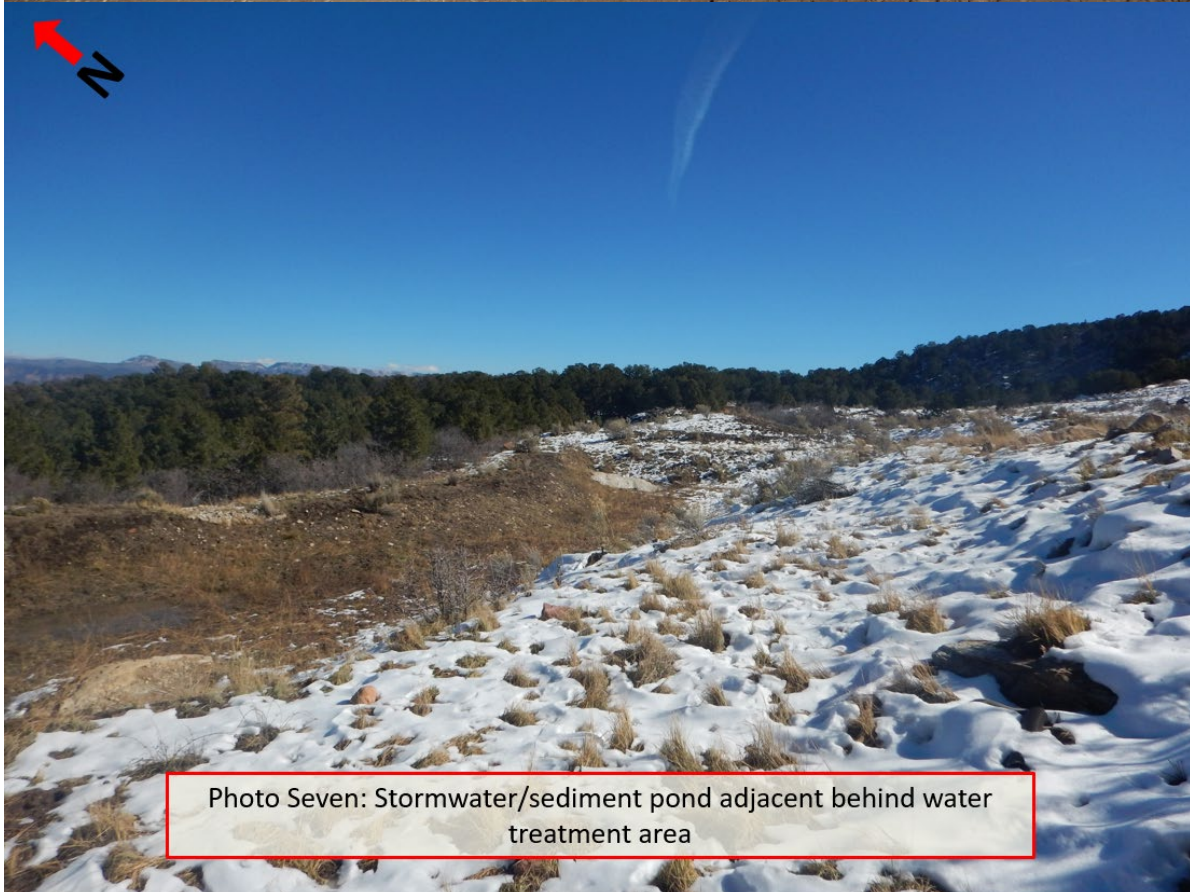
Photo Seven: Stormwater/sediment pond adjacent behind water treatment area
