MINERALS PROGRAM INSPECTION REPORT PHONE: (303) 866-3567

MINE NAME:	MINE/PROSPECTING ID#:	MINERAL: COUNTY:
October Ore Pile Reclamation	M-2008-050	Vanadium and uraniu Mesa
INSPECTION TYPE:	WEATHER: Windy	INSP. DATE: INSP. TIME:
Monitoring		November 7, 2022 12:15
OPERATOR:	OPERATOR REPRESENTATIVE:	TYPE OF OPERATION:
Nuvemco, LLC	Craig Howell	110d - Designated Limited Impact
REASON FOR INSPECTION:	BOND CALCULATION TYPE:	BOND AMOUNT:
Normal I&E Program	Complete Bond	\$18,212.00
DATE OF COMPLAINT:	POST INSP. CONTACTS:	JOINT INSP. AGENCY:
NA	DRMS	None
INSPECTOR(S):	INSPECTOR'S SIGNATURE:	SIGNATURE DATE:
Amy Yeldell	Amy Geldell	November 14, 2022

PERMIT #: M-2008-050 INSPECTOR'S INITIALS: ACY INSPECTION DATE: November 7, 2022

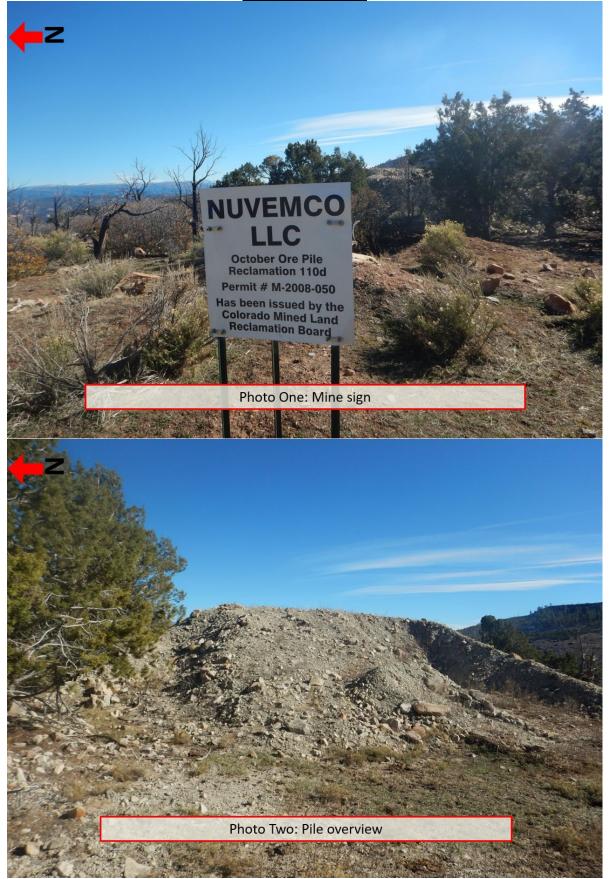
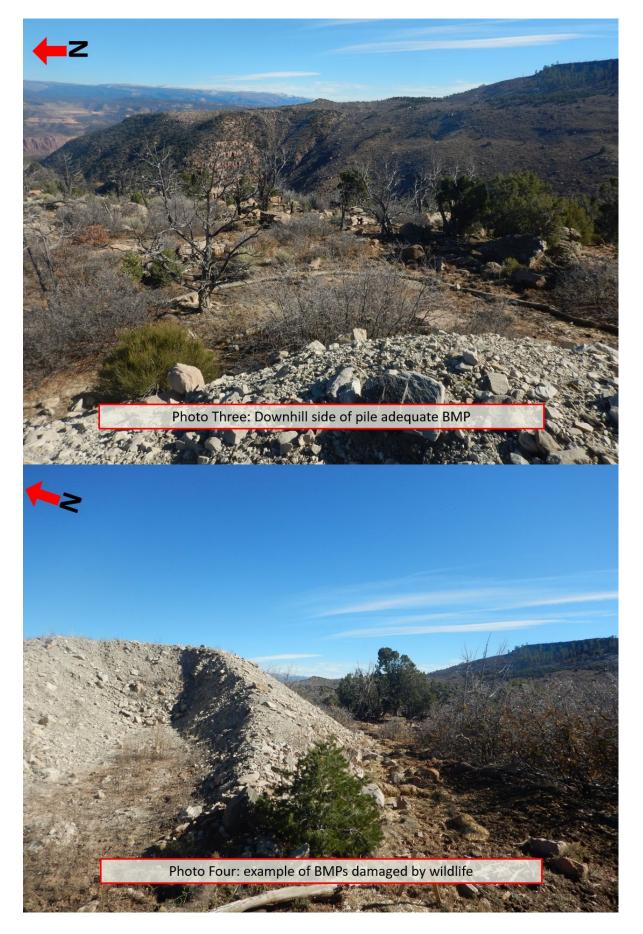
The mine identification sign and affected area boundary markers are in place and in compliance with Rule 3.1.12. There are no structures, equipment or other mining related features on site. The ore stockpile and surrounding areas remains stable and no erosion was observed. Straw waddles were installed around the entire pile. The majority of which appear in good shape. A small section has been ruined by wildlife on the uphill side. Given that they filter run-on water repair is not immediately necessary. Please repair come spring when the normal maintenance is conducted. Vegetation surrounding the pile remains adequate and no weeds were observed.
