MINERALS PROGRAM INSPECTION REPORT
PHONE: (303) 866-3567

MINE NAME: Allison Gravel Pit	MINE/PROSPECTING ID#: M-2001-010	MINERAL: Gravel	COUNTY: Elbert
INSPECTION TYPE: Monitoring	WEATHER: Clear	INSP. DATE: November 2, 2022	INSP. TIME: 11:15
OPERATOR: Elbert County	OPERATOR REPRESENTATIVE: Jason Kohring	TYPE OF OPERATION: 112c - Construction Regular Operation	
REASON FOR INSPECTION: Normal I&E Program	BOND CALCULATION TYPE: None	BOND AMOUNT: \$0.00	
DATE OF COMPLAINT: NA	POST INSP. CONTACTS: None	JOINT INSP. AGENCY: None	
INSPECTOR(S): Amy Eschberger	INSPECTOR'S SIGNATURE:

M-2001-010 / Allison Gravel Pit / Elbert County (112c)

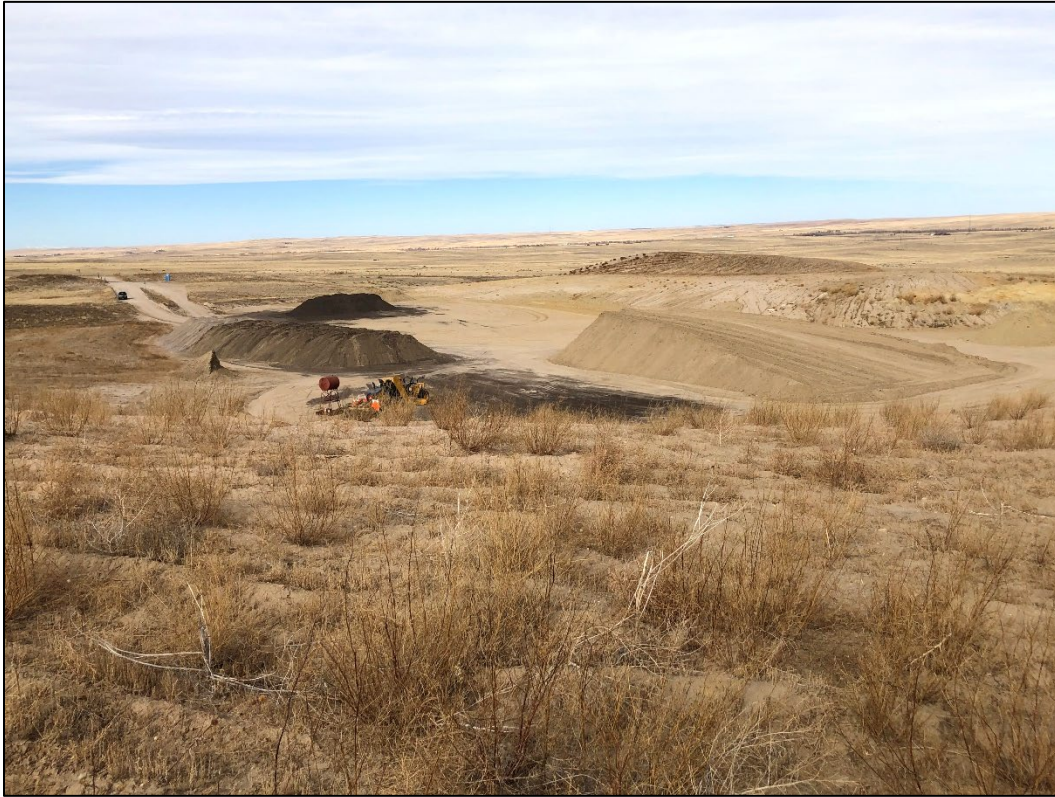
Photo 1. View looking west across active pit area. Note material stockpiles temporarily stored on pit floor, including recycled asphalt (per TR-5).

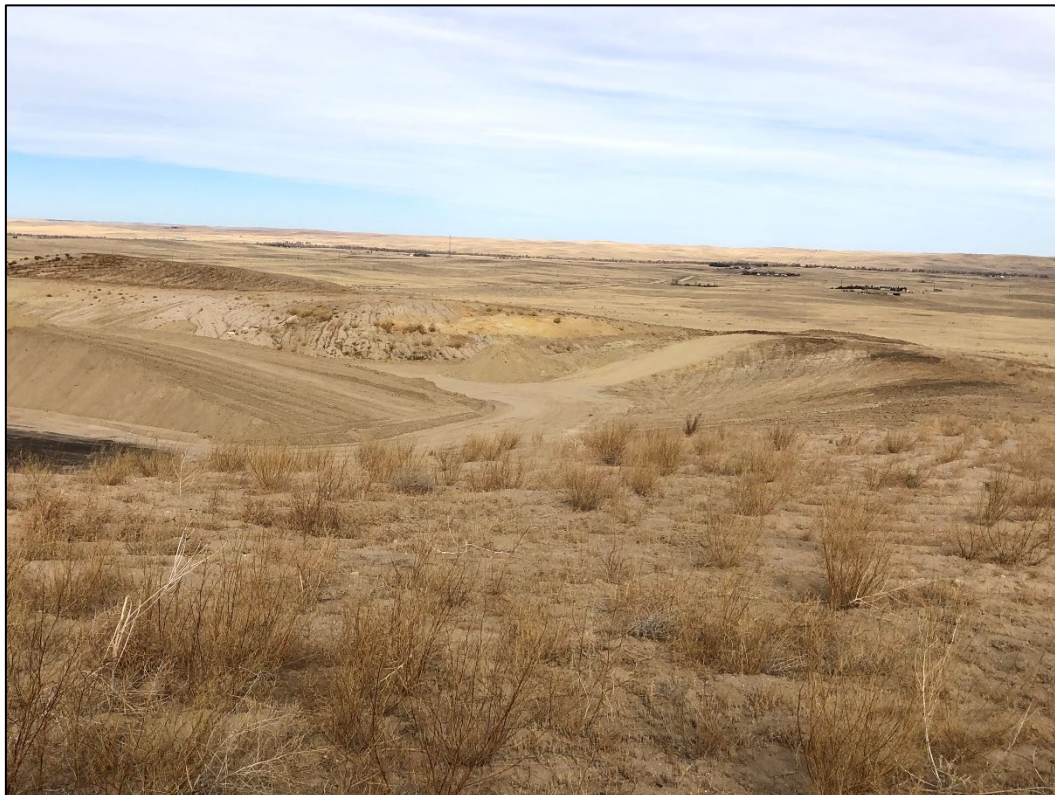
Photo 2. View looking northeast at northern pit wall, showing slopes maintained at 3H:1V or flatter gradient.

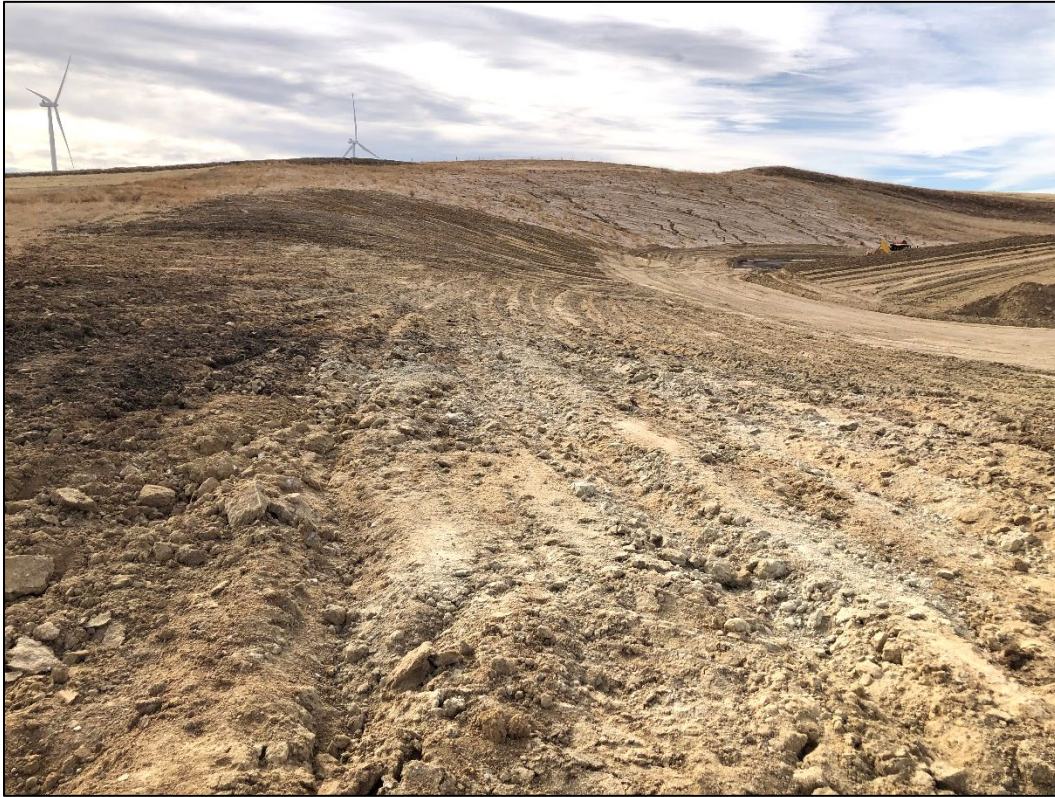
Photo 3. View looking south across eastern pit wall, showing slopes maintained at 3H:1V or flatter gradient.

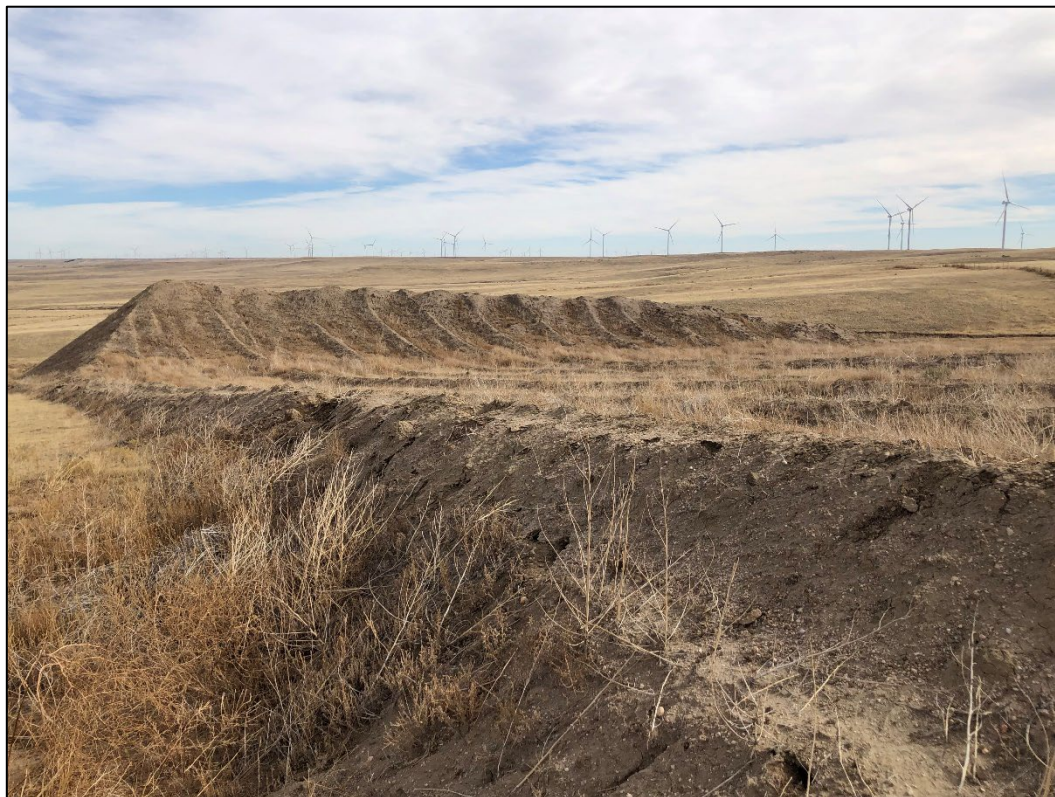
Photo 4. View looking southeast across area immediately east of active pit stripped in preparation of mining. Note topsoil berm in background.

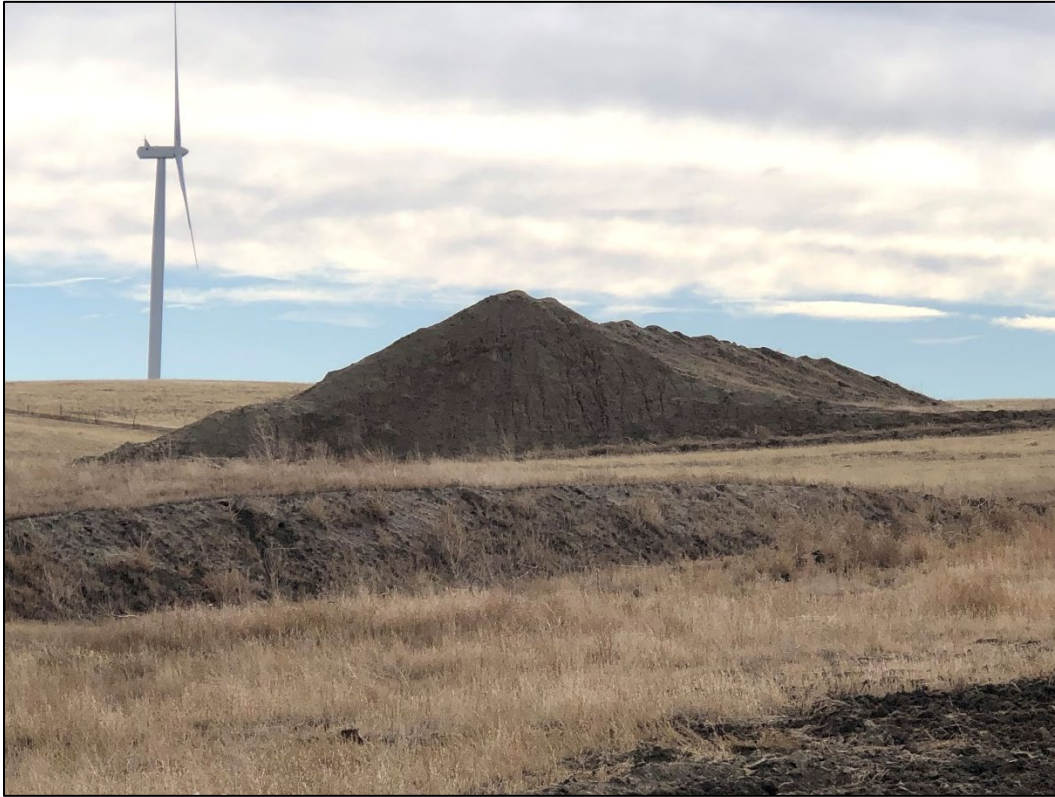
Photo 5. View looking southeast, showing closer view of topsoil stored along eastern edge of stripped area. This stockpile needs to be seeded to protect it from erosion.

The operator has stripped an area along the eastern edge of the current pit area in preparation of expanding the pit eastward. This new disturbance area does not appear to be captured on the most recent aerial imagery available in Google Earth, and is therefore approximated in the Division's estimated disturbance area (see enclosed Google Earth image of site). The salvaged topsoil from the stripped area is bermed along its eastern edge. Additional topsoil stockpiles are stored along the northern and southern edges of the current pit area. All topsoil stockpiles appeared to be stable; however, the newer eastern stockpile is not yet protected with a vegetative cover. In the approved permit, the operator committed to broadcast seeding any topsoil stockpiled for longer than one year with a perennial grass species. This will protect it from erosion and ensure the topsoil is in a usable condition for reclamation. The Division recommends the operator seed the eastern stockpile as soon as feasible.

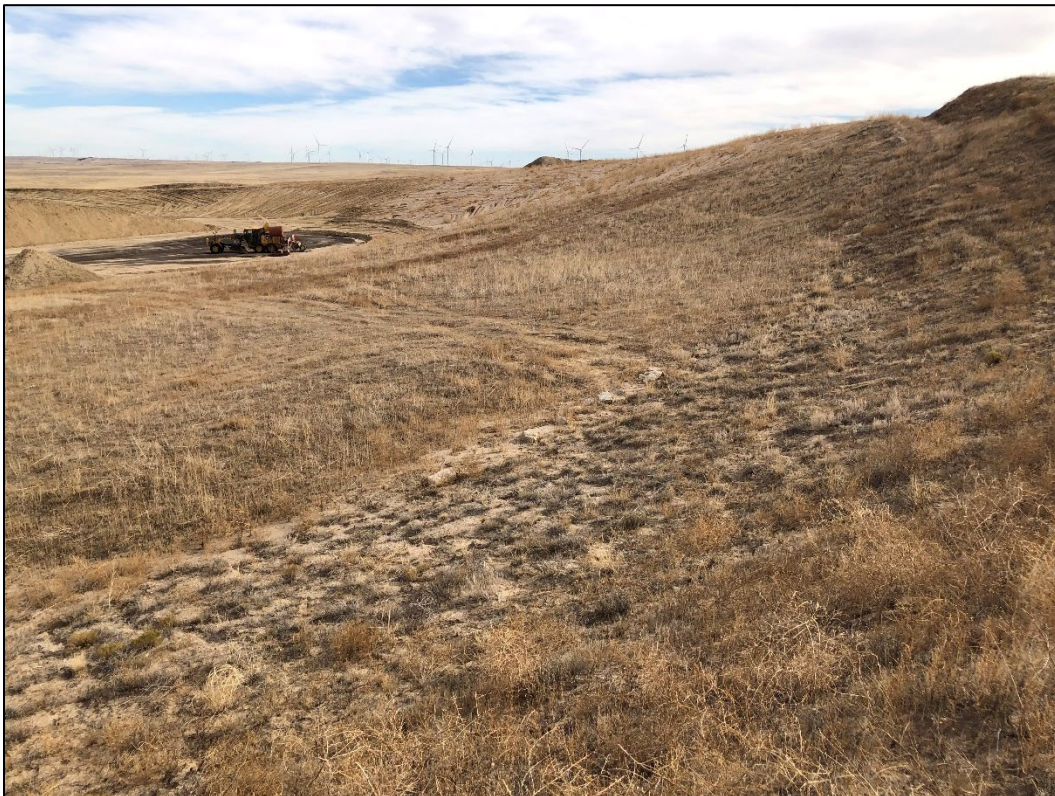
Photo 6. View looking east across reclaimed southwestern portion of active pit, showing slopes graded to 3H:1V or flatter with a good vegetative cover.

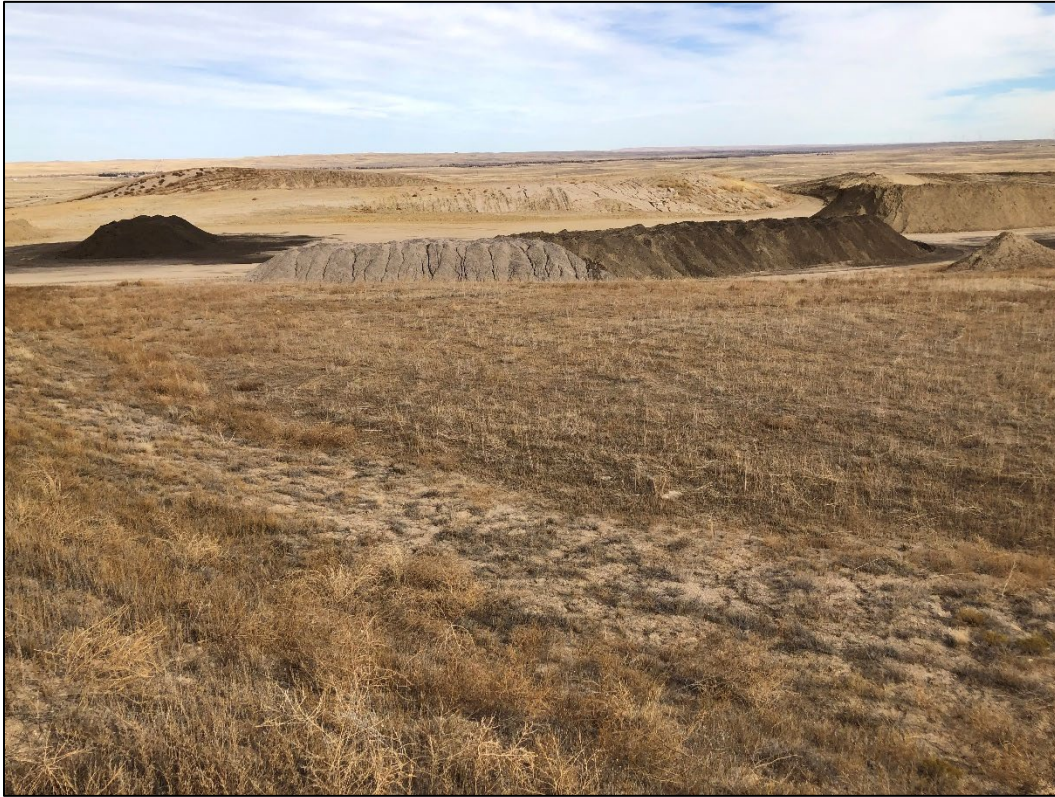
Photo 7. View looking north across reclaimed southwestern portion of active pit, showing slopes graded to 3H:1V or flatter with a good vegetative cover.

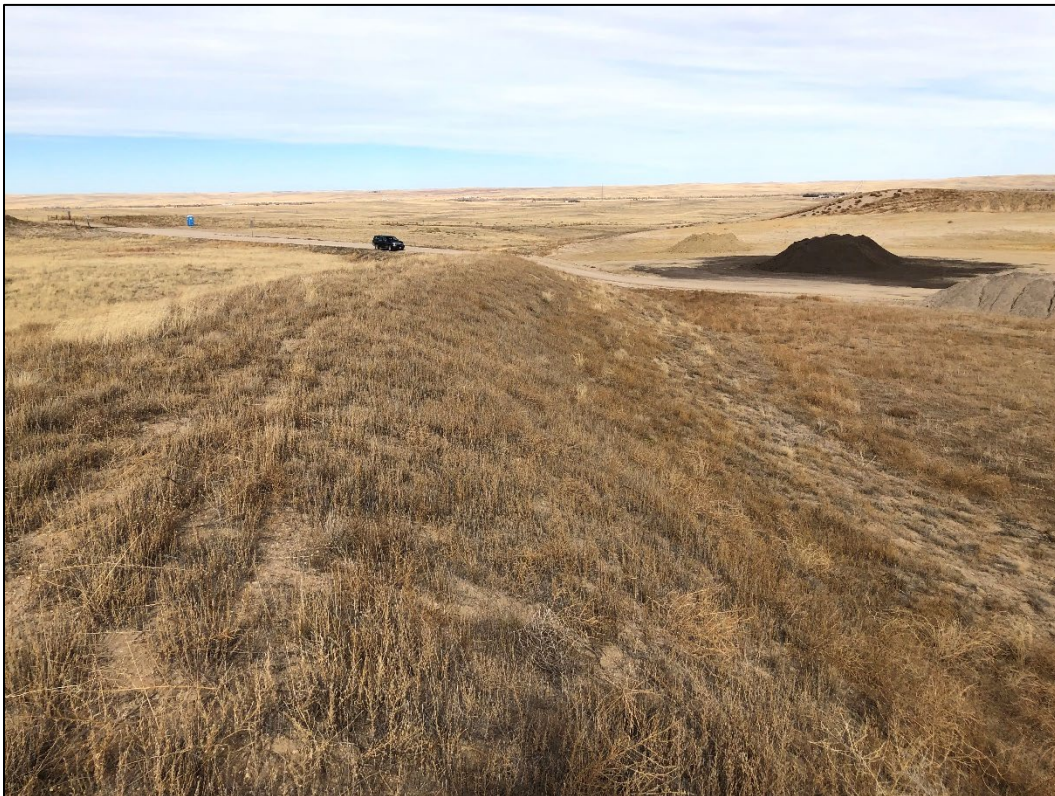
Photo 8. View looking northwest across reclaimed southwestern portion of active pit, showing slopes graded to 3H:1V with a good vegetative cover.

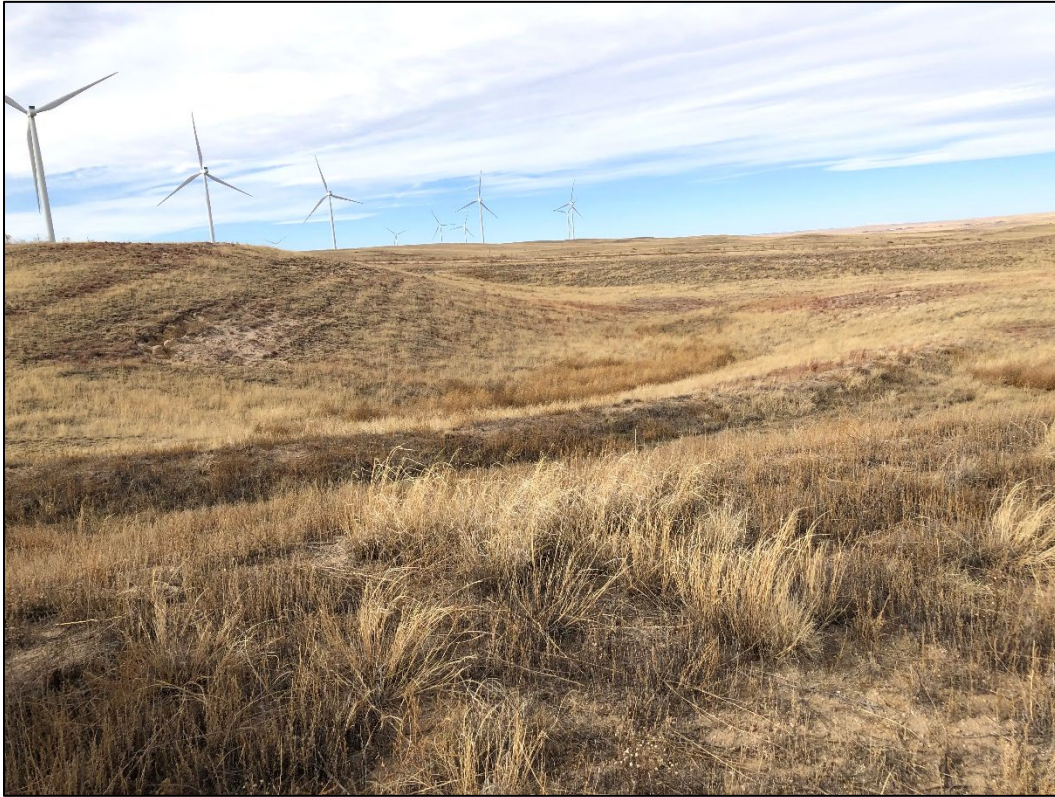
Photo 9. View looking west across reclaimed pit (in mine phase A) located west of active pit.

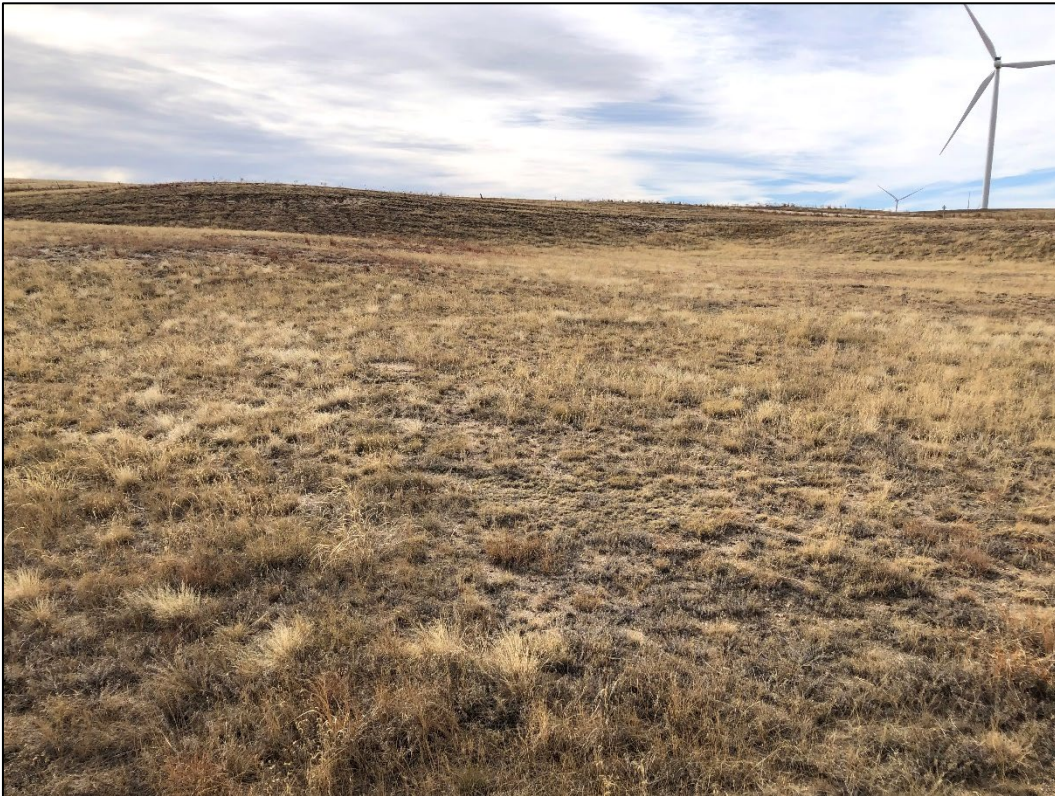
Photo 10. View looking south across reclaimed pit (in mine phase A) located west of active pit.

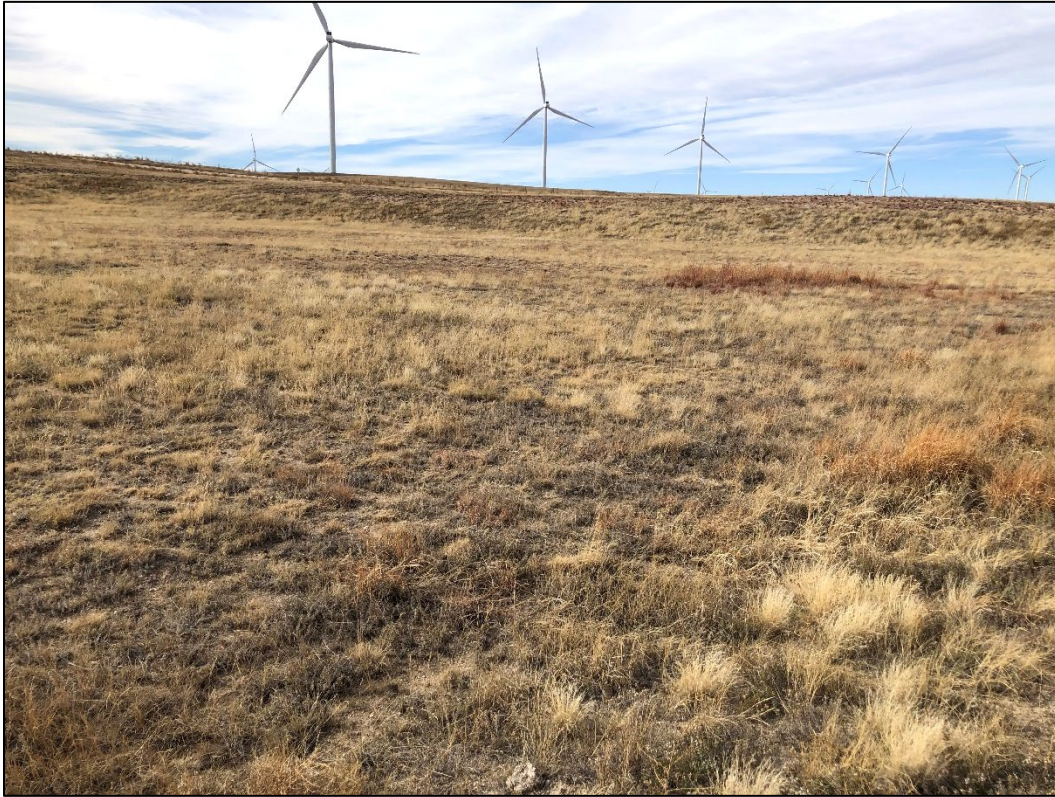
Photo 11. View looking southwest across reclaimed pit (in mine phase A) located west of active pit.

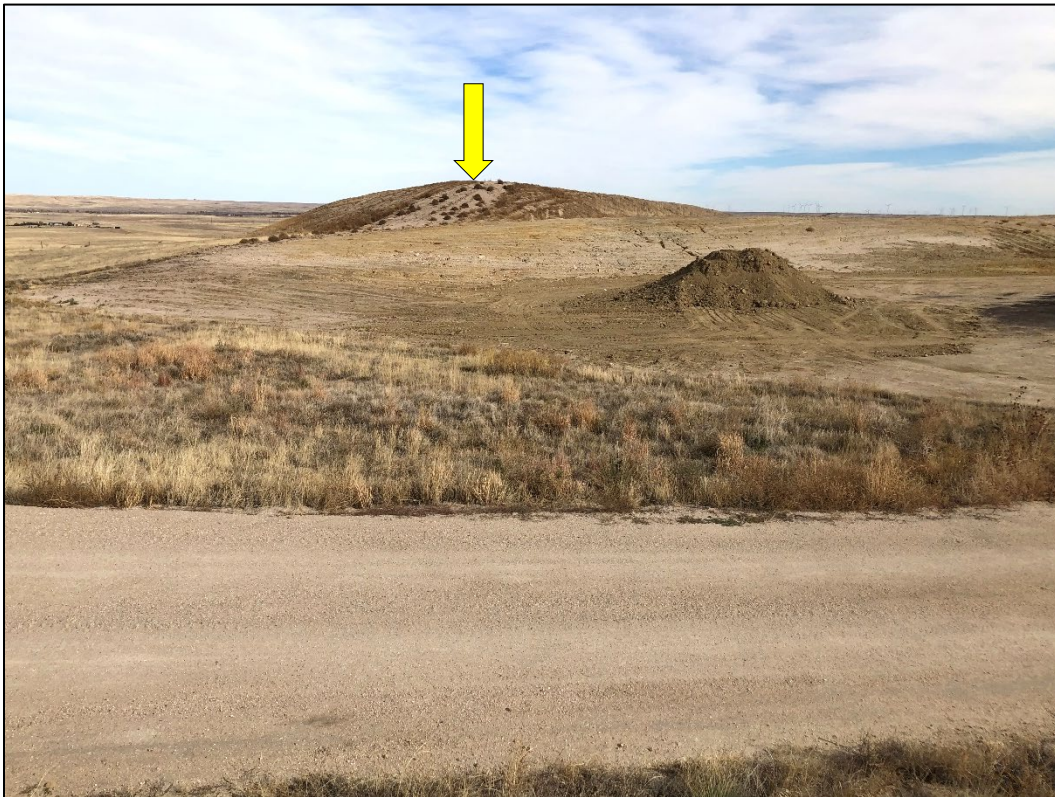
Photo 12. View looking north at northwestern portion of active pit (on other side of access road), showing slopes maintained at 3H:1V or flatter gradient. Note large topsoil stockpile (indicated) stored at northern edge of pit.

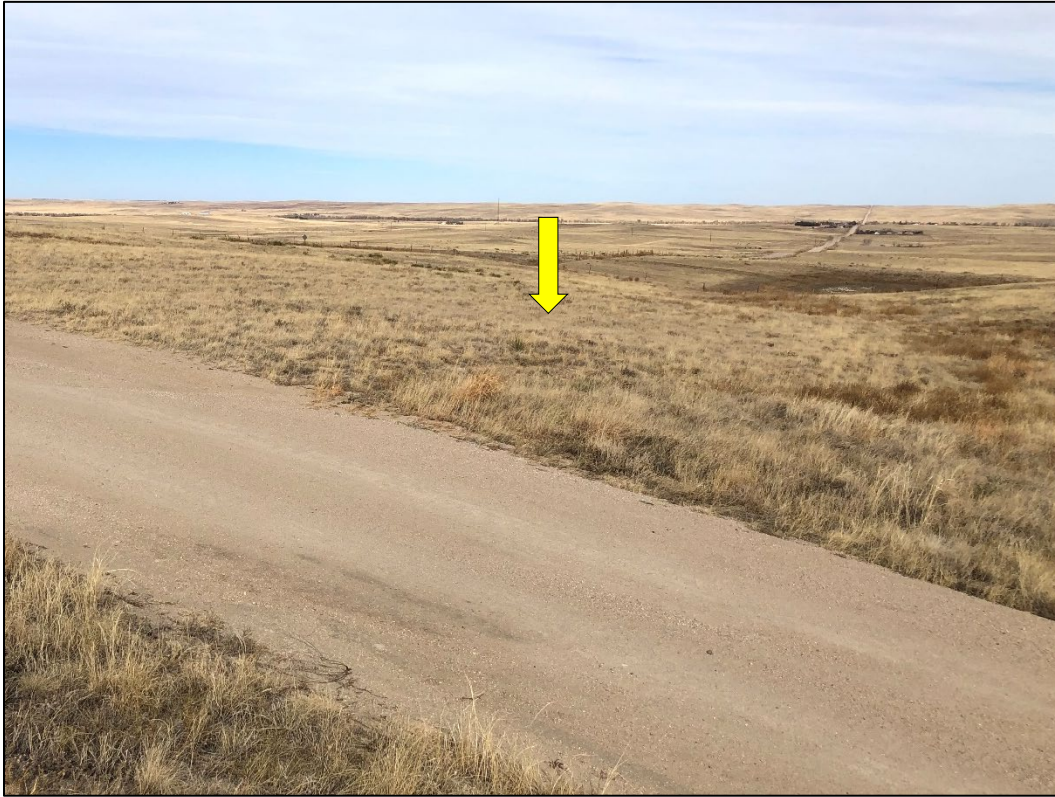
Photo 13. View looking north/northwest at area north of access road (indicated) previously used for temporary storage of recycled asphalt. This area is no longer used for this purpose and is in reclamation.

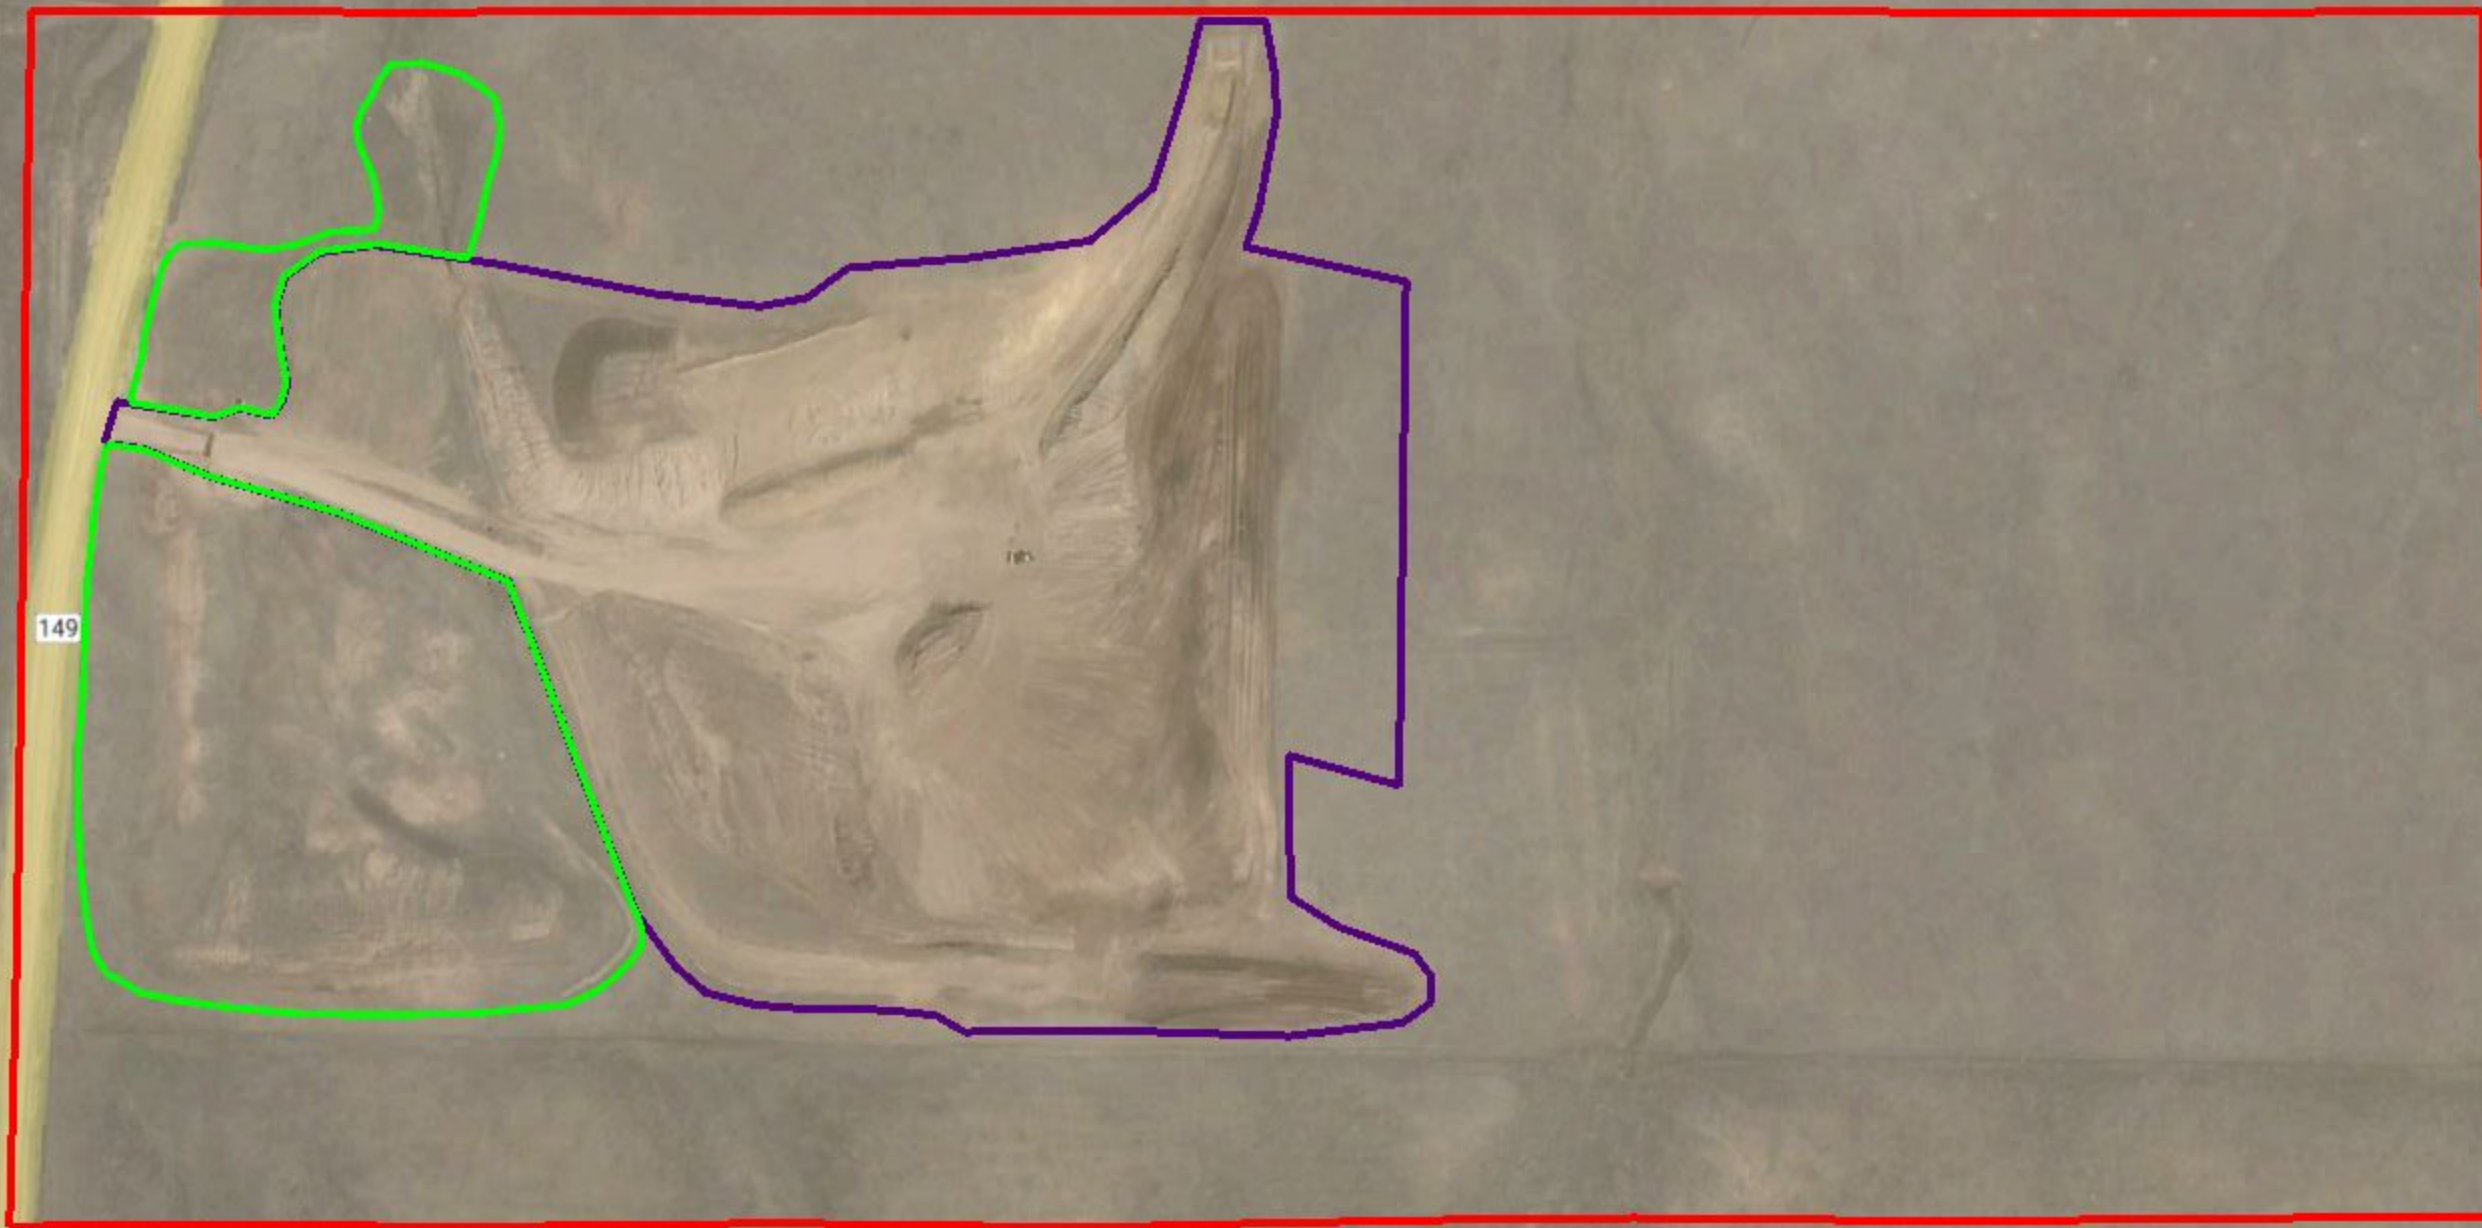
The Division estimates the operation has disturbed a total of 26.6 acres at the site, including 19 acres of active (unreclaimed) disturbance and 7.6 acres of reclaimed disturbance. This amount of disturbance is in compliance with the approved maximum disturbance at any time of 40 acres. Prior to disturbing more than 40 acres, the operator will need to either submit a Technical Revision to increase the maximum allowed disturbance or submit an Acreage Reduction to release reclaimed areas from the permit.

Red Outline = 80 acres = Approved Permit Area (location approximated based on permit maps)
Purple Outline = 19 acres = Approximate Disturbed Area (based on 11/2/2022 inspection)
Green Outline = 7.6 acres = Approximate Reclaimed Areas
(Image data from 4/2020)
