PERMIT INFORMATION

Permit Number: C-1981-012 Mine Name: New Elk Mine Operator: New Elk Coal Company, LLC Operator Address: Mr. Mark Gray 12250 Highway 12 Weston, CO 81091	County: Las Animas Operation Type: Underground Permit Status: Active Ownership: Private
	Operator Representative Present: Pete Saint
Operator Representative Signature: (Field Issuance Only)

Inspection Start Date: November 10, 2022 Inspection Start Time: 08:00 Inspection End Date: November 10, 2022 Inspection End Time: 14:00		Inspection Type: Coal Complete Inspection Inspection Reason: Normal I&E Program Weather: Clear	
Joint Inspection Agency: None		Joint Inspection Contacts:	
Post Inspection Agency: None		Post Inspection Contacts:	
Inspector(s): Brock Bowles Amber Michels Jared Ebert	Inspector's Signature:   Signature Date: November 15, 2022

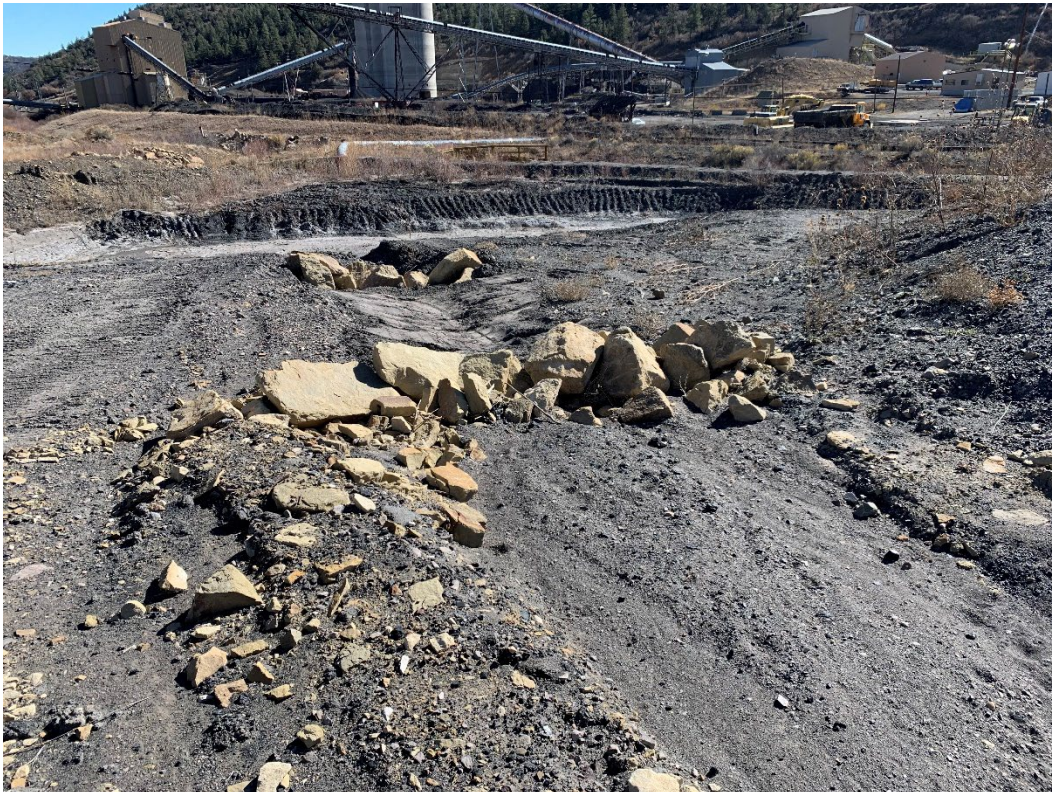
DWDA #2 did not have vegetation and contained numerous rills and gullies. Ditches D12 and D14 are in place directing all runoff and sediment to a catchment basin at the east end of the pile. Both ditches were clear of obstructions. The sediment basin had recently been cleaned (photo 1). The east berm of the sediment basin that was noted needing repair in the Sept 2022 inspection report has been repaired (photo 2).

Photo 1-DWDA #2 sediment pond and D12 in foreground

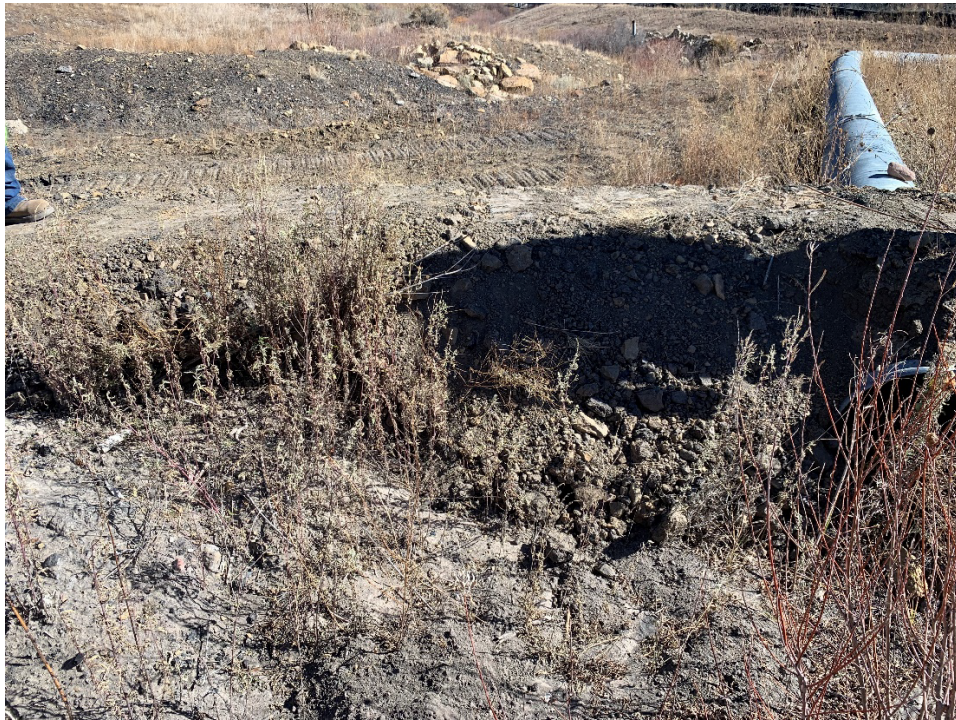
Photo 2 – Sediment basin berm repaired

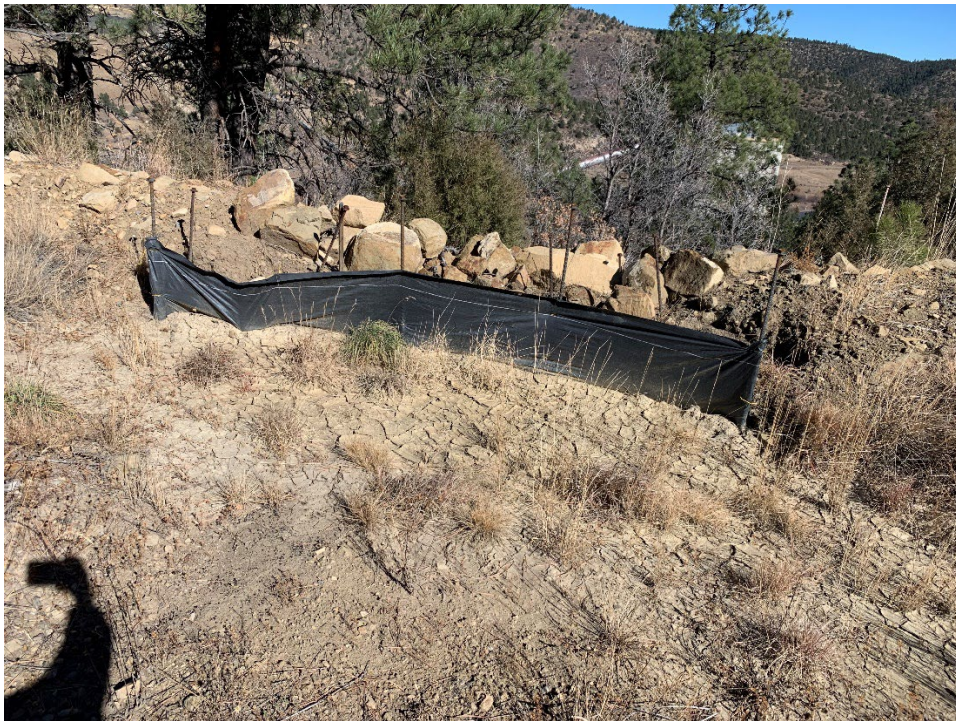
The SAE structure for the 400k gal water tank was in good condition (photo 3). The check dams along the water tower access road in Ditch D18 need cleaning.

Photo 3 – SAE silt fence in good condition

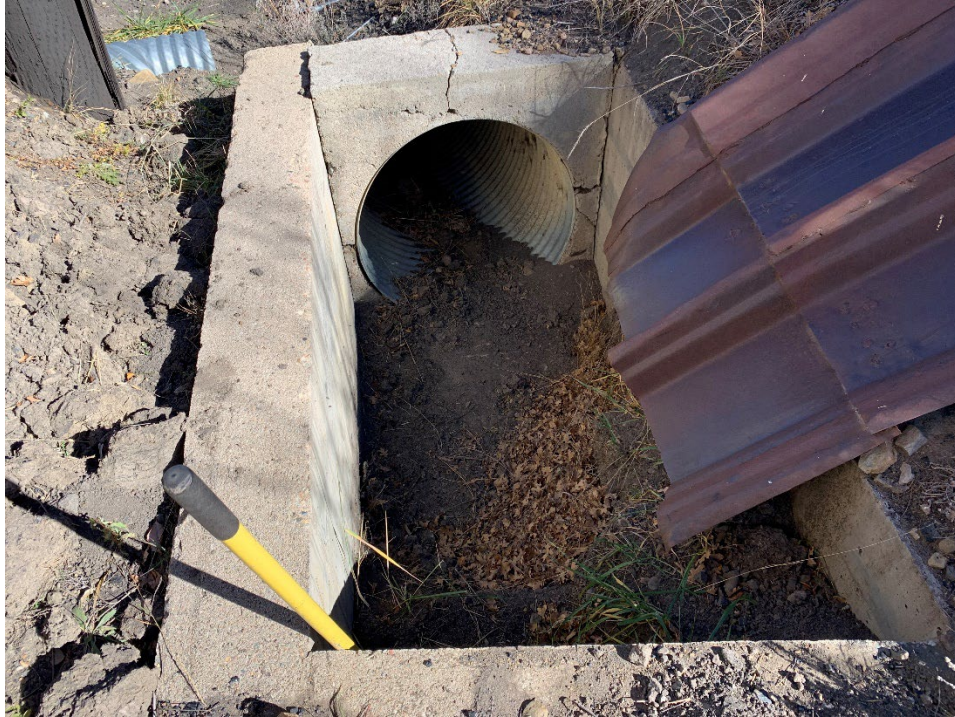
The concrete box at the bottom of the clean water flume by the portal has been partially cleaned (photo 4). Culvert C46 under the road by the clean water concrete box needs to be cleaned and have the willows removed on the outlet side of the culvert because they are obstructing the water flow (photo 5).

Photo 4 – Clean water diversion box partially cleaned

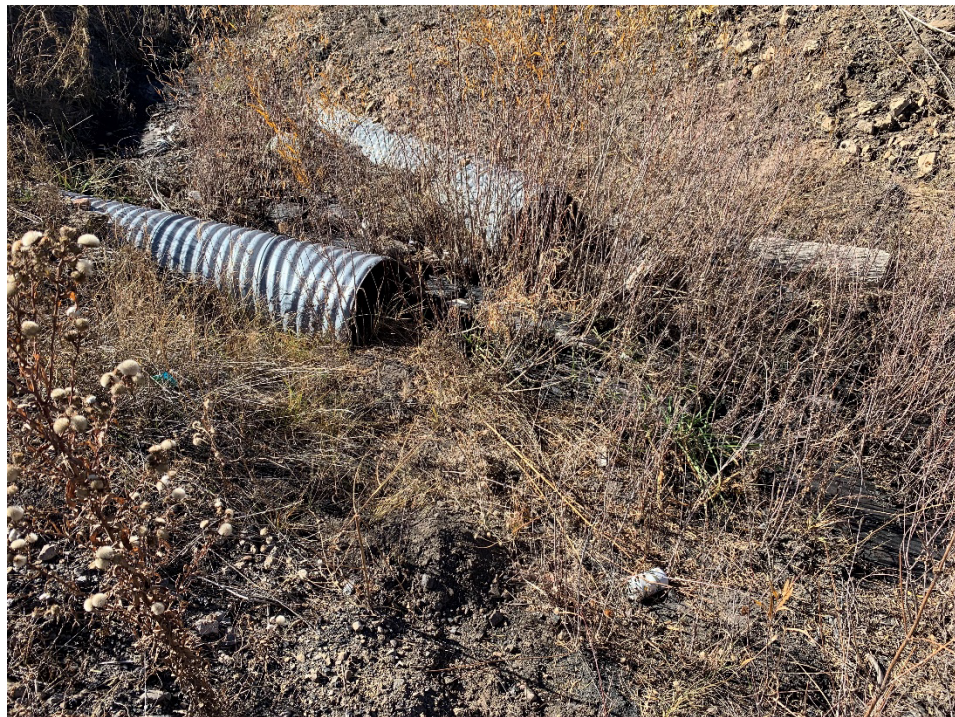
Photo 5 – Willows need to be removed from culvert outlets

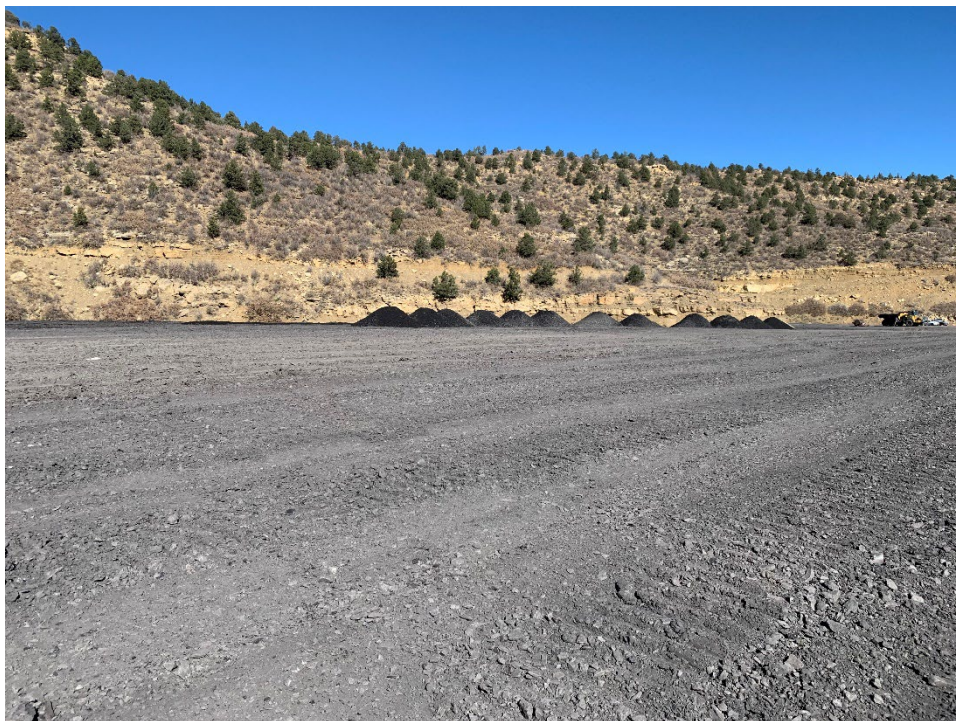
Waste material was being conveyored to the RDA and hauled across the top of the pile for drying by articulating trucks (photo 6). The top of the RDA was sloped to the sides for positive drainage. No ponding or low spots were seen on the pile.

Photo 6 – Material drying on top of RDA

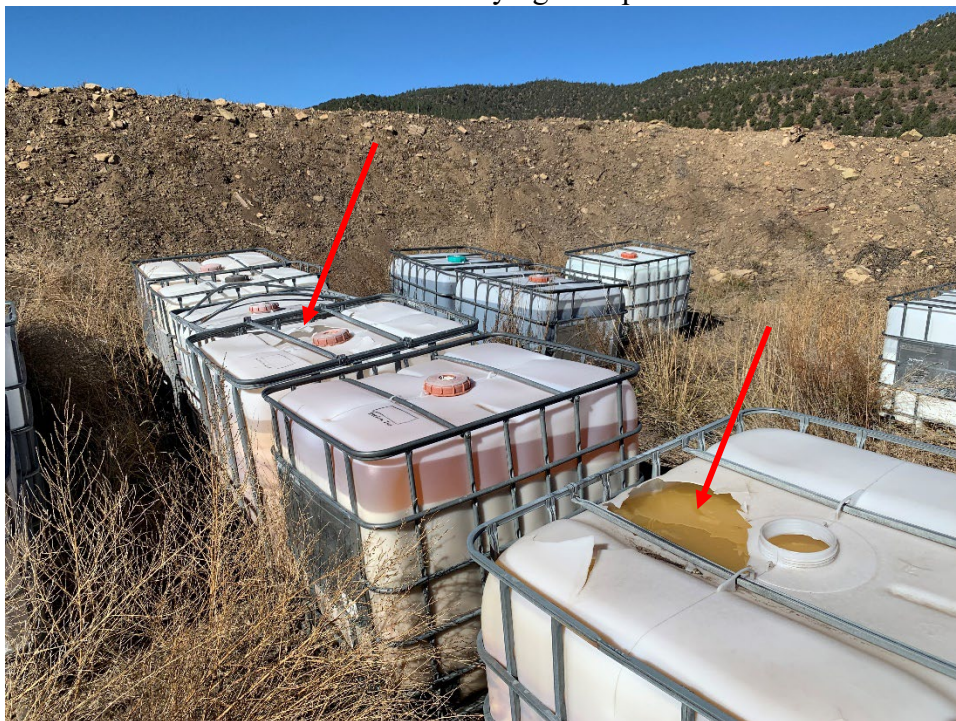
A few of the liquid storage containers being store in the Portable Explosive and Chemical Storage area

were damaged (photo 7). These containers had holes in the top and were being filled with rainwater. They are getting close to overflowing and they need to be addressed before they spill on the ground.

Photo 7 – Damaged chemical containers
