MINERALS PROGRAM INSPECTION REPORT

MINE NAME: Pikeview Quarry	MINE/PROSPECTING ID#: M-1977-211	MINERAL: Limestone (general), granite, granite gneiss and dolomite	COUNTY: El Paso
INSPECTION TYPE: Monitoring	WEATHER: Clear	INSP. DATES: October 13, 2022 October 25, 2022	INSP. TIME: 09:00 16:15
OPERATOR: Continental Materials Corporation	OPERATOR REPRESENTATIVE: Jerry Schnabel	TYPE OF OPERATION: 112c - Construction Regular Operation	
REASON FOR INSPECTION: Normal I&E Program	BOND CALCULATION TYPE:	BOND AMOUNT: \$13,389,784.00	
DATE OF COMPLAINT: NA	POST INSP. CONTACTS: None	JOINT INSP. AGENCY: None	
INSPECTOR(S): Timothy Cazier, P.E.	INSPECTOR'S SIGNATURE:

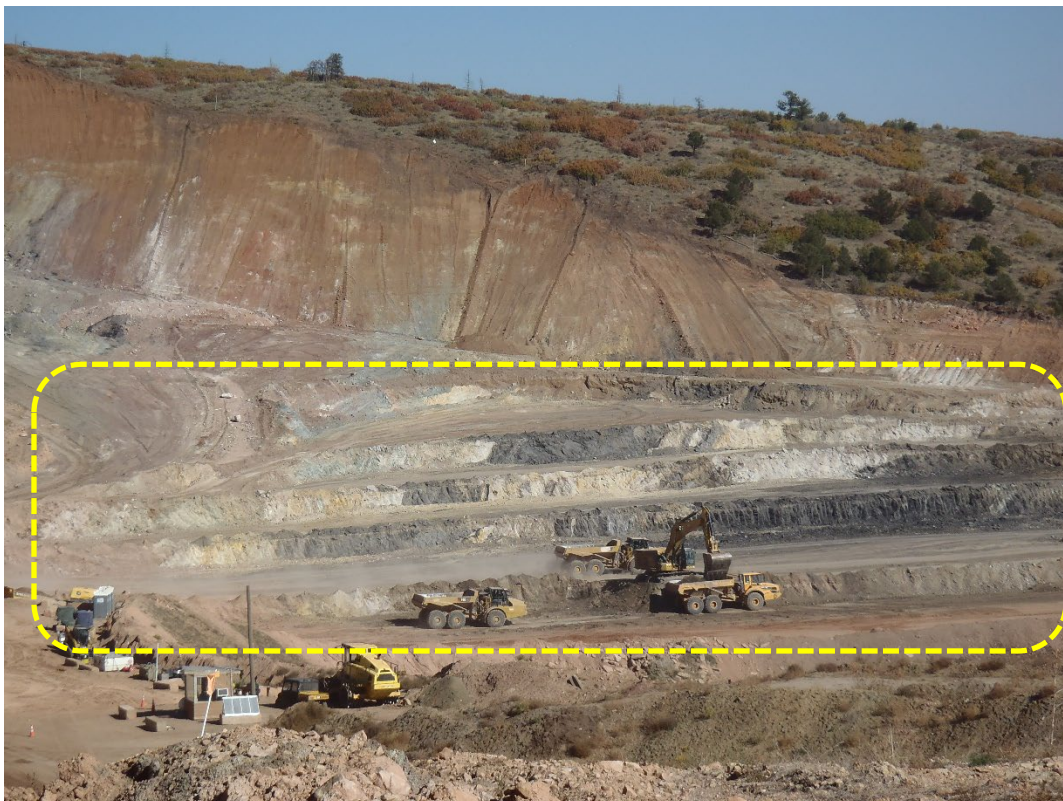
Backfill: On October 13th, site representatives indicated approximately 70 vertical feet of backfill had been placed. Backfill material was being excavated from the north end, in the previous location of the maintenance shop (see **Photos 1** and **2**). Material continued to be excavated via benches to facilitate efficient haul truck traffic and safety. Benches will be graded to a continuous slope for final reclamation. The excavated material was observed being hauled to the east central fill area for placement (see **Photo 3**). Imported fill continued to be placed in the south end (see **Photo 4**). Site representatives stated they had imported about 100,000 cubic yards (CY) of backfill material – a small fraction of the total volume of placed material.

Photo 1. Benched borrow area (looking NE).

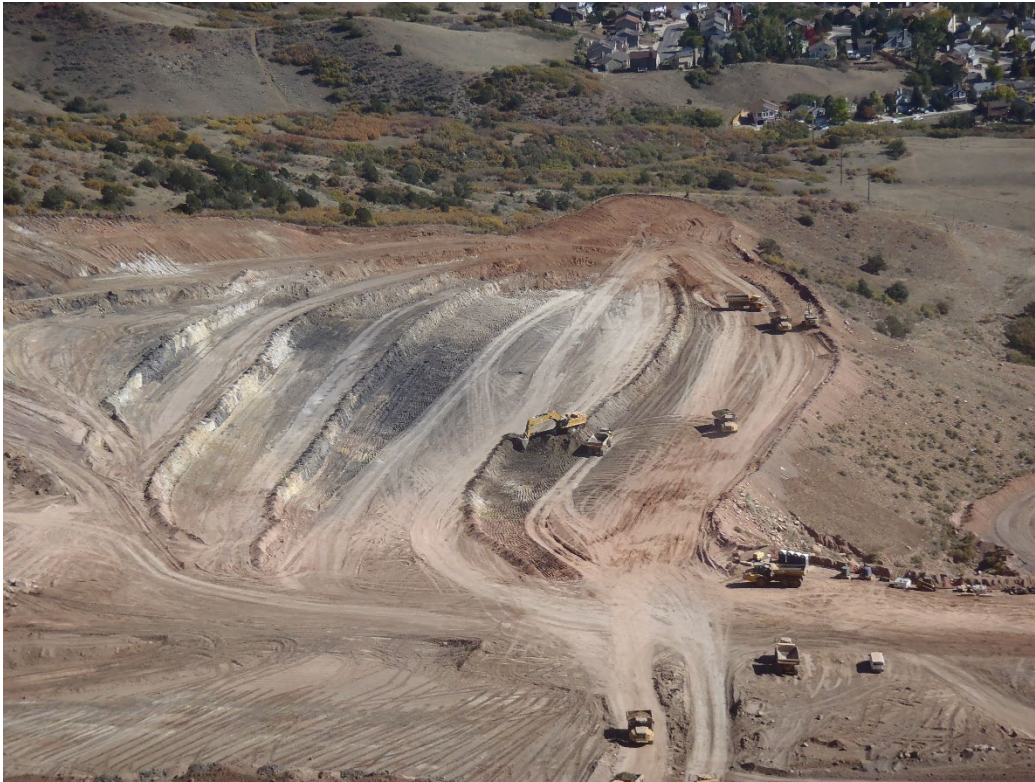
Photo 2. Benched borrow area (looking east from top of highwall).

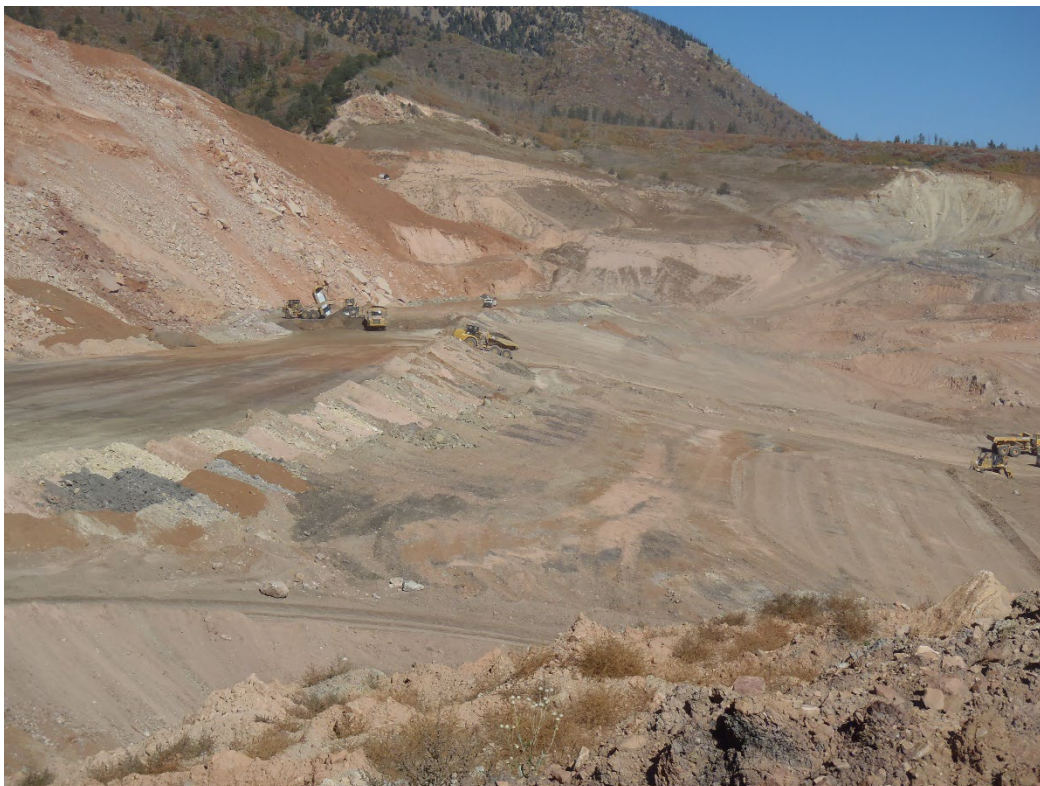
Photo 3. Fill placement in central backfill area (looking north from south overlook).

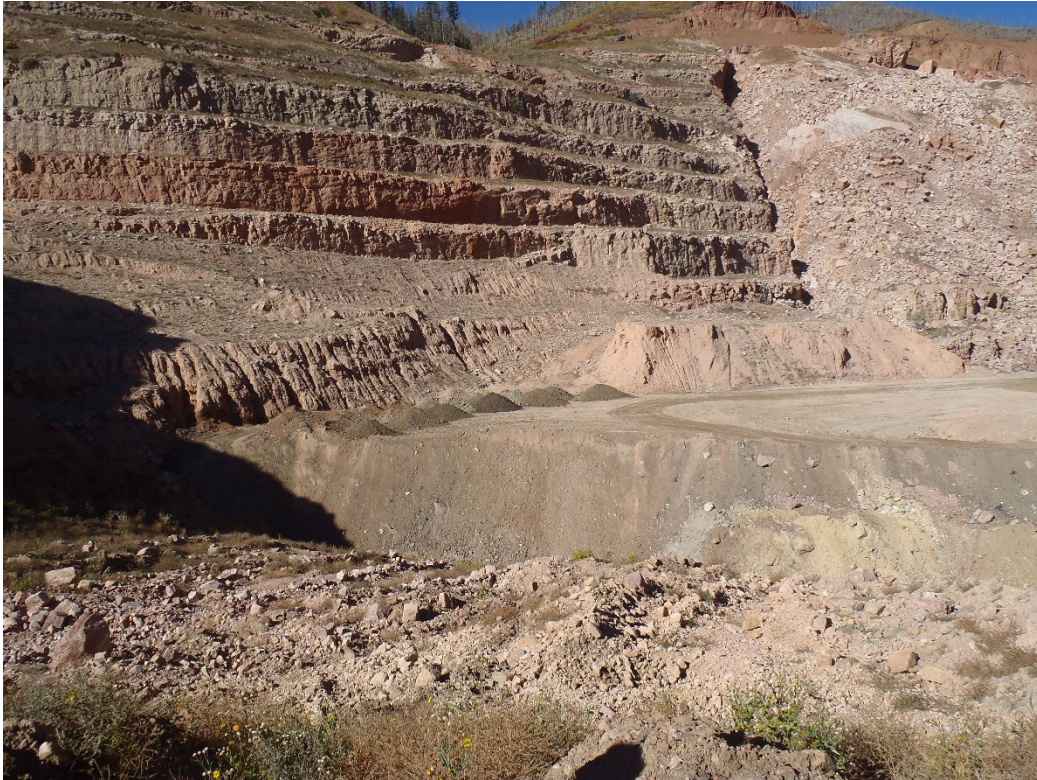
Photo 4. Imported backfill on south end (looking NW from south overlook).

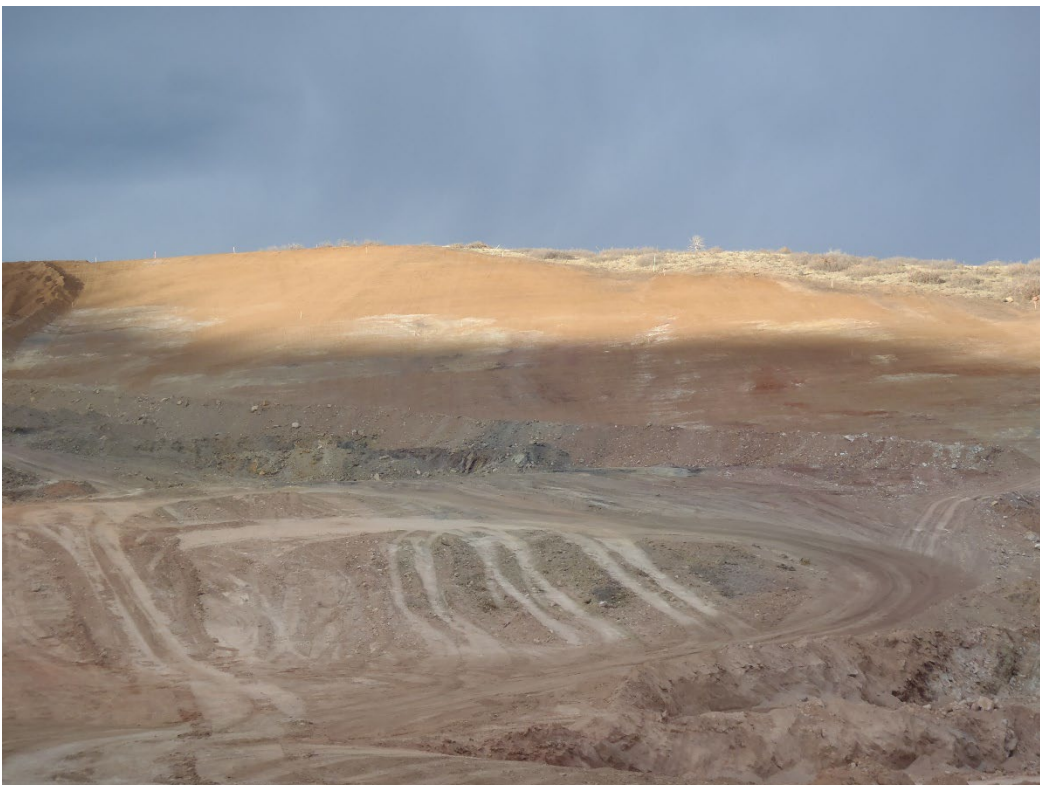
On October 25th the CMC invited several agencies, including the DRMS to tour the reclamation project to provide acknowledgement of reaching the point of having placed 50 percent of the required backfill (1.7 million CY). CMC pointed out a five to six acre area on the north borrow area that had been graded and was ready for topsoil placement (see **Photo 5**)

Photo 5. 10/25/22 – Graded north borrow area ready for topsoil placement (looking north from south overlook).

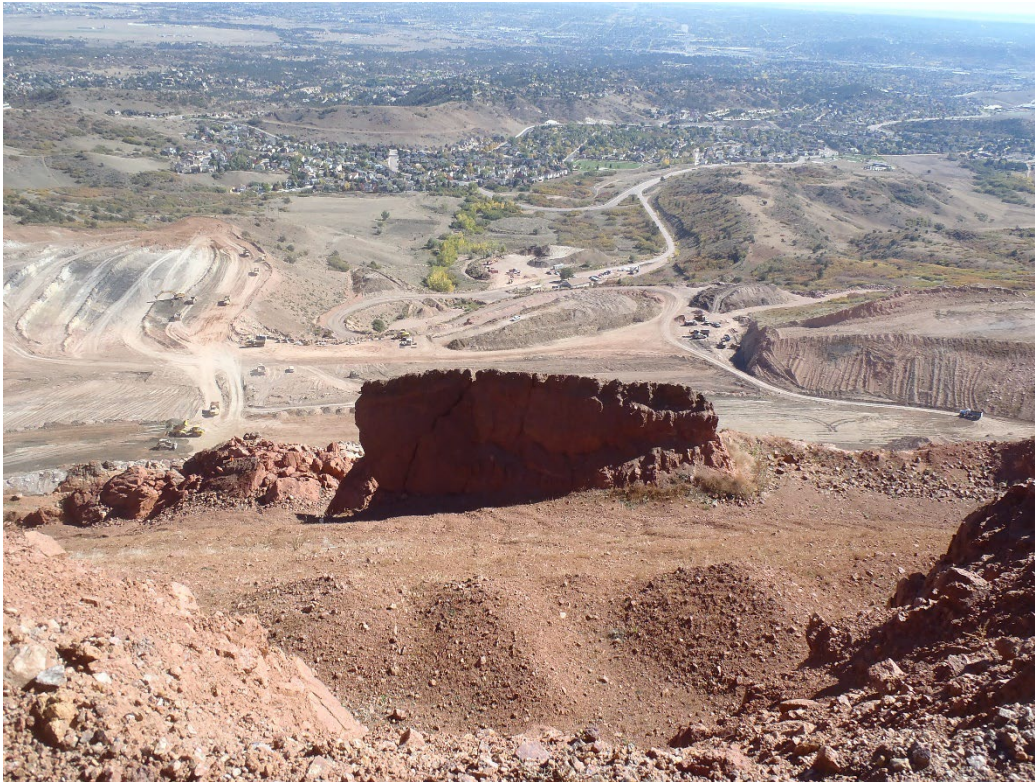
Explosives: Site representatives stated the plan for using explosives was limited to the very large boulder near the top of the slide area (see **Photo 6**). This boulder has a large fracture on the west side (see **Photo 7**) and

Photo 6. West side of large boulder planned to be blasted (looking east).

should be removed for post-mine land use safety.

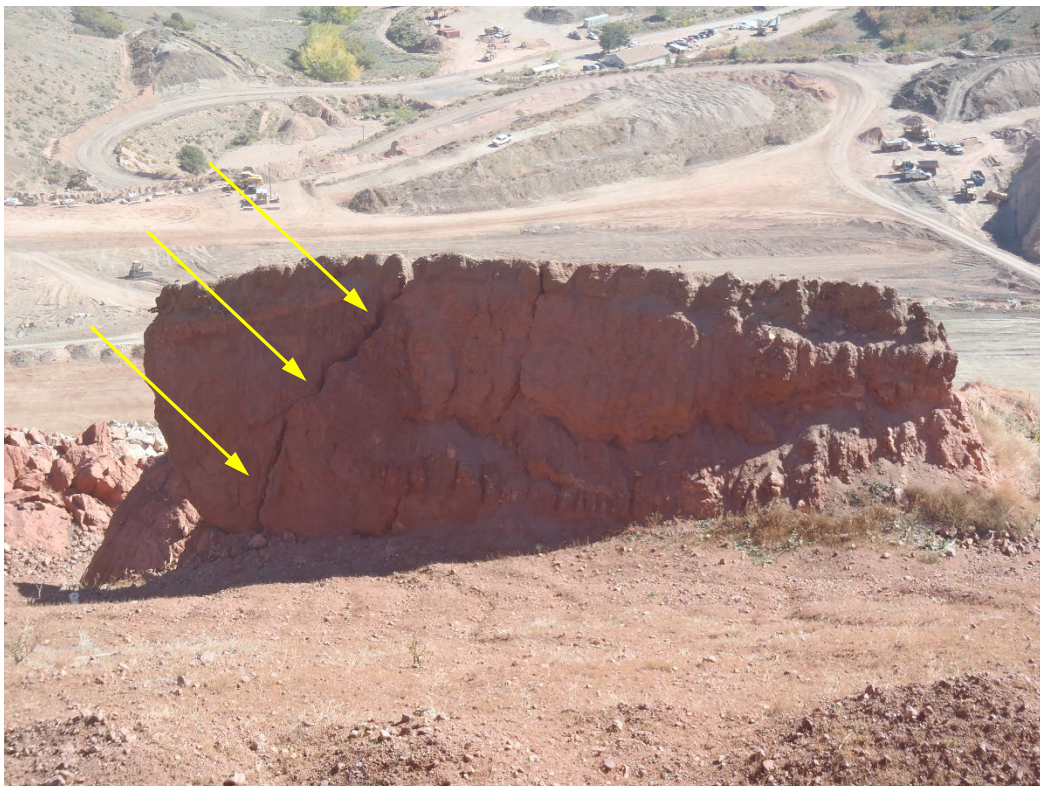
Photo 7. Crack in large boulder (arrows).

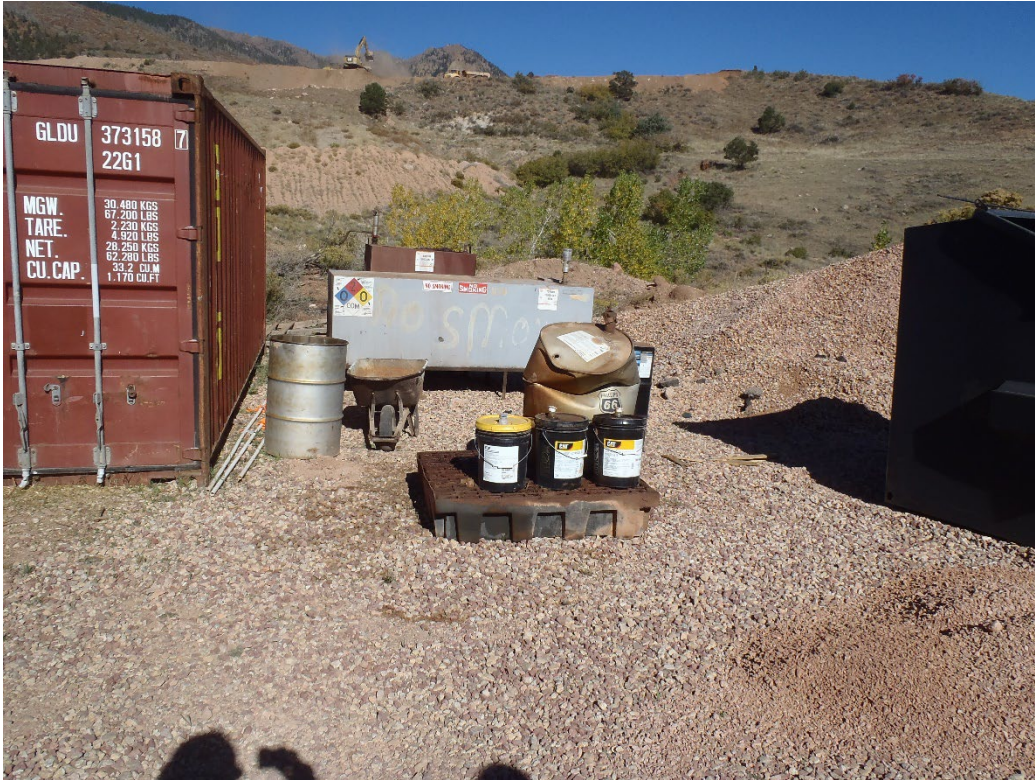
Environmental: No oil or fuel spills were observed on either site visit. On October 13th, containers being used for the disposal of used petroleum products were observed in the staging area north of the office (see **Photos 8 and 9**). CMC continues to treat noxious weeds (primarily knapweed). No impacts to wildlife were noted. Bighorn sheep were observed in the north borrow area.

Photo 8. Containers used for petroleum product disposal (staging area north of main office).

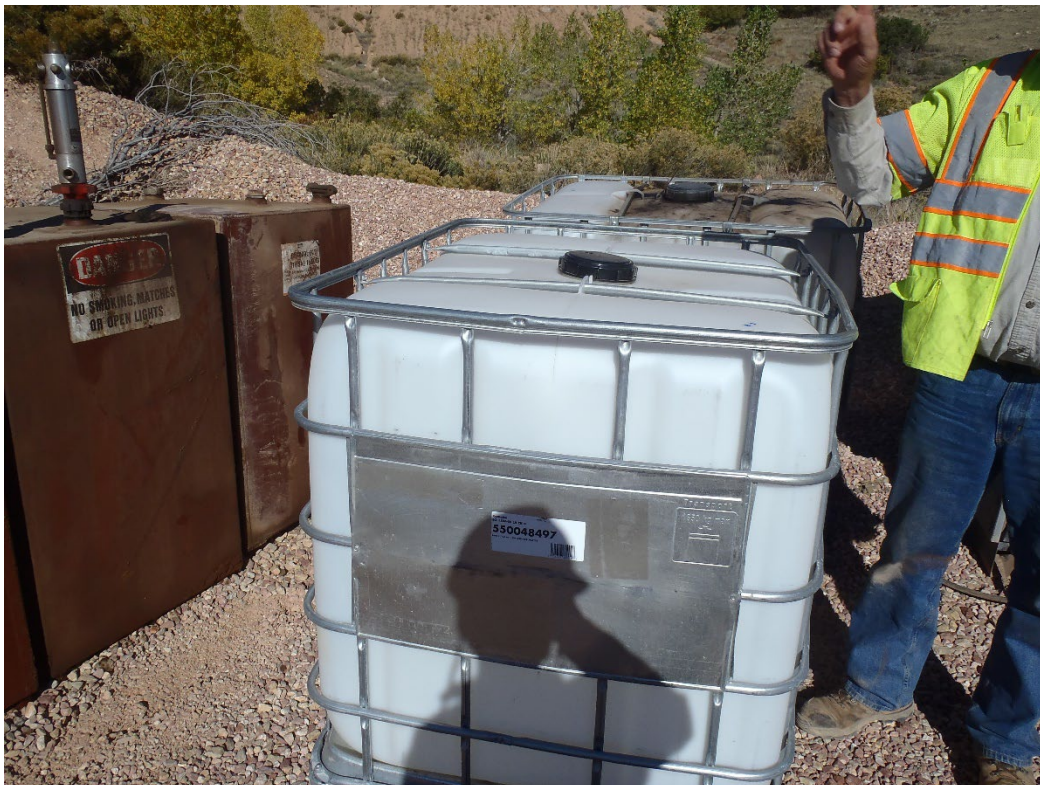
Photo 9. Totes used for petroleum product disposal (staging area north of main office).
