MINERALS PROGRAM INSPECTION REPORT
PHONE: (303) 866-3567

MINE NAME: Cheyenne County State Land Board Pit	MINE/PROSPECTING ID#: M-2022-030	MINERAL: Aggregate	COUNTY: Cheyenne
INSPECTION TYPE: Monitoring	WEATHER: Clear	INSP. DATE: October 25, 2022	INSP. TIME: 11:45
OPERATOR: A&S Construction Company	OPERATOR REPRESENTATIVE: Chris Robinette	TYPE OF OPERATION: 111 - Construction by Government Agency	
REASON FOR INSPECTION: Normal I&E Program	BOND CALCULATION TYPE:	BOND AMOUNT: \$75,000.00	
DATE OF COMPLAINT: NA	POST INSP. CONTACTS: None	JOINT INSP. AGENCY: None	
INSPECTOR(S): Nikie Gagnon	INSPECTOR'S SIGNATURE:

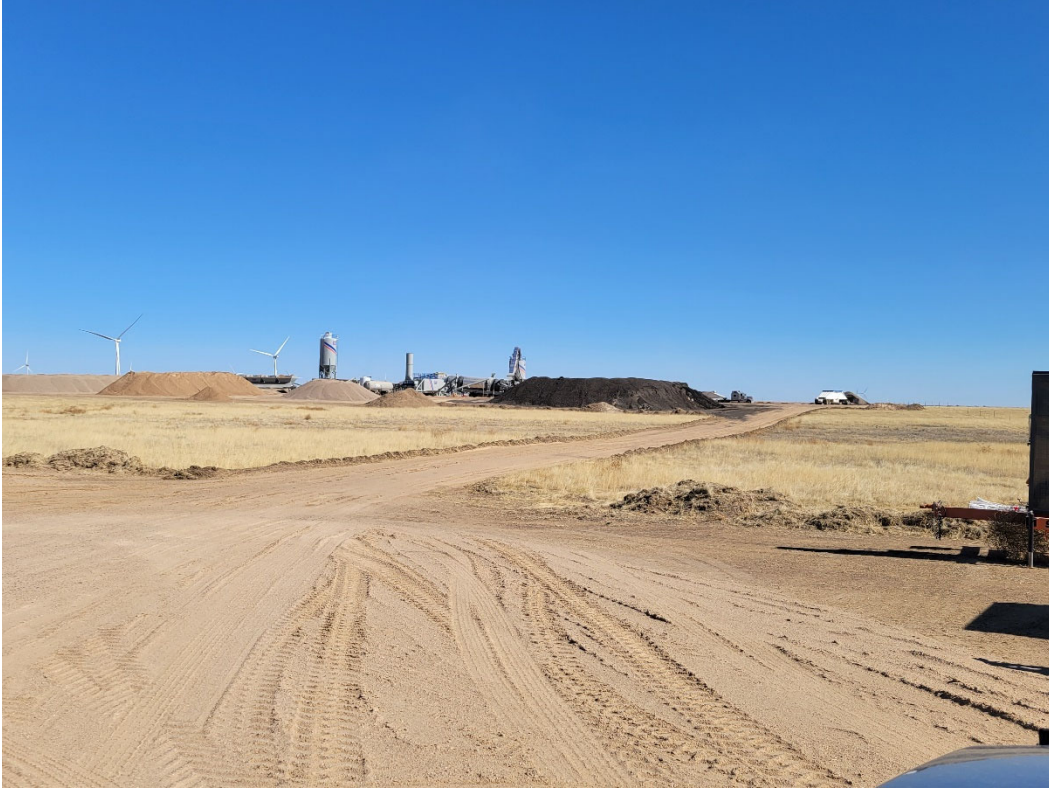
Looking east across hot plant and processing area

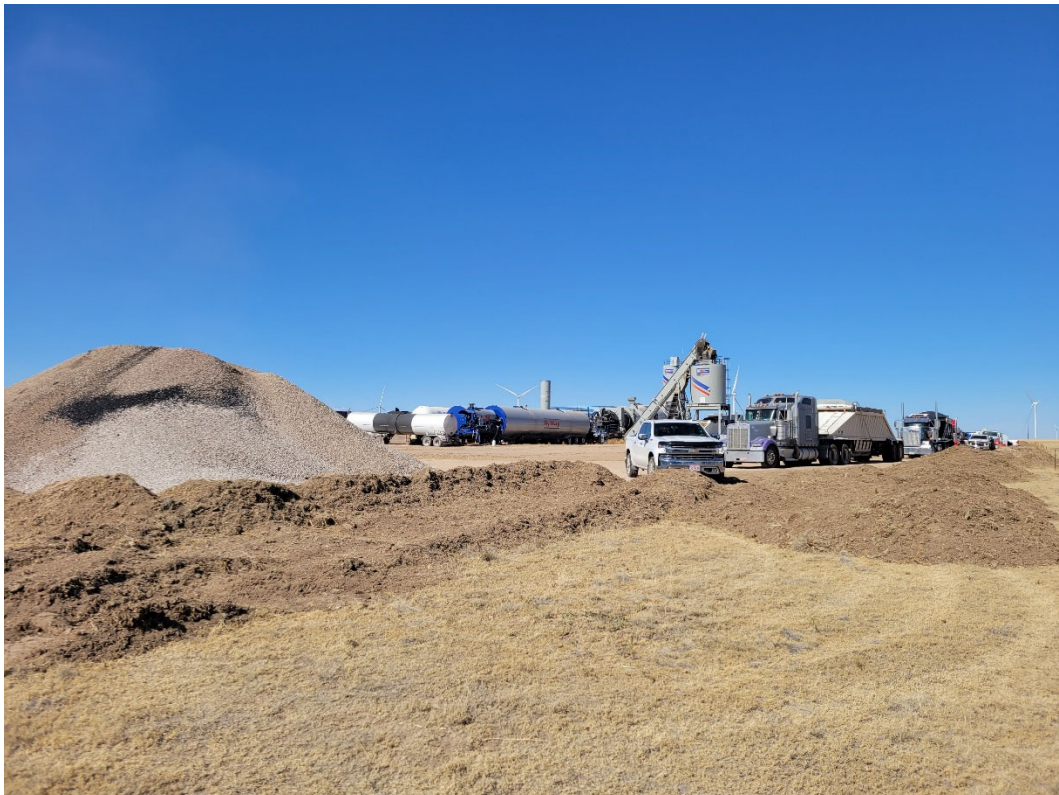
The site was dry at the time of inspection. No signs of offsite drainage or impacts from the processing area were noted. A soil berm runs around the processing area to contain storm runoff.

Looking west from southwest corner of permit area. Soil berm surrounds processing area.

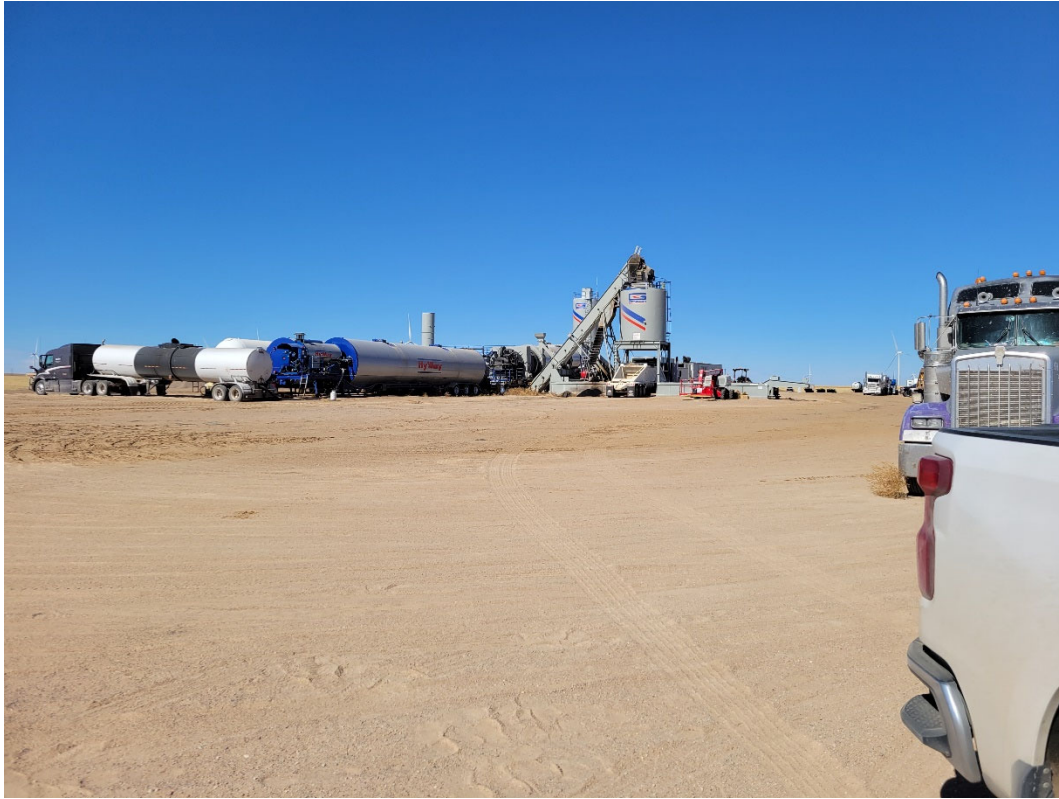
The site was very active during the inspection. Trucks were hauling material from the hot plant constructed in the southwest corner of the permit area. Stockpiles of material were located in the processing areas adjacent to the hot plant. The Operator indicated it is unlikely that they will mine the site because testing of the material indicated it is not the product they need.

Hot plant and processing area.

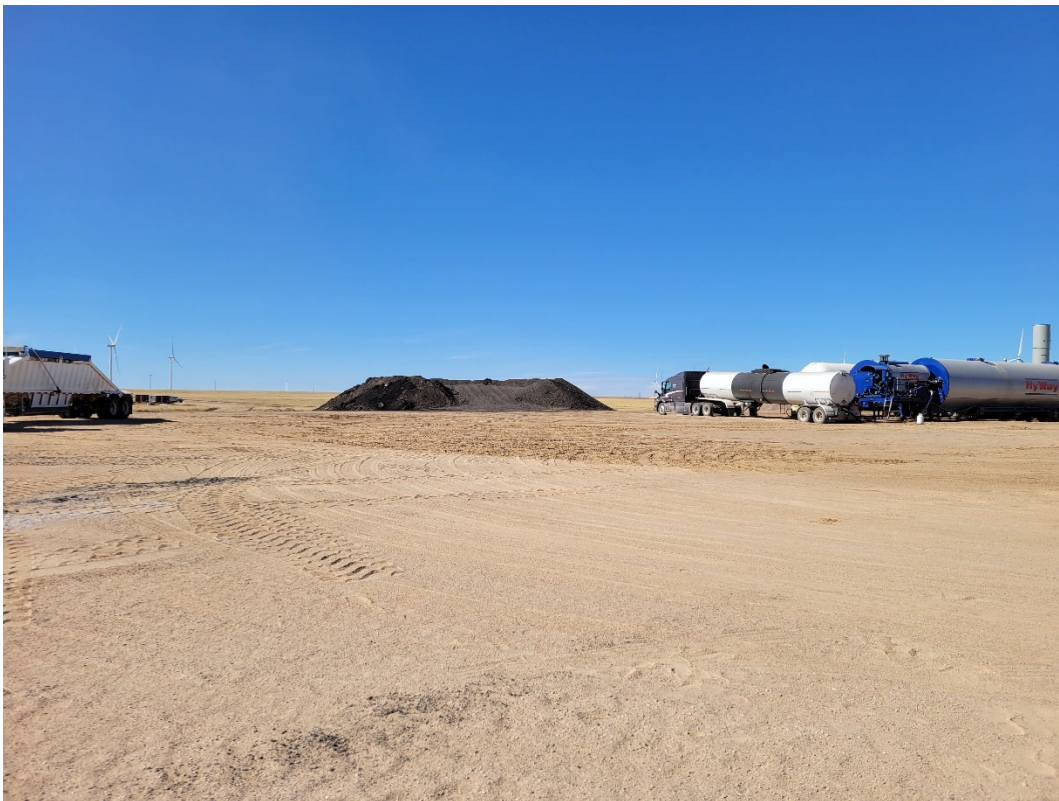
Stockpiles in the processing area.

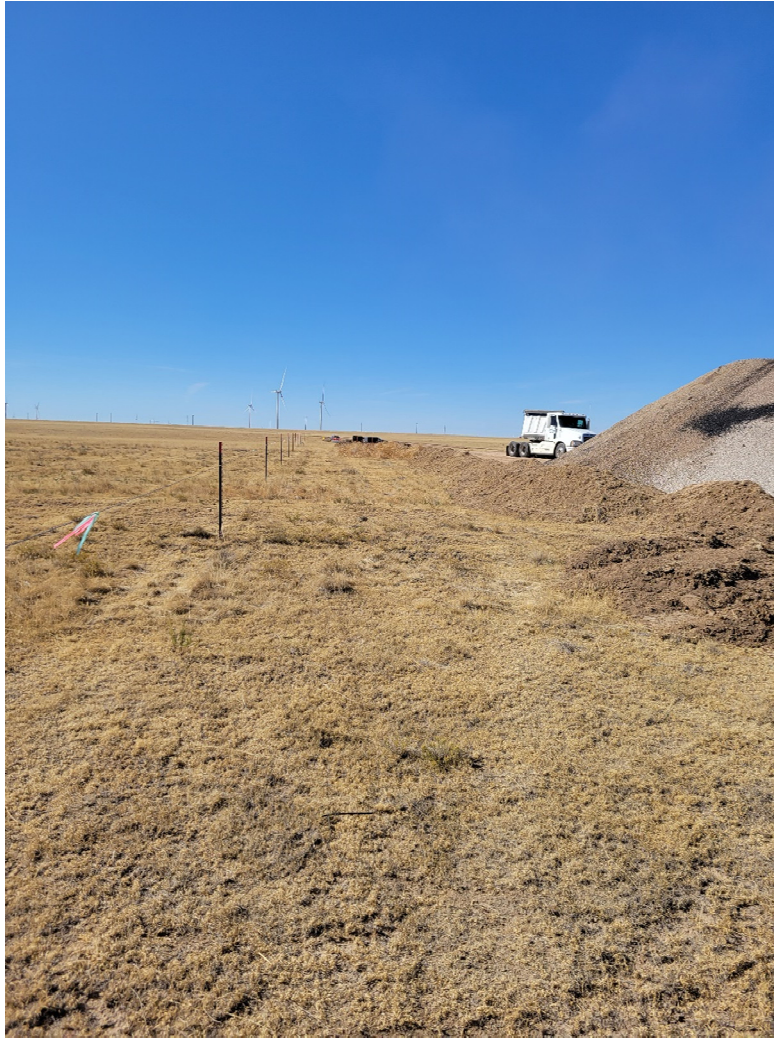
Overburden was pushed into berms surrounding the processing and hot plant area. These piles appear stable during the inspection.

Southern boundary looking west along the fence line.
Stockpiles and soil berm surrounds processing area.

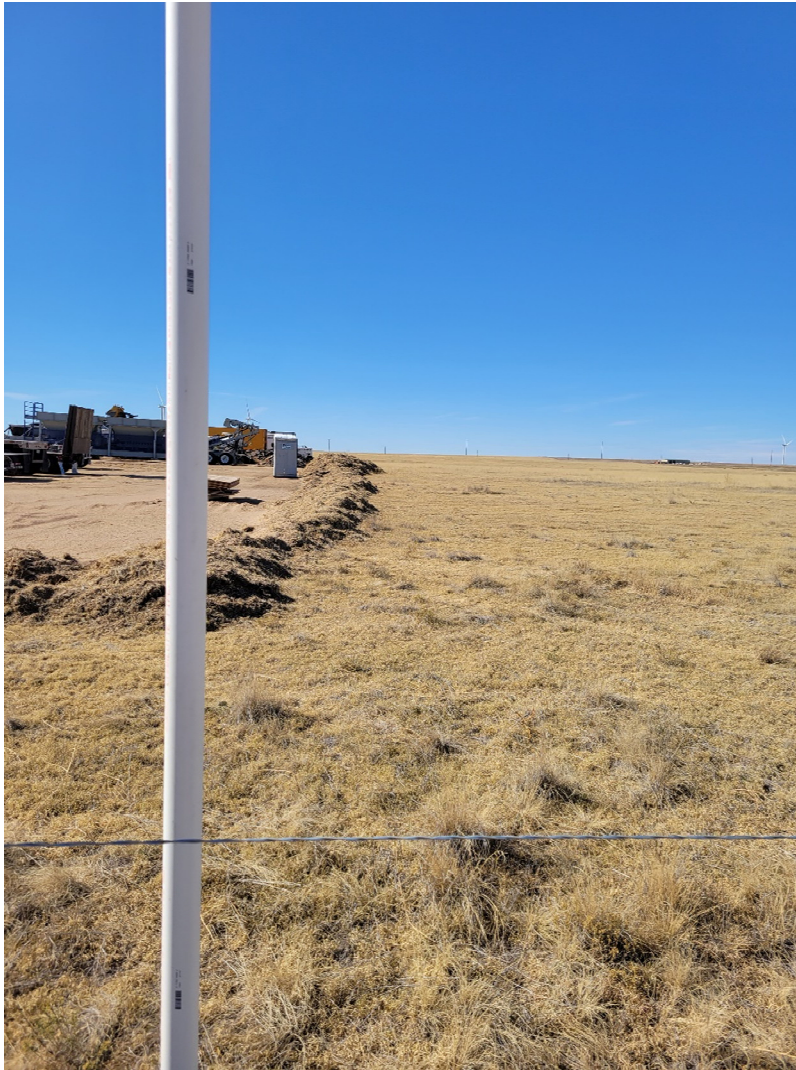
Northeast corner, soil berm surrounds processing area.

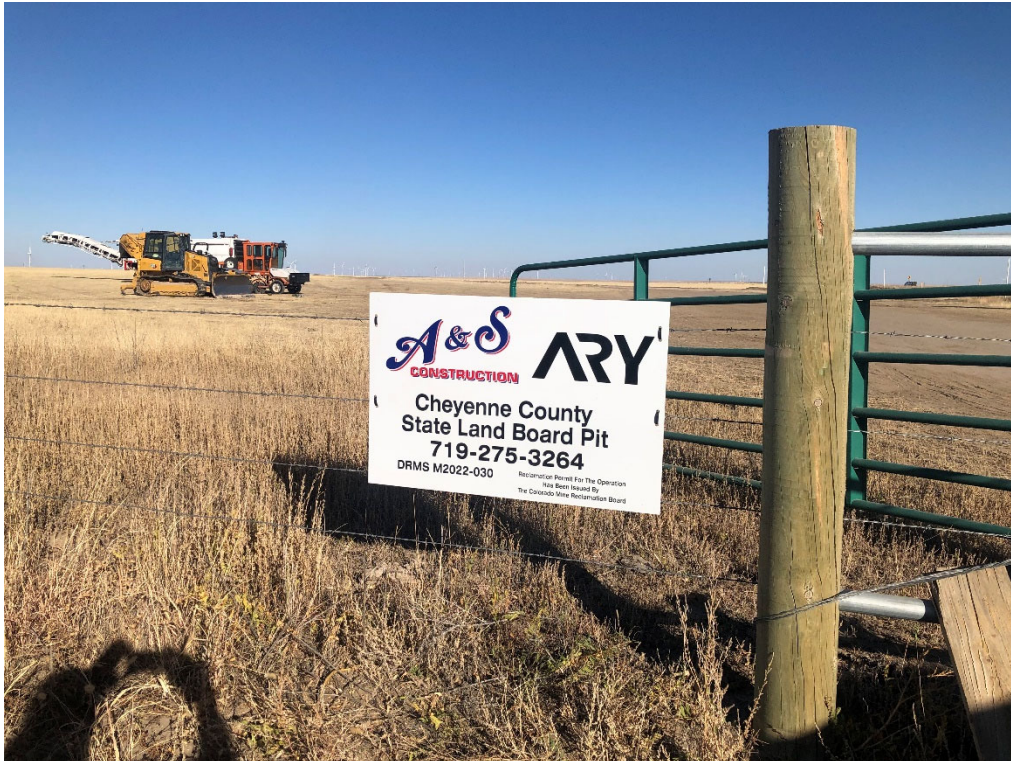
During the inspection, the original notice of application was posted at the entrance to the site, however the required permit identification sign was not in place. On October 28, 2022, the Division received a photo from the Operator showing a new mine sign in place at the entrance to the mine. The permit boundary was properly marked by white posts around the perimeter and along the access road. A barbed wire fence runs around the permit area.

New sign in place at front entrance. Photo taken by Operator and sent to the Division.

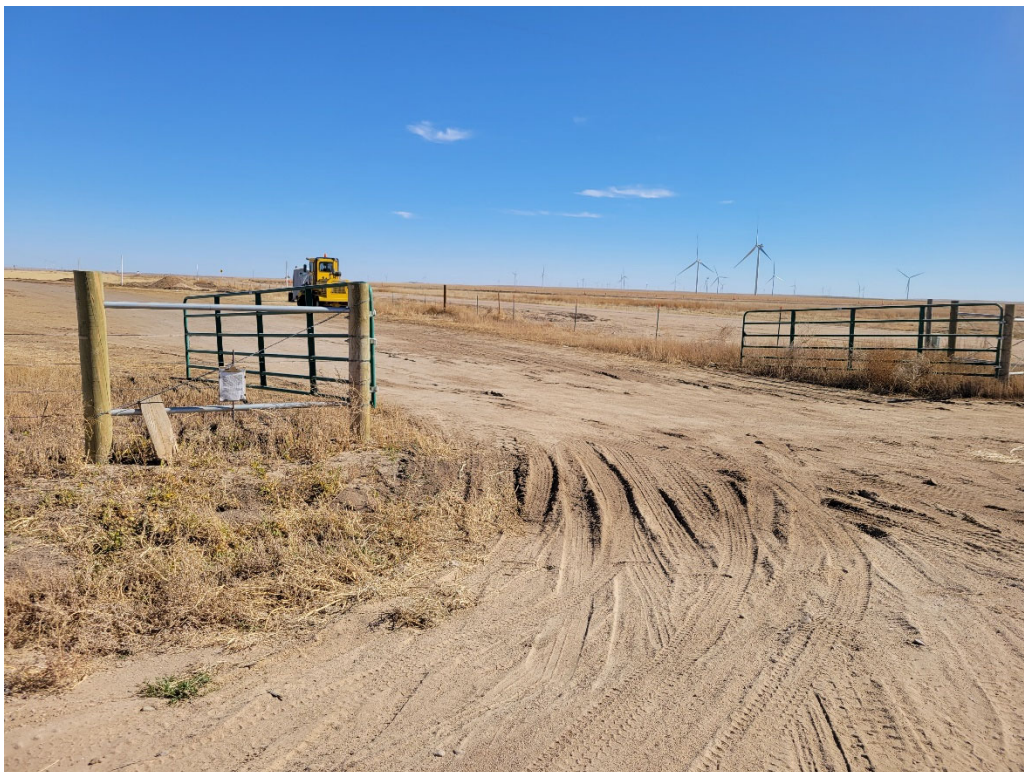
Front entrance and access road.

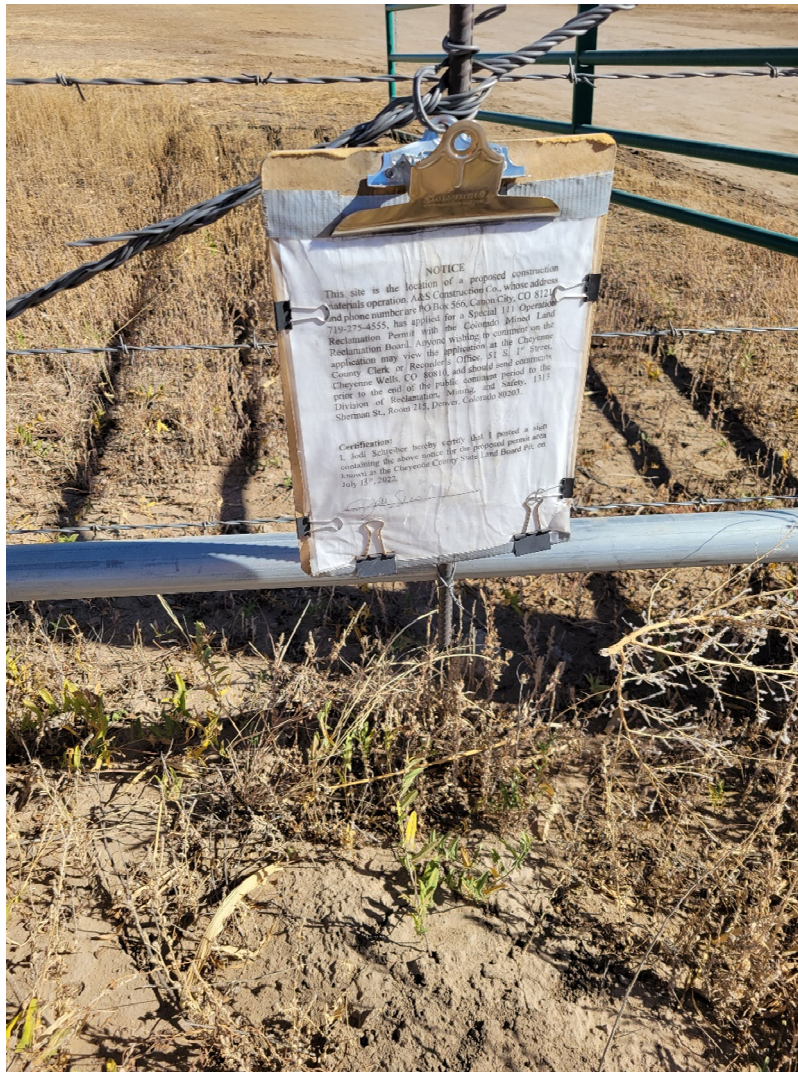
Notice of pending application posted on the gate during the inspection.

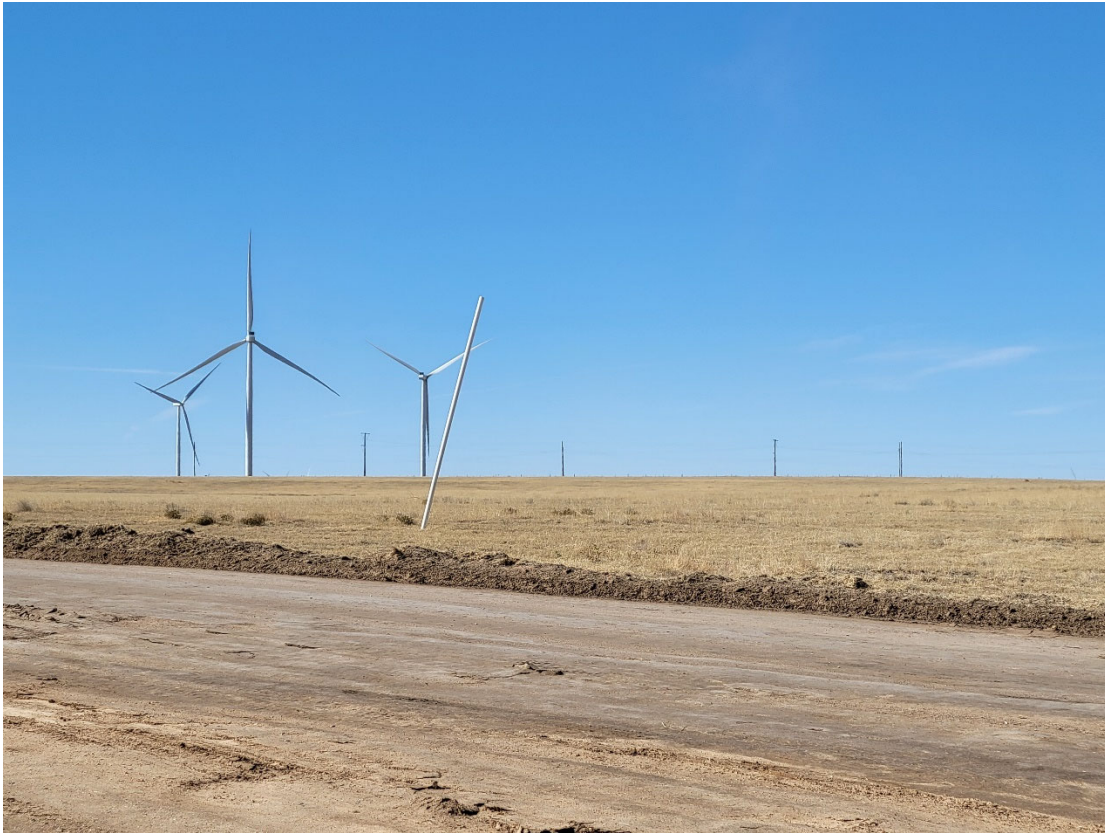
A graded access road leads to the processing area. Overburden is pushed to the side of the road to be used for future reclamation. The road boundary is marked with white posts.

Graded access road, white post marks permit boundary along road.
